Risø-R-1481(EN)

Final Report on In-Reactor Tensile Tests on OFHC –Copper and CuCrZr Alloy

B.N. Singh, D.J. Edwards, S. Tähtinen,
P. Moilanen, P. Jacquet and J. Dekeyser

Contract no.: TW2-TVV-SITU
(EFDA)

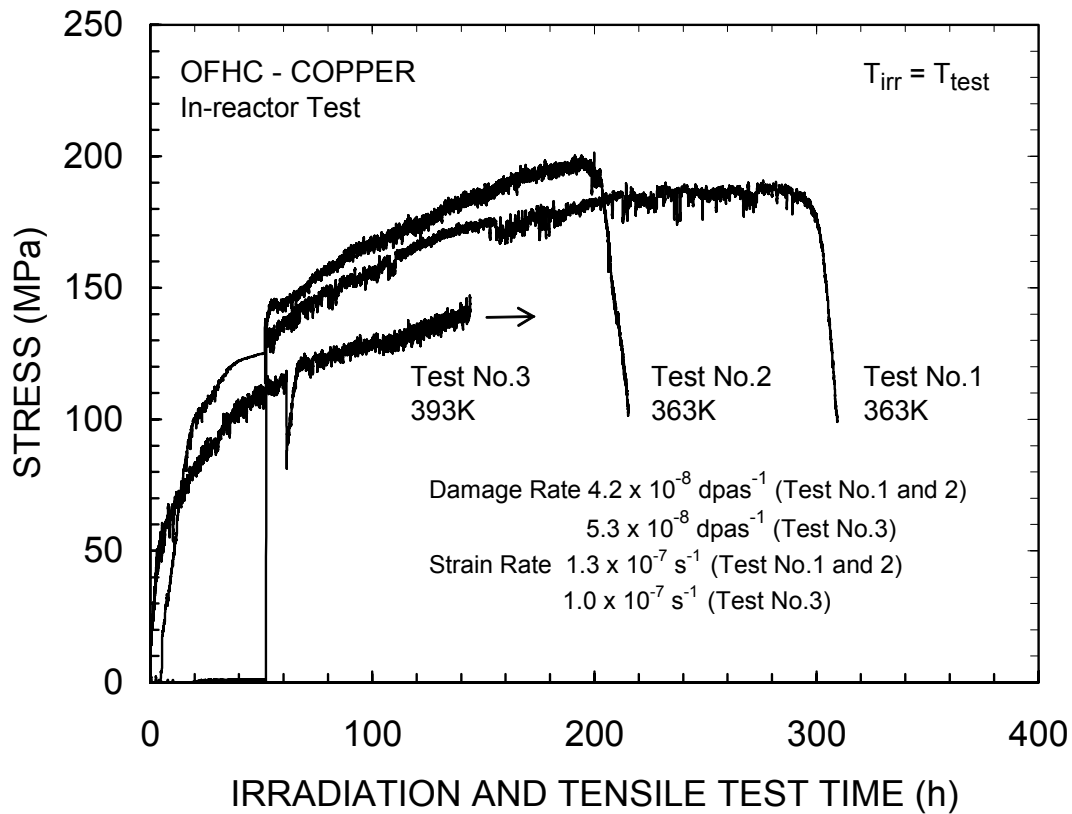
Figure 3. Continuously measured stress response as a function of irradiation and tensile test time during the in-reactor tensile tests. Note that the specimens in the Test No. 1, 2, 3 received different level of pre-loading displacement dose before the actual tensile test was activated and the specimens started experiencing applied stress. As a result, different amounts of irradiation-induced defects and their clusters accumulated during the pre-yield period in the absence of dislocation generation.

in figure 3 for the irradiation and test temperatures of 363K (Test No. 1 and 2) and 393K (Test No. 3). As can be seen in figure 3, the actual tensile test on these specimens were initiated at three different times after the specimens were brought in the reactor. In other words, the specimens in Test No. 1, 2 and 3 received different levels of displacement doses (see Table 1) while they were still at zero stress. Doses at which the yield point was observed and at which the tensile test was discontinued are also given in Table 1. The tensile properties of un-irradiated, post-irradiated and in-reactor tensile tested specimens at 363 and 393K are summarised in Table 2. The results presented in figure 3 clearly illustrate that the temporal evolution of the stress response of the material under the dynamic testing conditions is significantly affected for the whole lifetime of the test by the pre-loading displacement dose level. It is self-evident from the results that it is not only the yield strength but also the maximum level of hardening and the total elongation (i.e. lifetime) of the material are noticeably dependent on the level of pre-loading displacement dose level. It is rather surprising that even a pre-loading dose level of only 1.5×10^{-5} dpa (see Table 1) significantly alters the stress response of the material (Test No. 3, figure 3). It should be mentioned here that the influence of the pre-loading dose levels on the microstructural response is described in section 3.2.

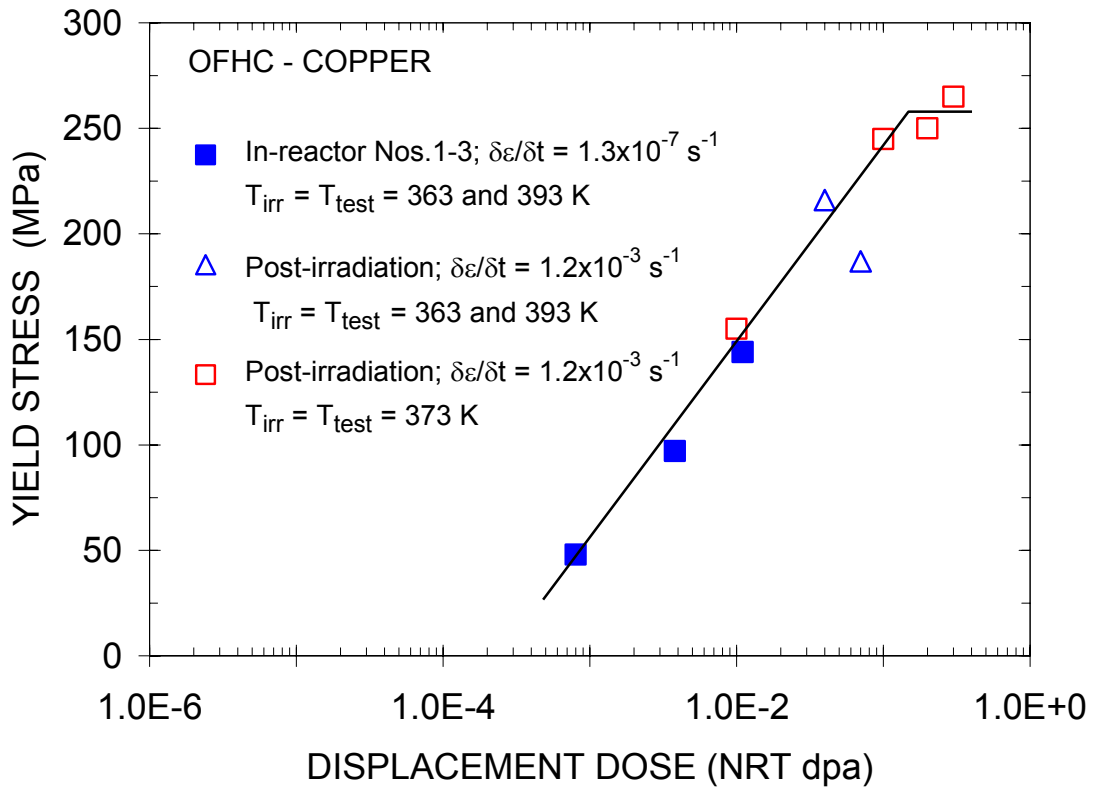
Figure 5. Displacement dose dependence of the yield stress for the in-reactor as well as post-irradiation tests at 363 – 393K. It is interesting to note that the dose dependence of the yield stress for the in-reactor rests and the post-irradiation tests is almost identical.

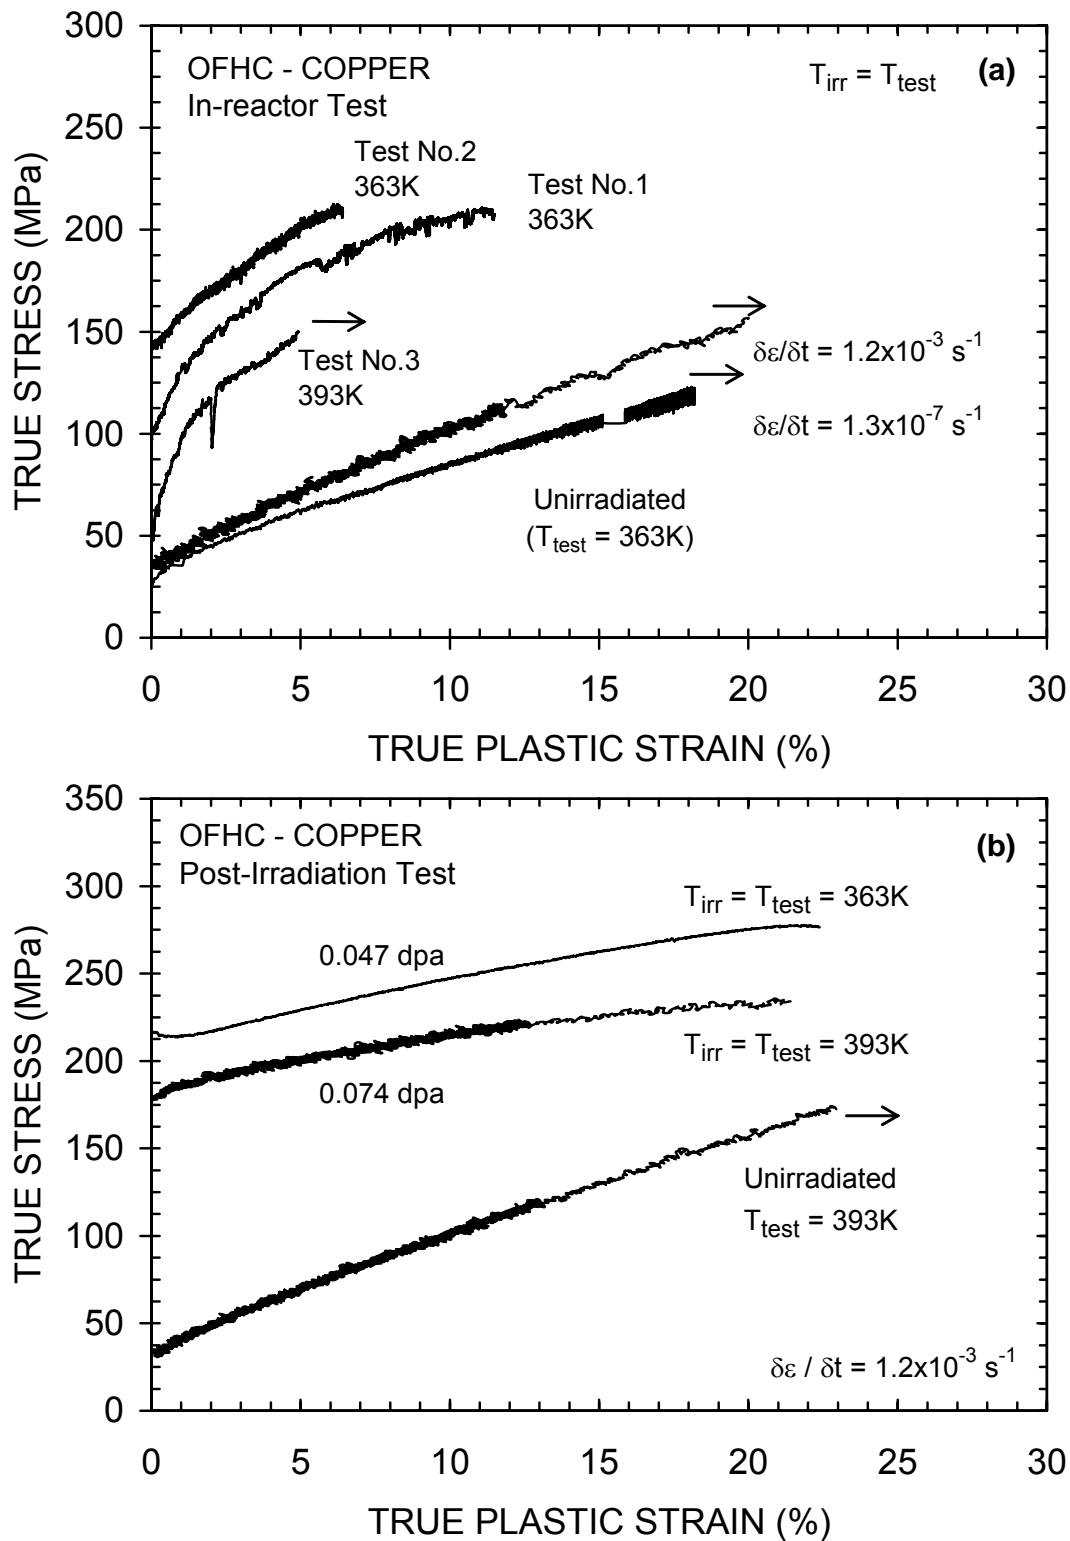
Figure 6. True stress – true strain curves for (a) the in-reactor tests and (b) the post-irradiation tests at 363 and 393 K. The corresponding curves for the unirradiated specimens are also shown. Note the difference in the hardening behaviour between the in-reactor tests and the post-irradiation tests.

In the case of the in-reactor tensile tests, on the other hand, in order to understand the dynamic nature of the combined effects of the applied stress and displacement damage, it is necessary to evaluate the hardening behaviour as a function of irradiation and test time (i.e. concurrently accumulating displacement dose and plastic strain). In other words, we need to determine the effect of irradiation not only on the yield stress but also on the hardening behaviour (i.e. the flow stress) in the post-yield deformation regime as a function of both displacement dose level and plastic strain. To facilitate such analyses, we first present the true stress – true strain curves for the in-reactor tensile tests in figure 6(a). Figure 6(b) shows the true stress – true strain curves for the corresponding post-irradiation tests carried out at 363 and 393 K. The true stress – true strain curves for the unirradiated reference specimens tested at 363 and 393 K are also shown in figures 6(a) and 6(b).

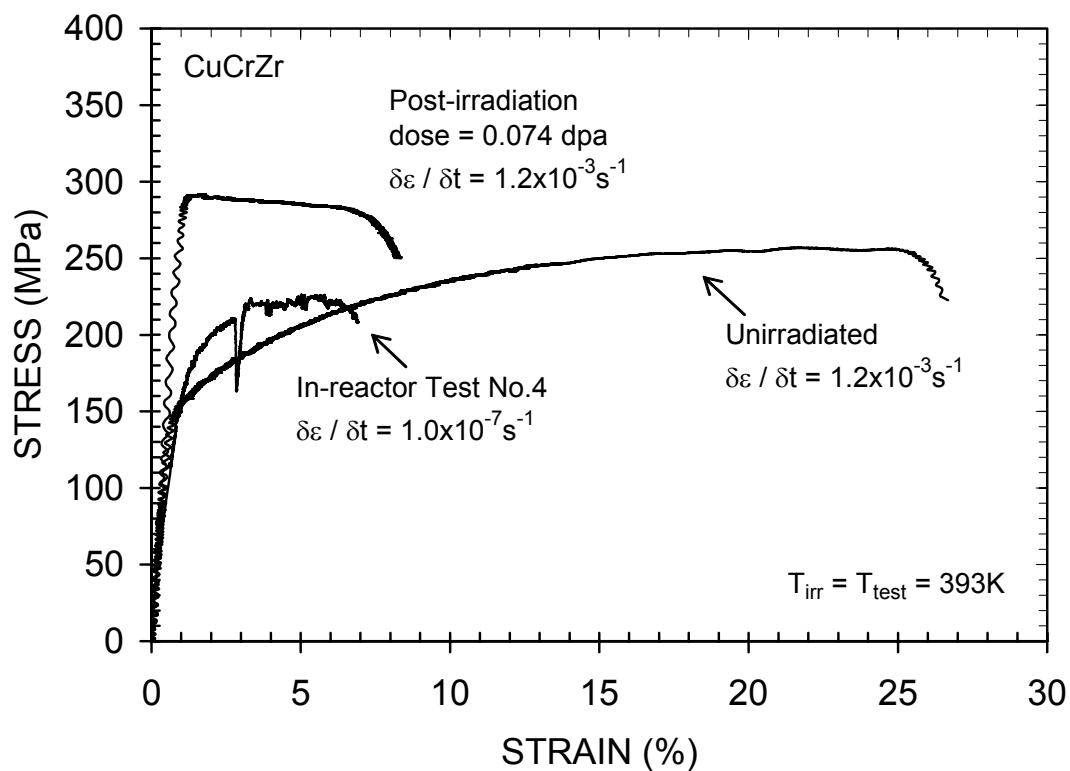
Figure 9. Stress-strain curves for the prime aged CuCrZr alloy at 393K obtained during the in-reactor test (Test No. 4). For comparison, the results for the out-of-pile tests on the unirradiated and post-irradiated (0.074 dpa) CuCrZr specimens are also shown. Note that the in-reactor test was terminated already at a dose level of ~ 0.037 dpa because of the onset of fracture.

The engineering stress-strain curve for the in-reactor Test No. 4 on CuCrZr specimen is shown in figure 9. The stress-strain curve was constructed from the raw data collected continuously during the in-reactor test in terms of the stress response as a function of irradiation and tensile test time, as shown in figure 3 for Tests No. 1, 2 and 3. For comparison, the stress-strain curves for specimens tested out of pile at 393K in the un-irradiated and post-irradiation conditions are also shown in figure 9. The specimen used for the post-irradiation test was irradiated in the same test module used for the in-reactor Test No. 4 at 393K. Note that the post-irradiated specimens received a displacement dose of 0.074 dpa.

The stress-strain curve for the in-reactor Test No. 4 (figure 9) demonstrates that, like in the case of pure copper, the plastic deformation even in the CuCrZr specimen occurs in a homogeneous fashion and without any transient in the form of a yield drop. It is interesting to note, however, that the level of increase in the hardening in CuCrZr due to irradiation is far less than that in the case of pure copper and comes to saturate at a much lower dose (strain) level. Soon after reaching the saturation level, the specimen begins to neck which leads to the initiation of fracture. Consequently, the specimen yields a uniform elongation of only about 5% (see Table 2).

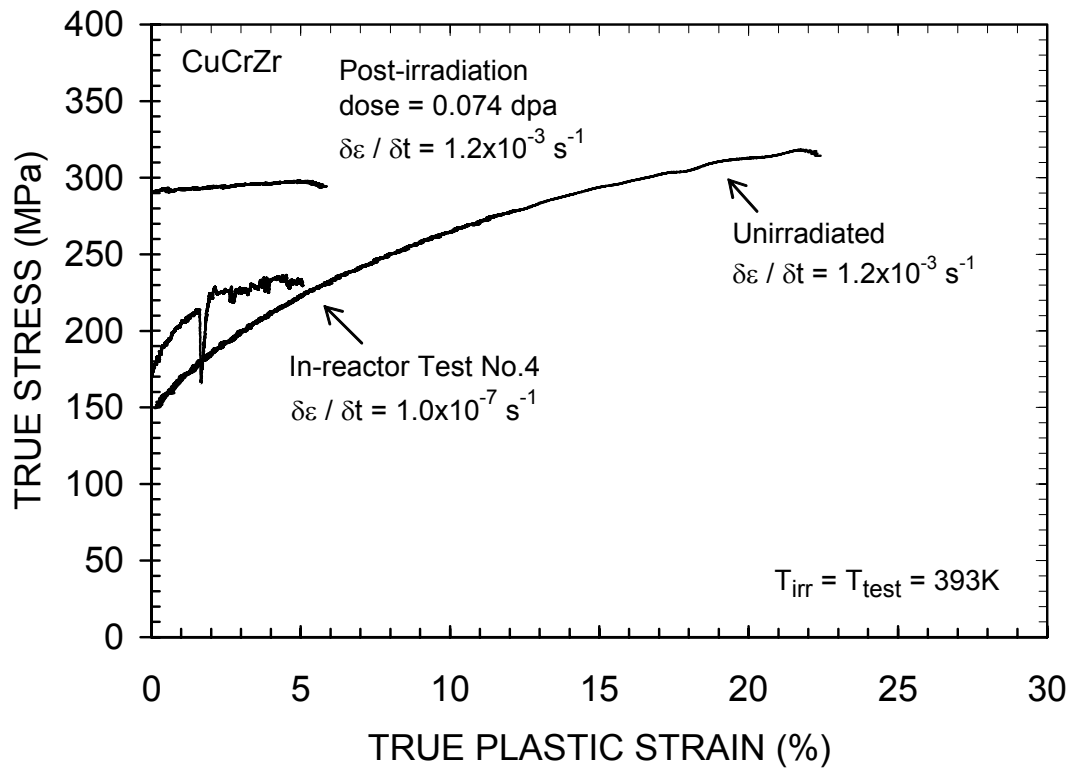
Figure 10. True stress - true strain curves for the CuCrZr alloy corresponding to the engineering stress-strain curves shown in figure 9.

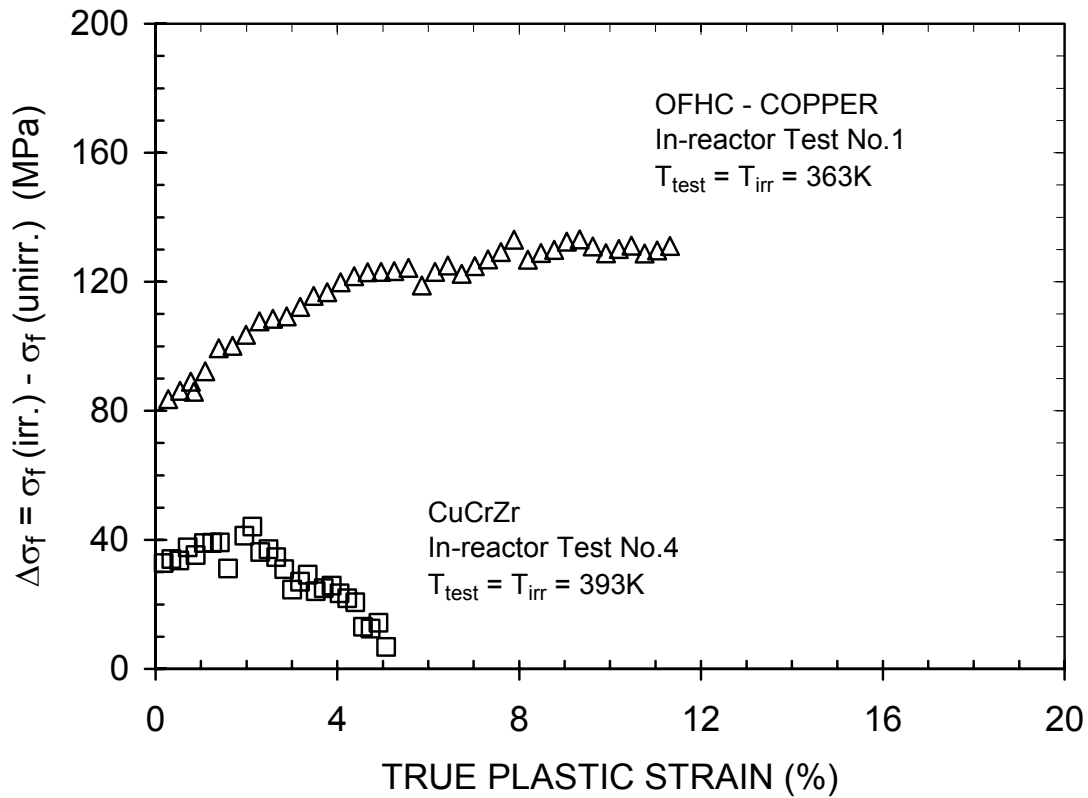
Figure 11. The irradiation-induced increase in the flow stress, $\Delta\sigma_f$, as a function of true plastic strain for the in-reactor test (Test No. 4) on CuCrZr alloy at 393K and the corresponding post-irradiation test carried out also at 393K. Note the difference in the strain rates between the in-reactor and the post-irradiation tests. For comparison the variation of $\Delta\sigma_f$ with strain for OFHC-copper tested at 363K (Test No. 1) is also shown. The dose level of the yield point was very similar in these two tests (see Table 1).

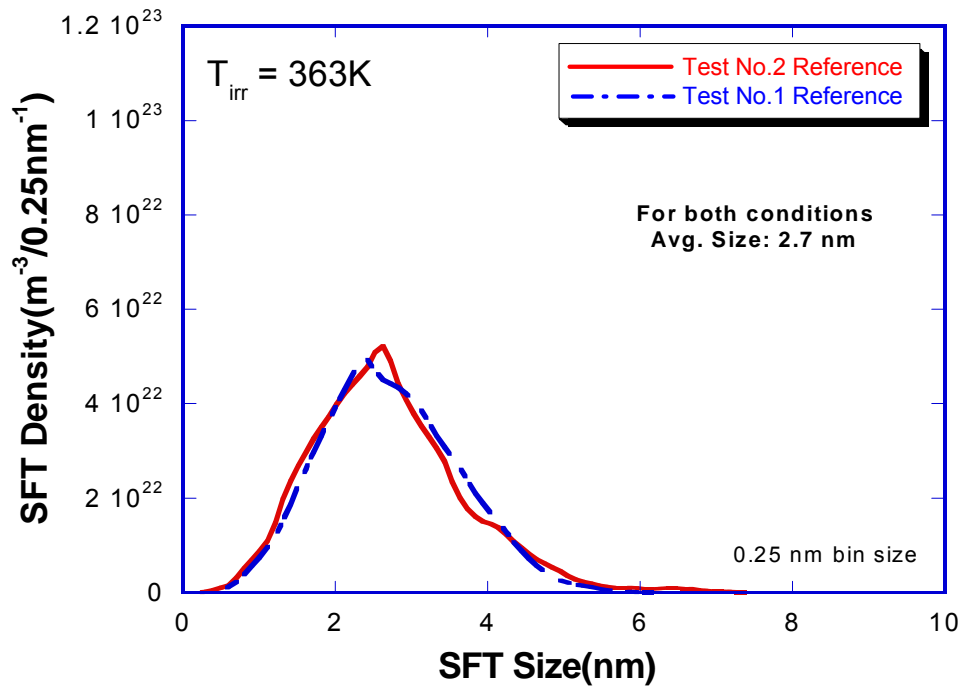
Figure 16. Size distributions of SFTs in the “reference” tensile specimens (without stress) corresponding to the in-reactor Test No. 1 and 2. Note that the size distributions are almost identical and are also similar to the ones reported earlier for the irradiation temperature of 373K (Singh et al. 2001).

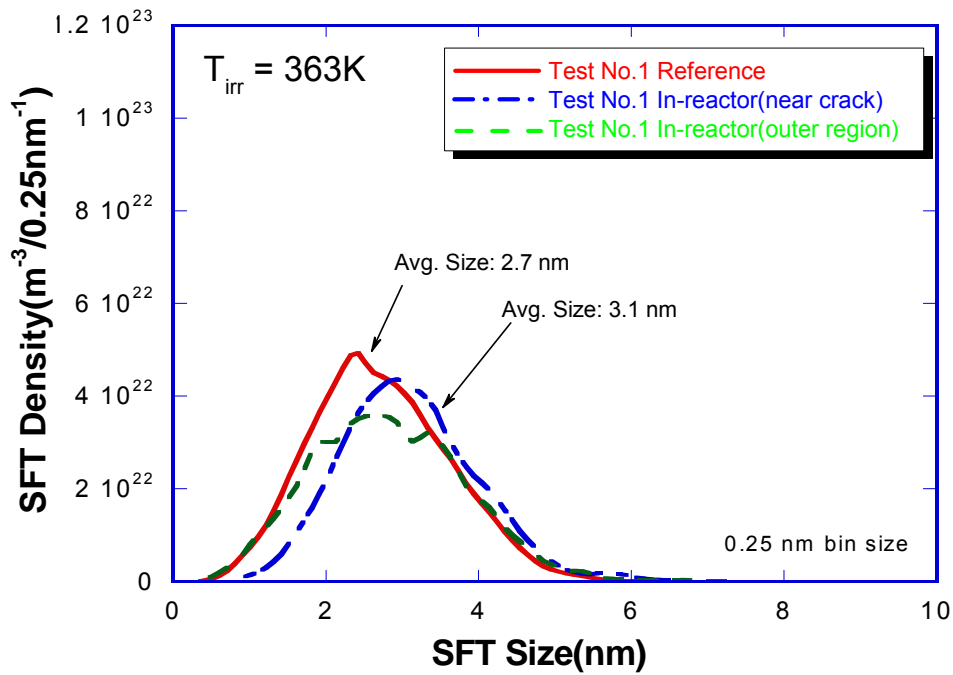
Figure 17. Size distributions of SFTs in the in-reactor tensile tested specimens in Test No. 1. For comparison, the size distributions for the “reference” specimens are also shown. Note the difference in the size distributions between the “reference” specimens and the in-reactor deformed specimen showing a significant decrease in the density of smaller SFTs in the in-reactor deformed specimen. The size distribution in the region away from the crack and the gauge length (i.e. “outer region” where practically no plastic deformation has occurred) is very similar to the one for the undeformed reference specimen.

Figure 17 compares the size distributions of SFT_s for the reference (unstrained) and the strained (in the reactor) specimens irradiated and deformed at 363K to 13% uniform strain. For TEM investigations, discs were prepared of materials taken from near the crack in both strained specimens. In the case of specimen strained to 13% strain, the density of SFT_s smaller than ~2.5 nm is noticeably lower than that in the reference specimen. The density of SFT_s larger than ~3.0 nm is almost the same in reference

(unstrained) and 13% strained specimens (figure 17). The total SFT density in the strained (13%) specimen was found to be lower than that in the reference specimen.

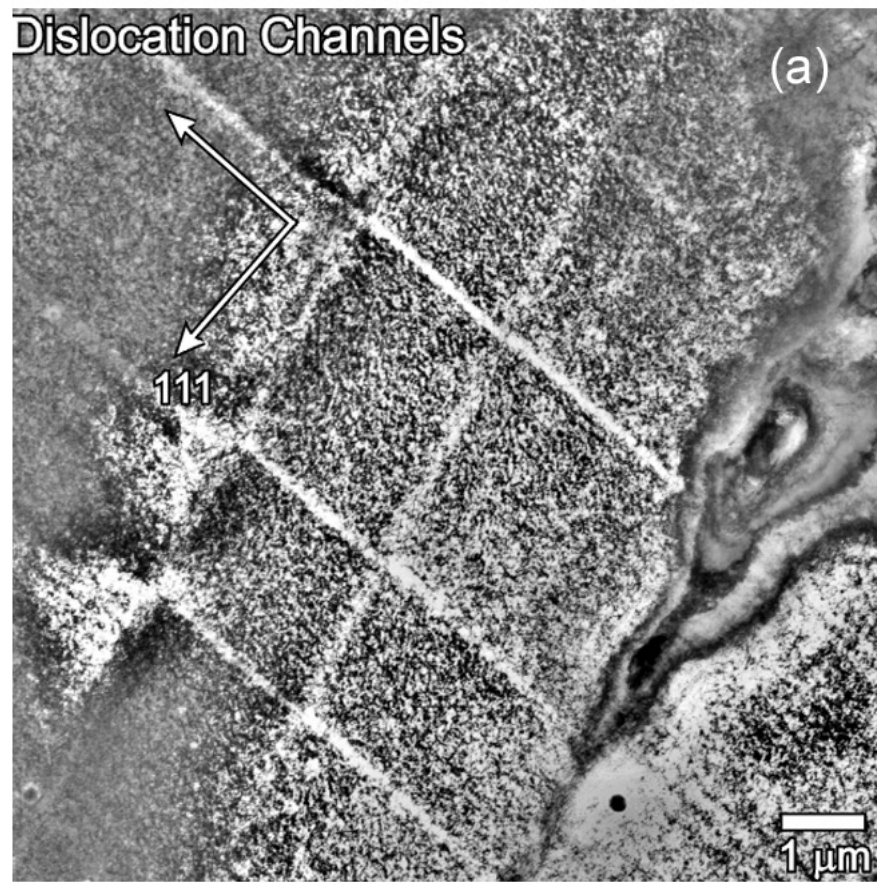
Figure 21. Examples of cleared channels observed in the specimens deformed in the in-reactor tensile tests (a) Test No. 1, (b) Test No. 2 and (c) Test No. 3.
