Meso- and Micro-scale Modelling in China: Site inspection trip to NE China (Dongbei)

Niels G. Mortensen, Jens Carsten Hansen, Yang Zhenbin,
Yu Hongming, Xie Jinfan and Yuan Guoen
Risø-I-2900(EN)
June 2010

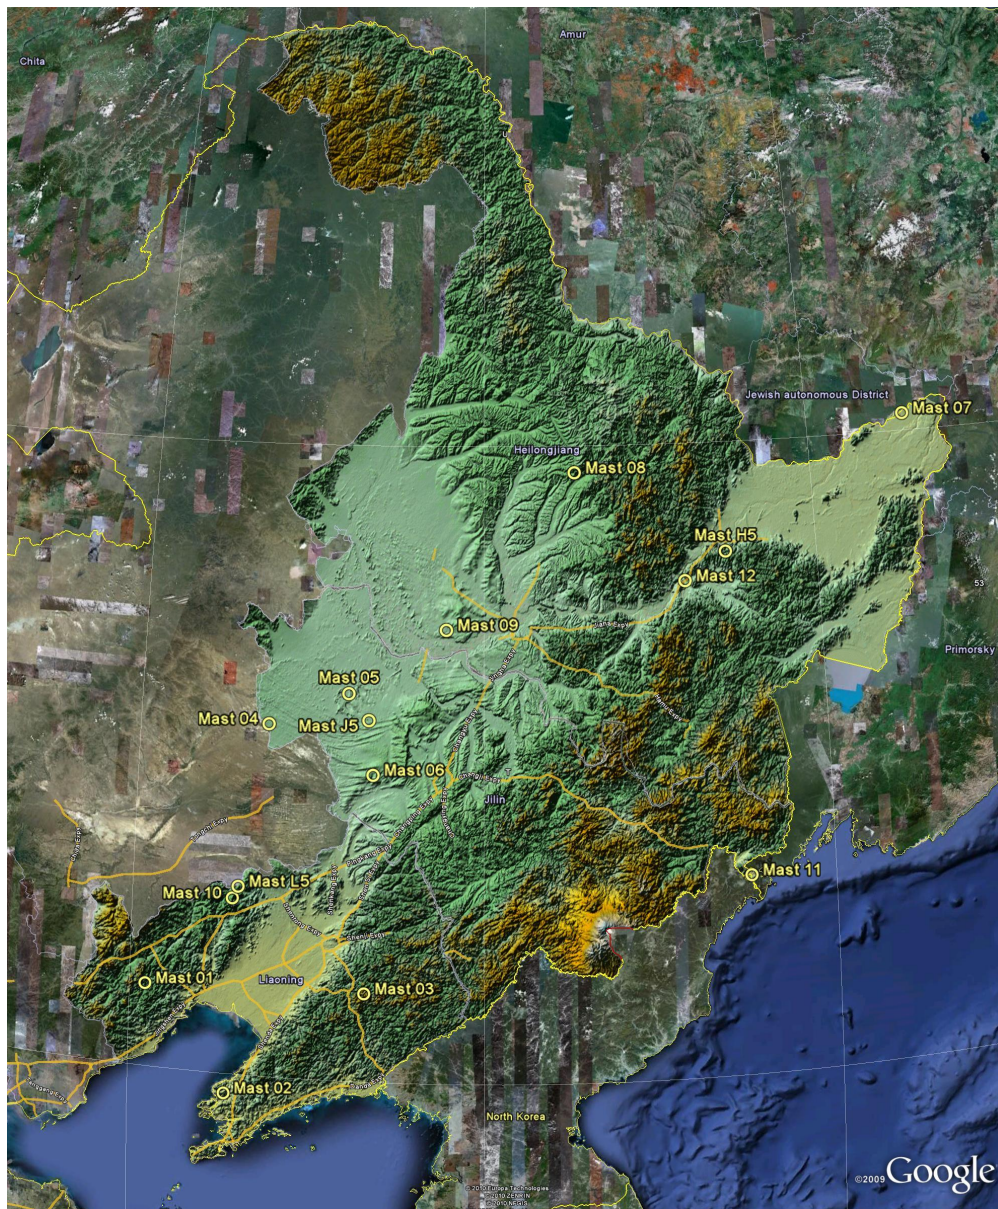
Figure 1. Overview map of Dongbei showing the location of the 15 meteorological masts referred to in the text (Image © 2010 Europa Technologies, NFGIS, ZENRIN, US Dept. of State Geographer and Google Inc.).

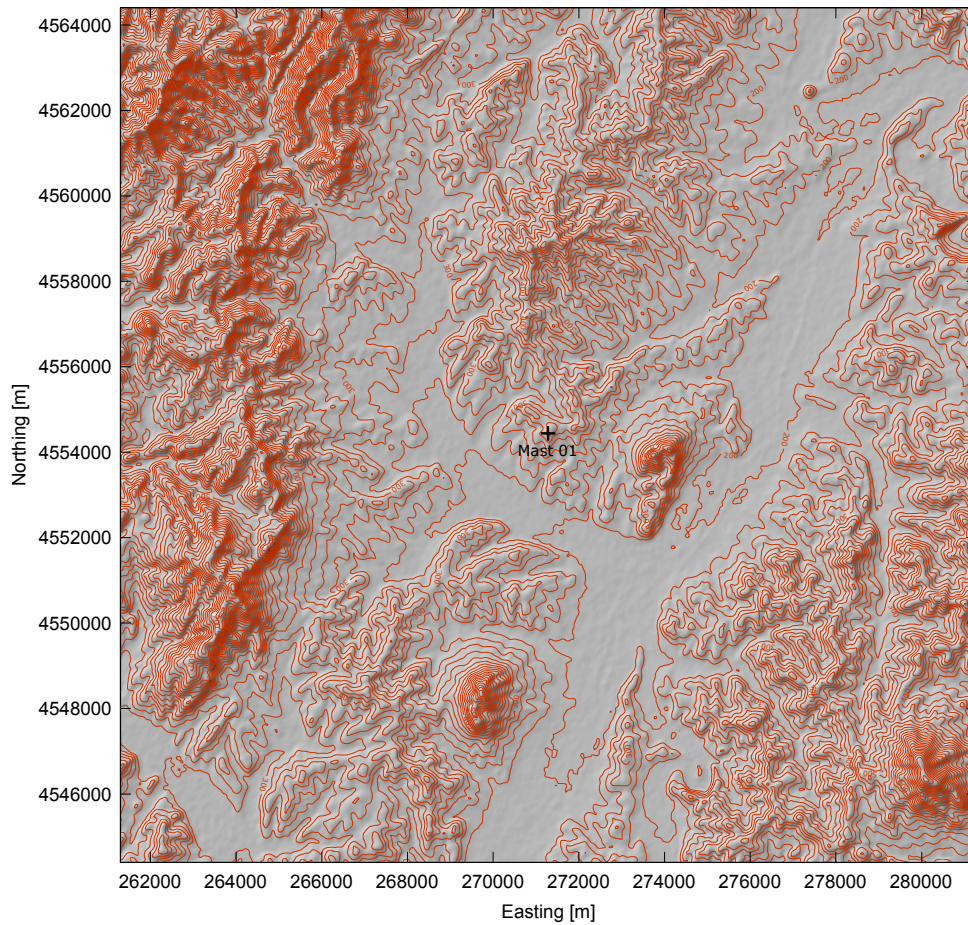
Figure 2. Elevation map from SRTM3 data, covering $20 \times 20 \text{ km}^2$, with 20-m contours. The ruggedness index for the site is 0%.

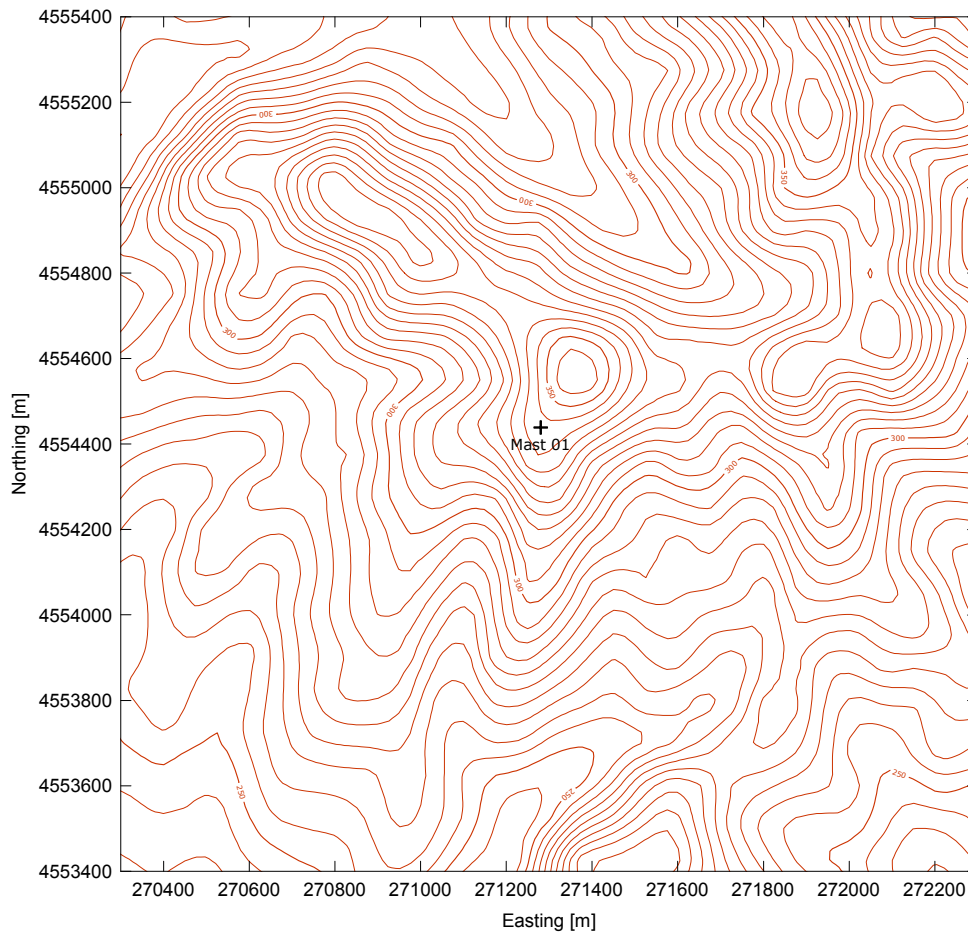
Figure 3. Elevation map from SRTM3 data, covering $2 \times 2 \text{ km}^2$, with 5-m height contours.

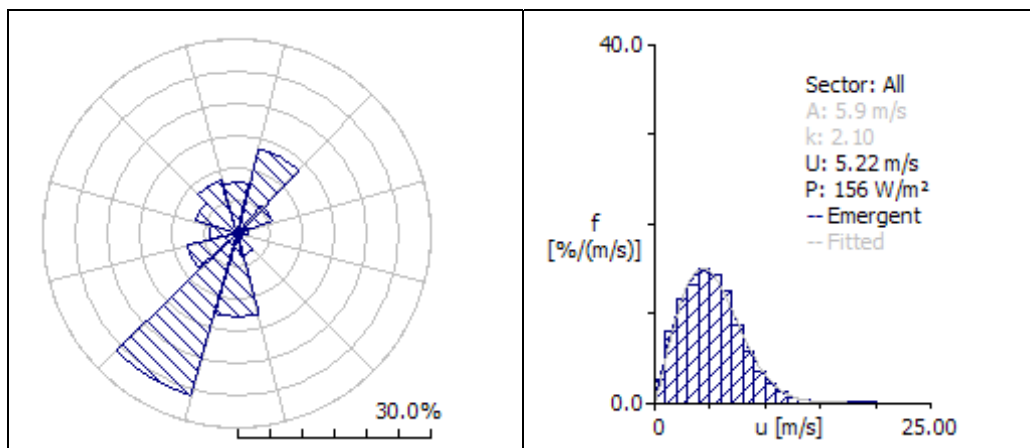
Figure 4. Wind rose and wind speed distribution for Chaoyang at 70 m a.g.l. The number of observations is 52560 and the recovery rate for 2009 is 100%.

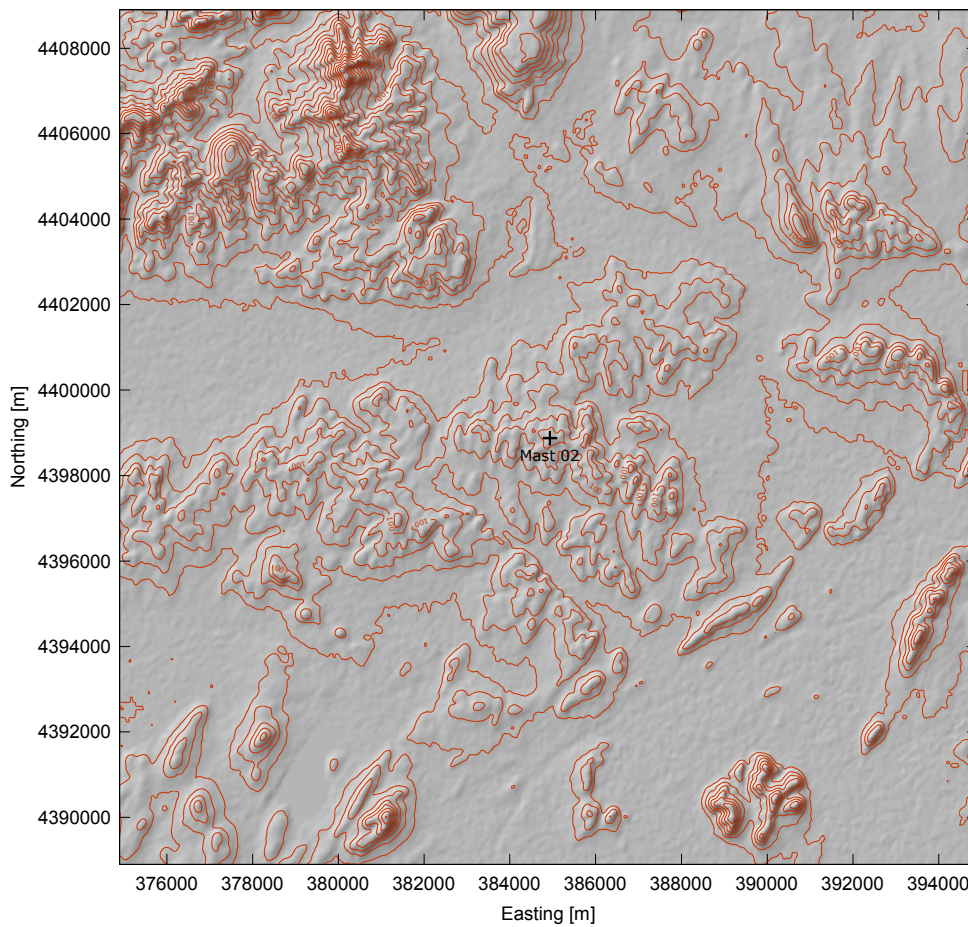
Figure 5. Elevation map from SRTM3 data, covering $20 \times 20 \text{ km}^2$, with 20-m contours. The ruggedness index for the site is 1.5%.

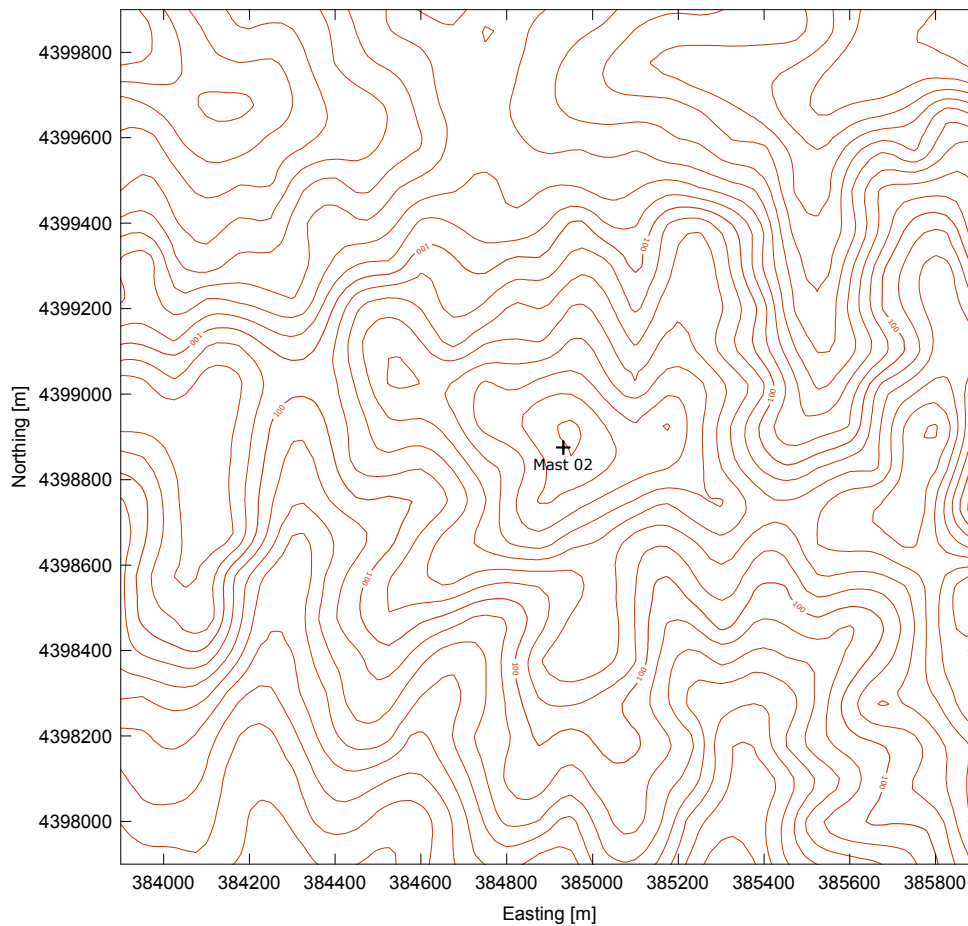
Figure 6. Elevation map from SRTM3 data, covering $2 \times 2 \text{ km}^2$, with 5-m height contours.

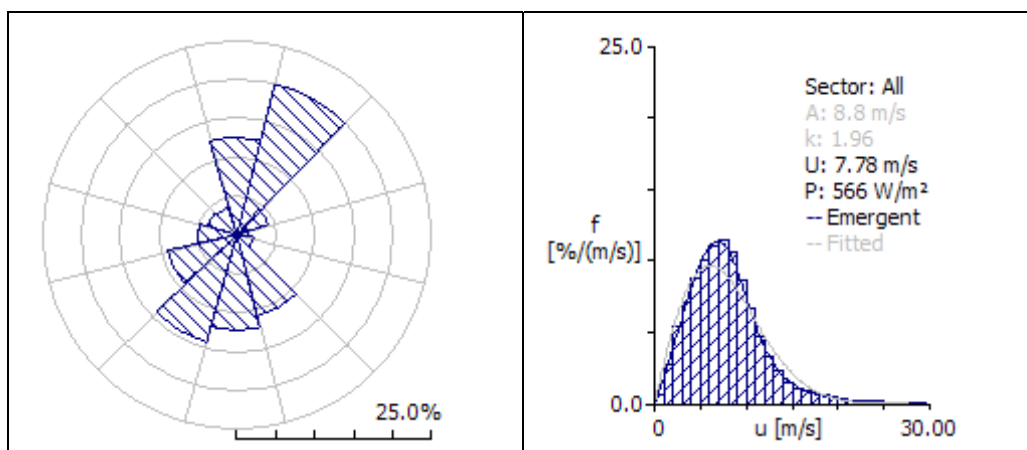
Figure 7. Wind rose and wind speed distribution for Wafangdian at 70 m a.g.l. The number of observations is 52557 and the recovery rate for 2009 is 100%.

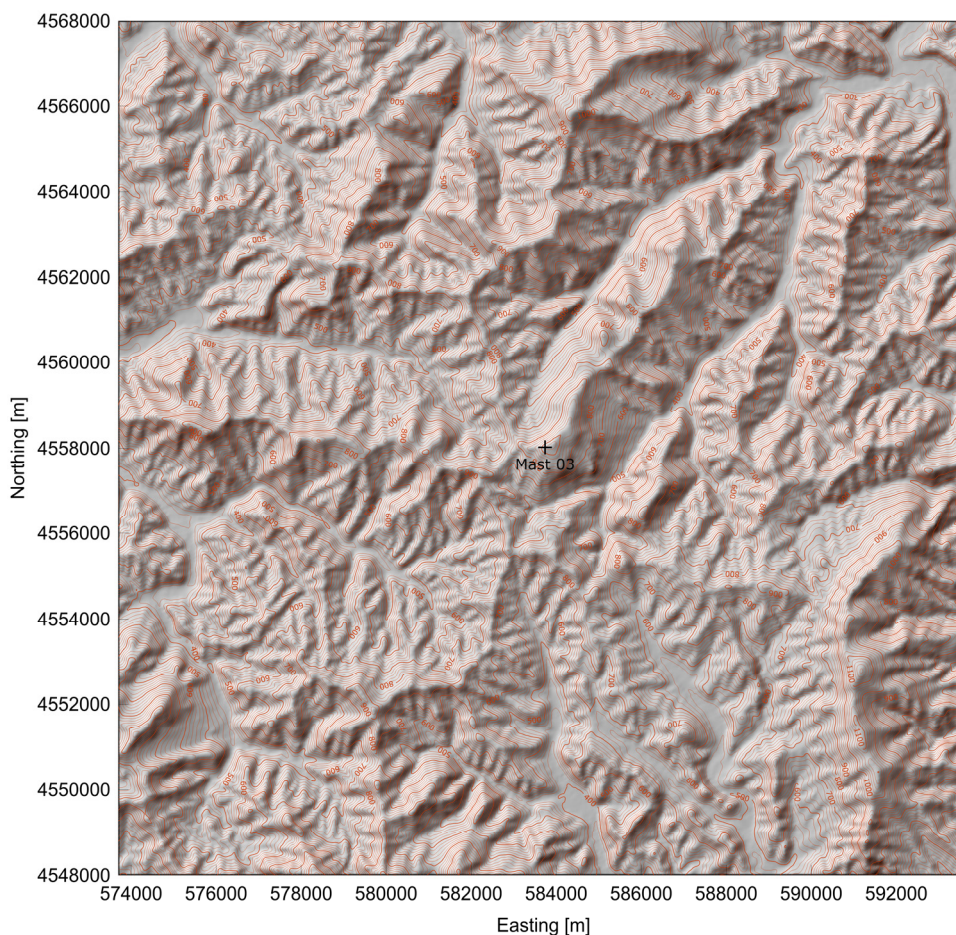
Figure 8. Elevation map from SRTM3 data, covering $20 \times 20 \text{ km}^2$, with 20-m contours. The ruggedness index for the site is 31.3%.

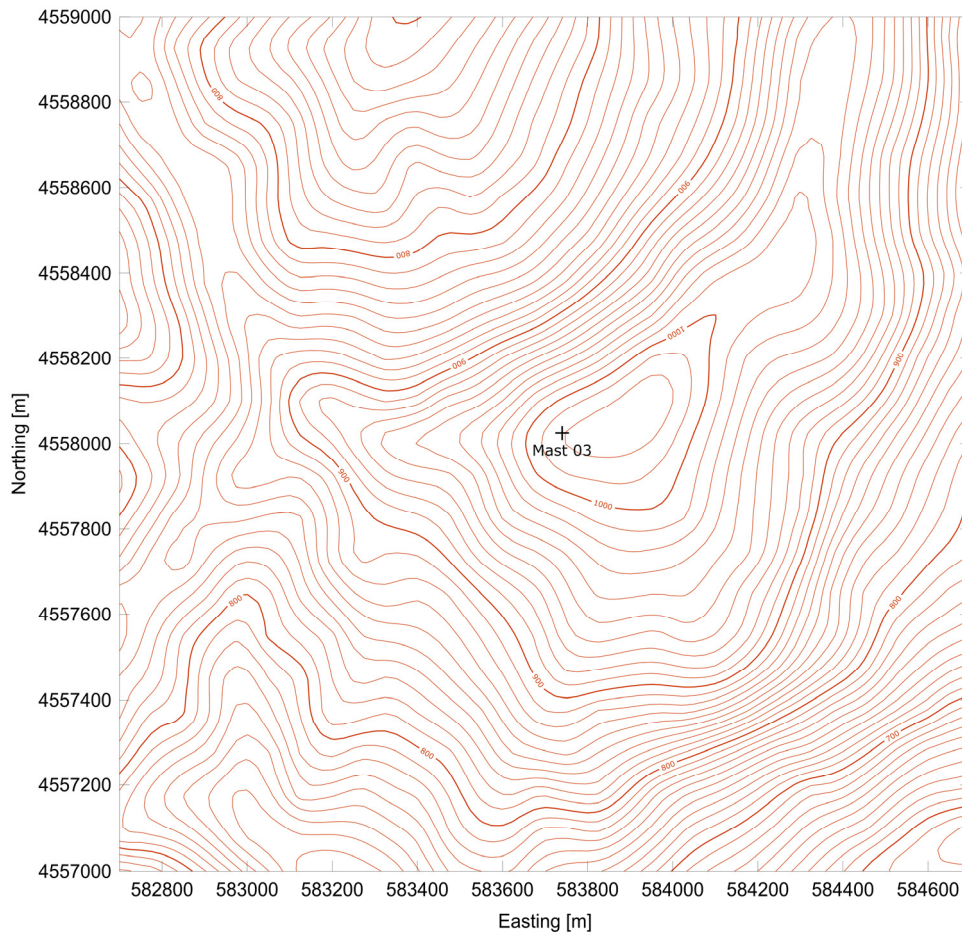
Figure 9. Elevation map from SRTM3 data, covering $2 \times 2 \text{ km}^2$, with 5-m height contours.

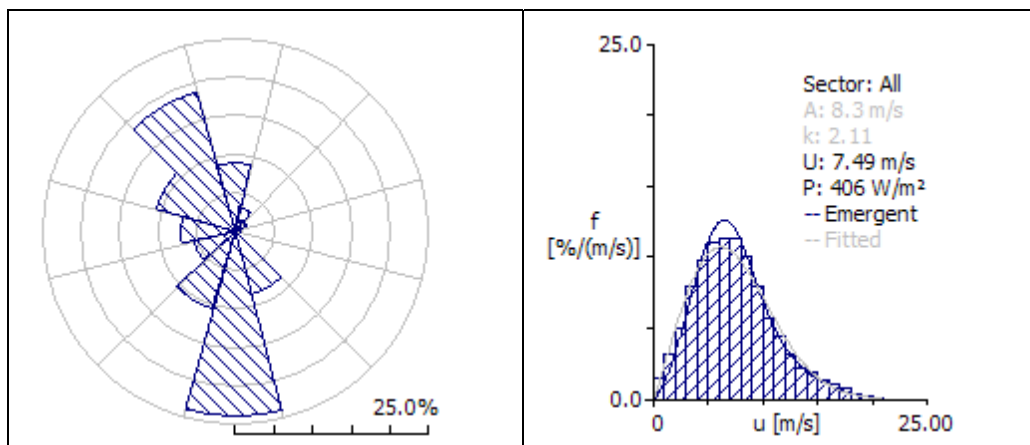
Figure 10. Wind rose and wind speed distribution for Benxi at 70 m a.g.l. The number of observations is 47894 and the recovery rate for 2009 is 91%.

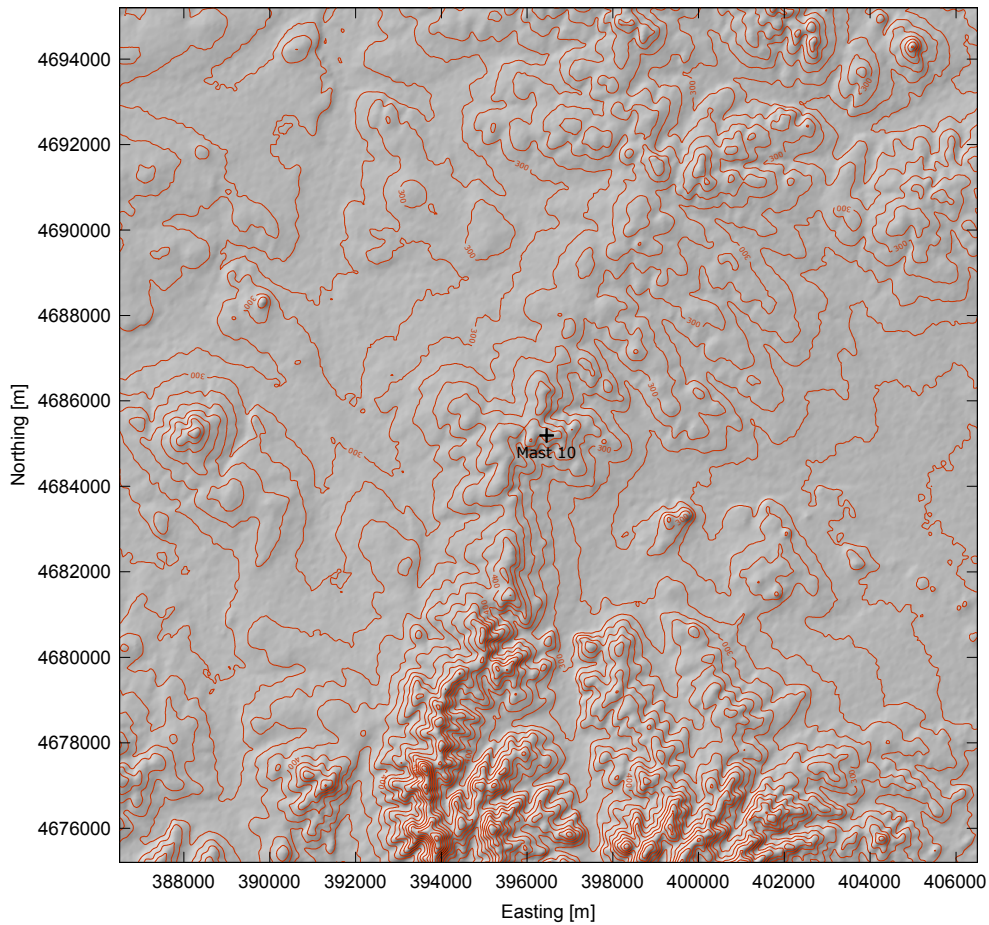
Figure 11. Elevation map from SRTM3 data, covering $20 \times 20 \text{ km}^2$, with 20-m contours.

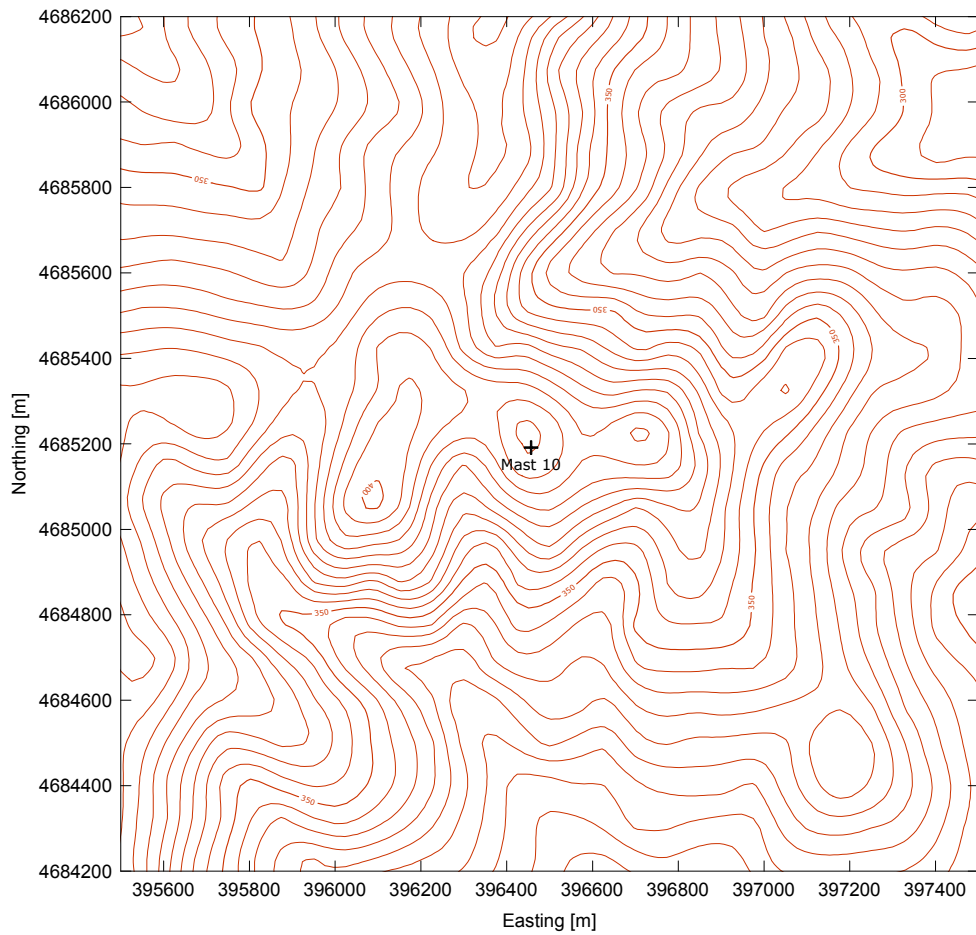
Figure 12. Elevation map from SRTM3 data, covering $2 \times 2 \text{ km}^2$, with 5-m contours.

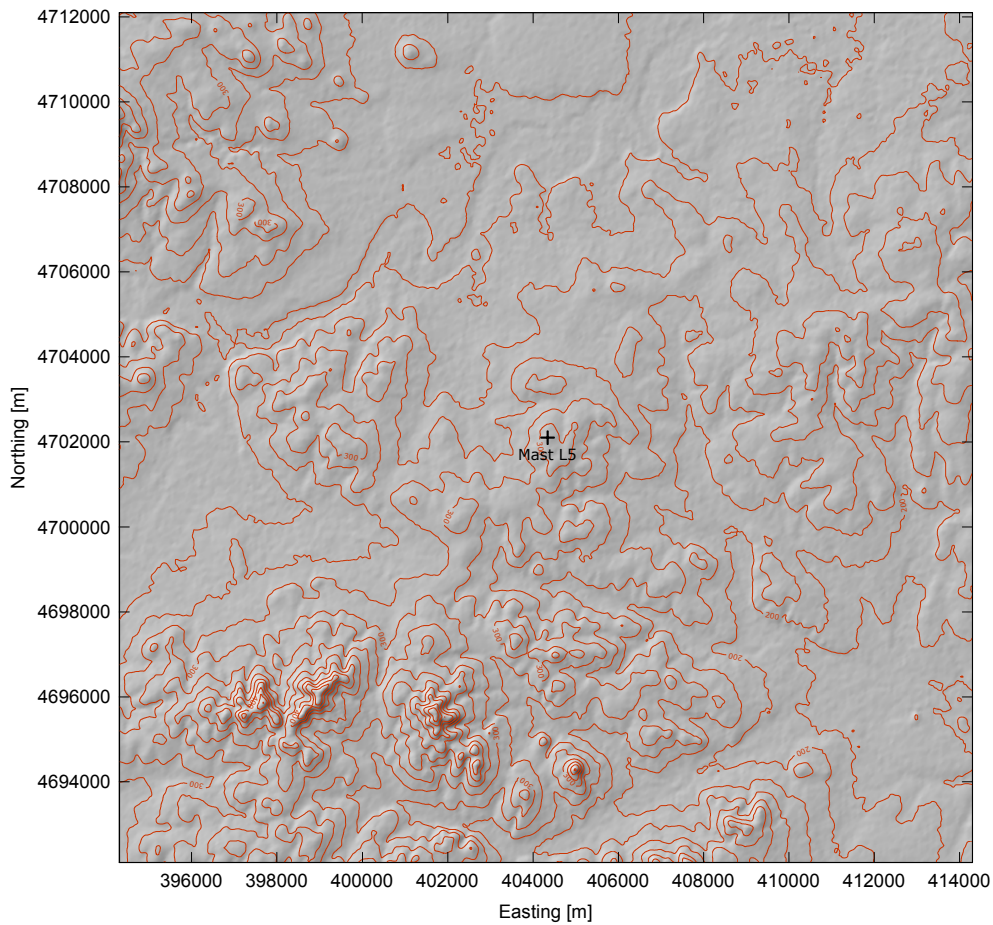
Figure 14. Elevation map from SRTM3 data, covering $20 \times 20 \text{ km}^2$, with 20-m contours. The ruggedness index for the site is 0%.

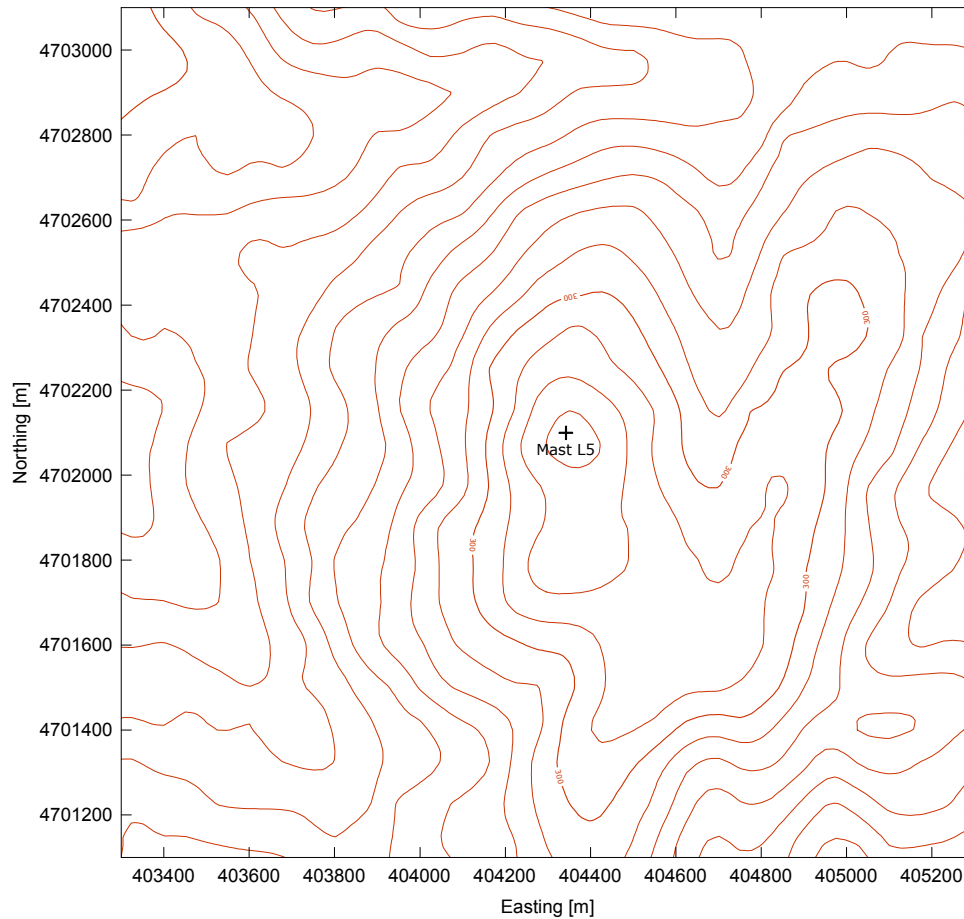
Figure 15. Elevation map from SRTM3 data, covering $2 \times 2 \text{ km}^2$, with 5-m contours.

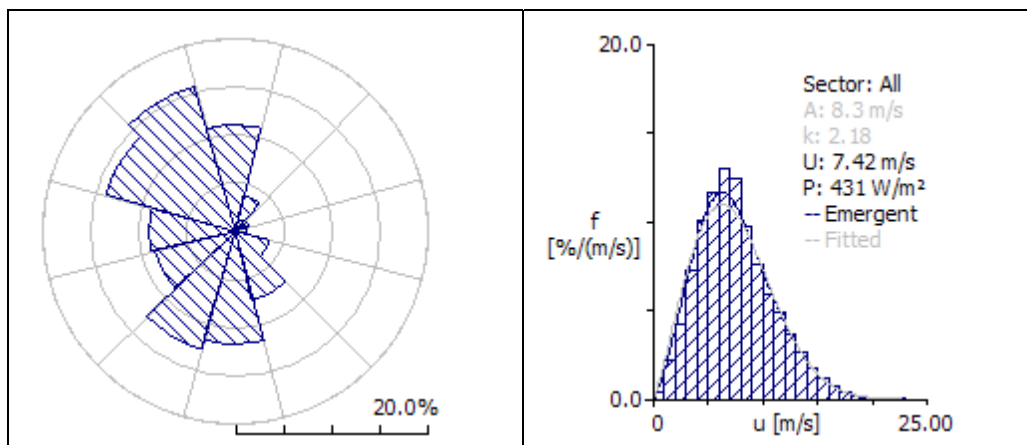
Figure 16. Wind rose and wind speed distribution for Fuxin, Pingandi at 70 m a.g.l. The number of observations is 52560 and the recovery rate is 100%.

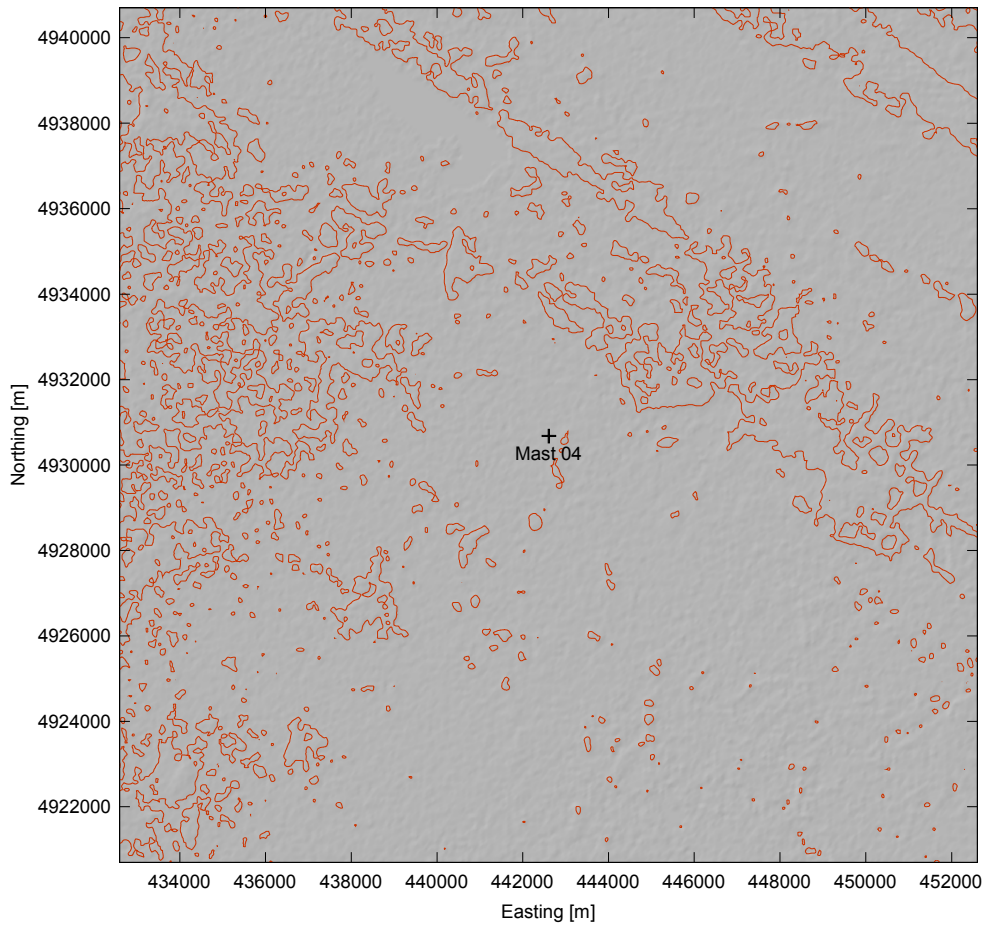
Figure 17. Elevation map from SRTM3 data, covering $20 \times 20 \text{ km}^2$, with 10-m contours. The ruggedness index for the site is 0%.

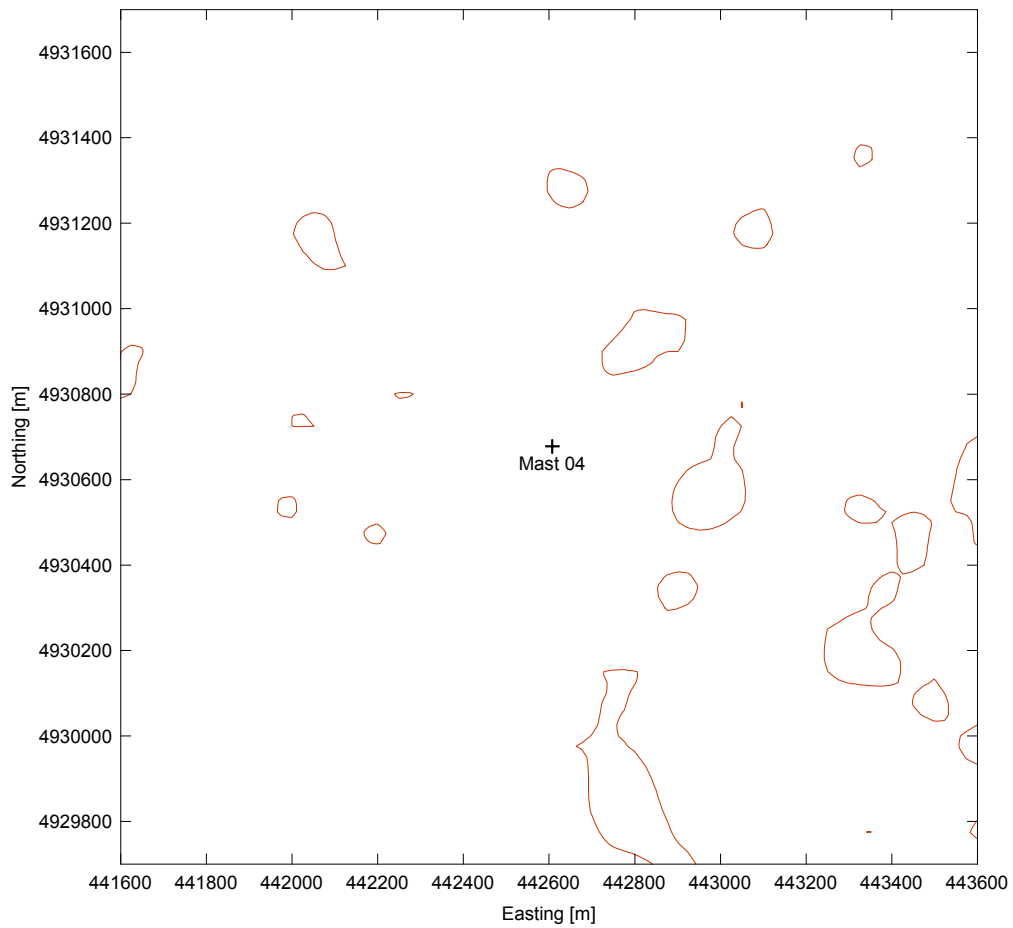
Figure 18. Elevation map from SRTM3 data, covering $2 \times 2 \text{ km}^2$, with 5-m contours.

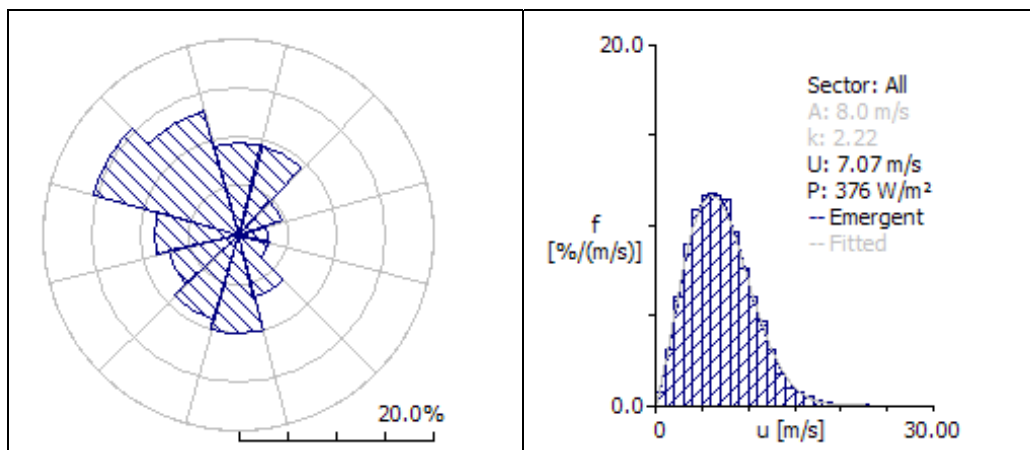
Figure 19. Wind rose and wind speed distribution for Jianshecun at 70 m a.g.l. The number of observations is 52560 and the recovery rate is 100%.

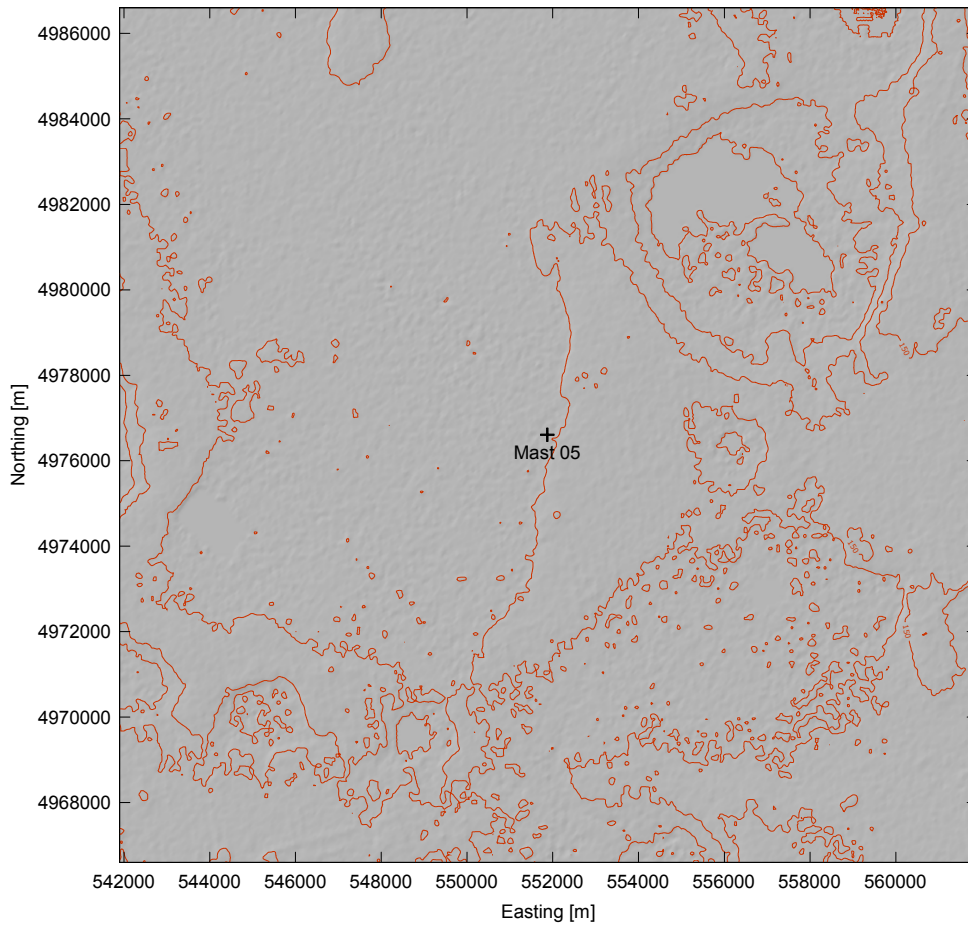
Figure 20. Elevation map from SRTM3 data, covering $20 \times 20 \text{ km}^2$, with 10-m contours. The ruggedness index for the site is 0%.

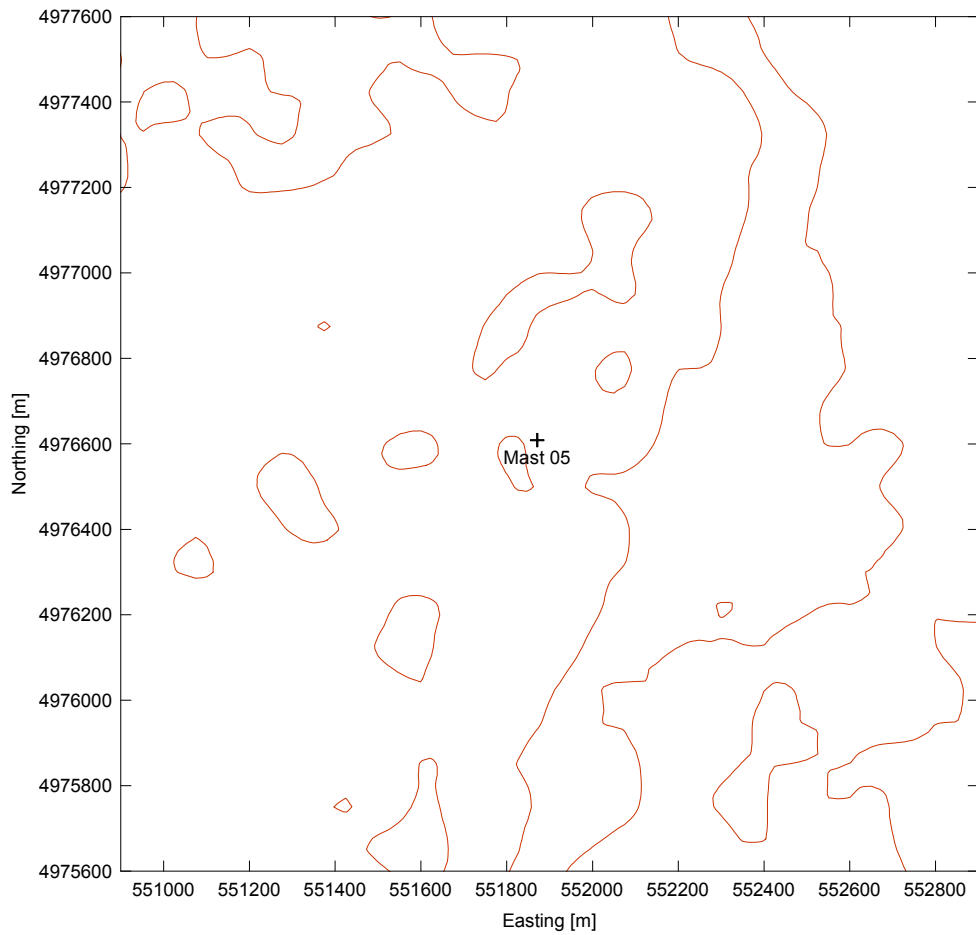
Figure 21. Elevation map from SRTM3 data, covering $2 \times 2 \text{ km}^2$, with 5-m contours.

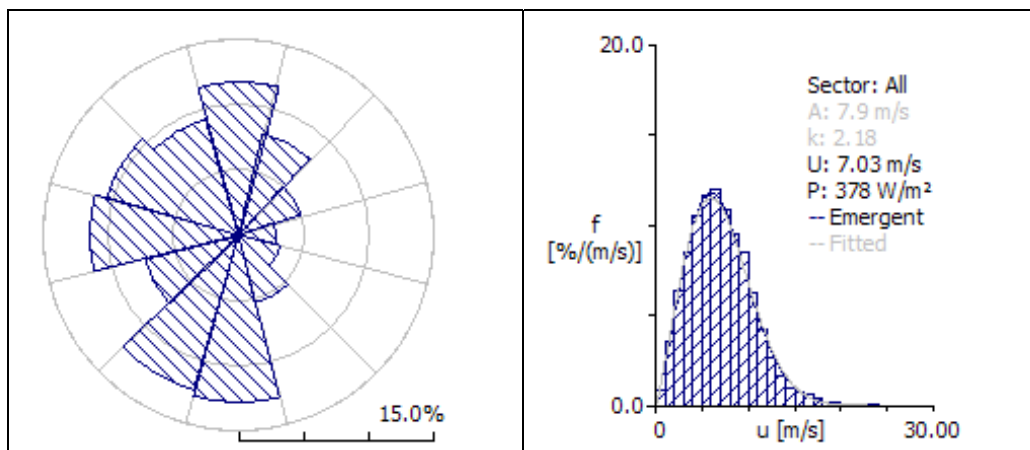
Figure 22. Wind rose and wind speed distribution for Chuizi at 70 m a.g.l. The number of observations is 52560 and the recovery rate is 100%.

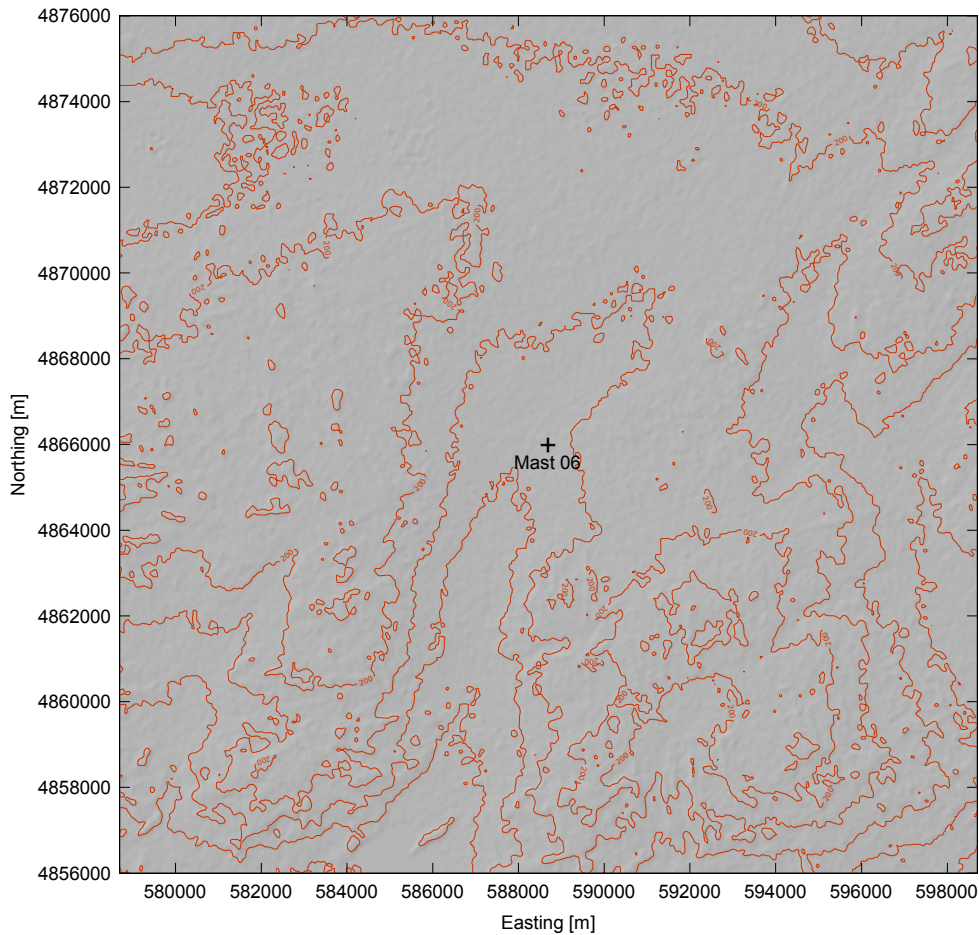
Figure 23. Elevation map from SRTM3 data, covering $20 \times 20 \text{ km}^2$, with 10-m contours. The ruggedness index for the site is 0%.

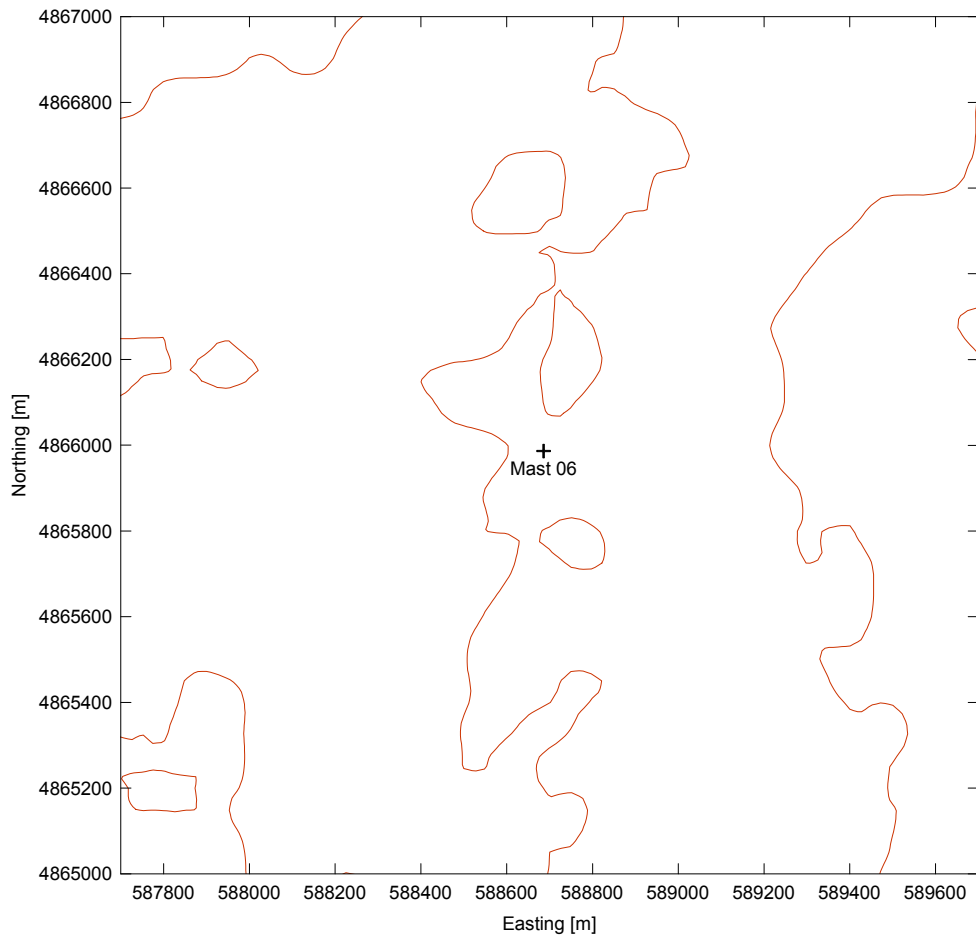
Figure 24. Elevation map from SRTM3 data, covering $2 \times 2 \text{ km}^2$, with 5-m contours.

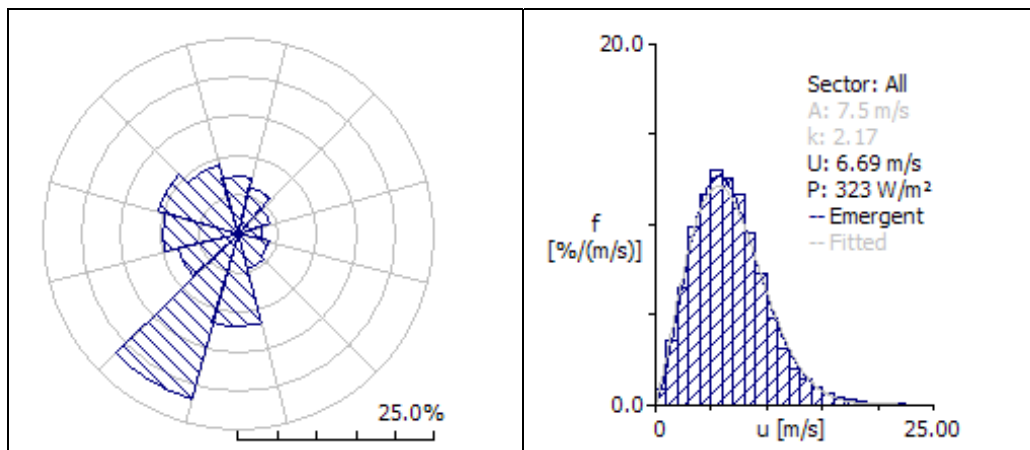
Figure 25. Wind rose and wind speed distribution for Tuanshan at 70 m a.g.l. The number of observations is 52560 and the recovery rate is 100%. Data from Risø DTU measurements (Jul-Dec 2009) and CMA measurements (Jan-Jun 2009).

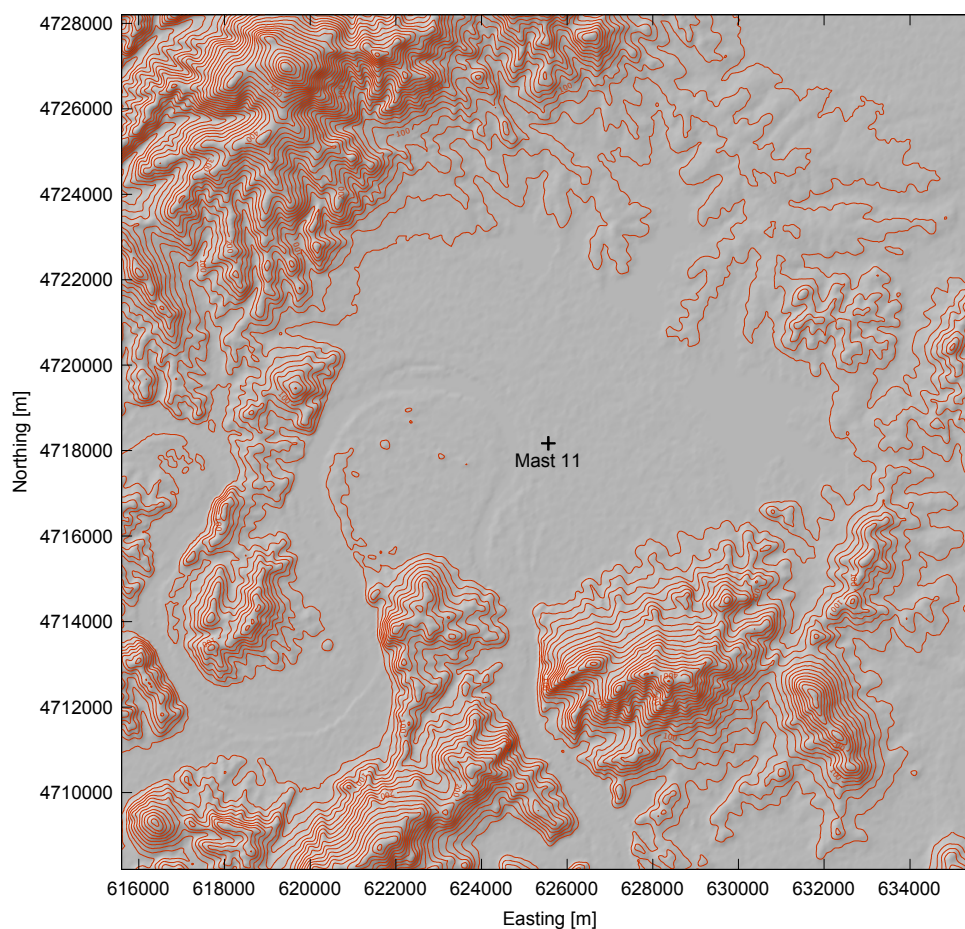
Figure 26. Elevation map from SRTM3 data, covering $20 \times 20 \text{ km}^2$, with 20-m contours.

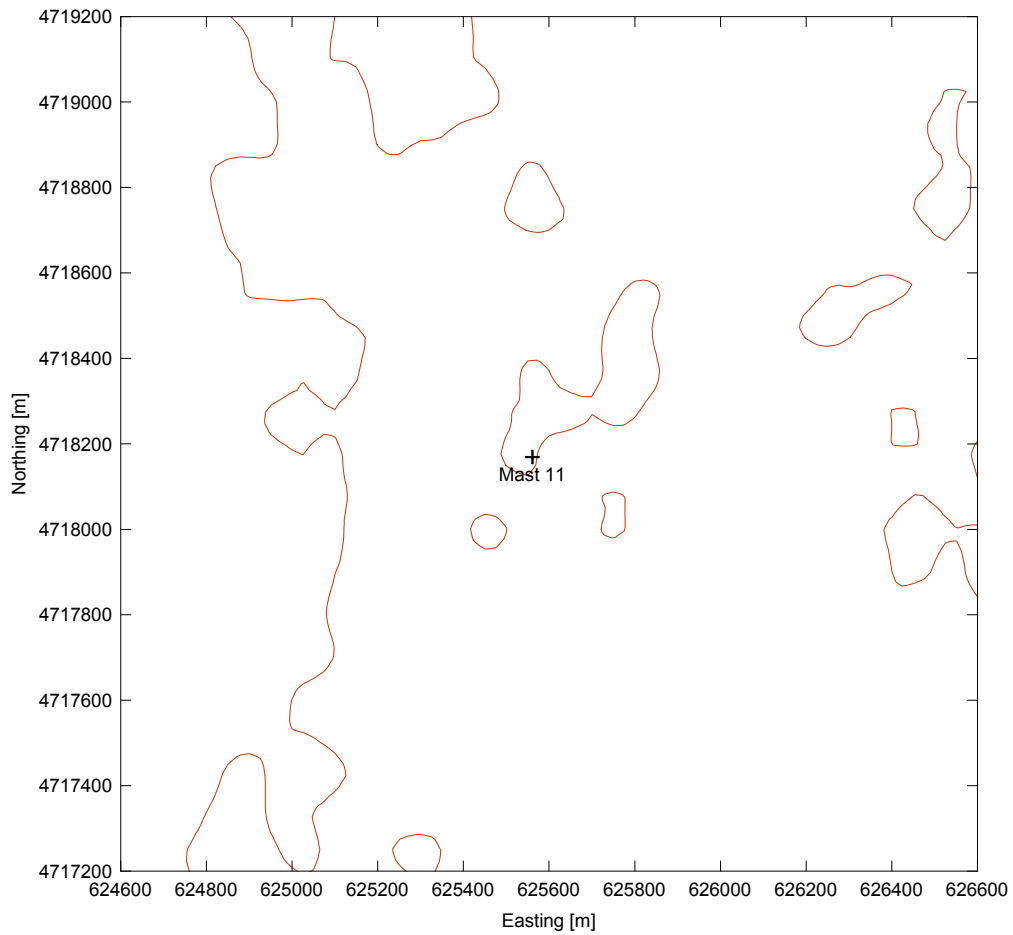
Figure 27. Elevation map from SRTM3 data, covering $2 \times 2 \text{ km}^2$, with 5-m contours.

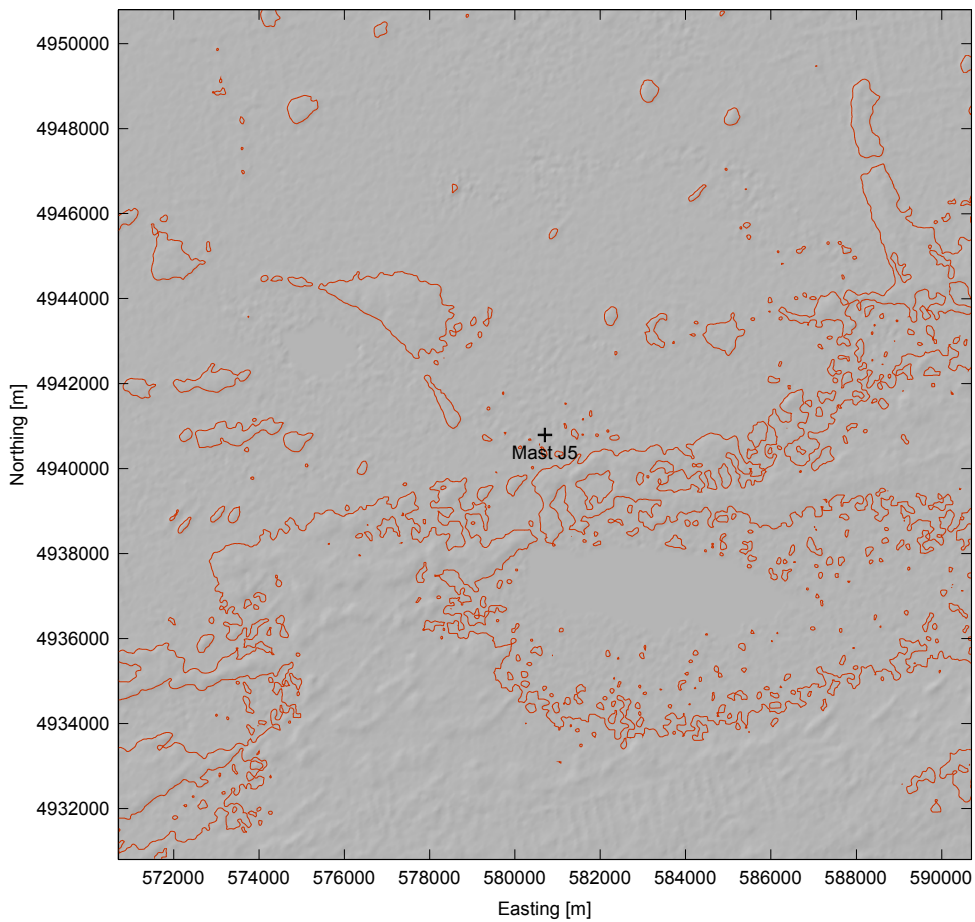
Figure 29. Elevation map from SRTM3 data, covering 20×20 km², with 20-m contours. The ruggedness index for the site is 0%.

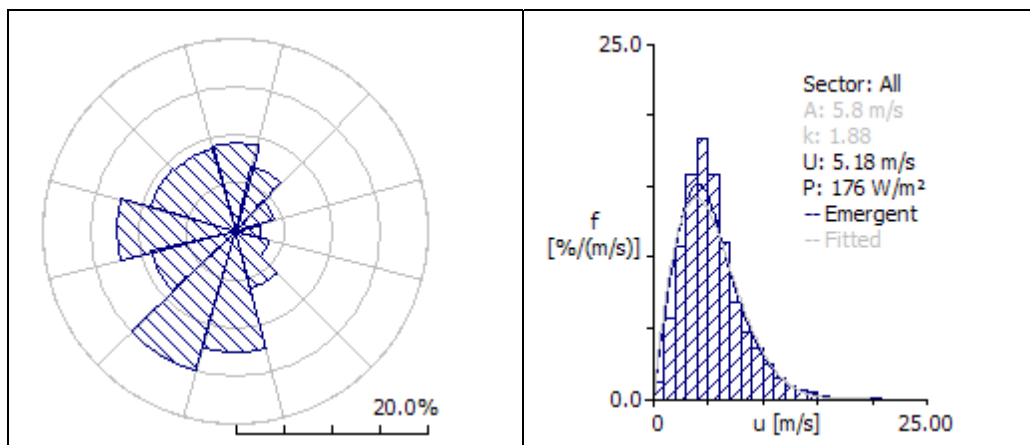
Figure 31. Wind rose and wind speed distribution for Songyuan at 30 m a.g.l. The number of observations is 52560 and the recovery rate is 100%.
