Meso- and Micro-scale Modelling in China: Site inspection trip to NE China (Dongbei)

Niels G. Mortensen, Jens Carsten Hansen, Yang Zhenbin,
Yu Hongming, Xie Jinfan and Yuan Guoen
Risø-I-2900(EN)
June 2010

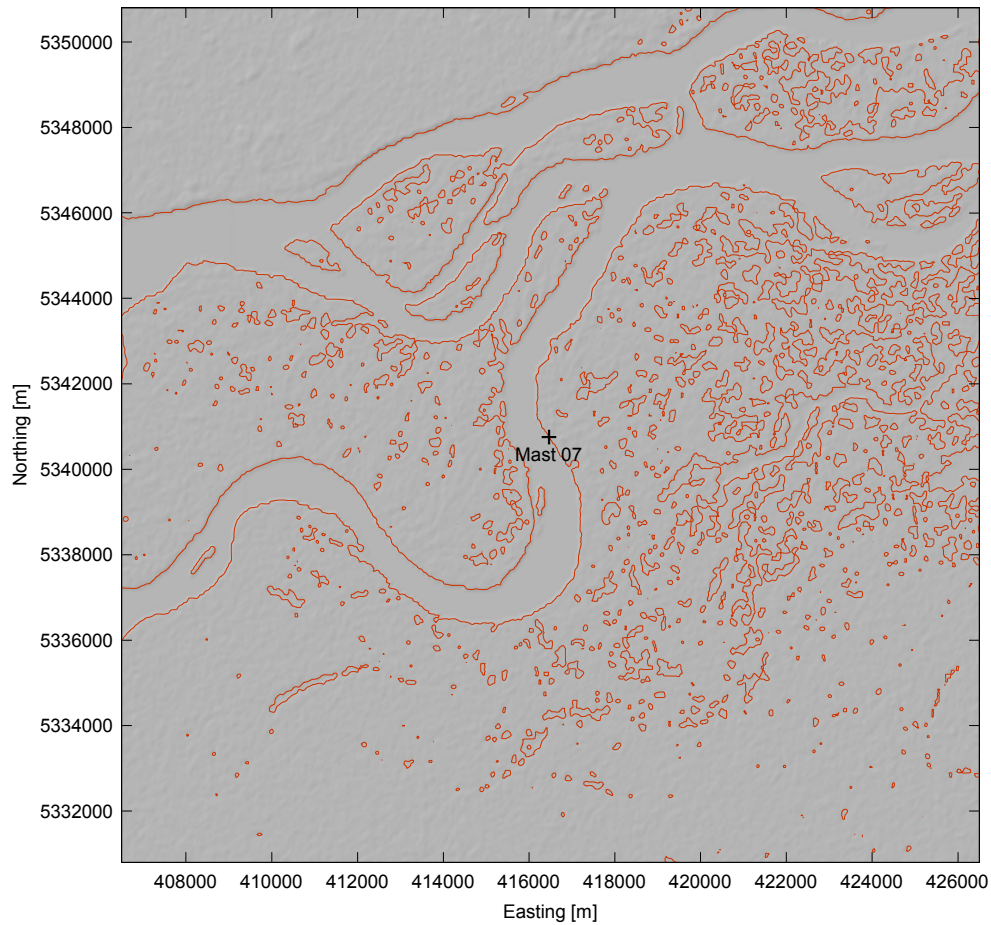
Figure 32. Elevation map from SRTM3 data, covering $20 \times 20 \text{ km}^2$, with 20-m contours. The ruggedness index for the site is 0%.

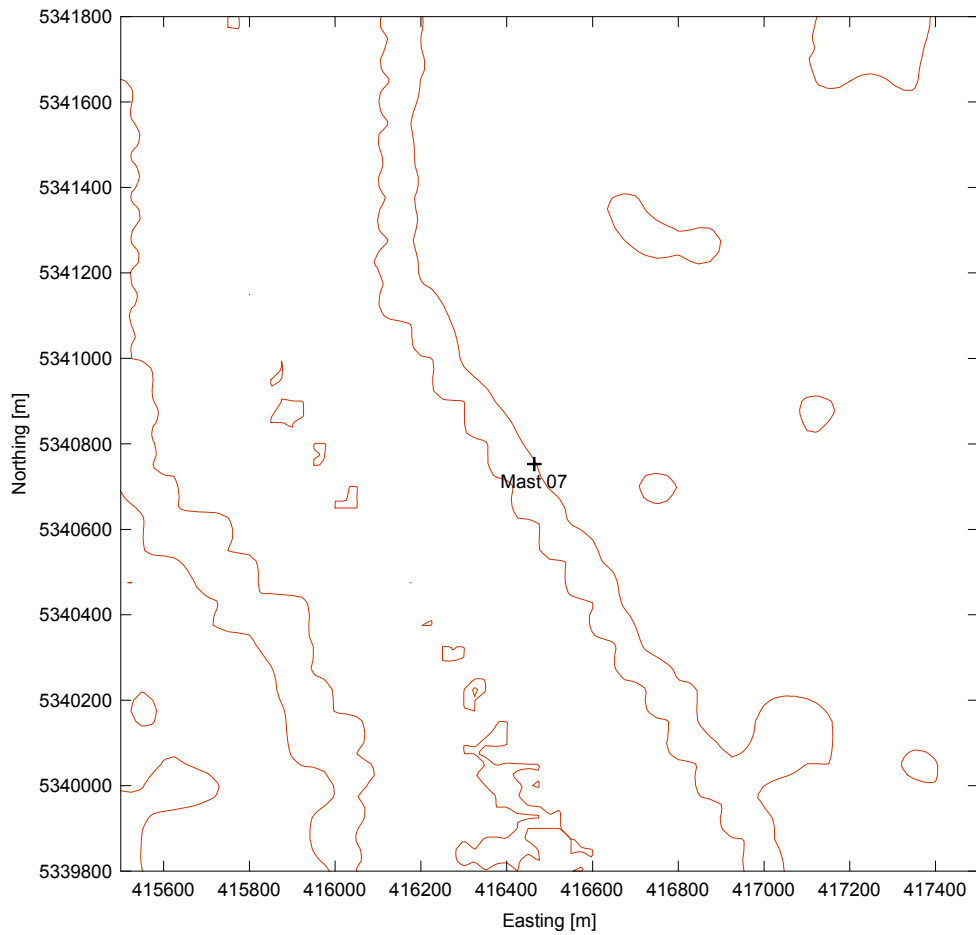
Figure 33. Elevation map from SRTM3 data, covering $2 \times 2 \text{ km}^2$, with 5-m contours.

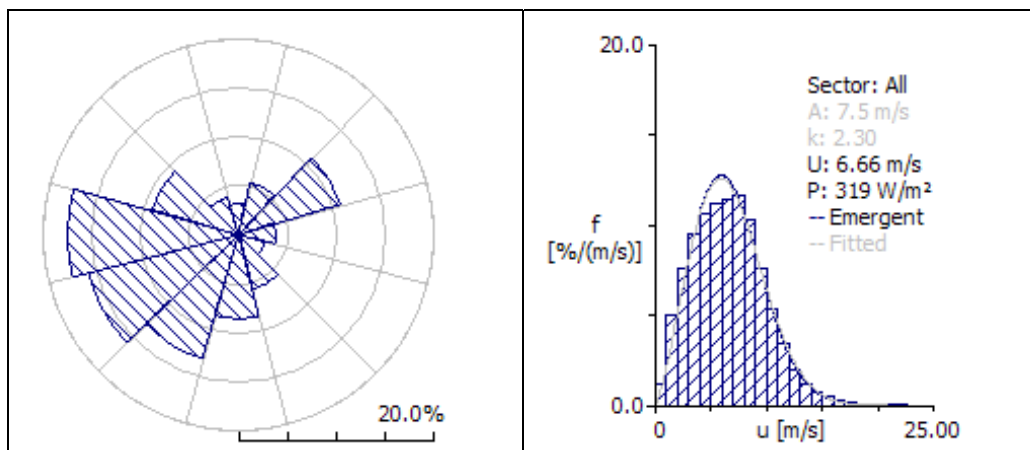
Figure 34. Wind rose and wind speed distribution for Tongjiang at 70 m a.g.l. The number of observations is 52560 and the recovery rate is 100%.

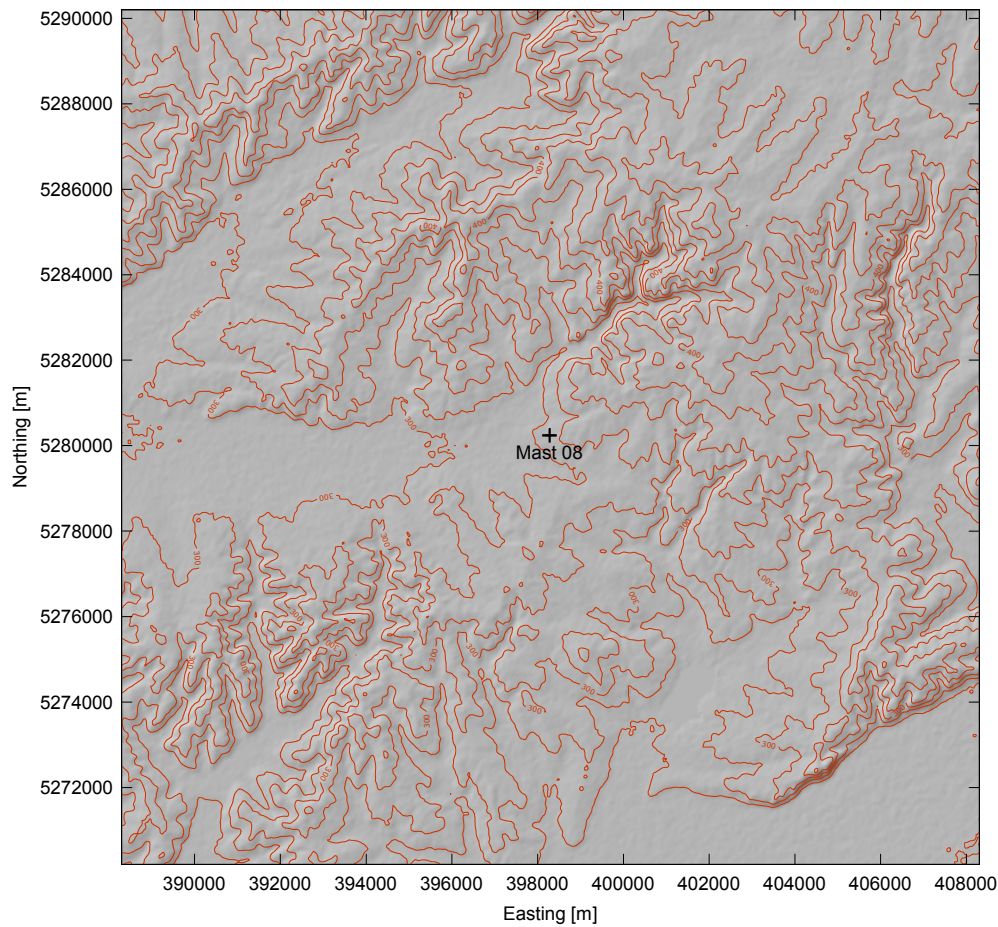
Figure 35. Elevation map from SRTM3 data, covering $20 \times 20 \text{ km}^2$, with 20-m contours. The ruggedness index for the site is 0%.

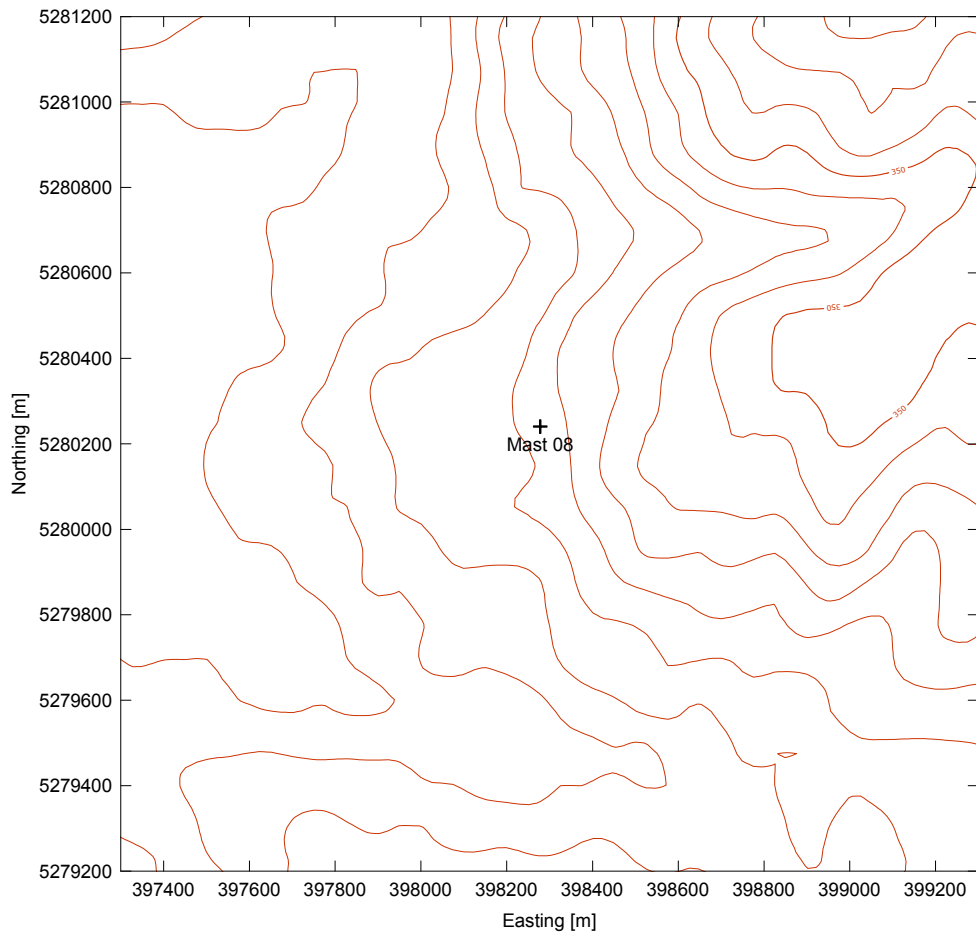
Figure 36. Elevation map from SRTM3 data, covering $2 \times 2 \text{ km}^2$, with 5-m contours.

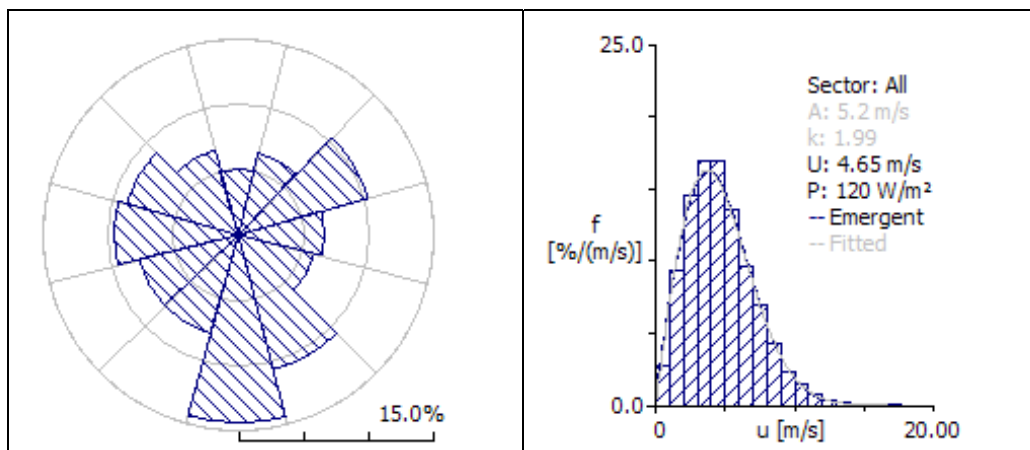
Figure 37. Wind rose and wind speed distribution for Suiling at 70 m a.g.l. The number of observations is 52560 and the recovery rate is 100%.

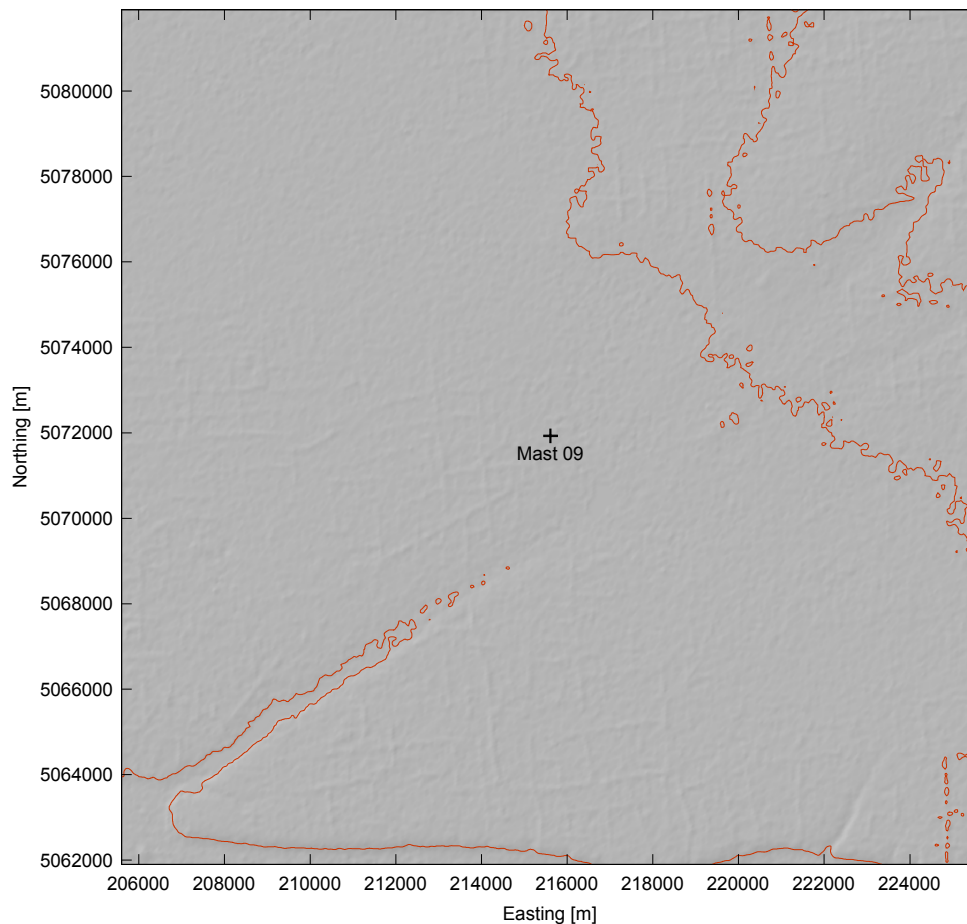
Figure 38. Elevation map from SRTM3 data, covering $20 \times 20 \text{ km}^2$, with 20-m contours. The ruggedness index for the site is 0%.

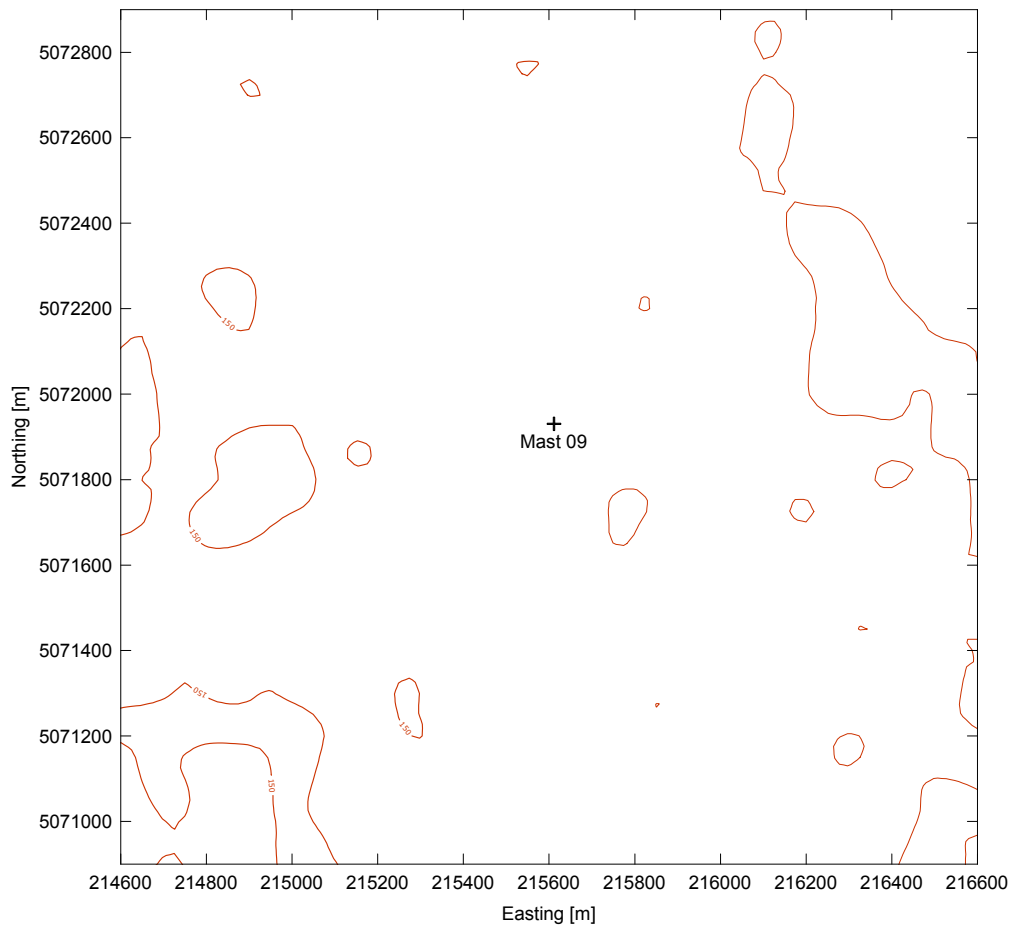
Figure 39. Elevation map from SRTM3 data, covering $2 \times 2 \text{ km}^2$, with 5-m contours.

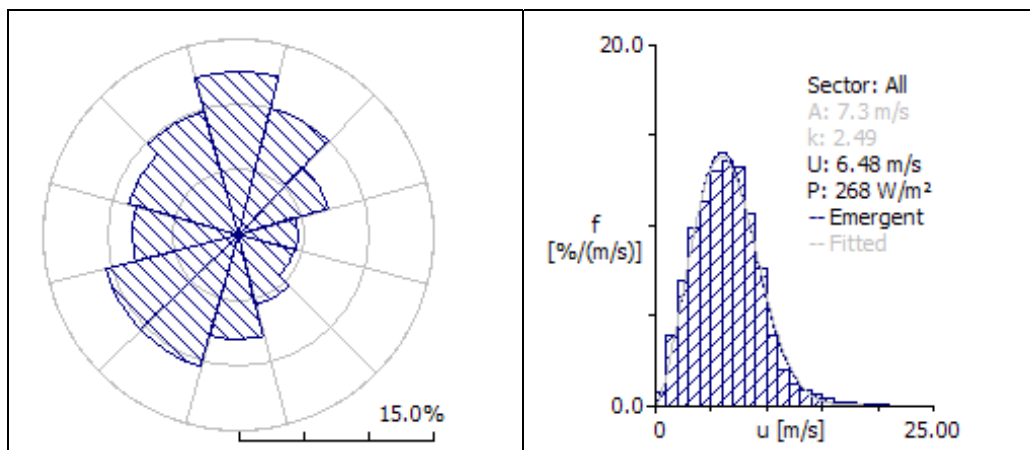
Figure 40. Wind rose and wind speed distribution for Zhaozhou at 70 m a.g.l. The number of observations is 52560 and the recovery rate is 100%.

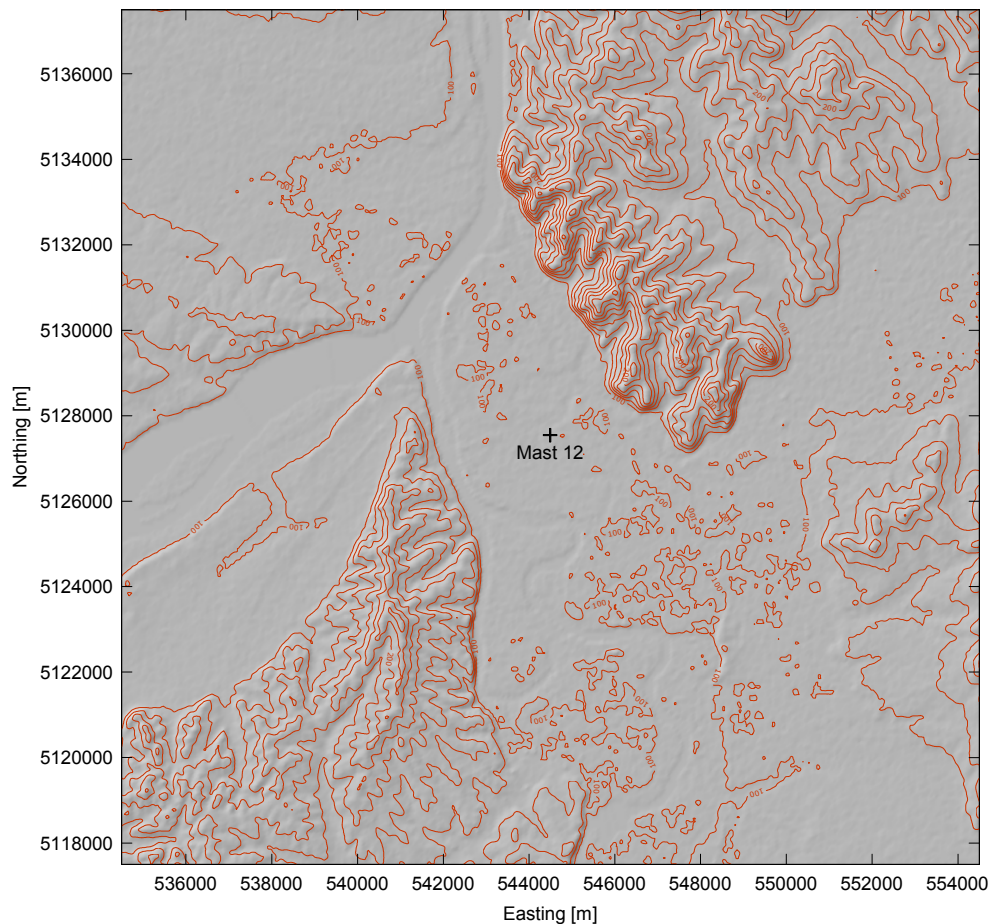
Figure 41. Elevation map from SRTM3 data, covering $20 \times 20 \text{ km}^2$, with 20-m contours.

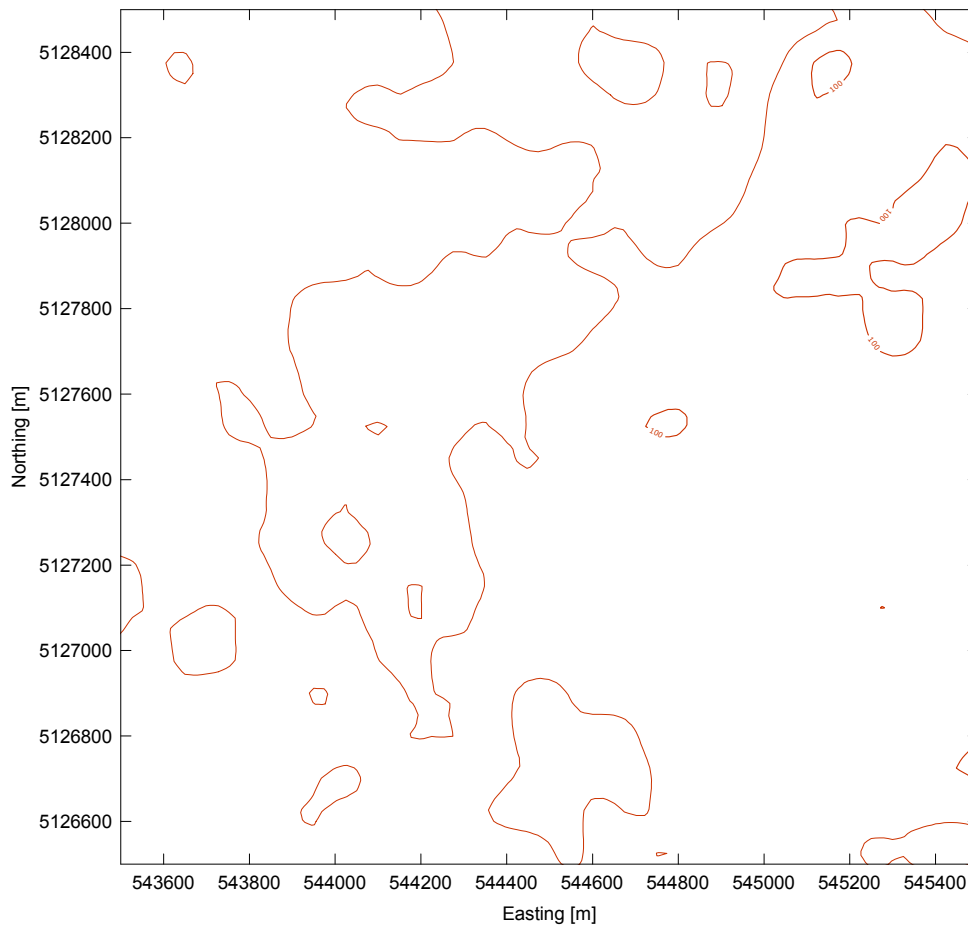
Figure 42. Elevation map from SRTM3 data, covering $2 \times 2 \text{ km}^2$, with 5-m height contours.

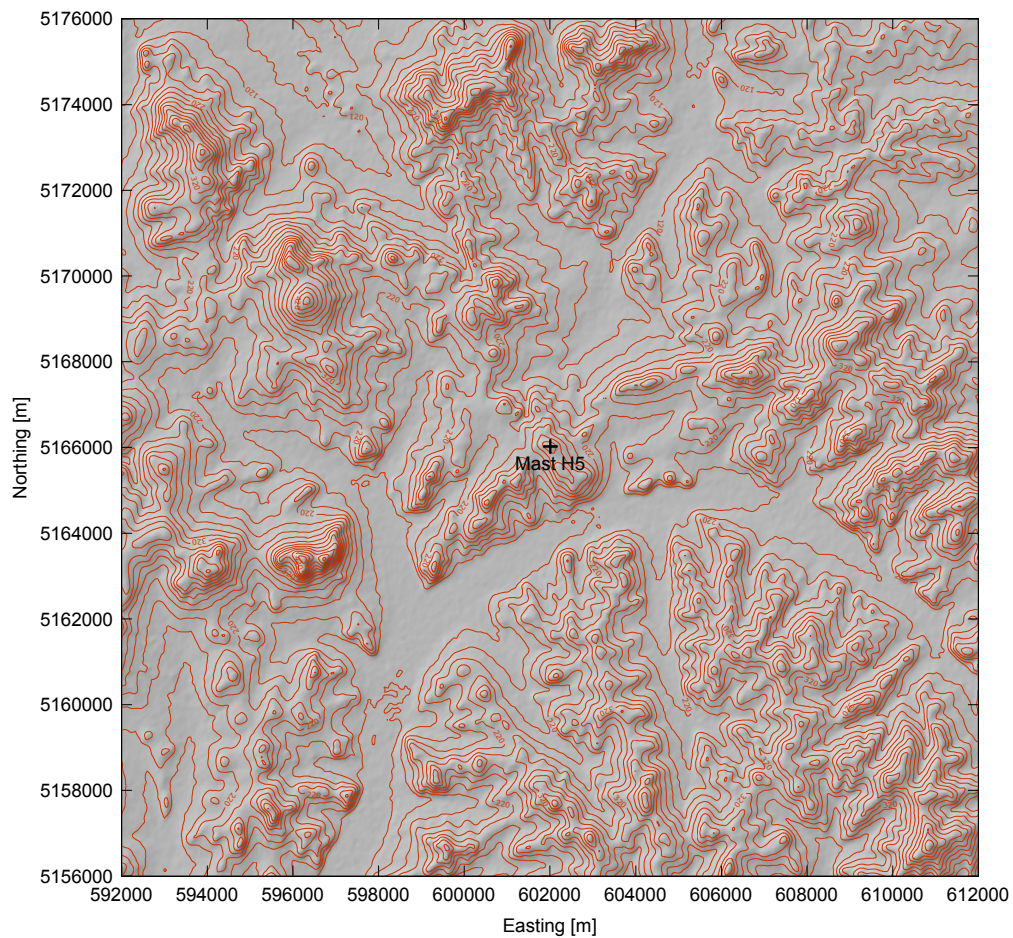
Figure 44. Elevation map from SRTM3 data, covering $20 \times 20 \text{ km}^2$, with 20-m contours. The ruggedness index for the site is 0.2%.

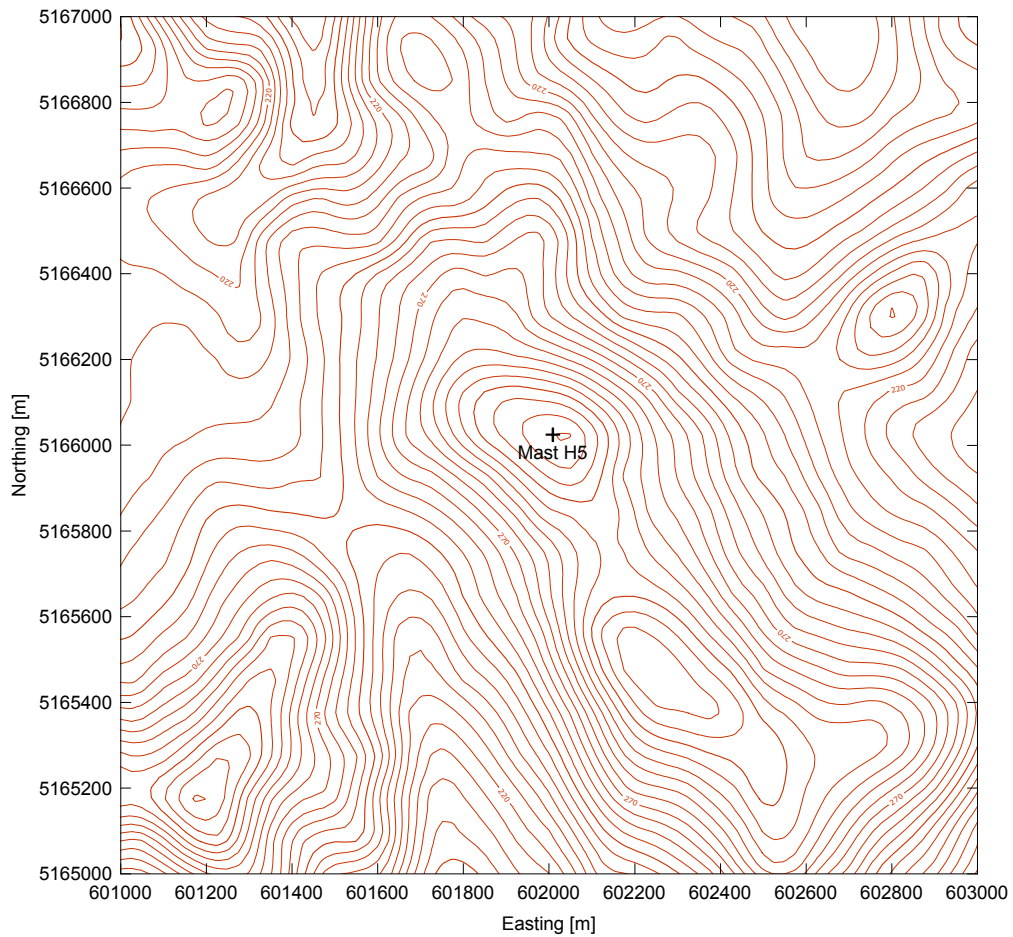
Figure 45. Elevation map from SRTM3 data, covering $2 \times 2 \text{ km}^2$, with 5-m height contours.

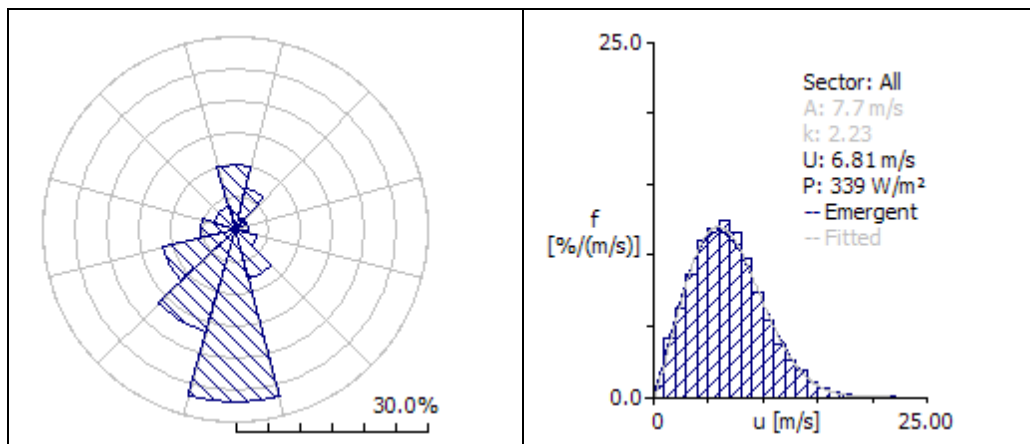
Figure 46. Wind rose and wind speed distribution for Jiamusi at 70 m a.g.l. Data period for mast MH5 is from 2008-11-01 to 2009-11-01. The number of observations is 52560 and the recovery rate is 100%.
