Tallafuss, Philipp J and Rosochowski, Andrzej and Campbell, Sylvia and Minguez, Xavier (2017) Implementing an on-line bond quality inspection system for cold roll bonded Al/Al-Sn/Al/steel strips using guided wave EMATs. Insight: The Journal of the British Institute of Non-Destructive Testing. ISSN 1354-2575 (In Press) ,

Implementing an on-line bond quality inspection system for cold roll bonded Al/Al-Sn/Al/steel strips using guided wave EMATs

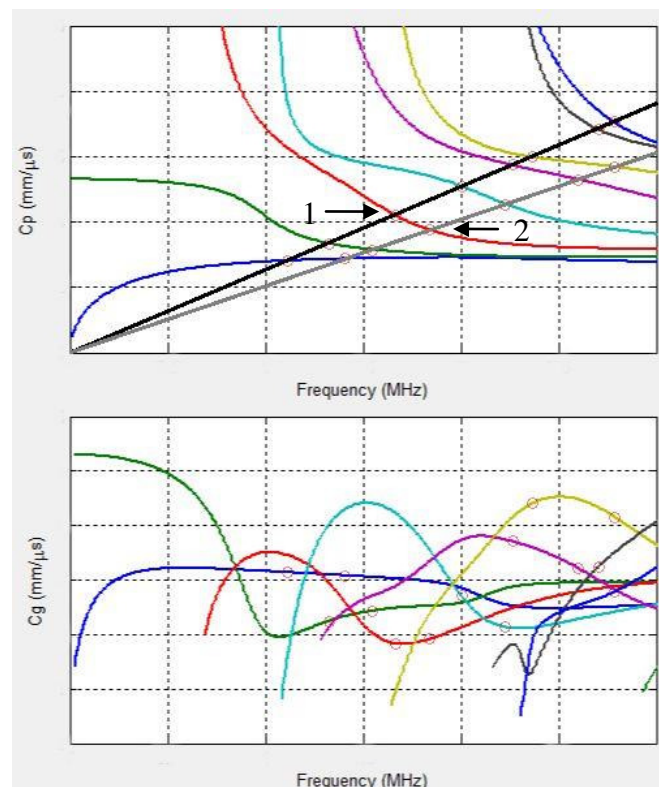
Figure 5. Dispersion curves of the four layer structure: (a) phase velocity with employed wave mode, (b) group velocity

λ and μ are Lamé's first and second coefficients and depend on the Young's modulus and Poisson's ratio of the material in each layer. The displacement field is u , ρ is the density and f is the distributed body force. The coordinate directions are indicated with the indices i and j , in which 1 refers to the direction of wave propagation, 2 refers to the direction of the wave front, and 3 refers to the thickness direction. Table 1 summarises the material properties considered for the guided wave propagation analysis. The Rayleigh-Lamb phase and group velocity dispersion curves for this study were calculated using the semi-analytical finite element method (SAFE) and identified various wave modes that appeared to be good candidates for inspection. Figure 5(a) plots the phase velocity and Figure 5(b) plots the group velocity dispersion curves for the four-layer system. Excitation lines for the wavelengths used are drawn on the phase velocity dispersion curve. The wave mode at the intersection between the excitation line and the phase velocity dispersion curve will be efficiently excited when the corresponding frequency is used. Figure 5 shows the selected wave modes for this study. Since the prototype system discussed in this article will be industrialised as a commercial product, the wavelengths and frequencies of the employed wave modes are not revealed. The wavelength was controlled by the period of the meander coil.

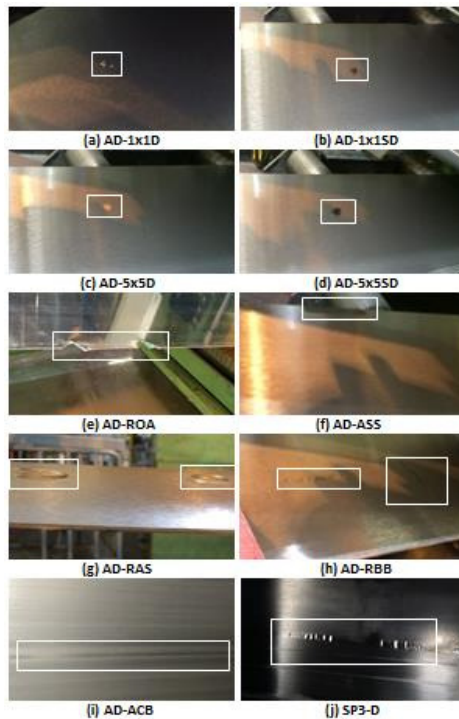
Figure 8 shows the production of the artificially implanted defects immediately before CRB.

Figure 8. Defects in cold roll bonded Al/Al-Sn/Al/steel strips (a) 1x1 mm alumina, (b) 1x1 mm steel debris, (c) 5x5 mm alumina, (d) 5x5 mm steel debris, (e) run-off clad Al, (f) altered steel sanding, (g) rolled-in clad Al slivers, (h) rolled-in brush bristles, (i) altered clad Al brushing, (j) Al-1050 foil blisters on sacrificial side

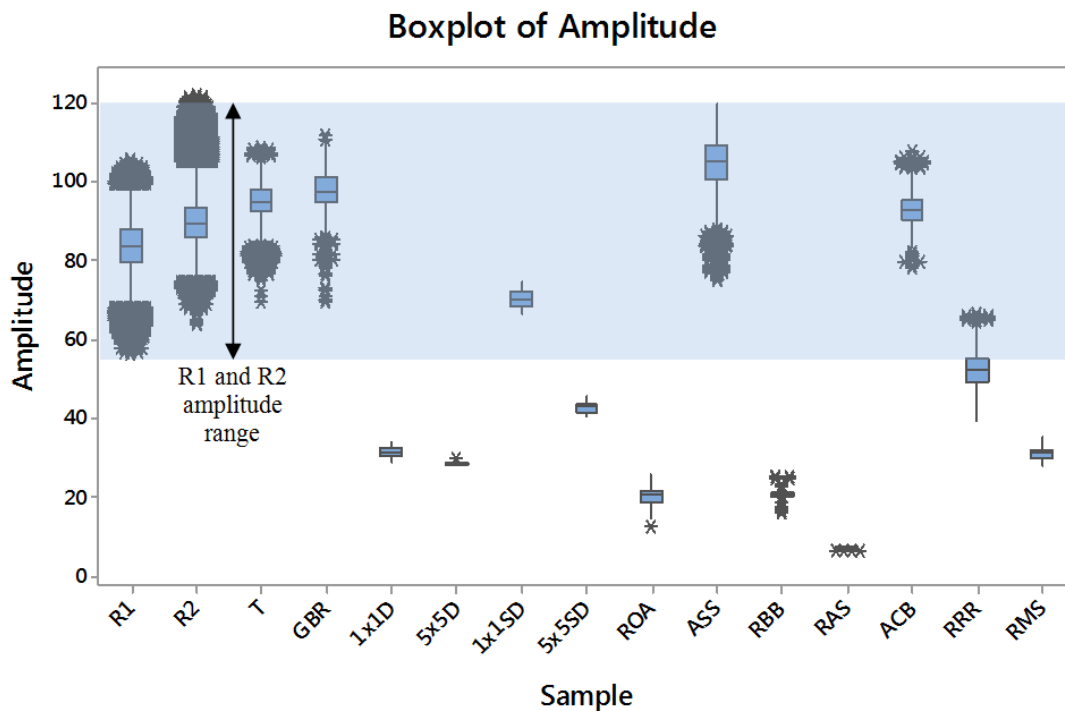
Figure 11 shows a boxplot of the SP and AD strip samples to compare the central tendency and variability of the measured amplitude for various defects. The interquartile range (IQR) from the first quartile (Q1) to the third quartile (Q3) shows that the middle 50% measurement points of all defects have a narrow spread. The IQR of the reference samples R1, R2 and GBR overlap. This was expected, since the reference samples were used to calibrate the system. All other measured amplitudes are normalised as the same gain was used to inspect the reference and defective samples. The range of the reference samples from the smallest to the largest amplitude value including outliers is from about 55% to 120% normalised amplitude. It can be seen that the combined interval of samples R1 and R2 completely contains the amplitude intervals of defective samples ASS, T, ACB and 1x1SD. These samples can therefore only be detected by accepting a significant false alarm rate. The sample RRR amplitude interval partly overlaps with the combined R1 and R2 interval, hence detection with a reduced false alarm rate is possible. Samples 5x5D, RMS, 1x1D, 5x5D, RBB, ROA and RAS amplitude intervals do not overlap with the combined R1 and R2 interval, therefore detection without false alarms is possible. The boxplot shows that the variances of the various samples are different.

Figure 11. Boxplot of SP-R1, SP-R2 and AD strip samples showing central tendency and variability

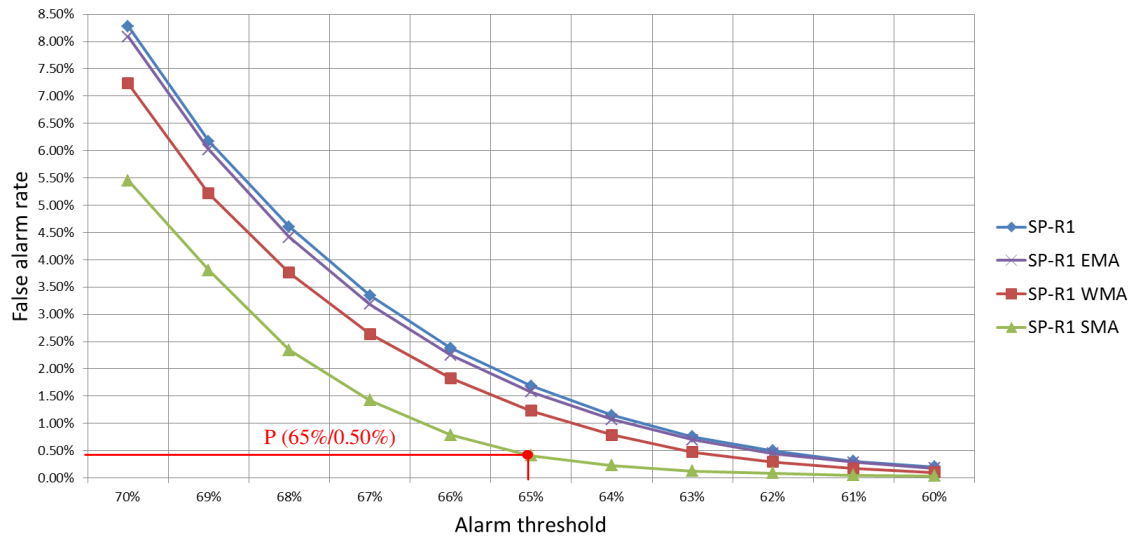
Figure 13 plots the SP-R1 sample false alarm rate depending on the alarm threshold for the different averaging techniques. The false alarm rate is calculated as the number of occurrences in which the calculated amplitude value based on the averaging technique falls below the defined alarm threshold, divided by the total number of measured amplitude values per sample. This calculation is based on the assumption that the good bond reference sample SP-R1 is free of defects. The criterion for the selection of the averaging technique is to minimise the false alarm rate. The SMA technique offers the smallest false alarm rate. Considering that a false alarm rate of 0.50% is reasonably acceptable, then the alarm threshold should be defined as 65% of the normal amplitude level for the SMA technique. This point P(65.3%/0.50%) for the SMA technique is marked on the graph. For the same 65% alarm threshold, the WMA false alarm rate is 1.23%, EMA is 1.58% and for the unchanged data set it is 1.69%. Therefore the measurement data should be processed with the SMA technique during inspection to reduce the amount of rejected material due to false alarms.

Figure 13. Relationship between false alarm rate and threshold for defect-free sample SP-R1
