# STUDY ON TAILINGS DAM OVER-TOPPING FAILURE MODEL TEST AND BREAK MECHANISM UNDER THE RAINFALL CONDITION

Original scientific paper

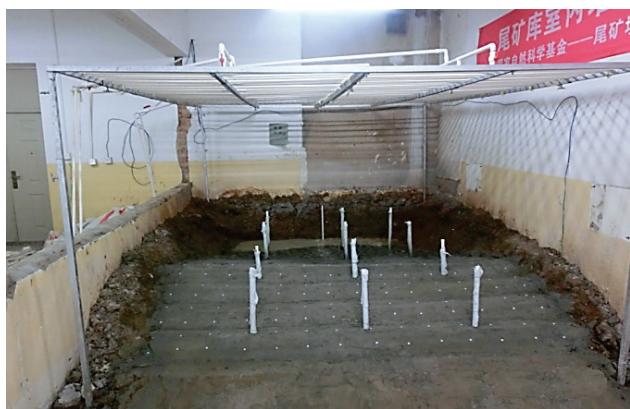
Using the upstream tailings dam as the research object, the model is scaled at 1: 50 reduced. The initial dam is with mixed earth-rock, its size is 3 m long, 0.08 m high, 0.12 m wide on the top and 0.47 m on the bottom. The ratio of the accumulation dam slope is 1: 1.25, the ratio of outer slope is 1: 3.125. The size of the accumulation dam is the same as the initial dam, and the model of the tailings dam is shown in Fig. 1.

Figure 1 The model of the tailings dam

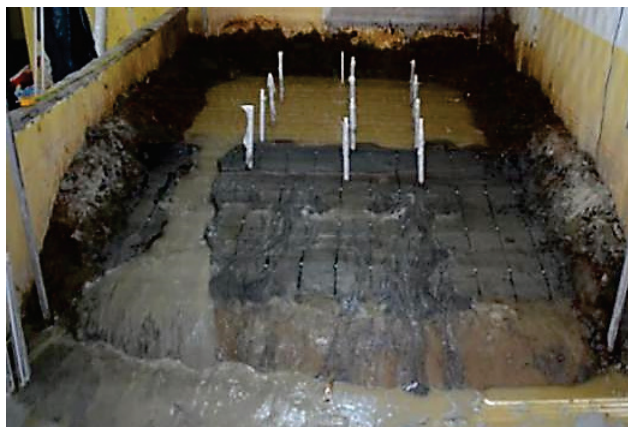
Based on the observation of dam-break model, the dam-break process is shown in the following Fig. 6, and the dam-break process is as follows:

The seepage of the tailings and the water overflow occurred at the dam site during the rising of the water level. At the beginning of the water overflow, the overflow has a very low sand content, and the speed of water flow is also slow. With the increasing of overflow water, some small gullies caused by water erosion are formed on the dam surface. There is swamping or surface flow at the downstream dam slope, and the outflow water takes away the tailings of the downstream dam and forms the small collapsed.

Figure 6 The process of dam-break

With the rainfall continuing, water level is rising, the water flows over the lowest point of the crest and the overflow phenomenon occurs at the left dam crest and causes the formation of breach. The water flow cross section of the breach is small, the water containing tailings is very low and close to the clear water flow. Because of the small flow velocity, the erosion intensity is weak, and the tailings which are washed up by water flow continuously into the water and quickly exceed the sediment carrying capacity of the current. The duration of this stage is shorter, mainly with vertical erosion, accompanied by small lateral broadening [27].

The water overflows the top of the breach, the top of the breach is completely eroded, and the cross-section of the breach increases, the breach is deepened and

accompanied by a slight lateral broadening. After the breach through, the amount of water in the breach increases and water erosion enhances. The accumulation of some tailings in the breach is transported to the downstream by the water flow, and the loose tailings on the dam surface flow to the dam foundation by the tailings flow erosion.

In the upstream of the dam, the amount of water in breach is large, but the rate of flow is small, erosion mainly occurs in the middle and downstream of the dam. The cut effect of the water flow is obvious in the downstream, the water flow erodes the downstream slope that leads to the downstream slope foot collapse, and the scarp appears in the downstream dam. At the same time, the water continuously washes the foot of the breach, causing both sides of the breach slope collapse. The breach in the downstream surface to the trumpet-like expansion and the downstream accumulation of tailings increases rapidly.

The breach flow increased rapidly and the water cutting effect was more obvious. Breach slopes of the dam have collapsed rapidly, the water flow and the water erosion reach the maximum, and a large number of tailings at the breach continued to be carried to the downstream by water erosion. The water level in the reservoir is decreased rapidly. The erosion is basically finished, the dam body is destroyed completely. A lot of tailings in the downstream of the dam were a fan-shaped accumulation after the dam collapse, similar to debris flow.
