The Journal of Global Radiology

ORIGINAL RESEARCH

A Survey of Structural Design of Diagnostic X-ray Imaging Facilities and Compliance to Shielding Design Goals in a Limited Resource Setting

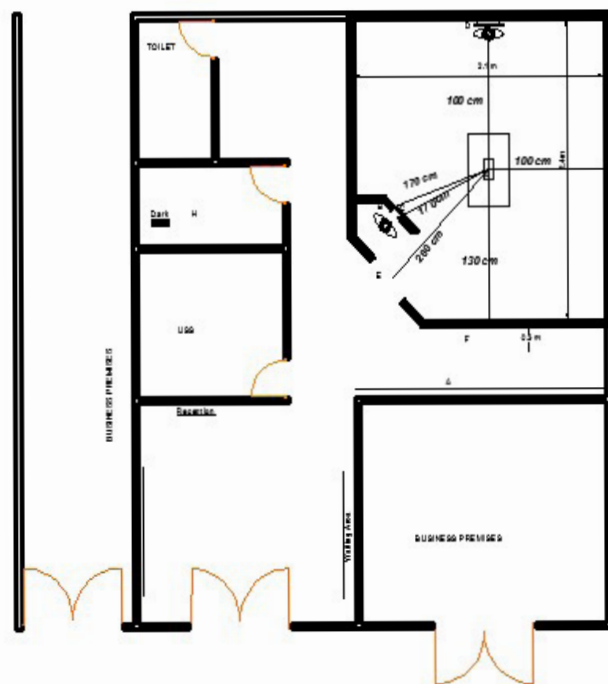
Figure 1. X-ray Room Layout for Center X

Findings from this study indicate that out of the three radiodiagnostic centers studied for structural designs, Center X (Figure 1) had a room dimension of 2.4 m × 2.1 m with a minimum and maximum distance of 100 cm and 280 cm from the x-ray tube to the nearest wall or protective barrier (Tables 1a and 1b). A 2.23 mm lead sheet bonded to plywood was used as the shielding material.

S/N	Point of Measurement	Description	Distance from the source	Measured Exit Dose	Recommended Dose (mSv/wk)
1	Point B	Lead Glass window	170 cm	0.00152± 0.0000	0.1
2	Point C	Control Console	170 cm	0.0014 ± 0.0000	0.1
3	Point H	Darkroom	150 cm	0.00068± 0.0000	0.1

S/N	Point of Measurement	Description	Distance from the source	Measured Exit Dose	Recommended Dose (mSv/wk)
1	Point D	Chest Stand	100 cm	****	0.02
2	Point E	X-ray room door	280 cm	0.00056± 0.0000	0.02
3	Point F	Wall 1	130 cm	0.0176± 0.0009	0.02
4	Point G	Wall 2	100 cm	0.0076± 0.0004	0.02
5	Point I	Patient Waiting Areas	30 cm	0.00066±0.0000	0.02

In this study, the distance from the x-ray tube to the chest stand in one of the centers was found to be 100 cm, which is less than the recommended distance for a standard chest x-ray of 140-200 cm (11). This implies that chest x-rays done at this distance may not reflect the true anatomical geometry of the patient's chest, since the source to image distance is not optimized. The radiation protection implication of this

finding is that the intensity of the radiation reaching this wall will be high, hence additional shielding may be required. This finding is just one among many issues that go unnoticed in limited-resource settings.

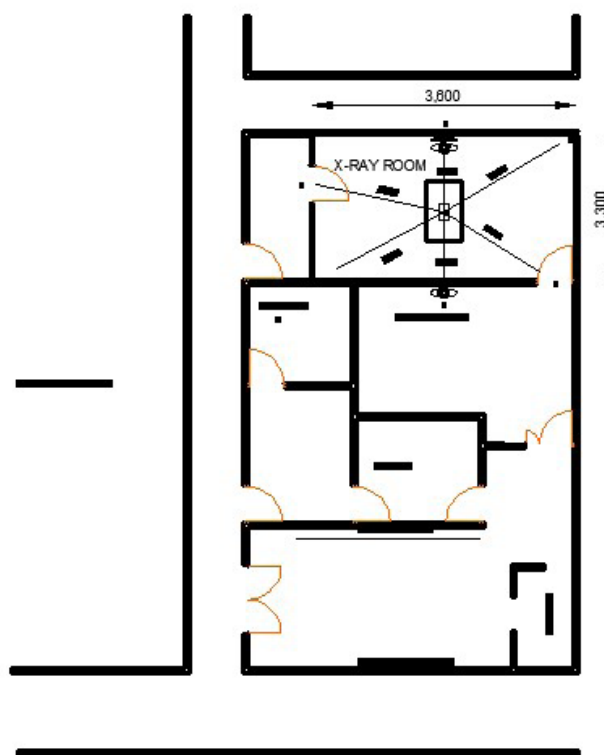
Figure 2. X-ray Room Layout for Center Y

Center Y (Figure 2) had an x-ray room dimension of 3.6 m × 3.3 m with a minimum and maximum distance of 140 cm and 310

cm from the x-ray tube to the nearest wall or protective barrier (Table 2a and 2b). Barium plaster with an unquantifiable thickness was used as the shielding material.

S/N	Point of Measurement	Description	Distance from the source	Measured Exit Dose	Recommended Dose (mSv/wk)
1.	Point B	Control console	180 cm	0.00496±0.0002	0.1
2.	Point G	Darkroom	30 cm	0.00208±0.0001	0.1

S/N	Point of Measurement	Description	Distance from the source	Measured Exit Dose	Recommended Dose (mSv/wk)
1.	Point C	Primary wall	310 cm	0.428±0.0214	0.02
2.	Point D	Secondary wall	200 cm	0.02416±0.0012	0.02
	Point E	X-ray room Door1	180 cm	0.01012±0.0005	0.02
3.	Point F	X-ray room Door2	140 cm	0.32144±0.0161	0.02
4.	Point H	Reception	30 cm	0.00064±0.0000	0.02

Findings of measured radiation doses transmitted through barriers showed that two of the three centers studied were in compliance with the recommendations of the shielding design goals. Only Center Y recorded doses above the recommended design dose limits at some locations, as shown in Tables 2a and 2b. While the measured exit dose for controlled areas in Center Y was below the recommended limit, high measured values above the recommended shielding design goal were observed at two locations for uncontrolled areas; Point C (Primary wall behind the chest stand), and Point F (x-ray room door 2). Possible factors influencing the high measured radiation exposure levels at these points could be inadequate shielding and room dimensions not being optimized. It was further observed that barium plaster was used in this center for shielding, but barium is less efficient than lead in terms of shielding efficacy (9). The doors were not adequately lead-lined, which accounted for the high x-ray beam transmission. The radiation protection implication of this finding is that passersby and patients could be subjected to unnecessary radiation exposure in these areas.

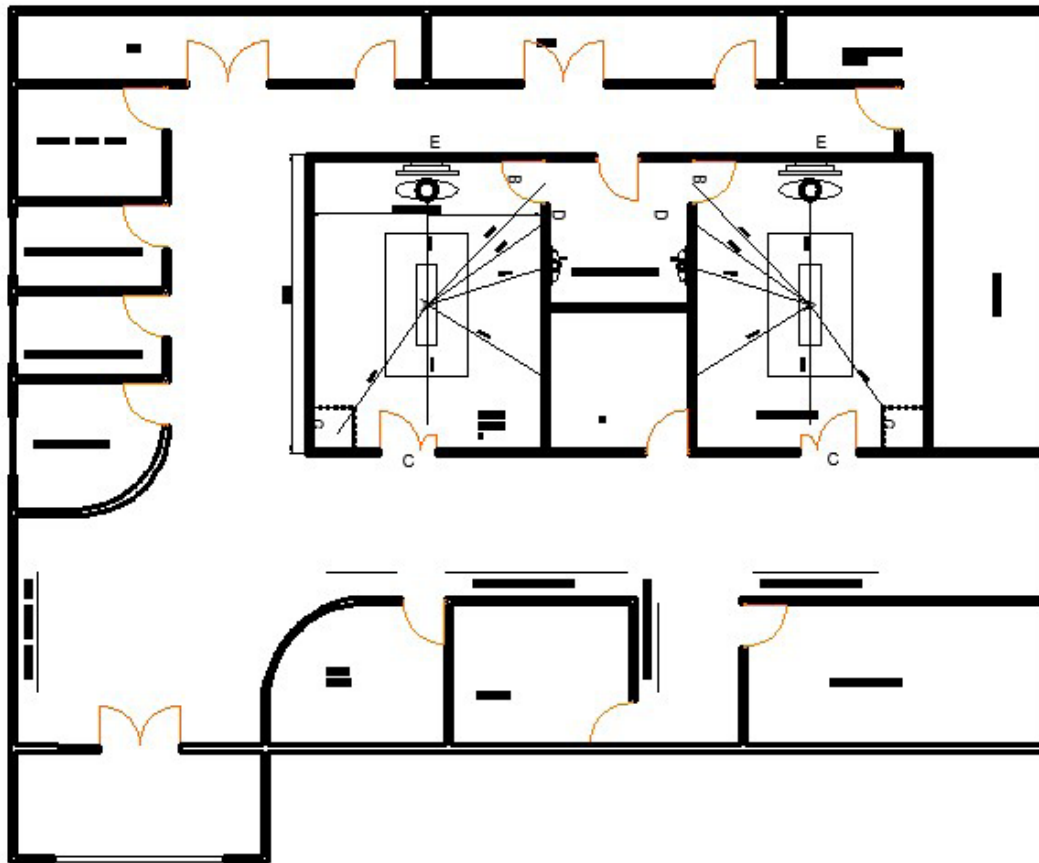
Figure 3. X-ray Room Layout for Center Z

Center Z (Figure 3) had two x-ray rooms (Room 1 and Room 2), which shared common features structurally. Both Room 1 and Room 2 had room dimensions of 6.3 m × 3.6 m with minimum and maximum distances of 240 cm and 440 cm from the x-ray tubes to the nearest walls or protective barriers (Tables 3a and 3b; Tables 4a and 4b). The shielding material used in the x-ray rooms of this center was lead. The edges of the lead-lined walls were adequately sealed such that the lead thickness could not be measured. However, x-ray beam transmission through these walls was considered a measure of protection efficacy.

S/N	Point of Measurement	Description	Distance from the source	Measured Exit Dose	Recommended Dose (mSv/wk)
1.	Point D	Wall 1	200 cm	0.00168±0.0000	0.1
2.	Point F	Control console	220 cm	0.00044±0.0000	0.1
3.	Point G	Cubicle	300 cm	0.00072±0.0000	0.1
4.	Point H	Darkroom	360 cm	0.00052±0.0000	0.1

S/N	Point of Measurement	Description	Distance from the source	Measured Exit Dose	Recommended Dose (mSv/wk)
1.	Point B	X-ray room Door1	240 cm	0.001±0.0000	0.02
2.	Point C	X-ray room Door 2	440 cm	0.00088±0.0000	0.02
3.	Point E	Wall 2	220 cm	0.00392±0.0000	0.02
4.	Point I	Waiting Area	30 cm	0.00096±0.0000	0.02

S/N	Point of Measurement	Description	Distance from the source	Measured Exit Dose	Recommended Dose (mSv/wk)
1.	Point D	Wall 1	200 cm	0.00224±0.0001	0.1
2.	Point F	Control Console	220 cm	0.00052±0.0000	0.1
3.	Point G	Cubicle	300 cm	0.00104±0.0000	0.1
4.	Point H	Darkroom	360 cm	0.00052±0.0000	0.1

S/N	Point of Measurement	Description	Distance from the source	Measured Exit Dose	Recommended Dose
1.	Point B	X-ray room Door1	240 cm	0.00104±0.0000	0.02
2.	Point C	X-ray room Door 2	440 cm	0.00544±0.0003	0.02
3.	Point E	Wall 2	220 cm	0.00904±0.0005	0.02
4.	Point I	Waiting Area	30 cm	0.00096±0.0000	0.02

Of the three radiodiagnostic centers covered in this study, one was owned by the Nigerian government, whereas the other two centers were owned by private practitioners. On the x-ray room layout, it was noted that only Center Z (Figure 3) had a standard, general-purpose diagnostic x-ray room size and layout, while the others were modified existing structures used for diagnostic centers. These findings are consistent with those of Muhogora and Kondoro (7), who conducted a study on secondary shielding barriers in Tanzania and noted that most of the x-ray rooms in private hospitals were not of the recommended standard sizes.
