# Monitoring and testing of a new stone masonry arch bridge in Vila Fria, Portugal

**ABSTRACT:** This paper reports on the monitoring and load testing of a new stone masonry arch bridge recently built over the river Vizela in Vila Fria, Felgueiras, located about 60 km from Porto, Portugal. Besides highlighting the scientific purposes subjacent to this bridge construction initiative, the paper addresses basic aspects on the installed instrumentation and provides a general overview of sensor types, location and measured signals, as well as data acquisition and transmission systems. Some of the most relevant result measurements obtained from the load test and their comparison with available numerical analyses are also presented.

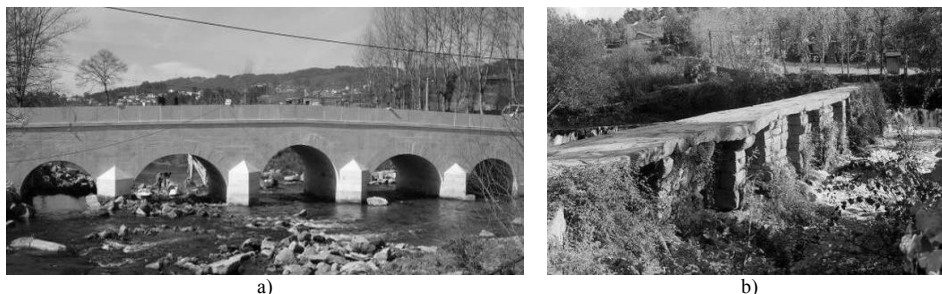
Figure 1 : Vila Fria Bridge. a) new bridge and b) old passage.

The case described in this paper is believed to assume particular relevance for the scientific and technical community interested in the field of structural analysis and monitoring of old masonry constructions, bridges in particular. The case study refers to the new stone masonry bridge Fig. 1a in Vila Fria - Portugal, over the Vizela River, recently built according to traditional techniques of masonry construction to replace an old and very deficient passage Fig. 1b.

The new bridge consists of a 60m long and 6m wide two-ramp deck, supported by five arches with 4.8m to 6m span, four piers and two abutments; the design and construction details are addressed in a companion paper Costa *et al.* (2007). The multidisciplinary work concerned with the design, construction and structural behaviour study of the bridge has involved several components, namely: structural modelling and analysis, laboratory and *in-situ* testing for numerical model calibration, instrumentation and measurement of structural and material parameters, *in-situ* data acquisition and remote monitoring. Undoubtedly, amongst all these interesting issues, the greatest motivation for this initiative was the possibility of continuously monitoring this construction from its very beginning.

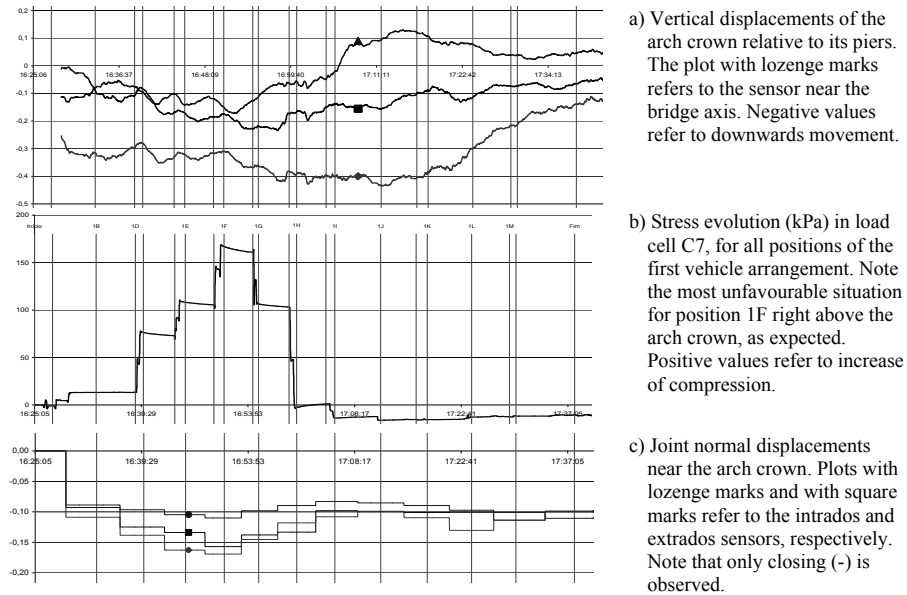
Figure 10: Load test results (a), (b) and (c) for arch 4 and load arrangement 1.

Although not corresponding to the larger total load, the arrangement 1 was found to produce the most unfavourable effects. Therefore, results herein addressed refer solely to that load configuration and particular attention is given to the arch 4, the most instrumented one and likely to exhibit more pronounced effects. Moreover, due to paper length limitations, results as shown in Fig. 10 only focus on the vertical displacement (Fig. 10a), compressive stress (Fig. 10b) and joint opening/closing (Fig. 10c) in that arch crown. Vertical alignments of these plots correspond to the several stopping positions and are identified in Fig. 10b.
