PHOTOGRAMMETRY AS A TOOL FOR CHRONOLOGICAL DATING OF FIRED BRICKS STRUCTURES IN GENOA AREA

KEY WORDS: Mensiochronology, Photogrammetry, Digital measurement, Fired bricks, Genoa

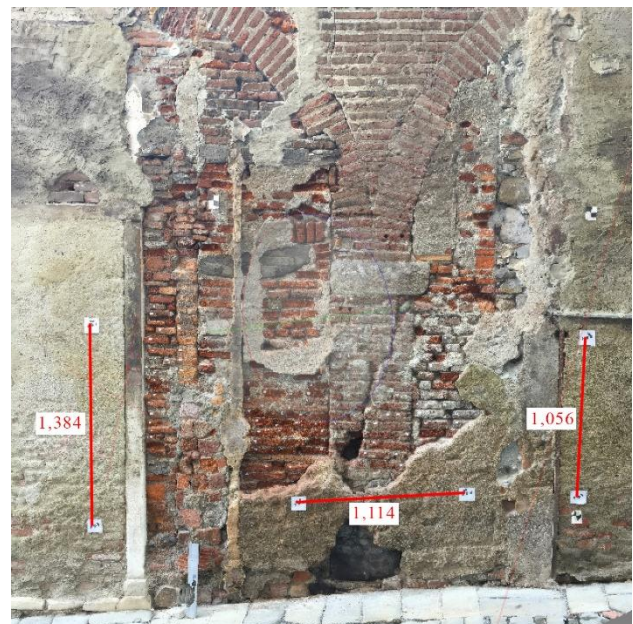
Figure 2. The digital model created by Agisoft PhotoScan software is scaled inserting the distance between couples of coded targets placed on site.

Six coded target (CTs)¹ were placed on the wall. The length between couples of targets was measured manually on site to scale the digital model. In case A and B coded targets were measured topographically with a total station Leica TS-15. This allowed to compare the difference between the point cloud resulting from longimetric survey and the one resulting from topographic survey. The gap between the two sets of measurements (longimetric and topographic) resulted to be less than one millimeter.

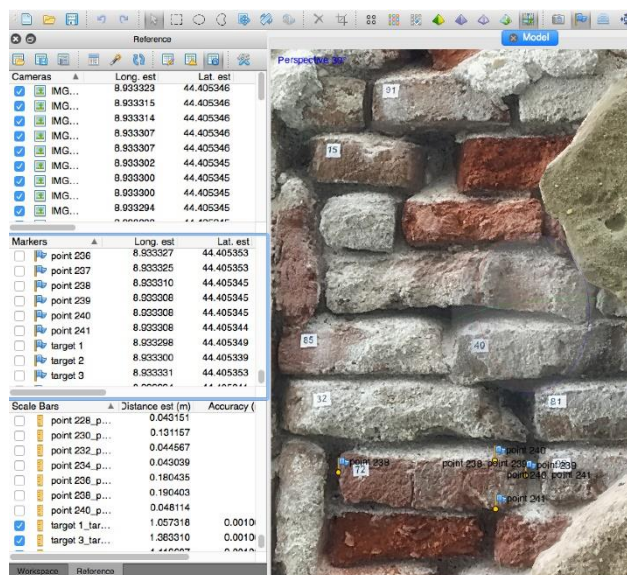
Figure 3. In case A and B, the bricks were identified on site with numbered labels to compare the results of direct and digital measurements block by block. The image displays inserted markers for brick n. 72.

In case A and B, the bricks were identified on site with numbered labels to compare the results of direct and digital measurements and to prove the effectivity of photogrammetry for mensiochronology.

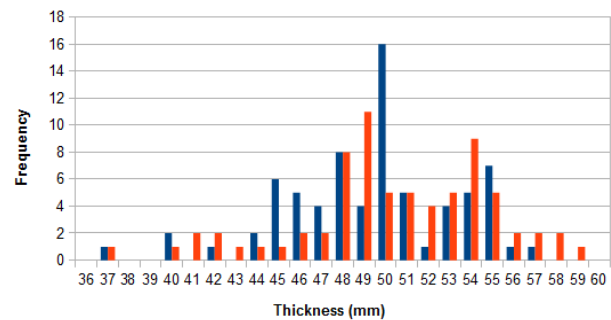
Figure 4. Graph regarding the distribution curve trend of bricks thickness in case A. Nm: direct measurements on site; Ne: measurements on digital model. As previously stated, the larger available number for each dimension was recorded for each of the dimensions, to deal with block irregularities. For example, if one element presented parts with different thicknesses, the larger value among the two was the one recorded. Both direct and digital systems allowed the identification of color and characteristics of all the bricks (such as color and cracks).

The comparison between direct and digital measurements on single elements showed that 25 measurements of 72 total have a difference of less than 1 mm and that the mean difference is 2.33 ± 1.99 mm.

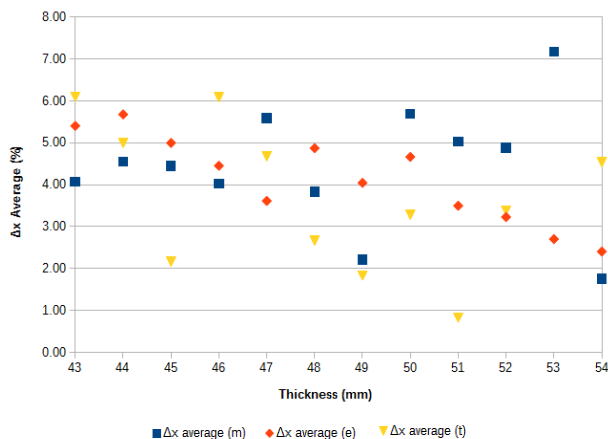
Figure 5. Graph regarding the difference between direct measurement on site by one operator, and digital measurement by three operators (m, e, t). This graph includes bricks of all stratigraphic units. Direct measurement is considered here as reference, since mensiochronology curves are usually developed based on measurements on site. Brick thickness is represented on x-axis: the range 43–54 mm is selected since it includes most measurements. The mean difference in absolute value is weighted on the brick thickness (from direct measurement on site), giving a percentage that is represented on y-axis. It is not possible to recognize a linear trend linking the difference between direct and digital measurements and brick thickness, nor considering the measurements by each operator alone working on the digital model. Further observation may be done by increasing the number of operators.

Then, data were analyzed to investigate whether a linear trend linking the difference between direct and digital measurements with brick thickness could be identified. To do this, the two sets of direct measurements were compared between them, using the second set to check the reliability of the first one. Elements displaying a difference of more than 3 mm between the two direct measurements were discarded. After this, direct measurements on single elements were compared with the corresponding measurement on each digital set, calculating the mean difference and standard deviation. Considering the first digital set, the mean difference is 2.14 ± 1.64 mm (76 measurements); for the second one, the mean difference is 2.00 ± 1.44 mm (79 measurements); for the third one, the mean difference is 1.54 ± 1.25 mm (63 measurements).

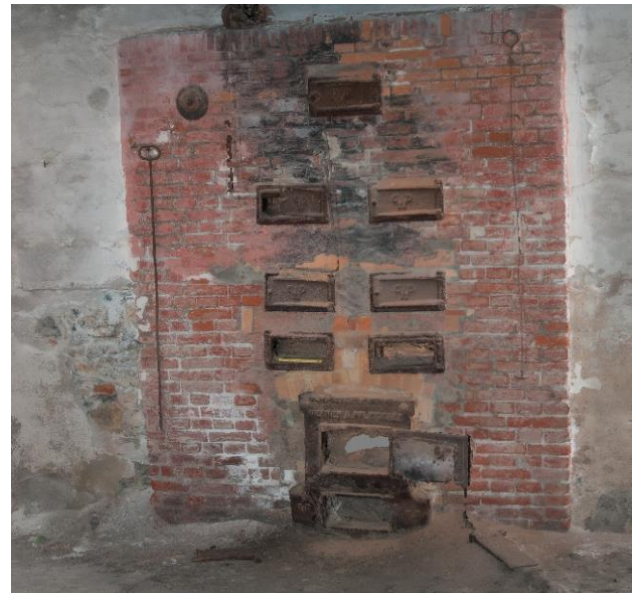
Figure 6. Tiled model view of case C, a wall of the ovens in the kitchen of the *Albergo dei Poveri*.

The third one – case C – is located in the kitchens of the *Albergo dei Poveri* (Hospice for the Poor) in Genoa, a construction dating back to the 17th century. The wall studied is part of the ovens and is made of industrial 19th century bricks. This example was chosen to verify the application of photogrammetry in the case of more standardized elements, checking the deviations of the resulting curve.

In case of the first operator, the difference between digital and direct measurements is less than 1 mm for 4 measurements of 11 total, and mean difference is 1.40 ± 1.13 mm. In case of the second operator, the difference between digital and direct measurements is less than 1 mm for 5 measurements of 11 total, and the mean difference is 1.96 ± 1.76 mm.
