Z. BURZIĆ, DŽ. GAČO, F. ISLAMOVIĆ, M. BURZIĆ, E. BAJRAMOVIĆ

ISSN 0543-5846
METABK 52(2) 181-184 (2013)
UDC – UDK 669.15:620.17:624.078.3=111

THE EFFECT OF VARIABLE LOADING ON INTEGRITY OF A WELDED JOINT OF HIGH ALLOY-STEEL X20

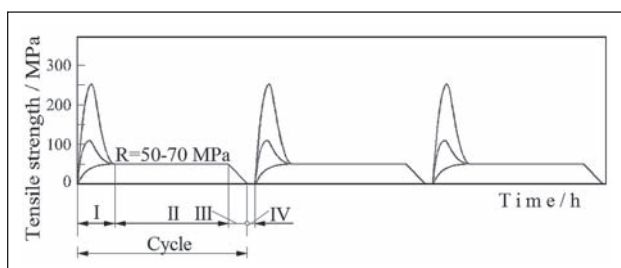
Figure 1 Typical diagrams of stresses of main steam lines at thermal power plants [1]: I – start-up; II – stationary regime; III stoppage; IV - pause

Fatigue of metal is defined as a process of cumulative damaging affected by variable loading, resulting in fatigue-crack initiation and fracture. Strength of a welded joint exposed to variable loading occurring in non-stationary regimes of operation of a steam line during the period of start-up and stoppage (Figure 1) is an important property of exploitation life. Thus one should have in mind that crack-type damages occur after a large number of variations of loading at stresses lower than yield stress (high-cycle fatigue) or after relatively small number of variations of loading (up to 50 000) at stresses close to yield stress (low-cycle fatigue).

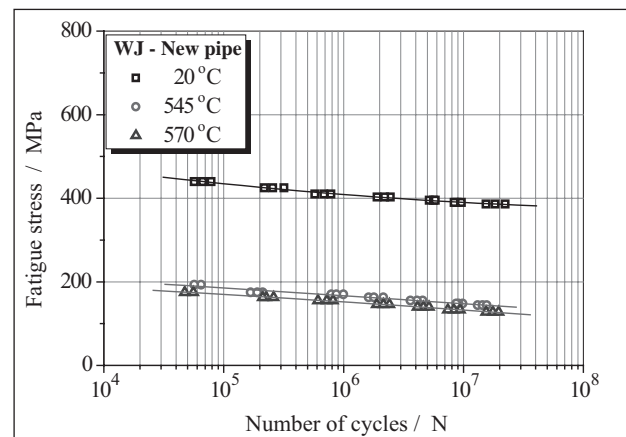
Figure 2 S-N diagrams of the welded-joint specimens of the sample of new pipe made of steel X20 [5]

The effect of exploitation time and temperature on the values of permanent dynamic strength, S_p, i.e. maximum dynamic stress at which no crack initiate, is graphically presented in a form of Veler’s curves (S-N diagrams): for welded joint of new pipe in Figure 2, and for welded joint of exploited pipe in Figure 3.

Analysing the Veler’s curves obtained by testing the specimens of the welded joints of new and exploited pipe, one can see that exploitation time and temperature

substantially affect the values obtained for permanent dynamic strength. The values of permanent dynamic strength, S_p , decrease with an increase of testing temperature. Exploitation period of 116 000 hours lead to decrease of the values of permanent dynamic strength, which can be important information if the conditions of steam-line operation are known.

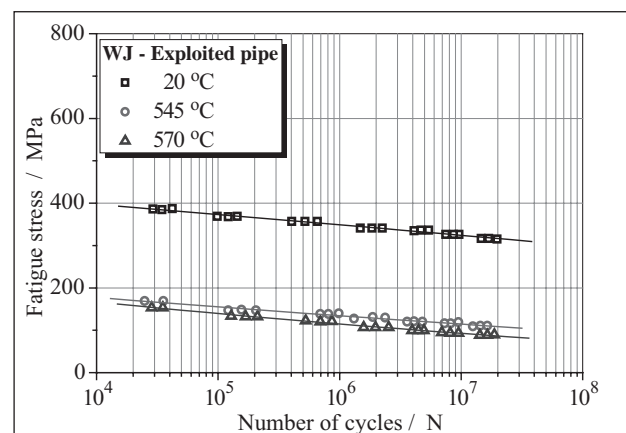
Figure 3 S-N diagrams of the welded-joint specimens of exploited pipe made of steel X20 [5]

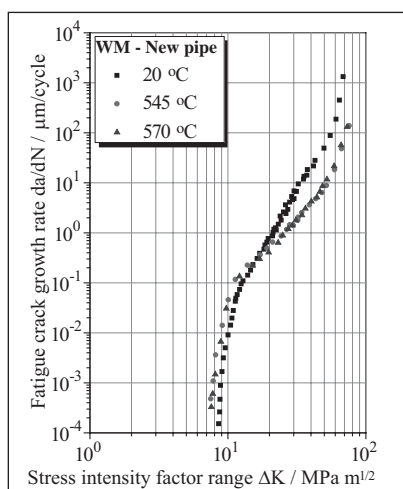
Figure 4 Diagram of dependence $da/dN - \Delta K$ for WM specimens of new pipe [5]

Typical diagrams Fatigue crack growth rate $da/dN -$ Stress intensity factor range ΔK , for the specimen with a notch in WM is shown in Figures 4 and 5, and that for the specimen with a notch in HAZ in Figures 6 and 7.

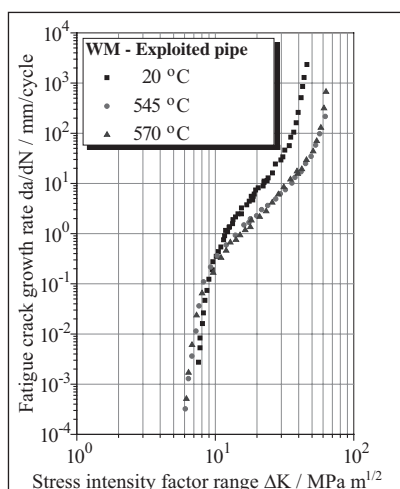
Figure 5 Diagram of dependence $da/dN - \Delta K$ for WM specimens of exploited pipe [5]

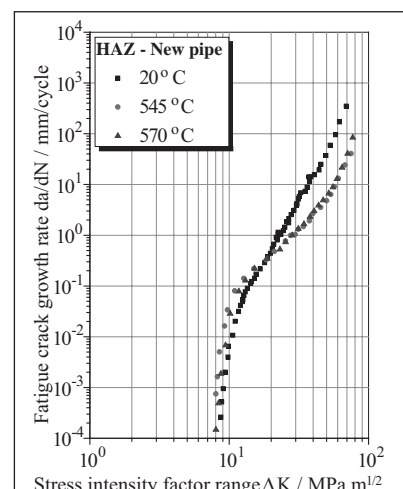
Figure 6 Diagram of dependence $da/dN - \Delta K$ for HAZ specimens of new pipe [5]

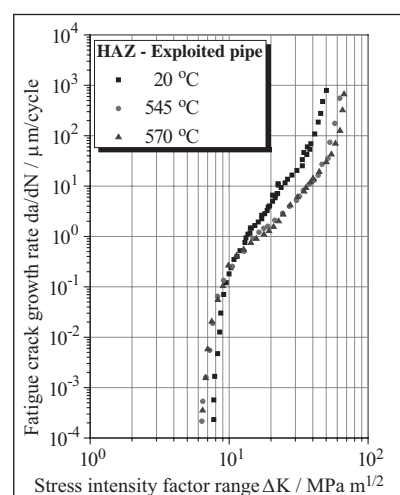
Figure 7 Diagram of dependence $da/dN - \Delta K$ for HAZ specimens of exploited pipe [5]

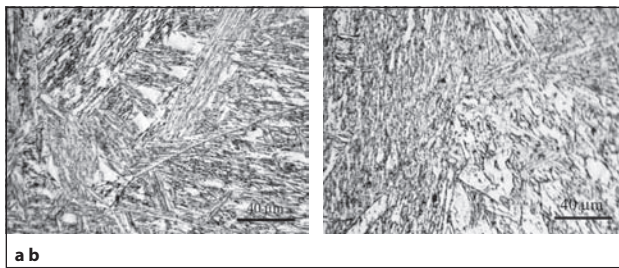
Figure 8 Microstructure of BM of a) new pipe, b) exploited pipe of steel X20

The foundation of the base metal (BM) microstructure of steel X20, Figure 8, is tempered martensite. Between primary martensitic aciculae and at the boundaries of primary austenitic grains carbide precipitates form, most probably $M_{23}C_6$, where M represents alloying elements of steel – most frequently chromium, molybdenum and vanadium [11]. Inside the martensitic aciculae there are no precipitates. Carbides separate mostly at the grain boundaries and near the grain boundaries, and their high temperature stability contributes to high creep resistance of this steel.

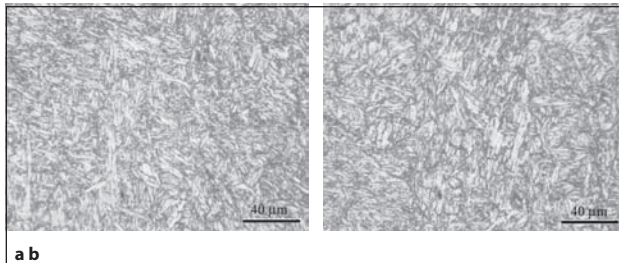
Figure 9 Microstructure of WM of a) new pipe, b) exploited pipe of steel X20

There is no substantial difference between weld-metal microstructure of new pipe and exploited pipe, Figure 9. The foundation of weld-metal microstructure is martensite, too, but the size of primary austenitic grains is significantly smaller than that in BM, which means that the length of the austenitic aciculae is also smaller.

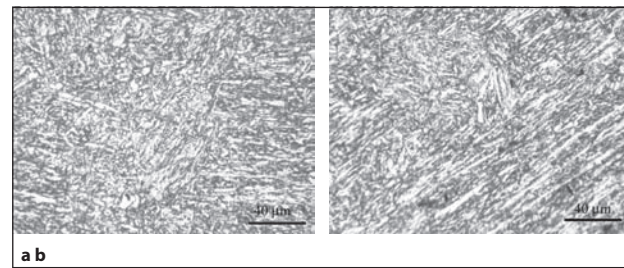
Figure 10 Microstructure of HAZ of a) new pipe, b) exploited pipe of steel X20

In Figure 10, the microstructure of HAZ of a welded joint of new and exploited pipe is shown. Note that pri-

mary austenitic grains in HAZ are coarser in the material that was exploited than in new material.

The size of primary austenitic grains is largest in BM (which is the consequence of steel production) and smallest in WM, which directly affects the size of martensitic aciculae. WM martensite with smaller grain size provides better mechanical properties, ductility and resistance to fatigue-crack growth. Therefore, it is clear why BM is the weakest spot in a welded joint.
