Bowland, P, Ingham, E [orcid.org/0000-0002-9757-3045](https://orcid.org/0000-0002-9757-3045), Fisher, J et al. (1 more author) (2018) Simple geometry tribological study of osteochondral graft implantation in the knee. *Proceedings of the Institution of Mechanical Engineers, Part H: Journal of Engineering in Medicine*, 232 (3). pp. 249-256. ISSN 0954-4119

## Simple Geometry Tribological Study of Osteochondral Graft Implantation in the Knee

### Abstract

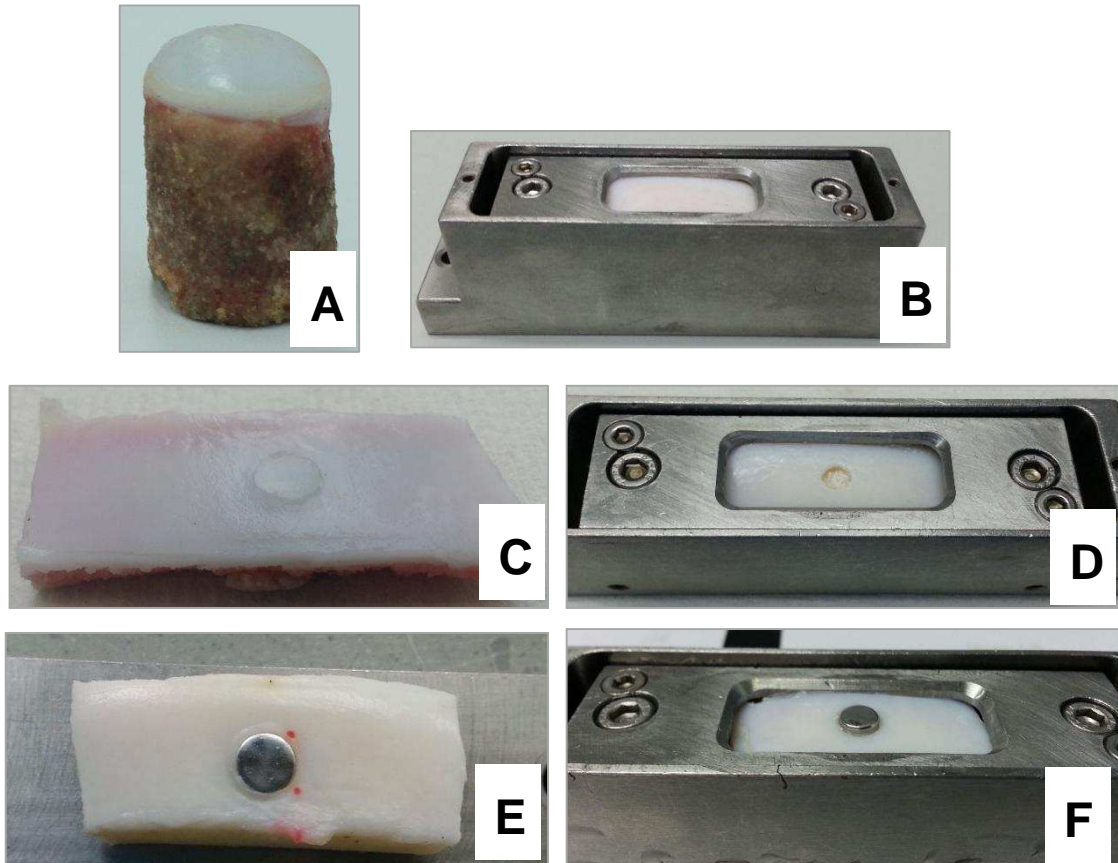
**Figure 1** Images of the 12 mm diameter reciprocating pin (A); an osteochondral plate with no graft / defects inserted (negative control group) within the lubricant bath (B); Xenograft group (C); Cartilage defect group (D); Positive control group 1 (stainless steel pins inserted flush) (E); Positive control group 2 (stainless steel pins inserted 1 mm proud) (F)

The experimental setup for all test groups consisted of a curved ended, 12 mm diameter porcine osteochondral pin, reciprocating against a flat bovine osteochondral plate (**Error! Reference source not found.**).

(Figure 1). A further two experimental groups were tested: Experimental Group 1) cartilage defects inserted down to subchondral bone (n=6); Experimental Group 2) porcine xenografts inserted flush with the articular cartilage surface (n=6). All experimental and control group tests were performed in a lubricant of PBS + 25% (v/v) newborn calf serum (Gibco Life Technologies, Paisley, UK) for a duration of 3 hours.

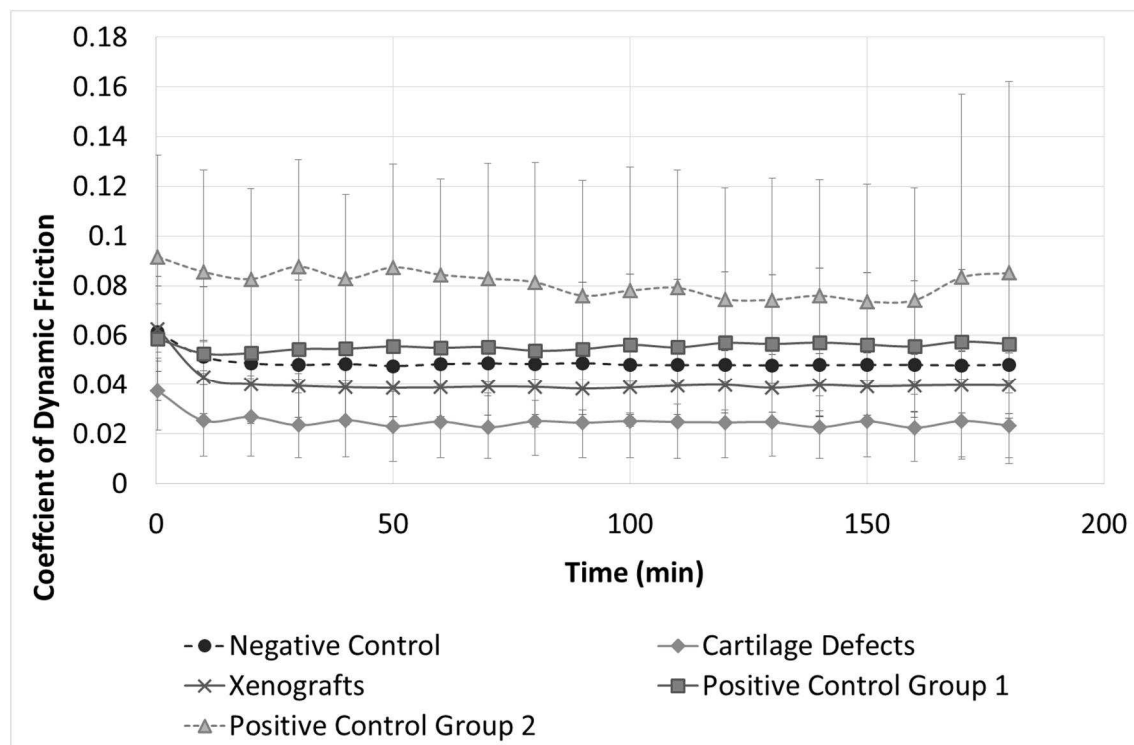
**Figure 1: Mean coefficient of dynamic friction plotted at 10 min time intervals (mean  $\pm$  95% confidence limits; n=6 per group).**

The negative control samples maintained a low constant coefficient of dynamic friction ( $0.049 \pm 0.007$ ) throughout the test duration following a small initial decrease during the first 10 mins (Figure 1). No significant differences ( $p > 0.05$ ; paired t-test) in dynamic friction were recorded between the negative controls and any of their paired experimental or positive control group tests at any time point analysed (60, 120 and 180 mins).

Overall, there were no significant differences in dynamic friction ( $p > 0.05$ , paired t-test) between the negative controls and the paired experimental or positive control group tests (Figure 1); furthermore, increased levels of articular cartilage surface damage and wear were not associated with significant increases in the coefficient of dynamic friction. The positive control groups exhibited the highest levels of friction, with a small increase in the coefficient of friction observed between 60 and 180 mins (Figure 2). The cartilage defect and xenograft groups demonstrated a lower mean coefficient of friction in comparison to the negative controls, with the greatest decrease in frictional coefficient (- 0.019) recorded in the cartilage defect group at 180 mins. The lower levels of friction recorded in the cartilage defect group were likely attributable to a reduction of contact area and increased fluid volume in the articulation, resulting in increased fluid load support of the applied load. These factors were also likely to have contributed to the low level of cartilage damage, wear and deformation ( $0.99 \text{ mm}^3$ ) measured in the cartilage defect group (Figure 4).

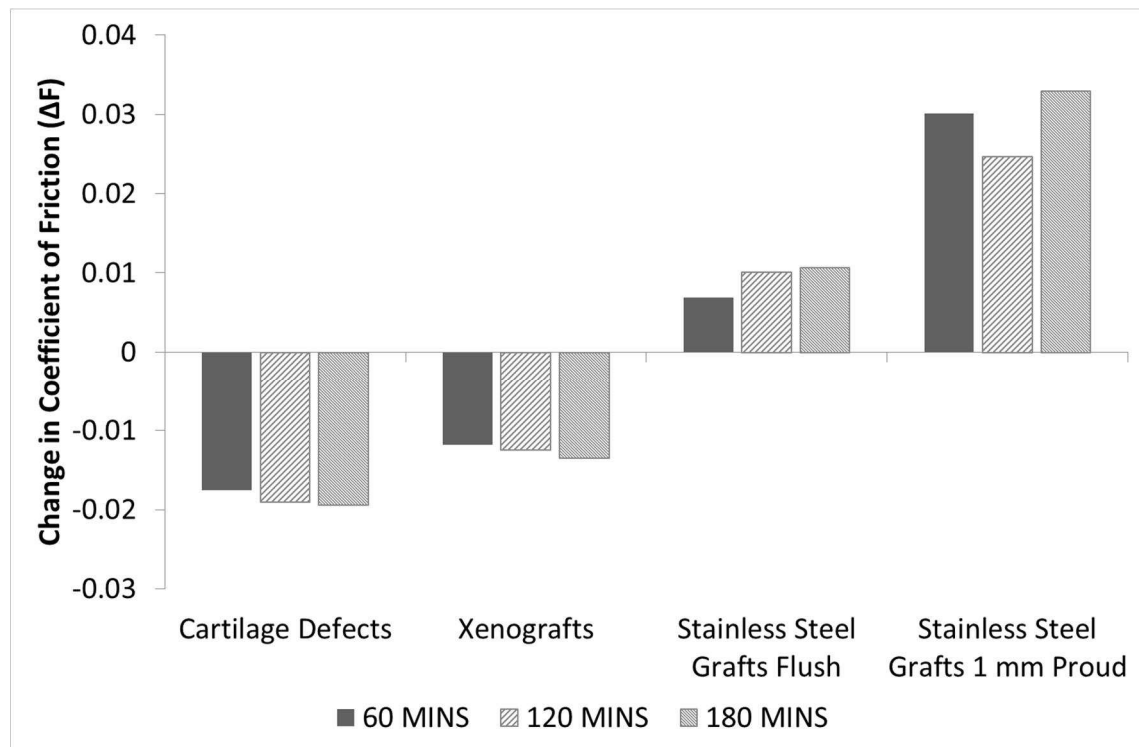
**Figure 2: Mean change in coefficient of dynamic friction between the negative control tests and each paired experimental or positive control group test at 60, 120 and 180 mins (n=6 per group). Change in dynamic friction ( $\Delta F$ ) calculated as experimental friction ( $F_E$ ) minus negative control friction ( $F_C$ ).**

The mean change in the coefficient of dynamic friction between the negative control groups and their paired experimental or positive control group is presented in Figure 2. A positive increase in dynamic friction was recorded for positive control groups 1 (stainless steel pins inserted flush) and 2 (stainless steel pins inserted 1 mm proud) at time points 60, 120 and 180 mins when compared to the paired negative control tests. Positive control group 2 exhibited the greatest overall change in recorded friction across all groups. The mean coefficient of friction for the cartilage defect and xenograft groups was lower than the negative controls; the largest

decrease in coefficient of dynamic friction was recorded in the cartilage defect group at 180 mins (- 0.019).

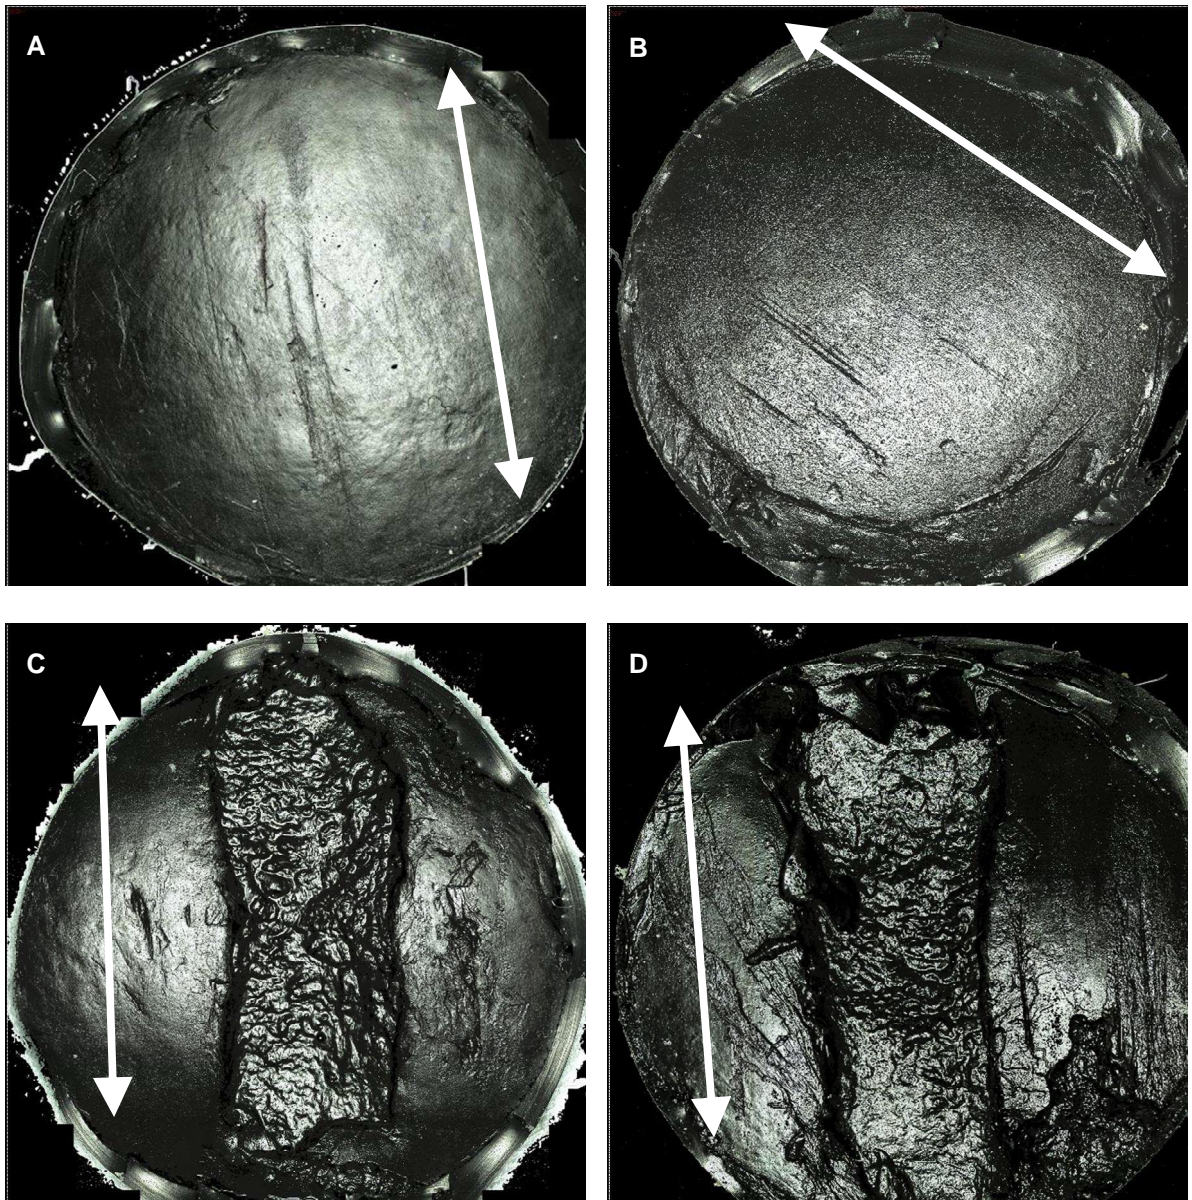
**Figure 3: Example Alicona Infinite Focus scan images of the reciprocating 12mm diameter pin surface with arrows indicating sliding direction. A) Cartilage Defect Group; B) Xenograft Group; C) Positive Control Group 1 (Stainless Steel Pins Flush); D) Proud Positive Control Group 2 (Stainless Steel Pins 1 mm).**

Positive control groups 1 and 2 sustained severe cartilage damage, wear and deformation as shown in Figure 3. Damage, wear and deformation in the positive control groups generally

consisted of large, steep flanked cartilage lesions stretching across the diameter of the pin surface, accompanied by multiple deep scratches on the surrounding cartilage surface. The mean volume of cartilage damage and wear in positive control group 1 and 2 was significantly greater ( $p=0.021$  and  $p=0.042$ ; independent t-test) than the negative controls, at  $15.3 \text{ mm}^3$  and  $37.1 \text{ mm}^3$  respectively (Figure 4).

The cartilage defect group had the smallest mean volume of damage, wear and deformation at 0.99 mm<sup>3</sup>, similarly the volume of the xenograft group was also low at 2.4 mm<sup>3</sup>. No significant difference ( $p>0.05$ ) was present between the negative control group (0.098 mm<sup>3</sup>) and both the cartilage defect ( $p=0.162$ ; independent t-test) and xenograft ( $p=0.188$ ; independent t-test) groups. Damage, wear and deformation in the cartilage defect and xenograft groups consisted of visible areas of increased surface roughness, scratches in the central region of the pin surface orientated parallel with the direction of translation, and/or small, shallow cartilage lesions with irregular boundaries (Figure 3).

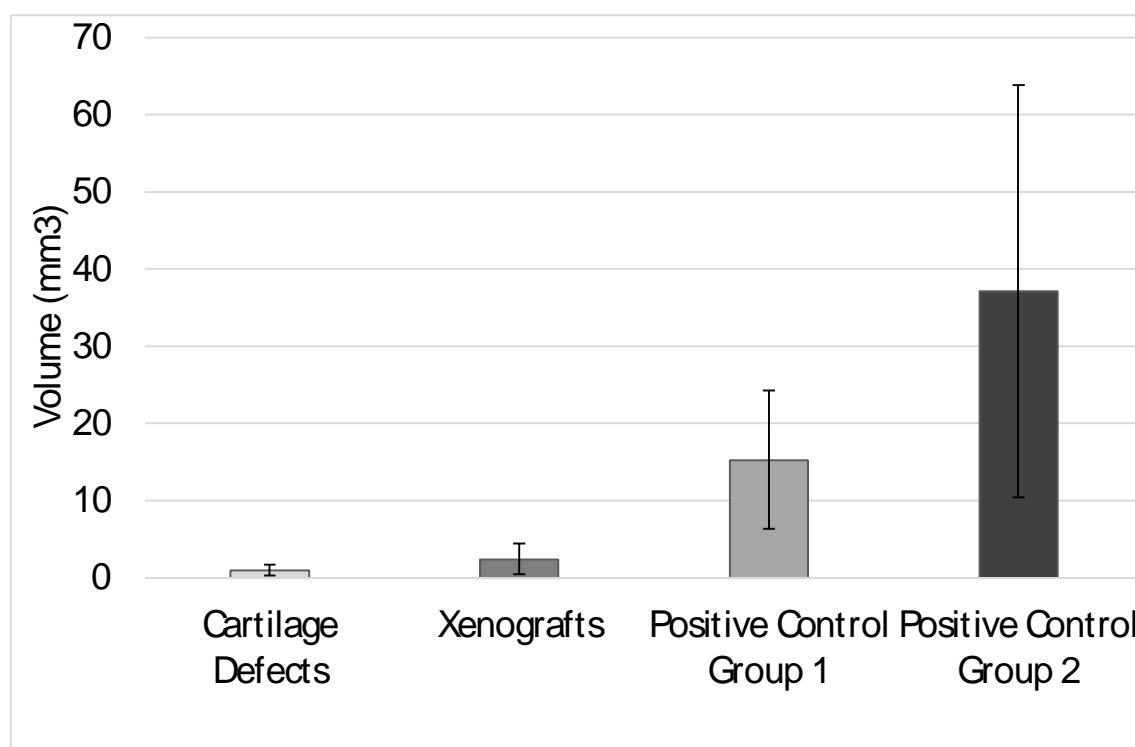
**Figure 4: Mean volume (mm<sup>3</sup>; volume extending beneath cartilage surface) of articular cartilage surface damage, wear and deformation (mean  $\pm$  95% confidence intervals; n=6 per group) measured using the Alicona Infinite Focus.**

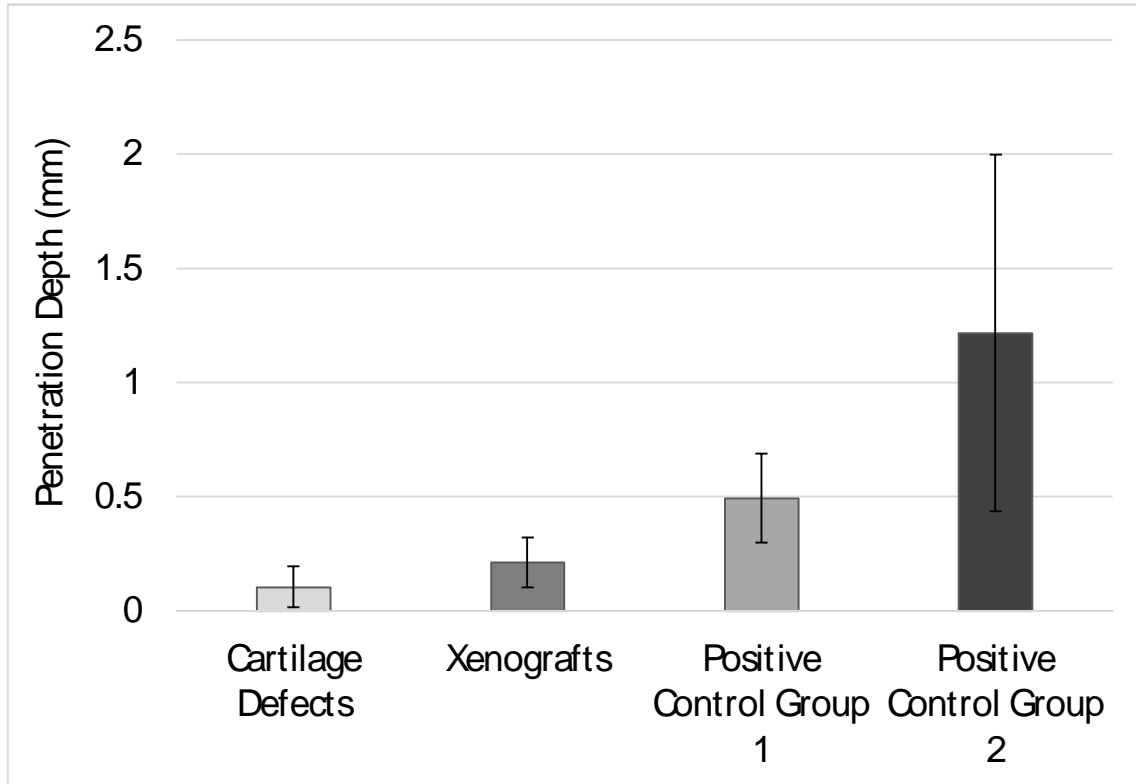
**Figure 5: Mean penetration depth of articular cartilage surface damage, wear and deformation (mean  $\pm$  95% confidence intervals; n=6 per group) measured using the Alicona Infinite Focus.**

The cartilage defect and xenograft groups had the smallest penetration depths of damage and wear at mean depths of 0.11 mm and 0.21 mm respectively (Figure 5); the group means were not significantly different ( $p=0.986$ ; ANOVA). Positive control group 2 had the largest mean depth of damage, wear and deformation at 1.22 mm and this was significantly greater ( $p<0.05$ ; ANOVA) than the cartilage defect and xenograft groups (Figure 5). Positive control group 1 also

had a greater mean depth (0.49 mm) of damage, wear and deformation than the cartilage defect and xenograft groups, however, these differences were not significant ( $p>0.05$ ; ANOVA).
