Pancreatic Pseudocyst Eroding Into the Splenoportal Venous Confluence and Mimicking an Arterial Aneurysm

Citation: Alhajji W, Nour-Eldin N-E, Naguib NN, Lehnert T, Koitka K, Vogl TJ. Pancreatic pseudocyst eroding into the splenoportal venous confluence and mimicking an arterial aneurysm. *Radiology Case Reports*. [Online] 2009;4:234.

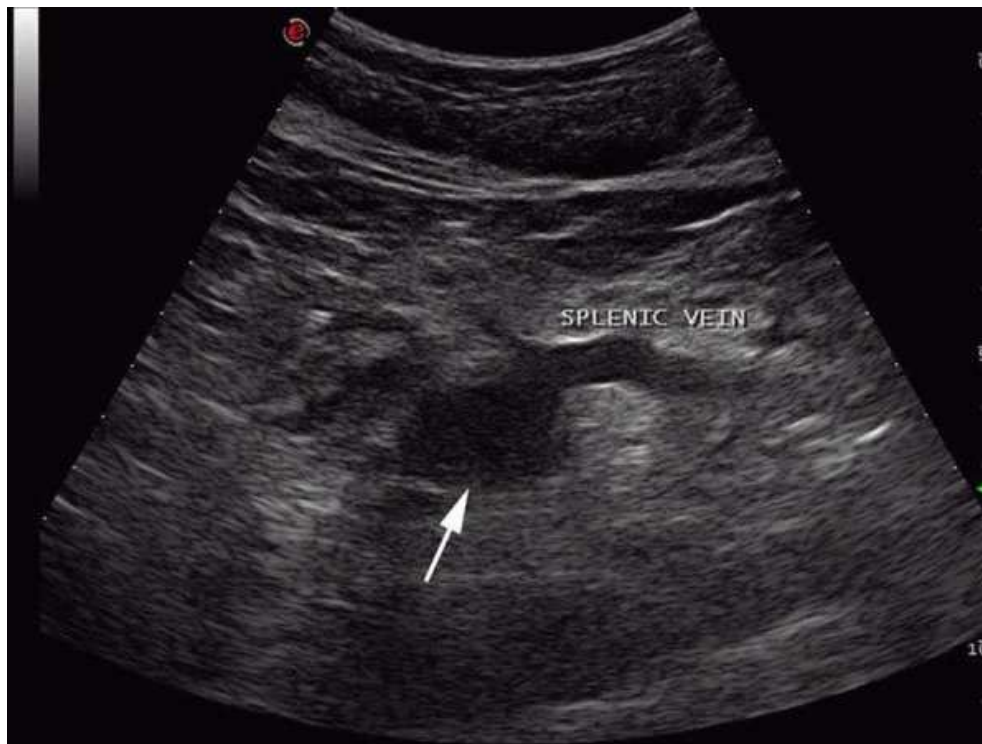
Figure 1A. 62-year-old man with eroding pancreatic pseudocyst. Transverse transabdominal sonogram shows an anechoic small cystic, round, lesion (arrow) that was 1.5 cm in diameter at the region of the pancreatic head.

a convex linear probe (3.5MHz frequency), focussing on the region of the pancreas and peripancreatic compartments. In particular, the lesser sac, anterior pararenal space and transverse mesocolon were investigated by scanning in the supine, longitudinal, transverse, semi-erect and coronal planes. The examination revealed well-defined oval, anechoic cystic lesion in the region of the pancreas, lying anteriorly and in direct contact with the confluence of the splenic and portal veins. Color Doppler scanning revealed incomplete color turbulent filling flow inside the lesion (Fig. 1). Biliary tract assessment revealed the absence of biliary stones in the gall bladder (extending to the intrapancreatic portion of the common bile duct) in addition to the absence of peripancreatic or intraperitoneal free fluid. The preliminary diagnosis entertained was a vascular aneurysm complicating pancreatitis. Vascular complications are known to arise in conjunction with pancreatitis due to the proteolytic nature of pancreatic enzymes which cause erosion of blood vessels. This often results in pseudoaneurysm formation or free rupture of a vessel. Hence, further assessment by MRI and CT was requested.

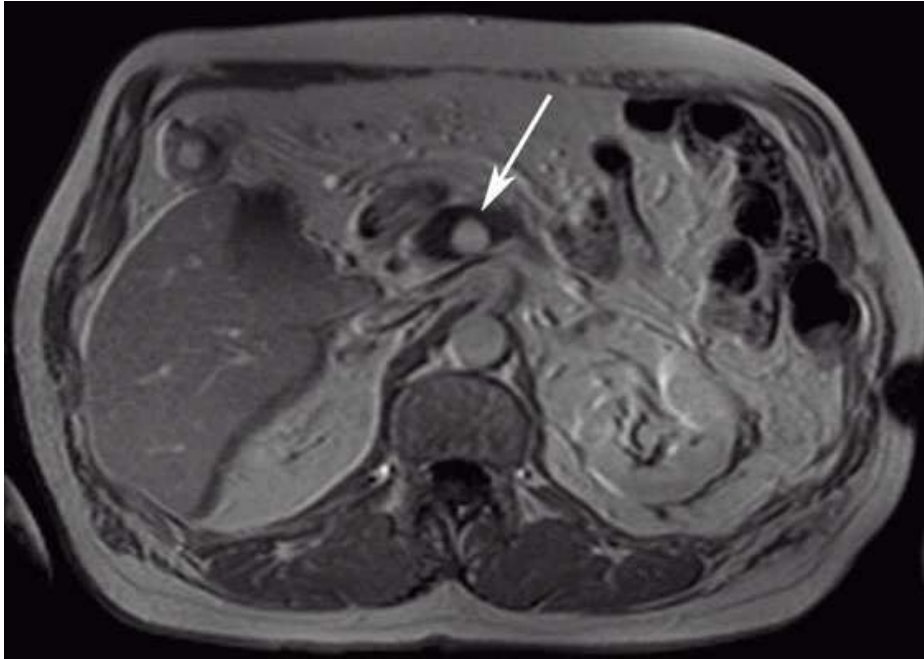
Figure 2C. 62-year-old man with eroding pancreatic pseudocyst. T1-weighted contrast-enhanced MRI shows low signal intensity of the lesion with high signal central area (arrow).

T1-weighted and fast spin-echo, T2-weighted, out of phase chemical shift and fat-suppression sequences were carried out in addition to contrast enhanced MRA in order to further assess the lesion. The pancreas was found to be atrophic with no evidence of a focal lesion or an enhancement pattern abnormality. MRI revealed a well defined, thin walled, oval lesion which was mildly enhancing and inseparable from the anterior aspect of the confluence of portal and splenic veins. MRI revealed a low signal intensity in T1 and high signal intensity in T2 weighted images denoting the cystic nature of the lesion. An area of high signal intensity in contact with the porto-splenic junction in T1 and T2 and post Gadolinium-bawee injection was also observed, denoting a subacute blood collection (Fig. 2).

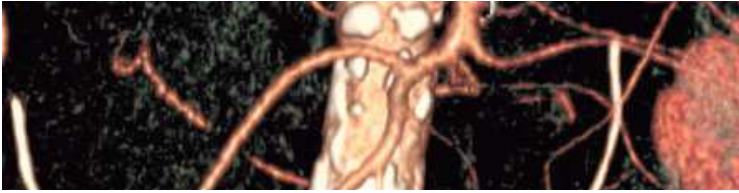
Figure 3C. 62-year-old man with eroding pancreatic pseudocyst. 3D reconstructed CT angiogram shows the contrast filling of the lesion (arrow) and its continuity with the splenic vein denoting vascular leakage (arrow head).

As contrast-enhanced CT imaging of the abdomen and pelvis remains the gold standard imaging modality in the evaluation of pancreatitis and its complications, this became the next step in the investigative process. Both intravenous and oral contrast were administered. Thin-section images were acquired during the peak of pancreatic arterial perfusion and venous phases. The protocol of scanning was the following: Tube Voltage: 120 KV, Tube current: 180 mAs, Pitch 1.2, slice collimation 0.6mm, Acquisition 64x 0.6 mm, slice width 0.75mm, reconstruction increment 0.4mm, Iodine concentration of contrast media 300 mg I/ml. CM flow rate 6.2 ml / sec; bolus timing determined by bolus tracking, bolus tracking threshold 180 HU, scan delay 7 sec for arterial phase and 15-20 sec for venous phase. Multiplanar reconstruction formats were employed for further assessment. The contrast-enhanced CT images revealed the presence of an oval shaped cystic lesion (40 HU) with anterior wall thickening which was mildly enhancing. The lesion was found to have a central collection of the contrast agent, and furthermore, a smooth anterior invagination of the splenic vein and its confluence with the portal vein was observed. The pancreas was atrophic with multiple, punctuate, calcific foci predominantly seen in the head and body of the pancreas. 3D reconstructed CT angiography confirmed that the contrast filling of the lesion seen during the portal venous phase was in direct continuity with the terminal course of splenic vein (Fig. 3).

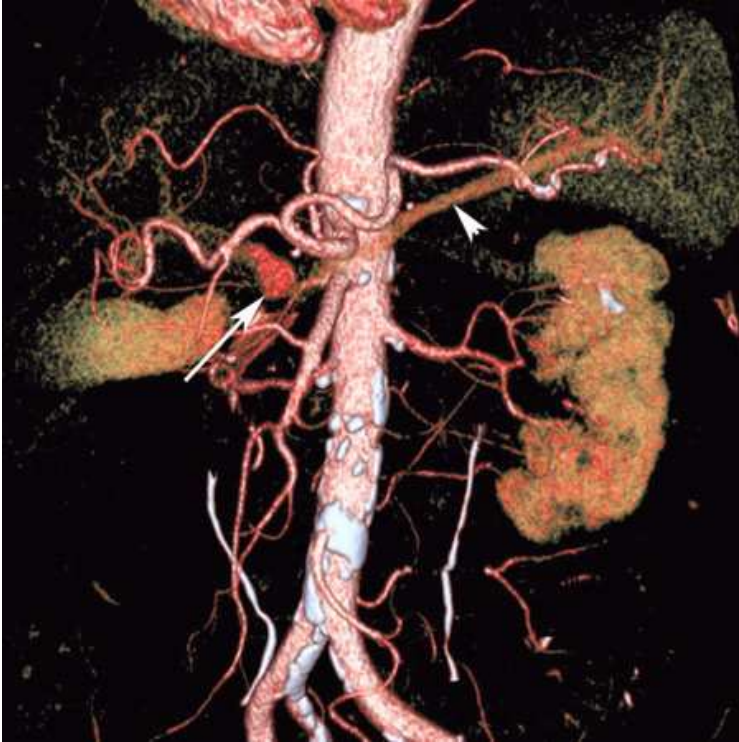
Figure 3D. 62-year-old man with eroding pancreatic pseudocyst. 3D reconstructed CT angiogram in different angle of obliquity.

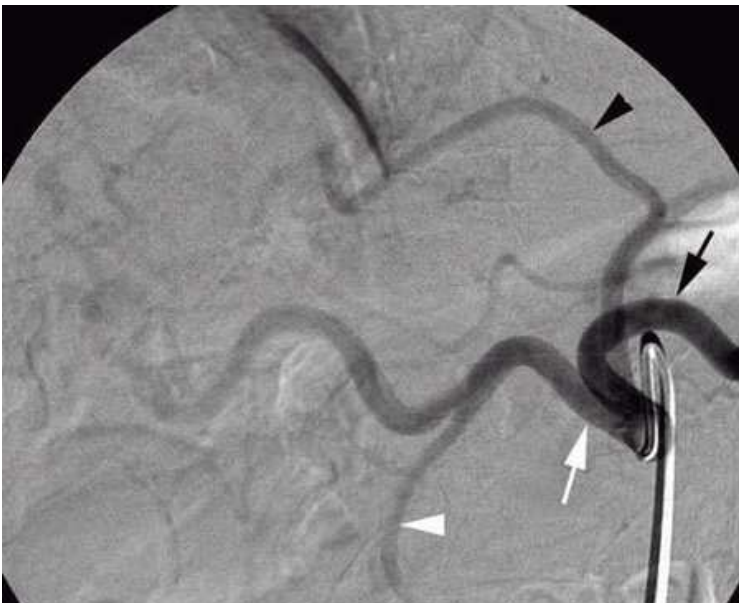
Figure 4A. 62-year-old man with eroding pancreatic pseudocyst. Celiac trunk catheter angiography in arterial phase shows normal angiographic appearance of common hepatic artery (white arrow), gastroduodenal artery (arrow head), left hepatic artery (black arrow head) and splenic artery (black arrow) with no evidence of aneurysmal change or vascular leakage.

As a final imaging tool prior to surgical exploration, celiac catheter angiography and indirect portography were carried out in order to further clarify the vascular nature of the lesion and definitively assess the extent of vascular involvement. These studies once more demonstrated the presence of contrast filling of the lesion during the portal venous phase (Fig. 4). No evidence of venous thrombosis of the splenic vein and/or collateral venous pathways was found.
