Real-time Failure Monitoring System for High Power IGBT Under Acceleration Test Up to 500 A Stress

Akihiko Watanabe, Ichiro Omura

Department of Electrical Engineering and Electronics
Kyushu Institute of Technology
Kitakyushu, Japan
nave@elcs.kyutech.ac.jp

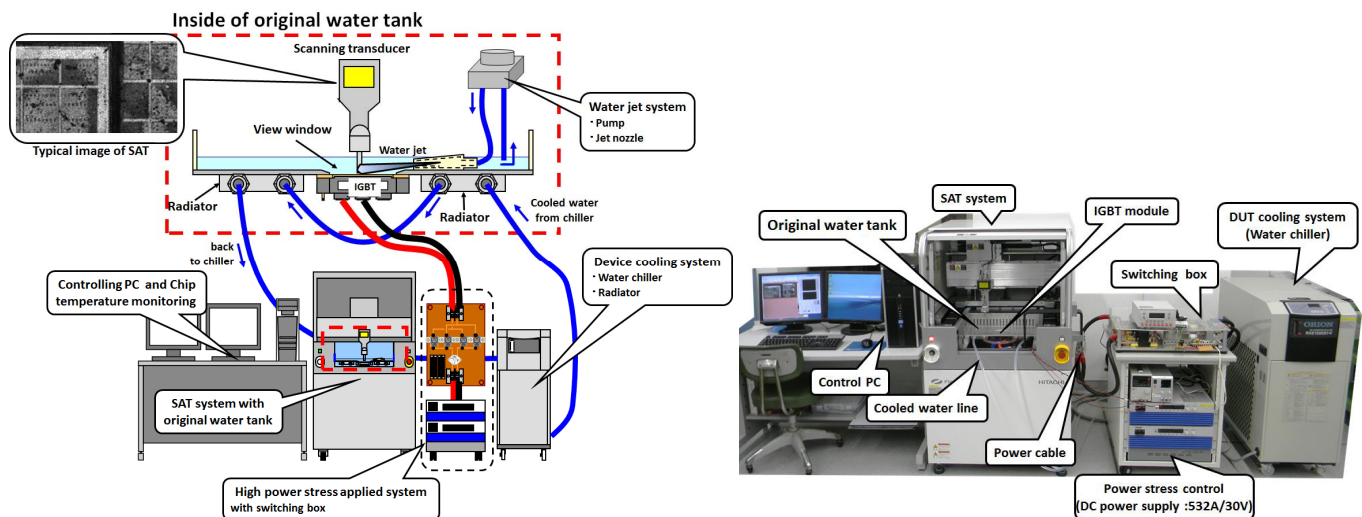
Figure 1. Real time failure monitoring system for high power IGBT modules

We have developed a real-time monitoring system for internal failure analysis system for power devices [3,4]. Main components of this system were (1) inside imaging by SAT, (2) high power stress control by DC power supply, (3) water cooling of DUT and (4) chip temperature monitoring (Fig. 1).

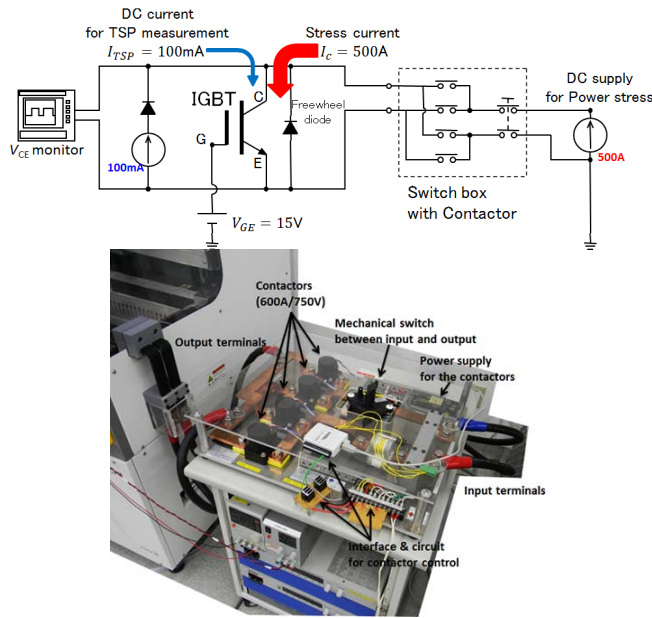
Figure 2. Power circuit with switching box

The power cycling was applied by PC controlled 16kW ($I_c = 532 \text{ A}$) DC power supply. The power supply was connected to DUT by bus bars and bold wires via switching system constructed by DC contactors (Fig.2). The contactors were controlled by TTL signal from PC and enable to isolate DUT from the power supply mechanically and also enable to change a polarity of the bias applied to DUT. The power stress sequence was programmed through an original GUI.

The junction temperature T_j of DUT was estimated from temperature sensitive parameter of on-state voltage drop at low current (Fig. 2). The $I_{TSP}=100$ mA was applied and the collector-emitter voltage V_{CE} of IGBT was monitored at all time of power cycling. When the power stress was turn-off, the DUT was immediately isolated from the high power supply by using the switching system. The T_j was estimated

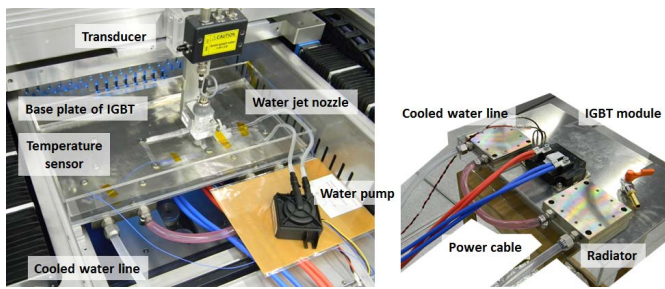
Figure 3. Experimental set-up with original design water tank

The temperature of a base plate of DUT was controlled by couplant water for SAT imaging which was necessary for ultrasonic wave transmission. Only observed surface of DUT was immersed the couplant water cooled by radiators placed at the bottom of an original design water tank (Fig. 3). In addition, a water pump and a water jet nozzle were prepared to generate efficient water flow along DUT surface and to remove tiny bubble generation by self-heating of DUT [3,4].

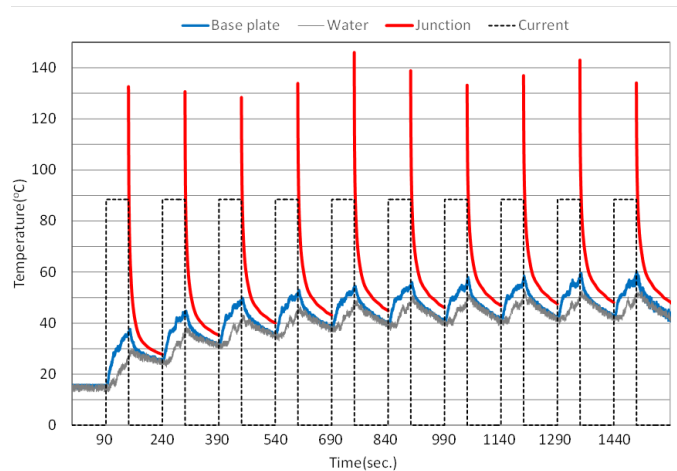
Figure 4. Temperature change with power stress

cycling sequence was 60 s turn-on and 90 s turn-off. Fig. 4 shows typical variation of temperatures at this demonstration. The temperature of surrounded water and the base plate was gradually elevated and it settled at around 45 °C after 10 times power cycle. The T_{high} and T_{low} also elevated with same tendency and these were settled around 135 °C and 50 °C, respectively, namely the ΔT_j was approximately 85 °C in this demonstration.

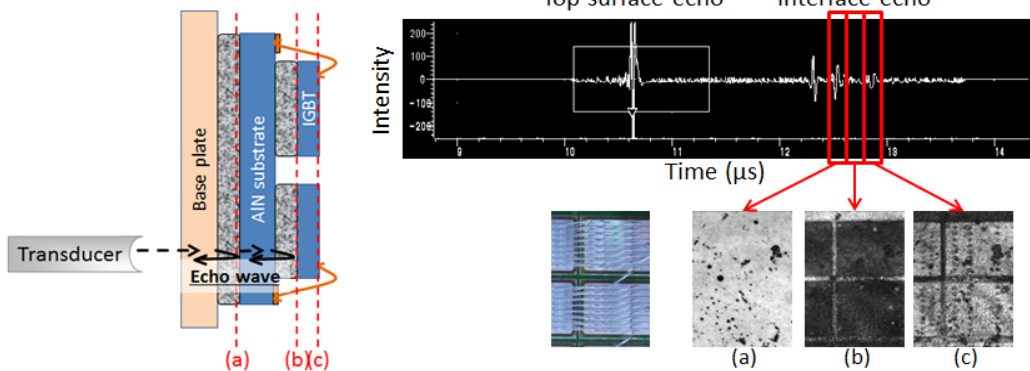
Figure 5. Procedure to obtain different interface SAT image

Three different interface regions were observed at the same time in this demonstration by using reflected echo in different time domain as shown in Fig. 5. Fig. 6 shows series of SAT images obtained by each 10 cycle in a certain time domain of the power cycling test. As shown in Fig. 5, interface labeled (a) to (c) was corresponded to base plate / solder, solder / chip and top region of the chip, respectively. The acquisition windows of reflected echo were configured from the base plate to the chip, therefore, if internal degradation occurs in the interface (a), other interface images (b) and (c) are affected by it. Such kinds of dark or bright spots in the image are pointed by black arrows in 1st image. A slight change of image was occurred at the chip center in the 4th image of interface (b) and (c), and it propagated to wide area. No image change was observed in this area in the interface (a), therefore, some internal change took place at the interface (b) or (c).

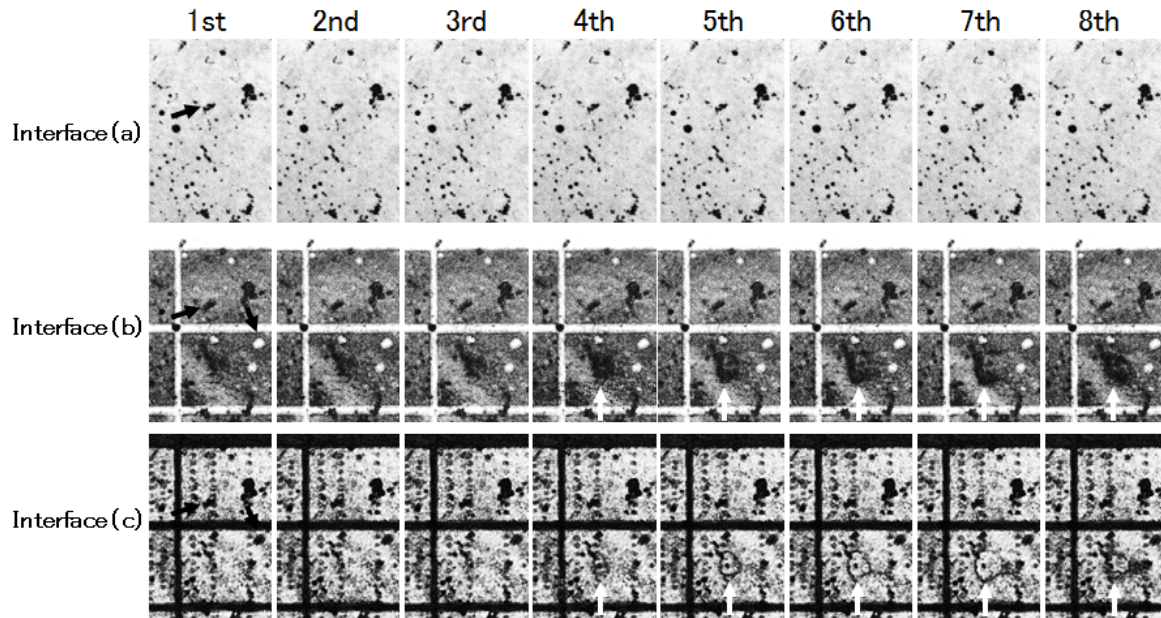
Figure 6. Inside images of IGBT obtained during power stress test

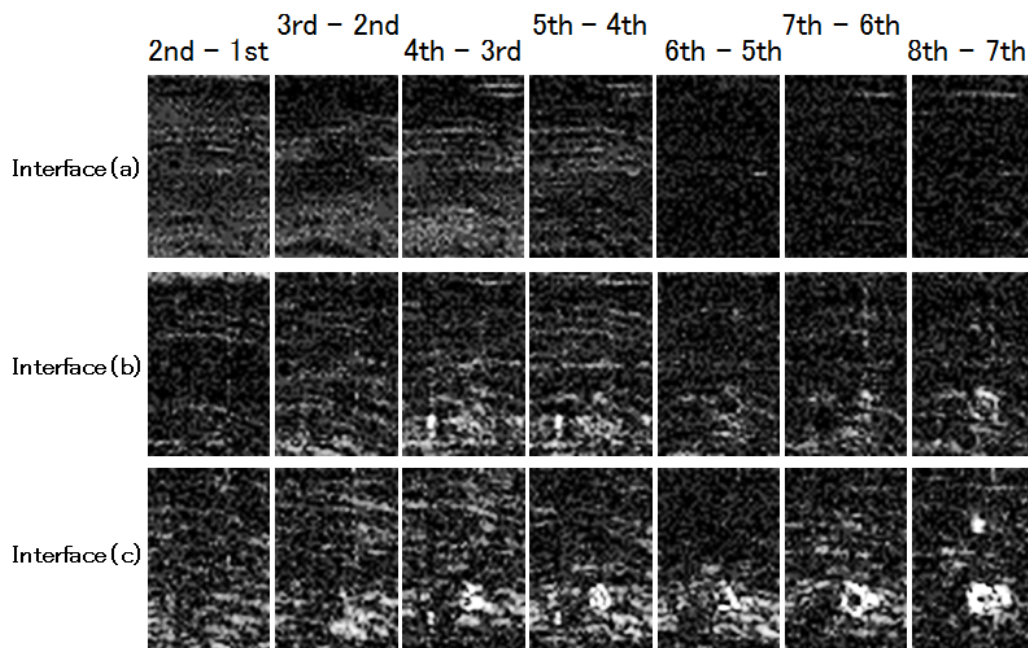
Figure 7. Subtract images obtained by each 10 power cycling

Fig. 7 shows subtract images obtained from each 10 power cycles, for example, the images leveled “2nd – 1st” was obtained by subtract the image “1st” from the image “2nd” in Fig. 6. The gray scale level was corresponded to the degree of brightness change in a pixel during the power cycle test. The brightness change in the interface (c) was obvious in comparison to the other interfaces and it started from the image “4th – 3rd”. Judging from this result, it is considered that the some serious phenomena took place in the interface (c) and it affected to interface (b) in the power cycling after the image “3rd”. In this way, by tracing the subtract images in the same interface, namely comparing the images in horizontal rows in Fig. 7, we can find out that internal changes had occurred in which time domain in the failure process. Moreover, by comparing the images in the same time domain, namely comparing the images in vertical rows, we can find that an internal change was occurred in which interface inside of DUT. Combining real-time monitoring under acceleration test and image processing techniques enables us new time domain failure analysis of power devices.
