# SYMPOSIUM 1988 TRONDHEIM

## CAVITATION EROSION OF HYDRAULIC MACHINES: GENERATION AND DYNAMICS OF EROSIVE CAVITIES.

François AVELLAN  
Philippe DUPONT

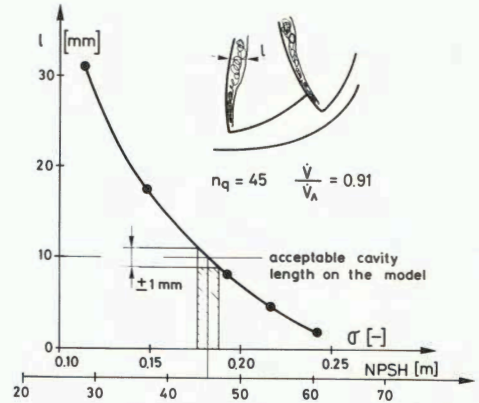
**Figure 2:** Influence of the cavitation number on the leading edge cavity length for the  $n_q = 45$  storage pump model.

As Gülich and Pace have pointed out, in the case of centrifugal pumps, the leading edge cavity length is a macroscopic parameter strongly related to cavitation erosion [4]. Thus, an acceptable cavity length (Figure 1) can be defined empirically as a reference for the setting determination, but this length obviously depends on the nominal head of the actual machines. Furthermore, the resulting setting level is very sensitive to the cavity length when the cavity is visible on the suction side. For instance, a typical length evolution, with cavitation number  $\sigma$ , is given in Figure 2. The reported values were obtained during a cavitation test on an  $n_q = 45$  storage pump model at the IMHEF laboratory. All the model design requirements for acceptance tests were fulfilled, in particular a rigorous geometrical homology with the prototype, and large windows installed at the inlet cone. Even under the best experimental test conditions, it was difficult to measure this length with an accuracy better than 1 mm on the blade. By taking into account this uncertainty on the curve for the 10 mm which corresponded to the

acceptable cavity length values, the calculations gave a  $\sigma$  value of 0.182 within a range of  $\pm 0.006$ . Since in this case the nominal head of the prototype was 250 m, the setting level could be estimated at 45.5 m to within  $\pm 1.5$  m. It should be emphasized that this uncertainty is due only to a lack of accurate observation, without taking account of the arbitrary character of the acceptable length definition. Moreover, for a high discharge operating point, in the case of centrifugal pumps, the cavity which extends on the blade pressure side is not visible.
