Social Rent Housing Refurbishment Demonstrator of LIFE Project “New4Old” (LIFE10 ENV/ES/439)

Sustainable Development and Renovation in Architecture, Urbanism and Engineering

Social Rent Housing Refurbishment Demonstrator of LIFE Project "New4Old" (LIFE10 ENV / ES / 439)

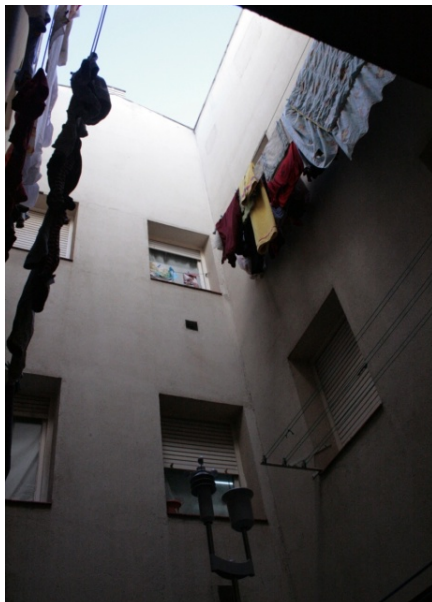
Fig. 5 Courtyard before refurbishment**Fig. 6** Courtyard after refurbishment

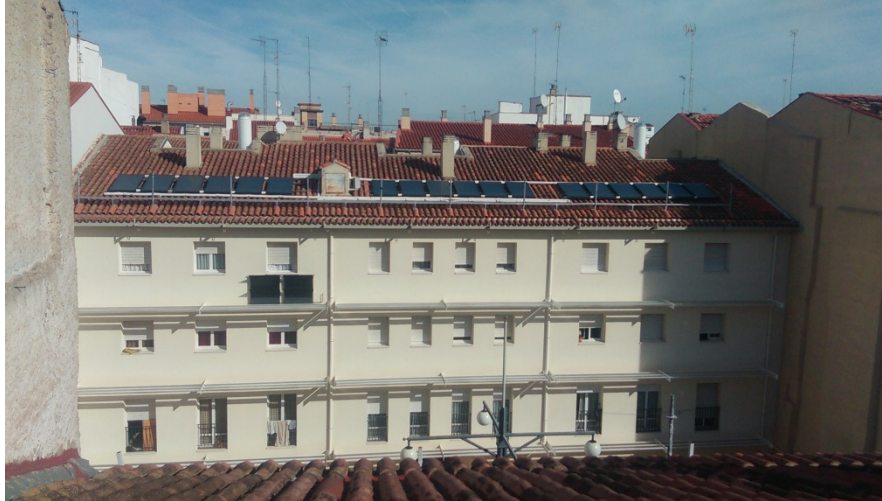
Fig. 7 Building A after intervention facade insulation, incorporation of sunscreen, hybrid solar panels for hot water and electricity, solar lighting conduits for patios and prototype passive solar heating.
