CHANSON, H. (2002). "Enhanced Energy Dissipation in Stepped Chutes. Discussion." *Proc. Instn Civ. Engrs Water and Maritime Engrg*, UK, Vol. 154, No. 4, pp. 343-345 & Front cover (ISSN 0965-0946).

ENHANCED ENERGY DISSIPATION IN STEPPED CHUTES¹

Discussion by H. CHANSON²

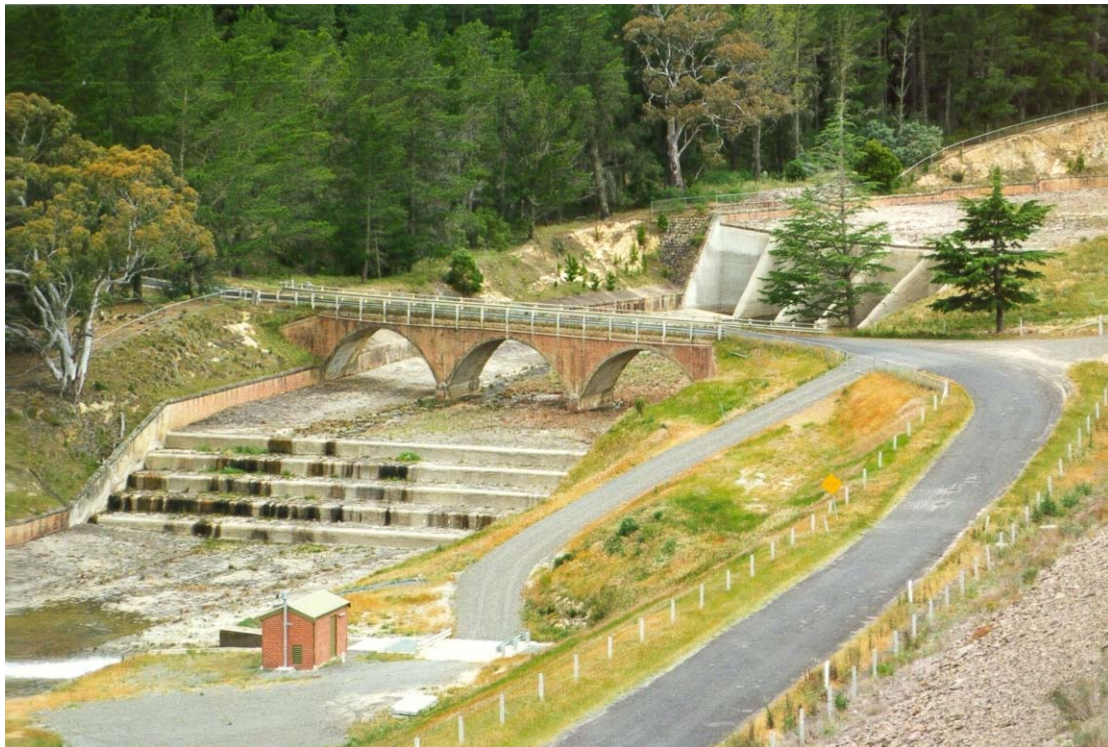
Fig. 1 - Upper Coliban stepped spillway (1903, Australia) 5 December 1997 (Courtesy of R. Smyth, Coliban Water) - Dam height : 30 m - View from the dam wall - Note the large drop upstream of the bridge and a series of smaller steps downstream

Enhancement of energy dissipation may be provided by superposition of small and large steps. In Australia, the Malmsbury (1870) and Upper Coliban (1903) stepped spillways were designed with a combination of large drops ($h = 2$ to 4 m) and stepped chutes ($h = 0.305$ m) (Fig. 1, Chanson 2001, pages 48 & 73). At design flows, the drops operate with a nappe flow and the chutes in skimming flow regime. Their successful operation for more than a century suggests that the design is sound. On the model of the Kennedy's Vale dam ($h/l = 1$), Stephenson (1988) superimposed occasional large steps to smaller steps and he observed a 10% increase in energy dissipation for this model.

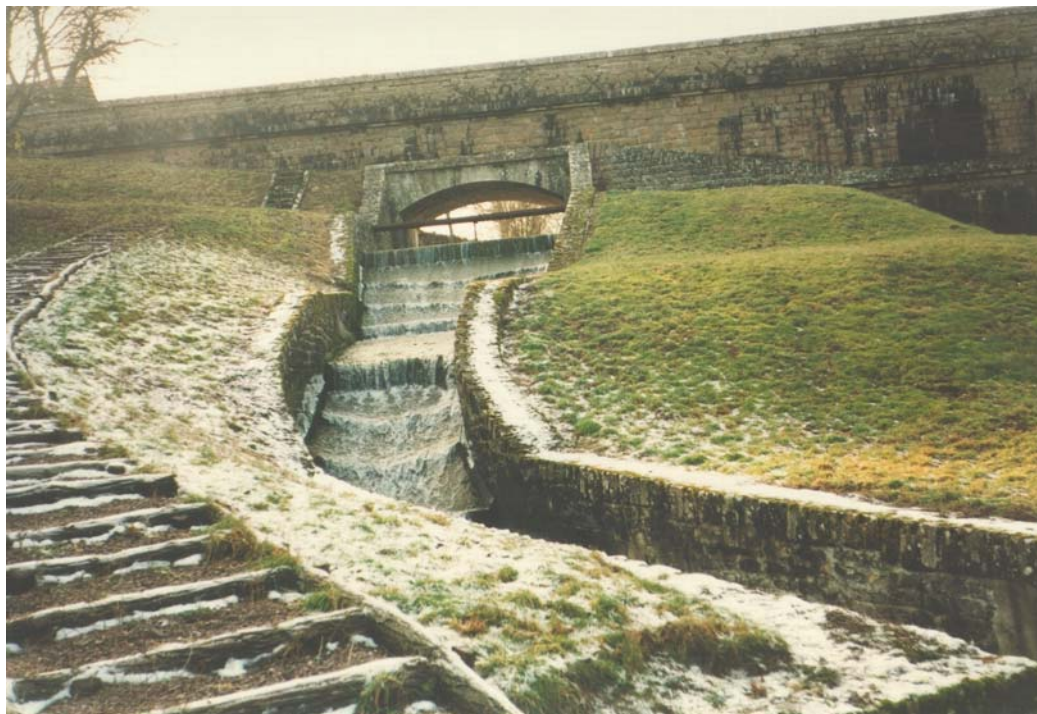
Fig. 2 - Tillot dam stepped spillway (1834, France) in January 1997 Note the small V-shaped steps (oriented forwards) in the lower series of steps and the surrounding snow

Two early French stepped spillways were equipped with V-shaped steps. Completed in 1834, the Tillot dam spillway was equipped with two series of small V-shaped steps (oriented forward) (App. I). Note the channel convergence and the absence of downstream stilling basin (Fig. 2). The Pas du Riot dam was completed in 1873 and it is equipped with a masonry stepped chute. The steps are sloped upwards and V-shaped, oriented backwards (Fig. 3). The spillway capacity was increased during the 1990 dam refurbishment, without modification of the original stepped chute. Both stepped spillways are still in use, highlighting the soundness of design.

The spillway, located on the right bank, is a rubble masonry construction (Fig. 2). It consists of a long flat crest followed by 2 series of 4 steps (Table I-1). There is no downstream energy dissipator. The design flow rate is 19 m³/s.

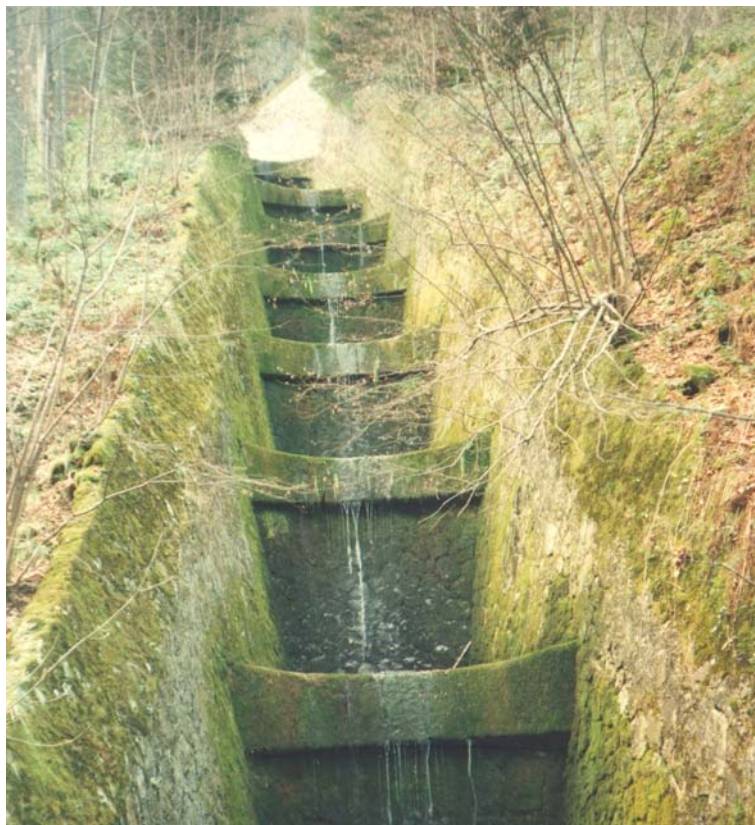
Fig. 3 - Pas du Riot dam stepped spillway (1873, France) in November 1994 - Dam height : 34.5 m - The spillway intake was enlarged in the 1990s without modification of the stepped chute
