POST-PROJECT ASSESSMENT OF PIT LATRINES IN RURAL PANAMA

A REPORT

In Environmental Engineering

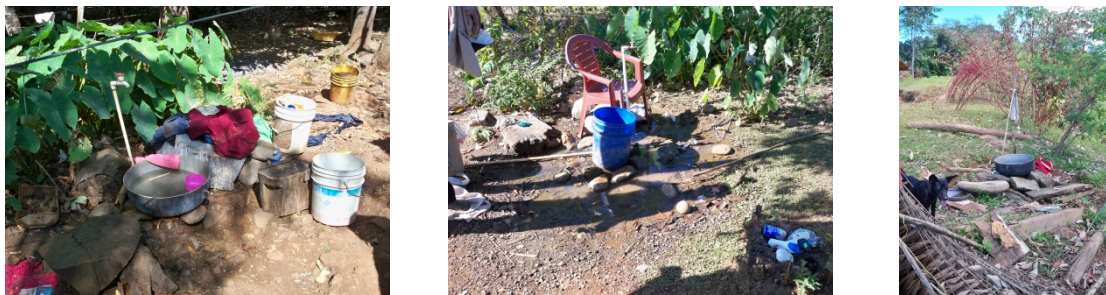
The standing water indicator evaluates the household’s management of grey water and rainfall runoff. The typical household evaluated had three areas of potential standing water problems. The first was the area around the spigot connected to the aqueduct and its drainage area. The second is the dish washing station, which usually consists of a table constructed of “1” to “2” diameter sticks. The grey water is often allowed to collect in a pool below the table. The third area is under the eaves of rooflines. Typical construction consists of metal or palm roofing with no gutters, allowing water to collect below the eave. Nearly all of the homes surveyed received a high score for this indicator, meaning that no pooled water or mud was observed. However, all data collection was done during the dry season, and very little rainfall was occurring. The rainy and dry seasons are very pronounced in Panama, and lower scores would be expected during the rainy season. Also, most of the projects assessed were in a mountainous region of Panama

Figure 7: Typical spigot connection to an aqueduct and wash area: (A), (B), and (C) are typical of washing area

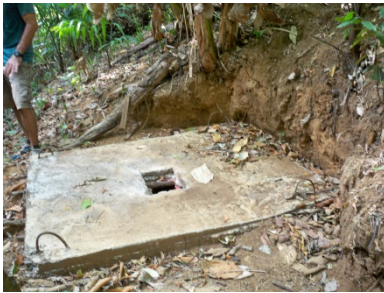
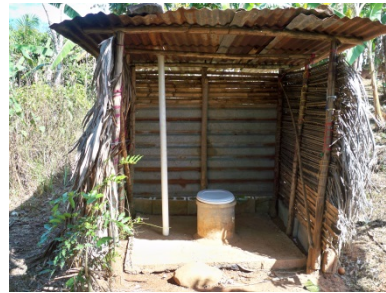
This indicator is meant to judge if the hole is properly covered. The purpose of the cover is to help in the reduction of odor, and consequently the number of flies in the latrine. Most of the latrines implemented these projects did not include ventilation in the form of a PVC pipe extending from below the pad to above the roof. The justification for this has been the added cost of the PVC and the fact that, historically, the latrines have been largely open to the air leaving little need for ventilation. Additionally, unless the latrine is specially designed, vent pipes typically puncture the roof causing leaks and reducing the effective life of the roof. However, many community members expressed concern about reducing latrine odor. Historically, Peace Corps volunteers have recommended adding ash from cooking fires or dried organics to reduce smell, in addition to the consistent use of a cover.

For this indicator the distribution of the scores indicated that if a cover was present, the hole was usually properly covered; however, nearly 50 percent of the latrines surveyed had no cover at all. Peace Corps does not provide materials for cover construction, or prefabricated toilet seats. Lids for 5 gallon buckets, or 2" X 12" scraps with handles were commonly observed as covers. Some of the latrines scored a 1 because the concrete seat structure was broken or never installed, and many of those latrines were abandoned or not in use. The EH sector does not provide a design or subsidy for a cover, meaning that the community members are required to find and pay for them on their own. Additionally, many of the covers are not attached to the seat, making it likely that children or unaware people will leave it off after use. The highest score was 2.57, in Vallecito, Cocle and the lowest score was 1.20, in Bajo Membrillo, Comarca Ngobe-Bugle. Figures 11A, 11B, and 11C are indicative of scores "1", "2", and "3," respectively.

Figure 11: Typical photo of latrine covering methods: (A) A score of "1", (B) A Score of "2", (C) A Score of "3".

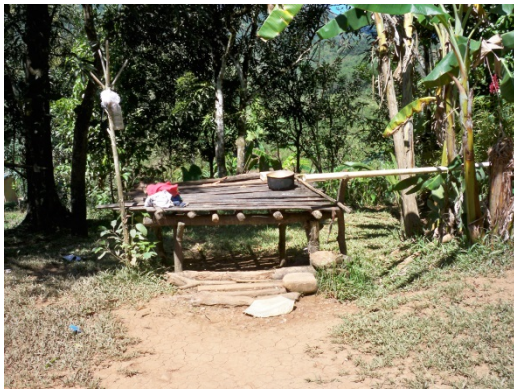
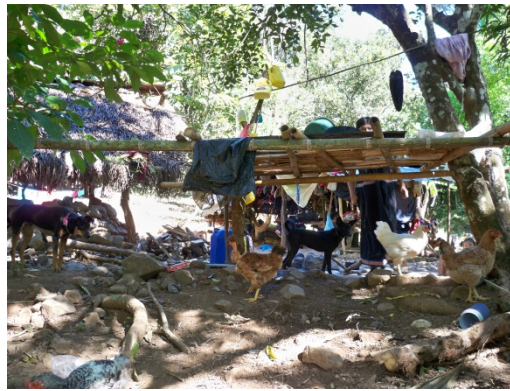
This indicator is used to assess the general sanitation practices in the kitchen area by judging general cleanliness, food storage, presence of animals, and soap for dish washing. Most households in rural Panama keep their cooking area in a separate hut from the main living area (or outside in the dry season) and include a nearby table for dishwashing. A score of “1” was indicative of poor general sanitation and would often include some or all of the following: no dish soap or water for washing, poor food storage, dirty dishes, the presence of flies and animals, solid waste, and mud under the dish washing area. A score of “2” was the most common and usually indicated that only dish washing was missing. A score of “3” met the following conditions: visible dish soap and water for washing, good food storage, no dirty dishes, no flies or animals, no solid waste, and a well-drained dish washing area.

Figure 16: Typical view of Kitchen Areas: (A) A score of “2”, (B) A score of “1”.

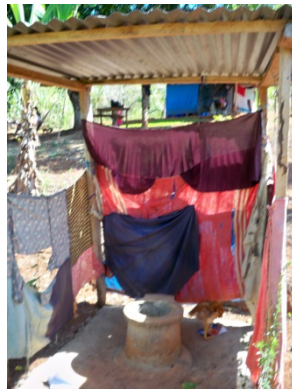
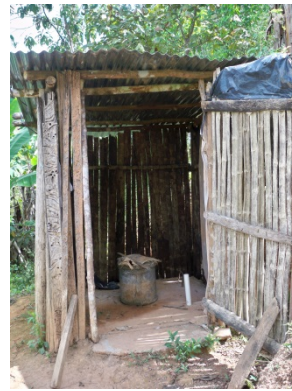
This indicator was meant to evaluate whether or not the latrine was being used and, if so, the effectiveness of use. A score of “1” indicated that a latrine was not currently in use. Many of these had never been completed and were never put to use. The others had fallen out of use usually from a family moving away or abandoning the house site. A score of “2” indicated that the latrine was in use, but that it was not being used in a completely sanitary manner. This was often due to the community members not having access to soap and water to wash their hands after use, but was also sometimes due to poor maintenance or leaving the top uncovered. A score of “3” was received by those latrines that were clearly in use and used in the proper fashion.

It should be noted that this indicator simply evaluates whether a latrine is being used or not, but not if all of the people living in the compound are using it. While the author did not collect data on the number of people using each latrine most volunteers estimate household size to be approximately 7. There may be some variability in usage based on sex or age of family members. For example very young children are probably less likely to use a latrine consistently than adults. Also, women may be more likely to use a latrine more regularly than men due to an increased need for privacy.

Figure 19: Typical Latrine Usage: (A) A score of “1”, (B) A score of “2”, (C) A score of “3”
