## WATER ACCESS AND MAINTENANCE IN KARONGA, MALAWI

A REPORT

In Mechanical Engineering

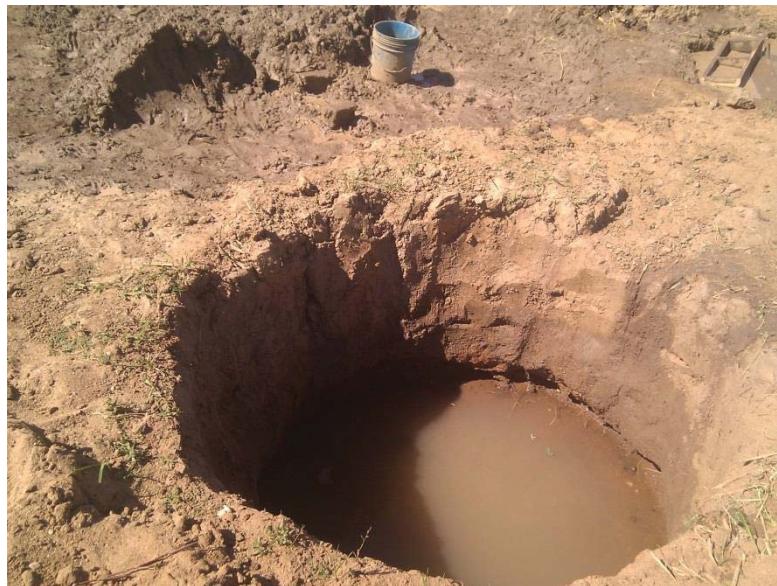
**Figure 3: Water access pit dug for brick making**

Mwangelala village is located in an alluvial aquifer which has a water table between 10 to 30 meters beneath the ground (Hooydonck 2001). This depth of ground water is ideal for siting shallow wells, and as a result nearly any spot on the Malawi lakeshore will produce water when a well is dug. The water table does drop below the depth at which some shallow wells are capable of pumping water. When a pump goes dry, water can sometimes still be reached by removing the pump and using buckets and rope to draw water. Illustrating the high water table along the lakeshore, Figure 3 shows ground water reached at a depth of 1 meter during the middle of July, which is approximately two months after the end of rainy season.

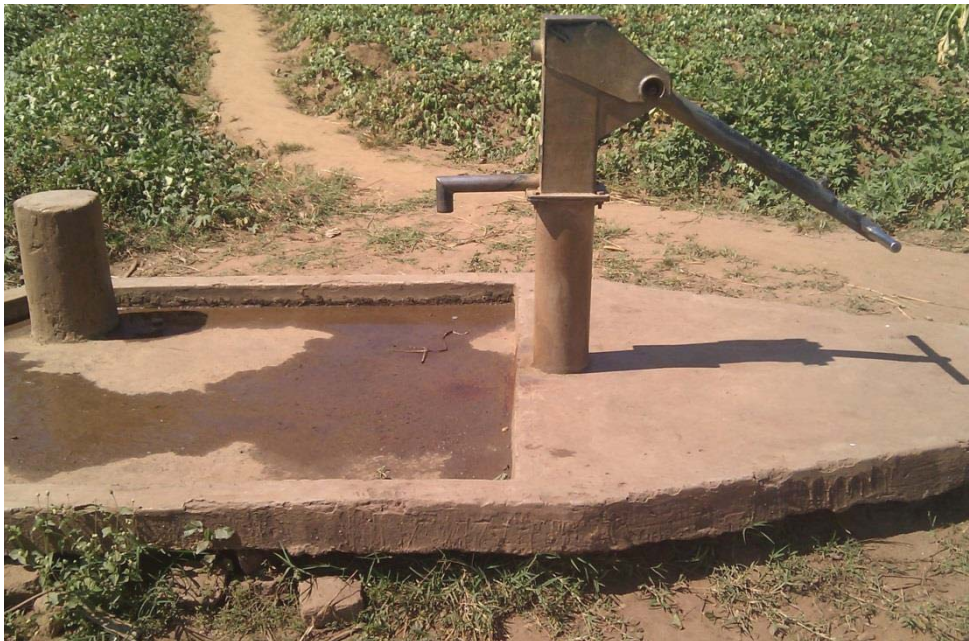
**Figure 4: Borehole with Afridev hand pump**

Boreholes have great depth, 40 meters, which results in a larger and heavier column of water that needs to be lifted to the surface. The pumping mechanism for Afridev wells were designed with this in mind, and offers a variable mechanical advantage, allowing large columns of water to be pumped with little effort on the part of the user (see Figure 4). The water is pumped to the surface using two valves, a foot valve and a plunger valve. The plunger valve closes when it is being drawn upwards and the foot valve opens, allowing water to be drawn upwards as well. This is like pulling the plunger back on a syringe, using a vacuum to pull water inside. Then as the plunger valve moves down it opens, as the foot valve closes. This keeps the water moved upwards by the previous stroke in the water column and resets the mechanism to draw water upwards again. Repetitions of vertical movement pumps water to the surface.

The Afridev hand pump uses a lever to reduce the effort needed to raise the water column. The handle, as seen in Figure 4, can be lengthened as necessary to reduce pumping effort. According to the Karonga District Water Board Director it costs approximately \$7500 (2.4 million kwacha) to install an Afridev hand pump. The community is expected to provide 5% of this cost through labor and raw materials, such as sand bricks. The Malawi government and UNICEF provide the rest of the necessary funds.

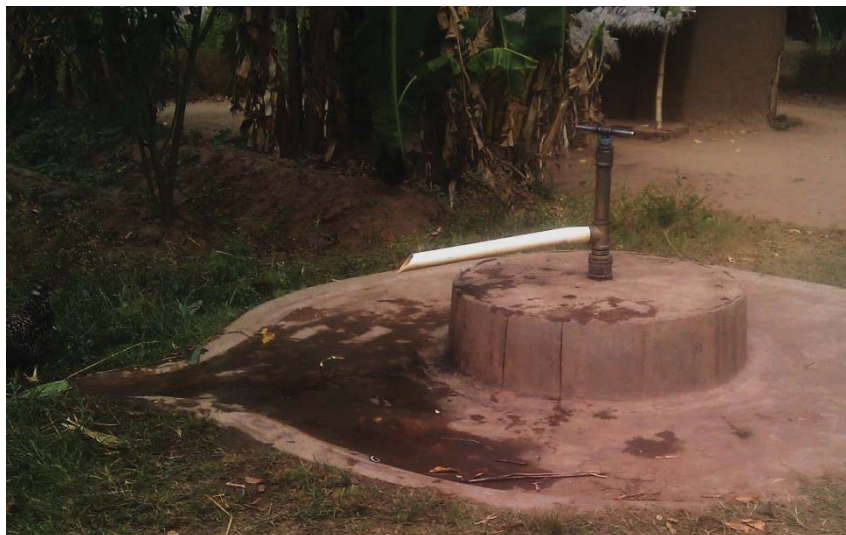
Figure 5: Shallow well with Mark V hand pump

Shallow wells are hand dug wells with a depth of 4 to 7 meters. They have a direct action pump mechanism, there is no mechanical advantage like in the Afridev; the user is lifting the column of water directly. Mark V hand pumps use a mechanism similar to Afridev hand pumps to draw water upwards, a foot valve and a plunger valve. These pumps can only be used in shallow wells because the water column must be small enough to be lifted by a user without too much difficulty. Direct action pumps are chosen because they are easier and cheaper to repair. They are designed to be village level operation and maintenance (VLOM). This means the pump can be repaired with few tools and locally available parts. Shallow wells in Mwangalala village all have Mark V hand pumps and were constructed with the aid of Marion Medical Mission between 2001 and 2004. These shallow wells have a donor cost of \$400 USD. (Mission n.d.)

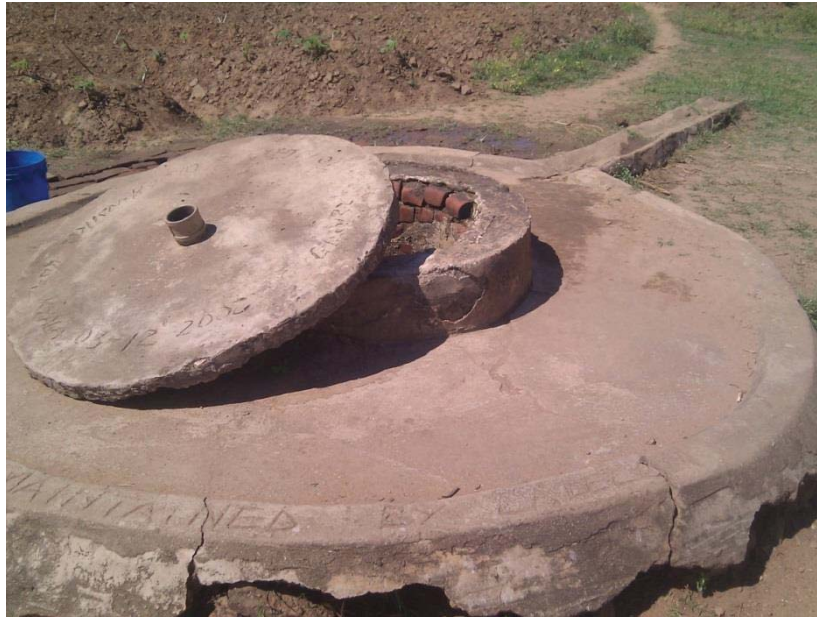
**Figure 6: Open well XII**

Open wells in Mwangalala village vary in construction and condition. There are six open wells. Four of those six wells used to be topped with a Mark V hand pump. Figure 6 shows an open well in Mwangalala village. It used to have a Mark V hand pump as evidenced by the concrete lid that is still next to the opening and the concrete apron which is the style of Marion Medical Mission.

Open wells are the simplest form of well, there is no maintenance of the pump required. As long as a community member is able to find string or rope and a pail (or borrow from a neighbor), they can draw water from the well. Figure 7 shows a community member drawing water from an open well using a 5 liter pail. The drawbacks of open wells are easy contamination from debris and animals and the danger of small children falling in the well.

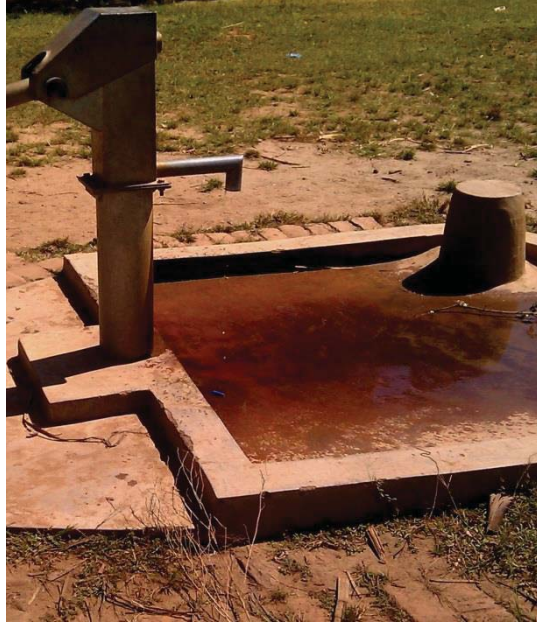
**Figure 8: Iron-stained borehole**

The high iron content of borehole water issue was prominent in Mwangalala village, and has yet to be resolved for the general population of afflicted rural Malawians. Boreholes in Mwangalala were used primarily for non-consumptive use; bathing, farming, washing non-stainable items, etc. I was warned immediately upon arrival at Lufilya CDSS not to use the borehole for drinking or cooking water. Participants in the interviews detailed later in this report preferred distant surface water sources rather than using water from a much closer borehole, if the primary water source shallow well was not producing water. Figure 8 shows iron stains on the concrete below the spigot of a borehole installed one year prior to the date the photograph was taken. While communities surrounding Lufilya CDSS were unable to use borehole water for consumption, other communities in Karonga district used boreholes without encountering high concentrations of dissolved iron. As a result, in areas without high iron concentrations boreholes were more prevalent than shallow wells possibly due to the year-round water availability associated with boreholes.

groundwater. Specifically, water at a depth of at least 40 meters below ground surface is contaminated by excess iron in Mwangalala. Shallow wells drawing water from a depth of 4 to 7 meters are not affected by iron contaminants. Boreholes in other parts of Karonga district do not have iron contaminants and produce palatable water. The quantity of dissolved iron in the water drawn from boreholes in Mwangalala is greater than the limits recommended by the World Health Organization. Community members disdain water sources containing these high concentrations of iron due to the discoloration and taste (Bath 1980).

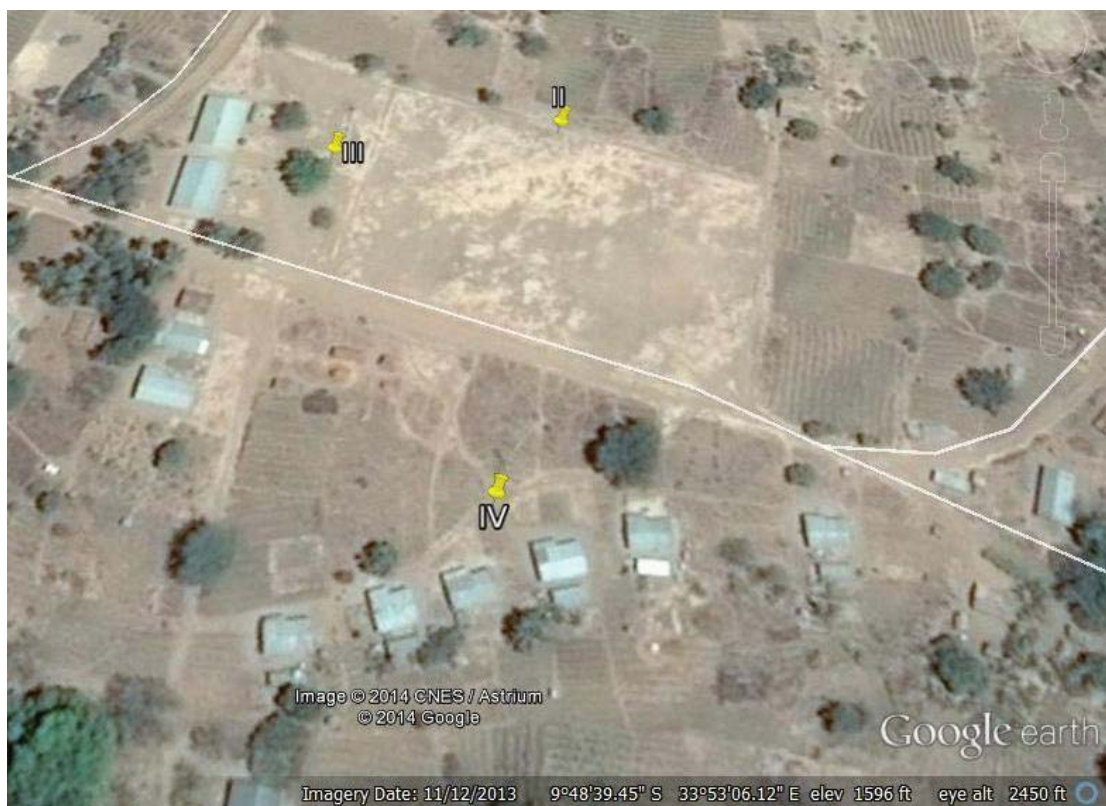
**Figure 9: Shallow well and Borehole observed**

A total of 50 community members were documented drawing water from two wells, either the shallow well, well II, or the borehole, well III, on three different occasions. The purpose of these observations was to verify the responses community members gave during interviews about their behaviors. Figure 9 shows the location of the two wells, denoted by II for the shallow well and III for the borehole. Buildings located west of the wells are classrooms for Lufilya CDSS. Buildings in a row south of well IV are teachers' housing including my house, which is third from the left.

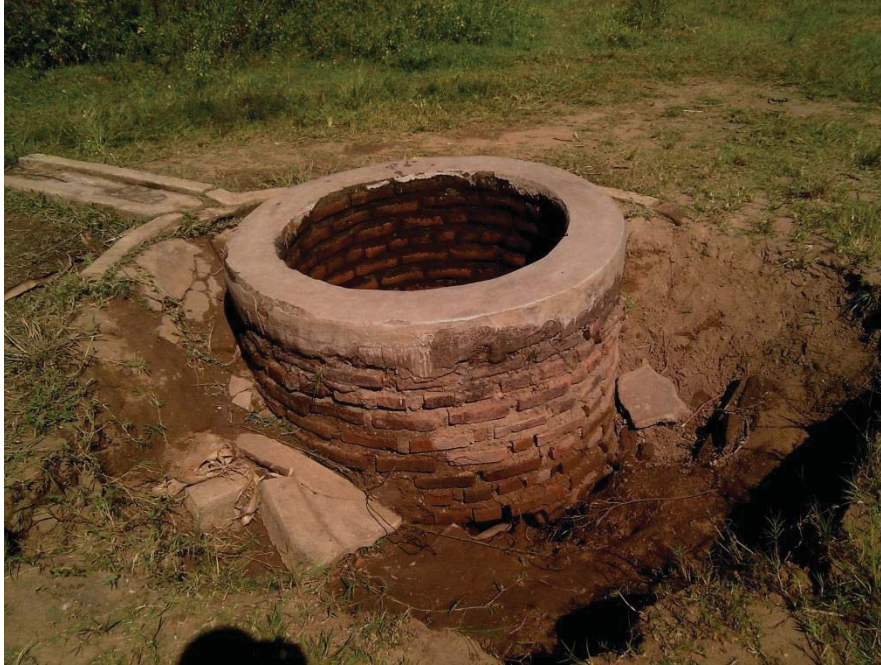
**Figure 10: Deteriorating open well X**

Forty percent of participants use open wells as their primary source of water, such as the open well X in Figure 10, which often has debris from the surrounding environment. Other open wells are in better condition than open well X, with an intact concrete apron and a lid that can be used to cover it at night. Participants commented that debris was undesirable, but the quality of the water was acceptable enough that the proximity of the well makes it a more desirable choice than walking to a shallow well that is further away. Participants also use Lake Malawi when shallow and open wells are dry, preferring to walk further to a surface water source than to use boreholes.

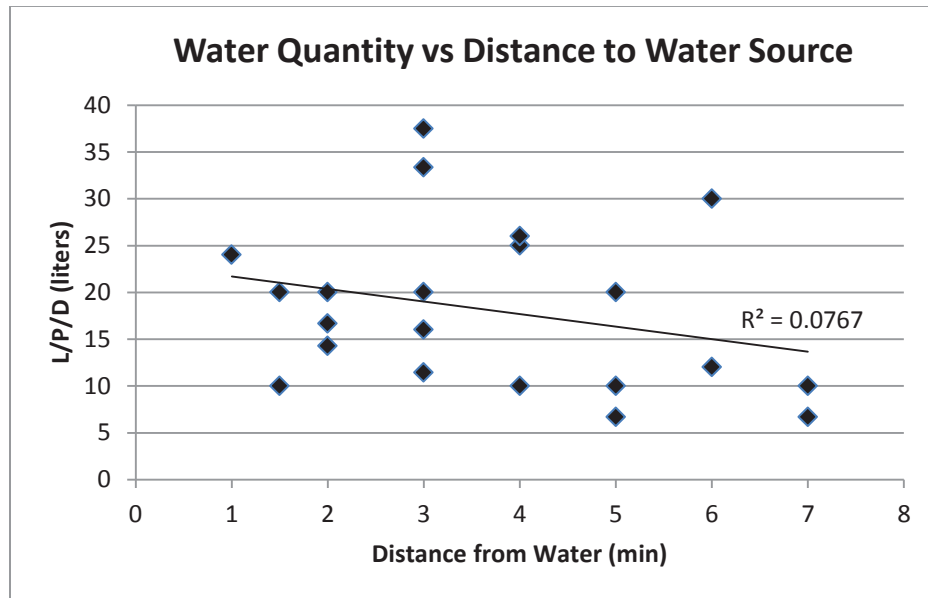
**Figure 13: Graph of water quantity used versus distance from well**

Although carrying water is arduous, there was no correlation between the Liters of water used per Person per Day (L/P/D) and the distance to the primary water source. I measured the distance to the primary water source by timing how long it took me to walk from the participant's household to the water source at a water-carrying pace,

and compared it to the quantity of water fetched each day by the participant's family divided by the number of family members in the household. I removed outliers, participants who drew 80 liters per person or more a day, and graphed the results in a scatter plot in Figure 13. I added a trend line to illustrate the best fit linear relationship between water used and distance to the water source. The coefficient of determination,  $R^2$ , is formed by a Pearson correlation.

The distance from the water source does not determine how much water a participant uses in a day. None of the participants lived further than seven minutes from a primary water source, although behavior may differ from these results if community members live a significant distance from a water source. Within a seven minute distance, however, the probability value was 0.22 which indicates a lack of correlation between the quantity of water used per person in a day and the distance from the household to the water source. A statistically significant correlation will return a result of 0.05 or less.

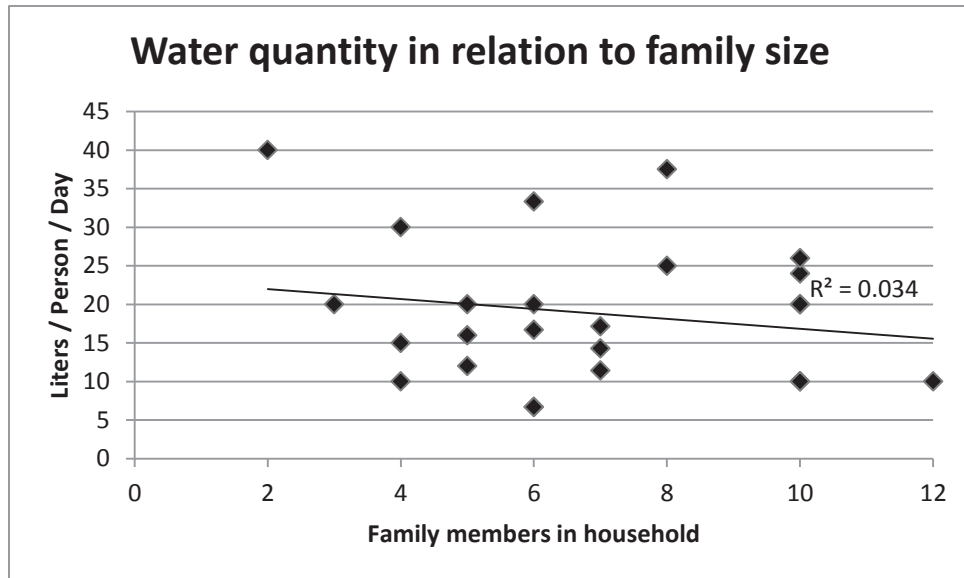
Figure 14: Water quantity in relation to family size

I also compared the L/P/D against the number of family members staying in the household. Figure 14 shows a graph of the water quantity used on a daily basis as the independent variable against the family members in a household as the dependent variable. There is no correlation between how much water per person a family uses

and how many people are using the water. The probability value for the variables was 0.22 which is far bigger than the minimum probability value for statistical correlation significance of 0.05. Larger families do not use less water per person than smaller families.

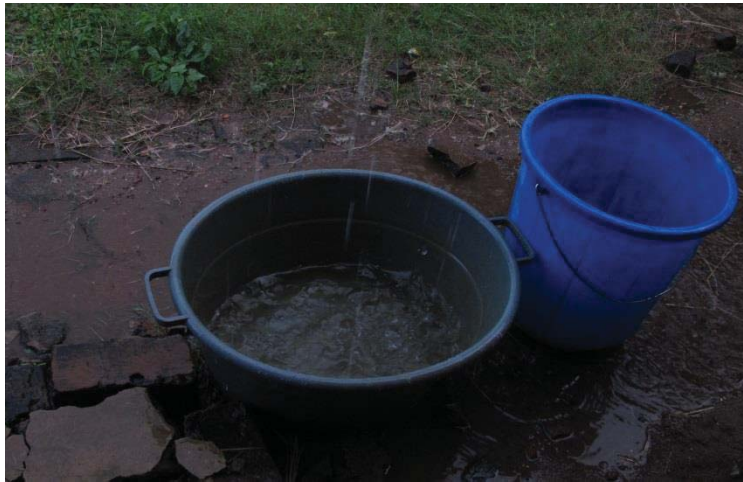
**Figure 15: Collecting rainwater**

The water table is likely to be at its lowest level at the start of rainy season, January, but consistent rainfall lets community members collect water runoff from their roofs. I did not observe any houses with rainwater collection systems, but did observe people placing buckets under the edge of the roof. A 20 liter bucket can be filled with the rainfall from a single night when placed under a roof without any gutter system. During my first year living in the village, shallow well II broke and was not repaired for two months. I was able to collect enough water from rainfall coming off the roof

for all my consumptive uses during those two months, as shown in Figure 15. Bathing and clothes washing water was still collected using a borehole.
