Protection of Historical Heritage From The Point Of Sustainable Environment and The Sample of Caca Bey Madrasa In Kırşehir District

Keywords: Caca Bey Madrasa, Kırşehir, earthquake

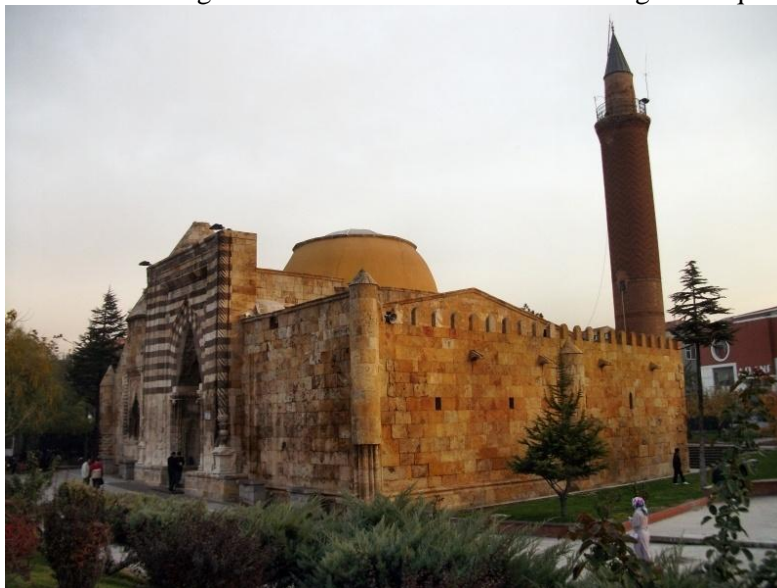
Figure 1: Kirşehir Cacabey Madrassa

There are a number of striking special and common motifs used in the buildings of Seljuk on the outside of the building used currently as mosque (Figure 1). When the front part of the structure is divided into three; there are the main tomb on the left side, crown door in the middle and flat wall without window on the right side. Also, there is tower now used as minaret in the South west corner of the building. There is not a strong evidence, but still it is claimed by the public that it is a observation tower. This tower as minaret takes attention because its position is opposite to the structure (Figure 2). It is still a question why this structure has been built. There is a possible observation wells inside it and right under half-open dome over which was closed later by glass [6]. Today, it is still unknown that what kind of an observation system is used in it and how the possible observation well's inside is organised. In addition, there are two marble columns on both sides; right and left hand, a few meters behind the altar when the structure is entered inside. It is noticed at the first glance that the altar was built later. It is known that the origins of astrophysics and spectroscopy

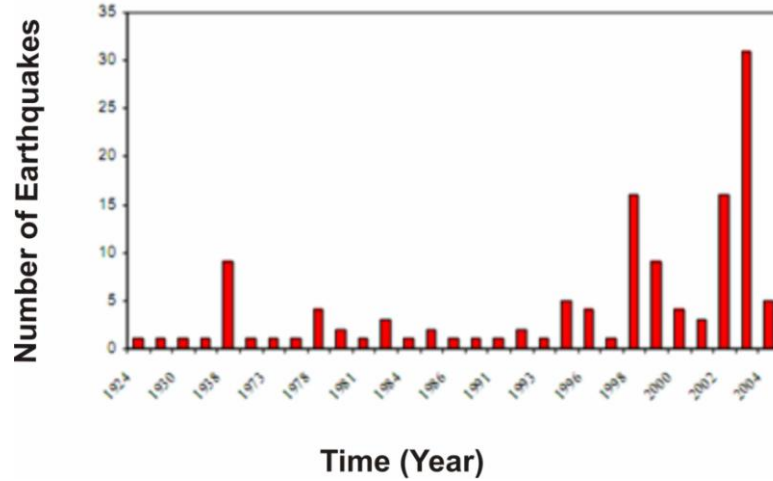
Figure 5: Distribution of the earthquakes over the years whose size is bigger than 2.0 in the region restricted with the coordinates (38.00-40.00)N-(33.00-35.00)E between the dates 01.01.1900-0.03.2004 [8-10]

Earthquakes coming into existence in the region between the coordinates (38-40)K ve (33-35)D till now from 1900 when earthquakes started to be recorded instrumentally have been given in Table 1. Distribution of earthquakes over time in order to demonstrate earthquake effectiveness of the region has been showed graphically according to years (Figure 5). It is observed that there is a significant increase in the number of earthquakes since 1990. One of the reasons of this increase is seismic activity, as well as an increase in the number of the seismograph. Earthquakes happening in the region between the coordinates (38-40)K and (33-35)D generally focus on the region near Kırıkkale in the northwest (Figure 4) and shows a sequence in the direction of E-W. That is associated with the fault in Ezinepazarı located in KD of Kırıkkale. Compared to this region, earthquakes happen less frequently in the town of Kırşehir and Akpınar. The location of their outside center and their size is unclear, however, 20 pieces historical earthquakes whose records were got came into existence (Table 2.) [11-13].

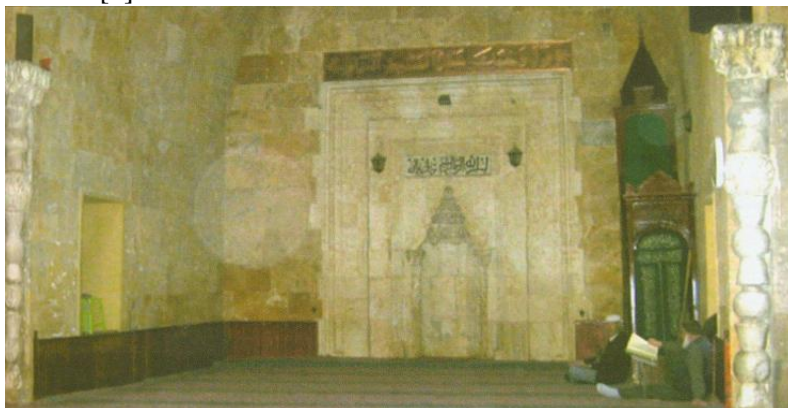
Figure 6: One of the columns shown on the right

Initially, two columns drew attention, existing on the inside of structure which presented, just opposite the entrance to your right and left hand, and a few feet behind of niche of a mosque indicating the direction of Mecca (Figure 6). These columns resembles each other, but rather than as an array of beads on a string of grains that have been ranked [1].

Four sphere and six truncated cone of shapes rowed side by side have been shown at these columns. On Looking in more detail in these columns, a sphere and two truncated cones made a section coming together. There has been an additional independent sphere between two lower sections at these columns (Figure 6). There was an additional sphere embellished over with rich motifs and a larger sphere in stature on the upper one third part of each column (Figure 7).

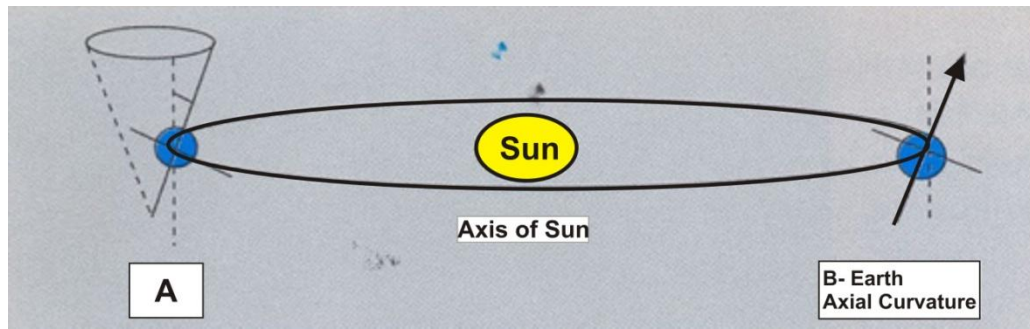
Figure 9: The axial tilt of the World

Interior columns of Caca Bey Madrassa was thought likely to be made as a result of a series of observations as a reference system, which was similar to the Earth. Looking at the movements of the Earth and other planets, some planets have axial curvature during rotations of the planets around the sun. These values are given in Table 4. An angular momentum occurred due to rotation of the planets on their own axis. Conical structure was come out when returned this angular momentum in axial inclination (Figure 9).
