Consolidation and Upgrading of Historic Earth Block Masonry Constructions

Ioanna Papayianni¹, Vasiliki Pachta¹

¹ *Laboratory of Building Materials, Department of Civil Engineering, Aristotle University of Thessaloniki,
Greece*

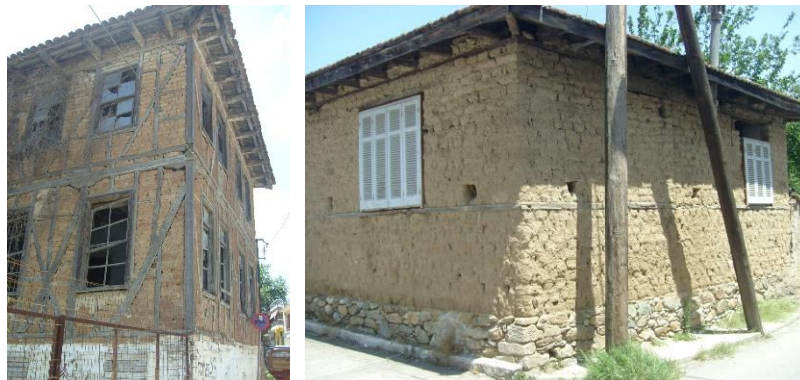
Figures 1-2 Earth-block houses of N Greece (town of Goumenissa)

Traditional earth-block houses can be of 1 or 2 storeys (Figs. 1-2). Masonries are usually 50-100cm thick and are constructed with earth-blocks and mud mortars (structural mortars, renders, plasters) based on locally available clay. Wooden beams and conjunctions reinforce the structure by connecting the structural members and increasing bearing capacity (Fig. 3). Foundations are usually of stone masonry in order to be stable and resistant to humidity.

In SE Europe they are usually located in lowland villages and mountainous settlements. Some of them are still inhabited, others have been abandoned. They are considered as cultural heritage of vernacular architecture, since they are constructed with earth blocks and mud-mortars of local raw materials and by using traditional techniques (Figs.1-2).

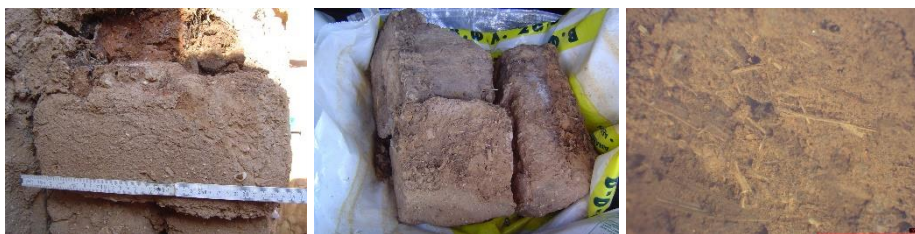
Figure 4 In situ, macroscopic and microscopic figures of a traditional earth block

Earth blocks (Fig. 4) were compact, with dimensions 30x15x10cm, manufactured with clay of local origin. Inert material, such as fine aggregates, wooden fibers, straw, was added in order to increase their stability and flexural strength. Their compressive strength was low, around 0.5MPa, while their porosity was around 10% and Apparent specific gravity 1,7. As expected, their water absorption and capillary sanction was high and led to material detachments.

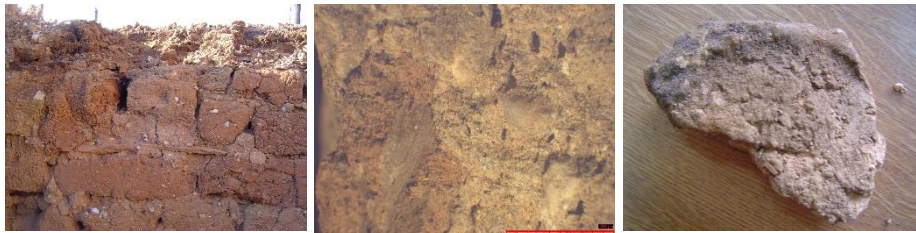
Figure 5 In situ, macroscopic and microscopic figures of structural mortars

Structural mortars (Fig. 5) were also based in clay of local origin, while hydrated lime was added in a ratio of clay:lime around 3:1. Aggregates were of natural origin and granulometry 0-8mm, while wooden fibers in a percentage of 2% w.w. of binders were added.

Binder/Aggregates (B/A) ratio was around 1/1,5. Compressive strength was around 0.6MPa, porosity 23% and apparent specific gravity 1.6

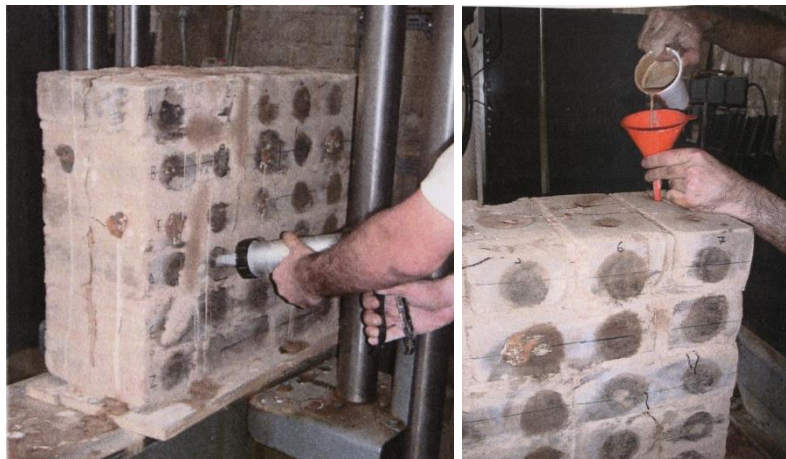
Figure 6 Grouting earth block masonry with soil based grouts

The effectiveness of the grout mixtures was checked by grouting models of mud-brick masonry which were previously crushed by applying loads at the Laboratory. The grout mixtures that have exhibited the higher mechanical strength, fluidity and volume stability were used for grouting earth block masonry walls previously loaded and crushed.

Before the grout penetrations, the walls have been subjected to pulse waves' velocity measurements made on the wall with sonometer in order to estimate the cracks or discontinuities of the crushed masonry walls. After one month period of curing at room conditions the consolidated masonry models were crushed again (Table 4). Measurements of the pulse waves' velocity were also made before the appliance of compressive loads. An adequate number of earth block masonry walls were crushed.
