MineWolf Flail and Tiller Machines: Testing the Differences between two Demining Technologies

by Heinz Rath and Dieter Schröder [MineWolf Systems GmbH]

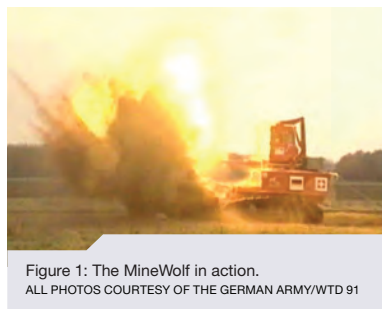
Figure 1: The MineWolf in action.
ALL PHOTOS COURTESY OF THE GERMAN ARMY/WTD 91

The MineWolf is a mine-clearing device developed especially for humanitarian mine-clearance. It is used for area clearing and clears up to 2,800 square metres per hour (3,349 square yards/hour), allowing for fast quality control on a demined area. The MineWolf system consists of a fragment-proof AHWI crawler tractor, a protected driver's cab and a mechanically driven mine-clearing device. Both a flail device and a tiller are available.

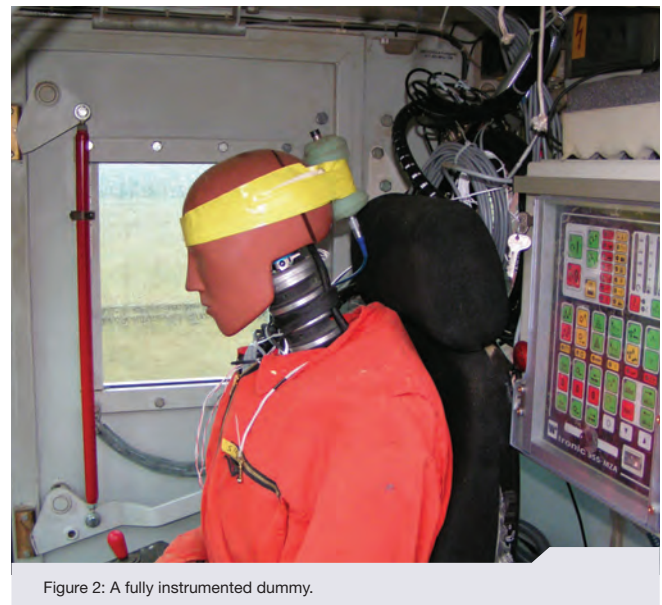
Figure 2: A fully instrumented dummy.

To record the measured values, an ATD was placed on the driver's seat and was fitted with various sensors to measure human-relevant impact information.

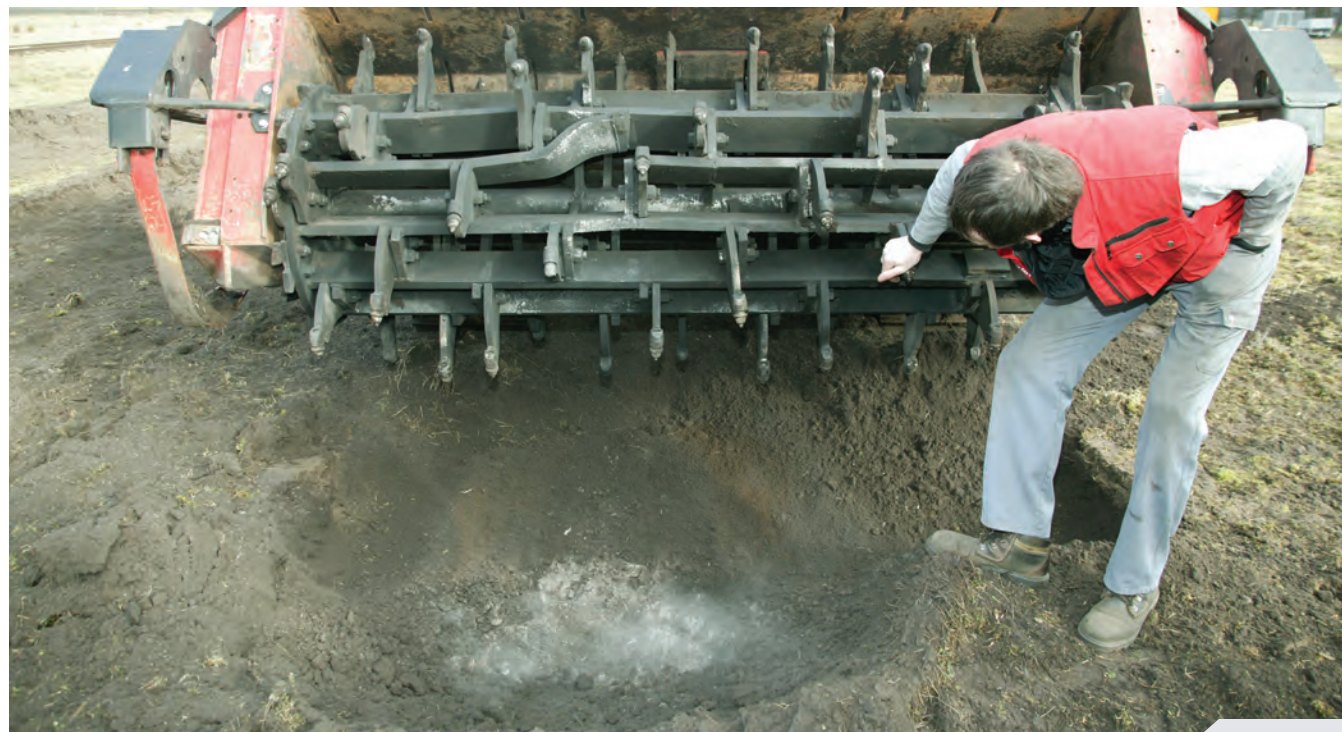
Figure 3: A typical mine crater after clearing a TM 57 or TM 62 AT mine.

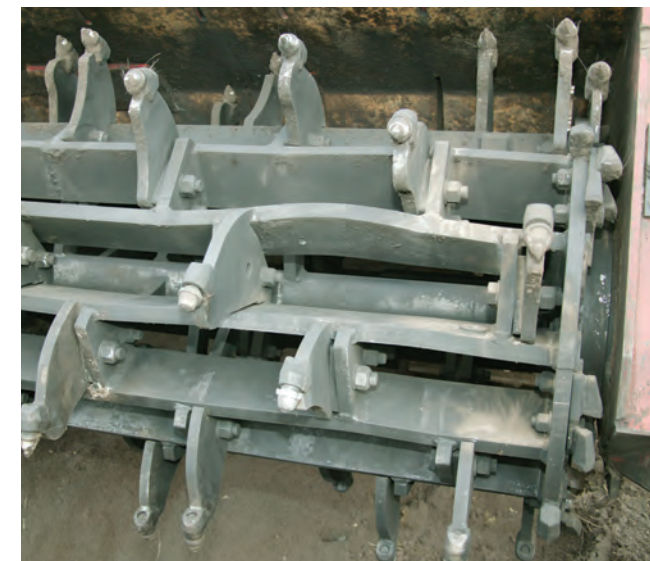
Figure 7: Damage after clearing a TM 62 P3 AT mine.

The AT mine TM 62 P3 detonated on-site upon contact with the mine-clearing device. The hit occurred approximately 0.5 metre (1.6 feet) off the left-hand side of the device.

Damage to the clearance machine included one worn chisel and two bent cross-spars (the cross-spars, or strut braces, were deformed by an area of 30 by 130 centimetres [11.8 by 51.2 inches]). The damage seemed to be minor as compared to the previous tests with the TM 57. The mine crater in the ground was of normal size. The machine could continue clearing despite the damage it suffered.

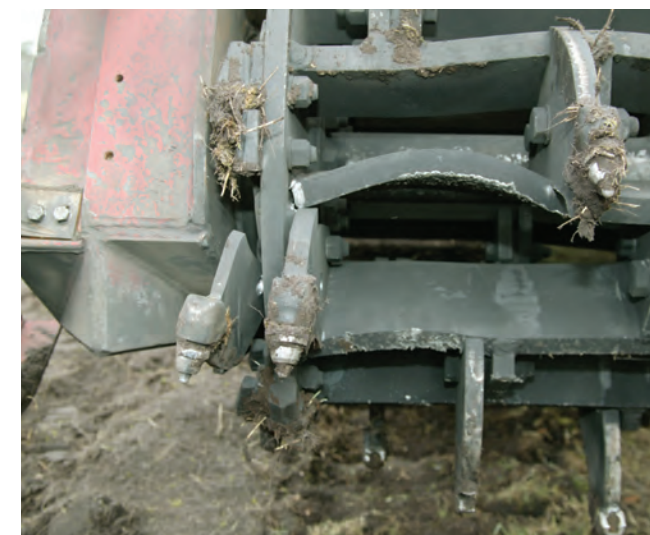
Figure 8: Damage after clearing a TM 57 AT mine.

The TM 57 also detonated on-site upon contact with the mine-clearing device. The hit occurred approximately 0.2 metre (0.66 foot) off the right-hand outer edge of the tiller.

Damage to the Minewolf included one outer tooth that was bent outwards and four cross-spars that were deformed by an area of 30 by 130 centimetres (11.8 by 51.2 inches). Two cross-spars were torn off at the end of the weld seam. The depth-control device was bent outwards but still functioning. After some provisional work lasting about 15 minutes, a test run with the tiller was performed. The tiller performance was still sufficient. The mine-clearing tool and drive train with power bands were still in repairable condition. The clearing quality was still good as shown by the ground appearance.

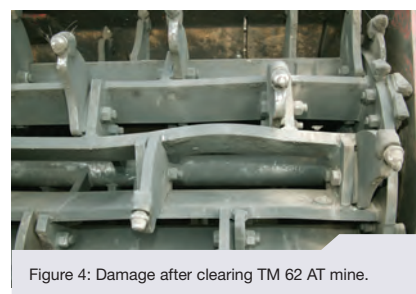
Figure 4: Damage after clearing TM 62 AT mine.

A total of six remote clearing tests were conducted against live AT mines. Four of these tests led to the detonation; two of the mines were crushed. Little or no flail repair work was necessary after the unmanned test. Damage to the tiller device is shown in Figures 4 and 5. The repairs shown in

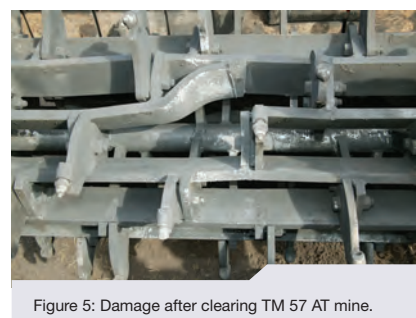
Figure 5: Damage after clearing TM 57 AT mine.

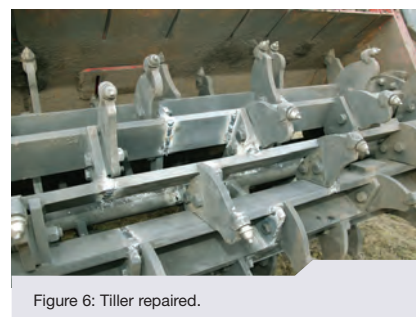
Figure 6: Tiller repaired.

Figure 6 are mainly welding work, which could be performed on-site the same day.

The mine-clearing MineWolf system with both accessory devices is suitable for clearing live anti-tank mines. The use of the flail device for clearing live anti-tank mines caused only minor damage that could be repaired with a limited effort or did not necessitate any repairs at all. The use of the tiller against live anti-tank mines, however, resulted in considerably greater damage, which could only be repaired with a substantially greater effort than those caused with the flail. The repairs, mainly welding work, could be performed on-site that same day.

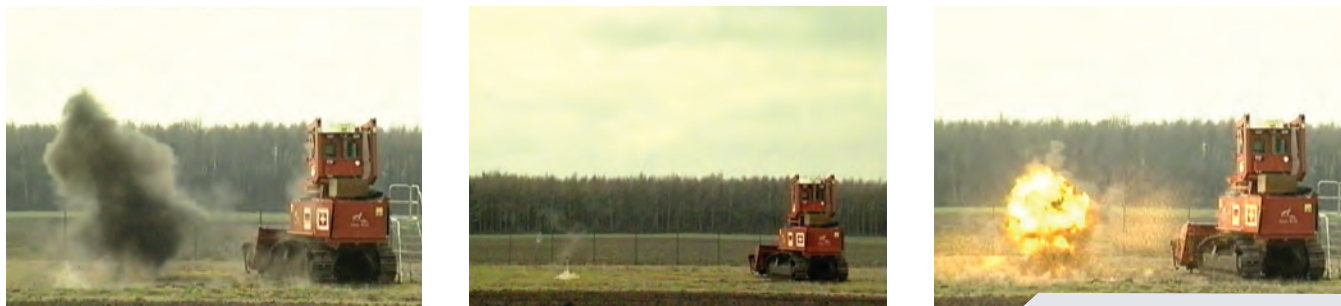
Figure 9: The operability of the MineWolf was not affected by fragment hits from the AP fragmentation mine DM 31.

Two contact detonations with AP fragmentation mine DM 31 were performed. The mines were placed on solid ground 10 metres and five metres (32.8 and 16.4 feet) from the tiller on the left-hand (fully armoured) side of the mine-clearing vehicle and the mine fuze DM 56A1B1 was initiated by a detonator placed on top of it. After approximately two seconds, the explosive device of the mine jumped from the launch box and detonated about one metre (3.3 feet) above the ground.

At a 10-metre (32.8-foot) distance, there were only a few fragment hits on the equipment. There were only small marks on the six-millimetre (0.24-inch) armour plates; there were two dents in the three-millimetre (0.12-inch) instrument box, one hit was found on

the cabin glass. At a five-metre (16.4-foot) distance, the fragment hits were more severe: slight dents in the six-millimetre (0.24-inch) armour plates. No fragment penetrations through the protected operator cab were detected. The operability of the MineWolf was not affected by the fragment hits.
