JOURNAL OF ENVIRONMENTAL GEOGRAPHY
Journal of Environmental Geography 10 (1–2), 41–51.
 DOI: 10.1515/jengeo-2017-0005
 ISSN: 2060-467X

CENTURIAL CHANGES IN THE DEPTH CONDITIONS OF A REGULATED RIVER: CASE STUDY OF THE LOWER TISZA RIVER, HUNGARY

Gabriel Jonathan Amissah^{1*}, Timea Kiss¹, Károly Fiala²

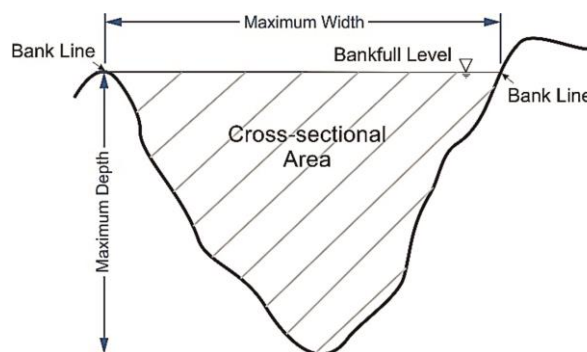
Fig. 2 The depth values were measured from the bankfull level of a cross-section

To understand the channel depth changes caused by direct human impacts, the maximum and mean depths along cross-sectional profiles were measured and analyzed. The study employed a dataset of hydrological surveys made in 1891, 1931, 1961, 1976 and 1999. The Hydrological Atlas of the Lower Tisza (1974) provided the locations of the surveyed cross-sections and it also showed the bank lines of the river at different dates. The channel surveys were undertaken using fixed geodetic survey points (VO-stones) at approximate spacing of 2.5 km. These VO-stones allowed subsequent surveys at the same cross-sectional profiles at different times. Along a profile the channel depth was measured at 5 m intervals. In the present study relative depths were calculated from the bankfull level, which was determined as lowest point of the bank line (Fig. 2). Based on the cross-sectional profiles the maximum (thalweg) depth and the mean depth for every cross-section were determined. The maximum depth refers to the location of the thalweg. The mean depth was calculated as the arithmetic mean of all depth data of a cross-section.

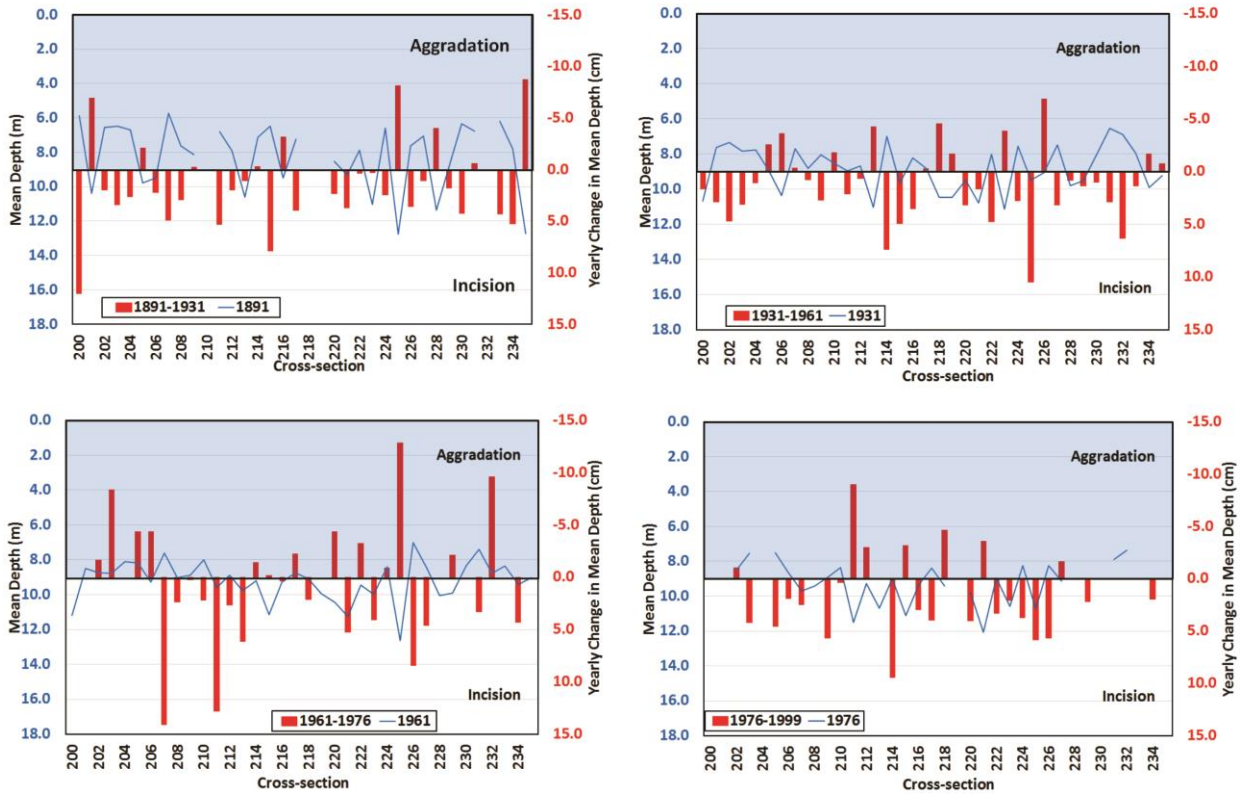
Fig. 5 Changes in mean depth: the mean depth at the beginning of a period between two surveys indicated by blue line; and the yearly change in mean depth in between survey years is indicated by red columns

A more detailed analysis of the changes of the mean depth along the studied section (Fig. 5) shows that the location of the greatest incision rates changed by time. While between 1891 and 1931 the greatest incision (12 cm/y) appeared on the upper reach (VO 200), in the next period between 1931 and 1961, it was in the lower reach (10.5 cm/y, VO 225). Between 1961 and 1976, it was measured in the upper reach (14.1 cm/y, VO 207), and finally the incision rate was 9.5 cm/y between 1976 and 1999 which occurred in the middle reach (VO 214). The VO 200 probably incised in response to cut-offs since it is located within an artificial channel, however the remaining sections were all located within meanders. Although most cross-sections referred to incision, some cross-sections had higher incision rates. The period 1976-1999 had its highest aggradation (15.9 cm/y) in the middle reach. The highest rates of aggradation for all the other periods (1891-1931: 8.7 cm/y; 1931-1961: 6.9 cm/y; and 1961-1976: 12.8 cm/y) occurred in the lower reach.

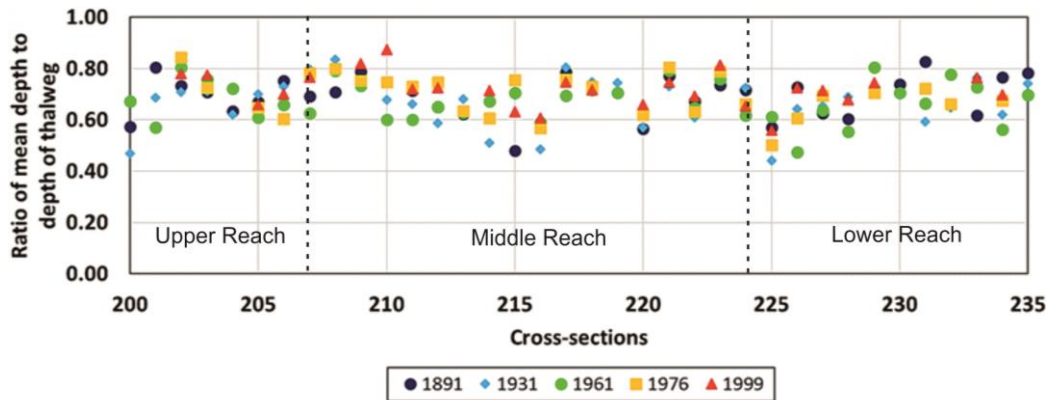
Fig. 6 The variation of the ratio of the mean depth to thalweg along the studied section

The ratio of the mean depth to the thalweg depth along the studied section of the river (Fig. 6) was also calculated, as it refers to the difference between the mean

depth and the thalweg depth: smaller value indicates a greater difference between the thalweg depth and mean depth. The ratio of mean and thalweg depths generally decrease from upstream to downstream (0.70 for upper reach; 0.69 for middle reach; and 0.67 for lower reach), referring to a more even channel bottom towards downstream. However, considering the temporal changes, it is interesting, that the ratio generally increases, referring to more intensive incision of the thalweg itself, than of the bottom of the whole channel.

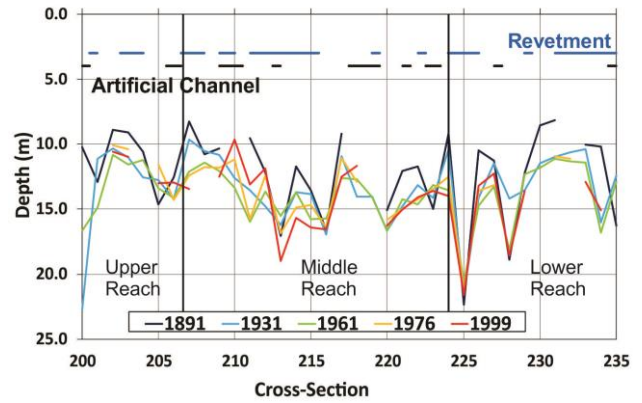
Fig. 8 Variation of thalweg depth along the studied section for various survey years

As the channel gradually developed towards quasi-equilibrium, the incision reduced (1931-1961), and the channel evolution process culminated in aggradation (1961-1976), similarly to the stages of the channel evolution model of Simon and Rinaldi (2006). The effect of high floods in the late 20th and early 21st centuries was combined with the effects of revetment and groin constructions, therefore the thalweg started to incise, thus the evolution model distorted. The range (i.e. the difference between the maximum and minimum thalweg depths) was up to 14.2 m in 1891. An increasing minimum thalweg depth and a decreasing maximum thalweg depth caused a reduction in the range until 1961. Afterwards this trend reversed, thus the range increased (1999:

12 m) was still short of the 1891 value. This reduction in range points to the development of a uniform channel, implying that although the channel was progressing to equilibrium after the cut-offs, the construction of the revetments and groynes initiated another cycle of dis-equilibrium.

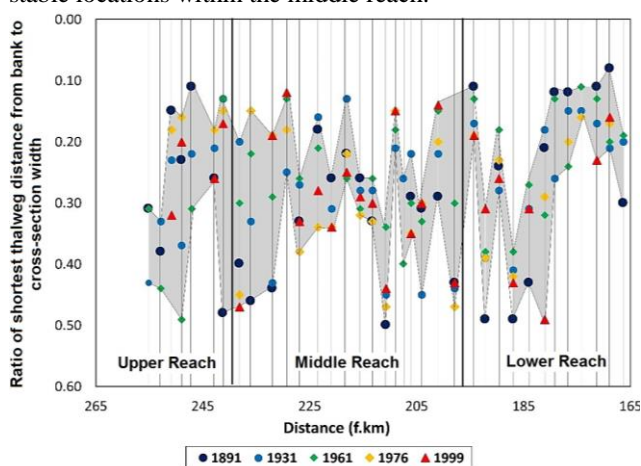
Fig. 10 Variation of the thalweg location relative to the whole cross-section width (the shaded area refers to the range of changes in the position of the thalweg)

The location of the thalweg within the cross-sectional profile was studied in detail too: the greater the ratio between the location of the thalweg to the closest bank and the channel width, the farther is the thalweg to the banks (Fig 10). Considering the whole, ca. 100 year-long period, it seems that the thalweg migrated closer to the banks in the upper reach, whilst the changes within the middle reach are smaller, and in the lower reach the thalweg migrated away from the bank. The trends also show that the location of the thalweg had the greatest range of variations in the upper reach, referring to frequent thalweg changes: in some cross-sectional profiles the thalweg shifted almost across half of the channel width. Although along the middle reach at some cross-sections the thalweg shifts were very small, in general the lower reach had the narrowest range. This implies the lower reach was more stable compared to the middle and upper reaches, although there were some very stable locations within the middle reach.

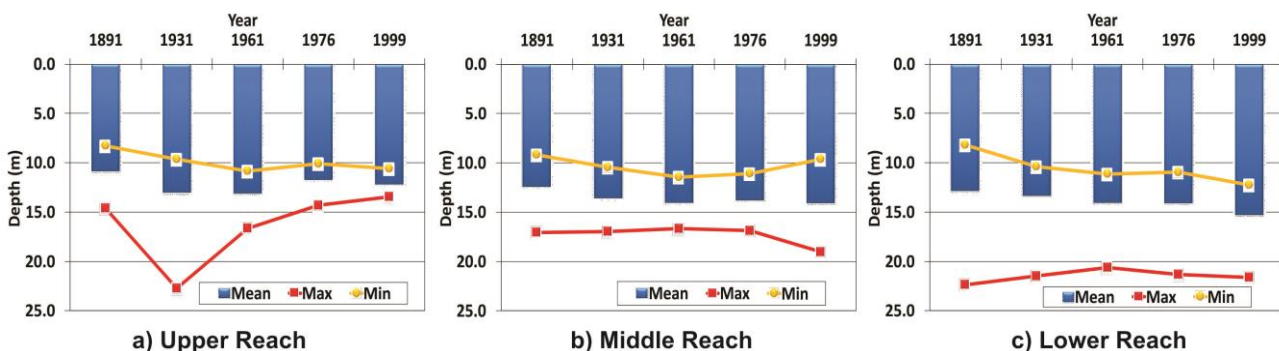
Fig. 11 Variations in thalweg depth values within the various reaches

The mean thalweg depth values of the upper reach were generally lower than the whole section, and the deepest thalweg depth was characteristic of the lower reach. The incision of the thalweg depth of the three different reaches (Fig. 11) during the whole period reflects an increasing trend towards downstream, as the mean depth of the thalweg increased by 1.3 m (1.2 cm/y) in the upper reach, by 1.7 m (1.6 cm/y) in the middle and 2.5 m (2.3 cm/y) in the lower reach.

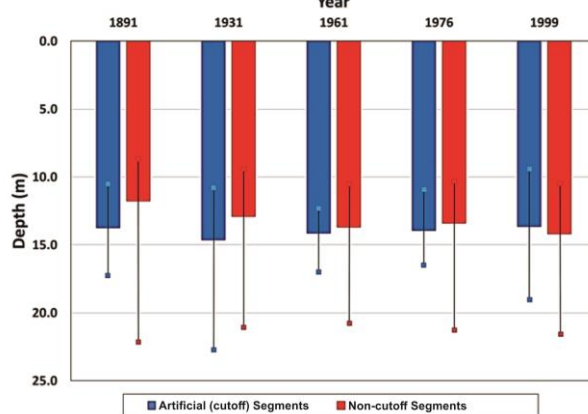
Fig. 12 Comparison of mean thalweg depths for cross-sections within segments affected and not affected by cut-offs, including the range (maximum-minimum) of thalweg depths

At the beginning, the mean thalweg depth in non cut-off segments was 11.7 m, while it was 13.7 m in artificial segments (Fig. 12). The higher mean thalweg depth in the artificial segments could be attributed to the initial scouring induced by the artificial channels of the cut-offs. However, by 1999, the mean thalweg depth in the non cut-off segments had increased by 21% to 14.2 m (2.3 cm/y), while in case of artificial segments almost zero net change was recorded. With the exception of 1961-1976 when the channel experienced a general aggradation, there was consistent incision of the mean thalweg depth within the non cut-off segments. In the artificial segments, although there was no net change between 1891 and 1999, there was a depth increase of 0.9 m from 1891 to 1931 (2.2 cm/y), which was followed by a consistent reduction of mean thalweg depth (1931-1961: 1.3 cm/y; 1961-1976: 2 cm/y and 1976-1999: 0.9 cm/y). The incision within the non-cut-off segments are partly due to the construction of revetments (80% of revetments built in segments which were not created by cut-offs) which restricted the lateral erosion within the channel, and therefore increased

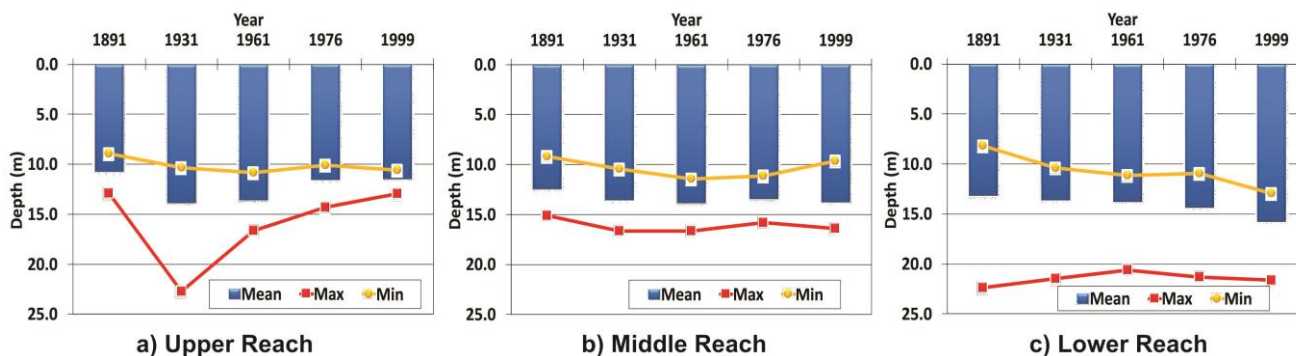
Fig. 17 Variation of the mean thalweg depth for the sections without direct human impact

Focusing on the reaches, the three reaches do not exhibit similar patterns (Fig. 17-18). The absence of clear trends shows the deficiency of generalization to responses of human impacts by rivers in some cases.

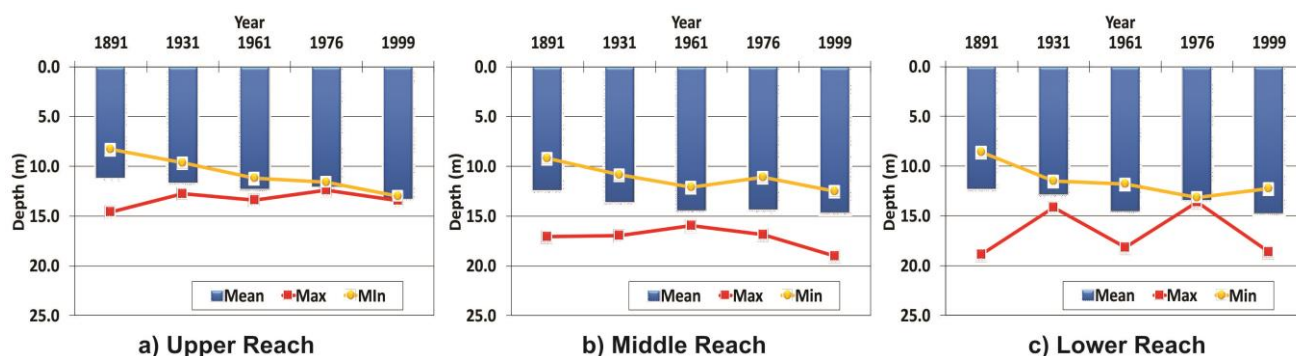
Fig. 18 Variation of the mean thalweg depth for the sections with direct human impact
