Ergonomic design intervention in a coating production area

ABSTRACT: The aim of this study is to redesign two workstations in a PVD coating production area, considering productivity and ergonomic aspects. Through the elimination of wastes such as unnecessary movements and transportations and by reducing the awkward postures as arm flexion larger than 45°, the productivity in the loading and unloading workstations increased 9% and 5%, respectively, and the ergonomic risk was improved from medium to acceptable. RULA was the chosen method to evaluate the ergonomic situation and anthropometric studies were performed to find the ideal ergonomic solution. This study shows the importance to consider ergonomic conditions when designing or redesigning a workstation in order to get effective productivity improvements.

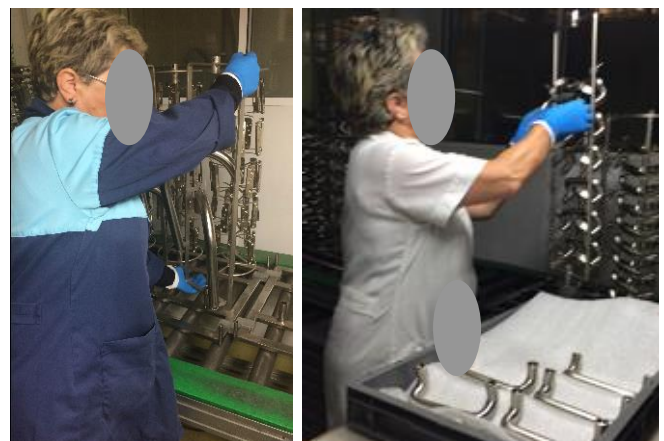
Figure 1– Unloading workstation before improvements.

The biggest team concern was the manually suspension movement between the carpet and the table due to the effort and the awkward posture necessary to perform this task and because it involves two kind of wastes: movement and transportation. Waste means, in a lean terminology, something that doesn’t add value to the product, this means something that the client doesn’t pay for (Womack et al., 1990). The other concern was the elevation of the arms considering the ergonomic aspects and the tiredness accused by operators, also contributing to a loss in productivity (Figure 1).

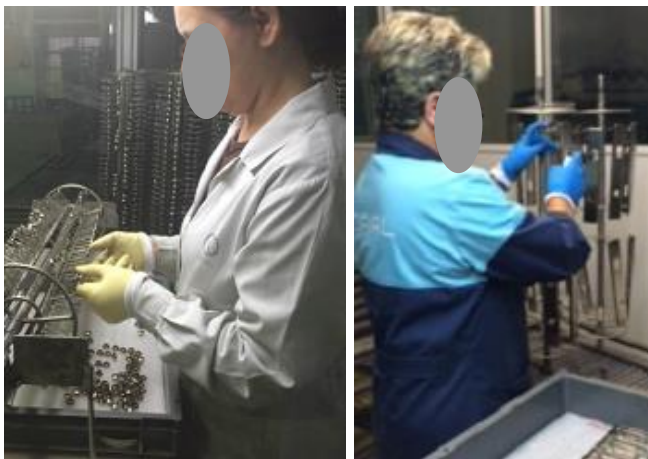
Figure 3– Unloading workstation after improvements

The Figure 3 depicts the worker in the unloading workstation after the implementation of these improvements.

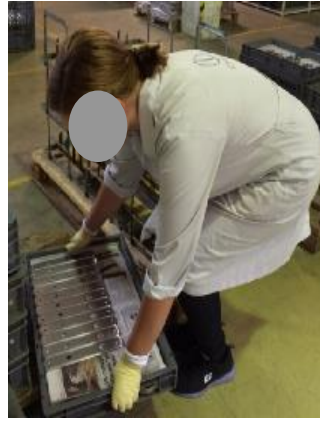
Figure 4– Container changing

The Figure 4 depicts the awkward posture adopted in this process. The container has an average weight of 6kg but could rise to 9kg maximum.

According to RULA method (McAtamney & Corlett, 1993), the most inappropriate postures before the improvements were moving the suspension and container changing (scored with 6).

The moving suspension task was eliminated and the RULA score to perform the task of changing container was reduced from 6 to 4 by the implementation of the lift car.

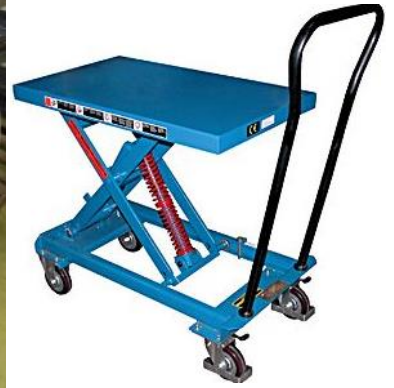
Figure 5 – Lift Car

The solution was the implementation of a lift car, similar to the one in Figure 5.
