Lessons learnt from early failure of a patient trial with a polymer-on-polymer resurfacing hip arthroplasty

Background and purpose — Hip resurfacing (HR) is a treatment option promoted for hip arthritis in young and active patients. However, adverse reactions to metal are a concern and the search for non-metallic bearing options proceeds. We present the first clinical study performed in patients using a newly developed hydrophilic polymer-on-polymer hip resurfacing device.

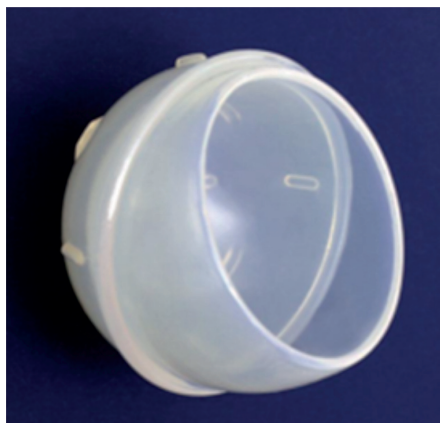
Figure 1. The Gradion Hip TCR implant (Biomimedica, Inc., USA).

In contrast to the earlier reported TriboFit System using PCU liners bearing against metallic femoral heads, the Gradion Hip Total Cartilage Replacement (TCR) System (Biomimedica, Inc., San Francisco, CA, USA) used in this study is an innovative polymer-on-polymer THA device, where both femoral and acetabular components are composed of a hydrated polymeric material that has similar structure, geometry, and functional properties to cartilage (Figure 1). Each component consists of 2 polymers, water, and small amounts of physiologic salts. For the 2 polymers, thermoplastic polyether urethane and polyelectrolyte, the weight ratio varies through the thickness of the device, with the highest percentage of the hydrophilic polyelectrolyte at the bearing surface and polyether urethane at the anchoring surface.

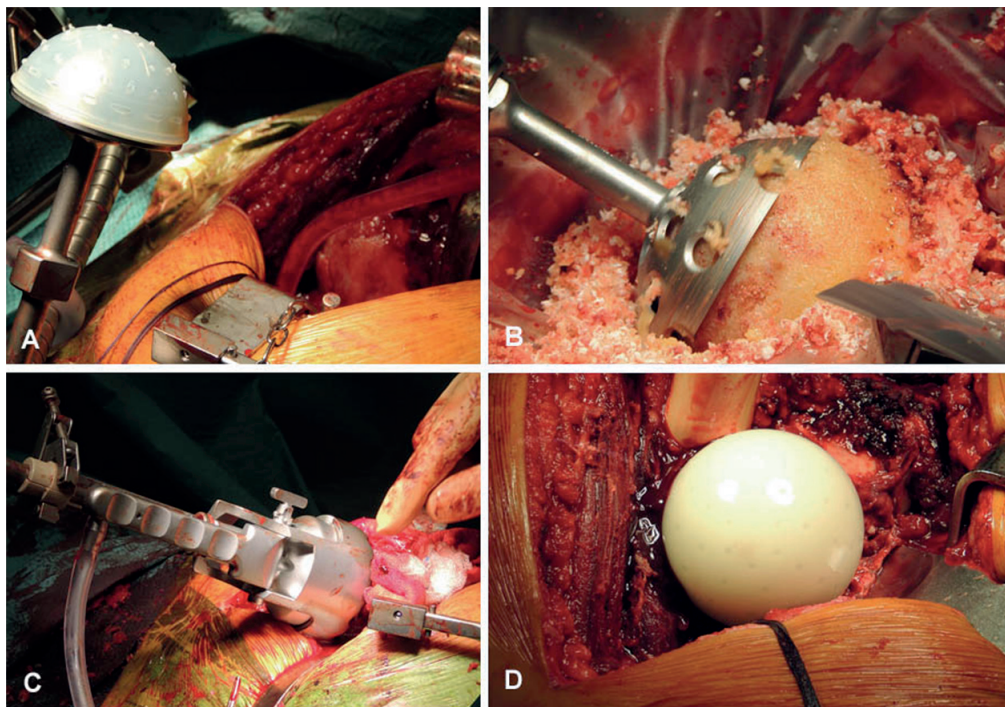
Figure 2.

- A. Intraoperative view of the acetabular component which is positioned on a vacuum suction device facilitating cemented implantation of the flexible device in a perfect concave shape. Cement spacers are present to facilitate cementing.
- B. Preparation of the femoral head by reaming.
- C. Subsequently the flexible femoral component is cemented on the femoral head and again a vacuum suction device is used to facilitate curing of the cement with the desired convex shape.
- D. The femoral component after cementing. Adequate cementing technique can be confirmed through the transparency of the component.

Surgical technique (Figure 2)

All surgeries were performed in collaboration by 2 out of 3 experienced hip (resurfacing) surgeons (JvS, BWS, PB) using a posterolateral approach. The surgical technique was matched with a hip resurfacing procedure as has been described before (Amstutz et al. 2006, Smolders et al. 2011). The Gradion HIP TCR was implanted and both the acetabular and the femoral component were cemented with low-viscosity cement after standard reaming. Both the acetabular and the femoral side were slightly over-reamed (1 mm) to

allow adequate cementing and avoid any potential for deformation during insertion. Prior to cementing, the acetabular component was fitted on a vacuum suction device facilitating cemented implantation of the flexible device in a perfect concave shape. Accordingly, preparation of the femoral head was performed by reaming, after which the flexible femoral component was cemented onto the femoral head again using a vacuum suction device to facilitate curing of the cement with the desired convex shape. The use of these custom-made vacuum suction devices while cementing ensured maintenance of a perfectly matched concave and convex spherical shape for the acetabular and femoral components, as had been confirmed earlier during in-vitro testing of the cementing technique on saw bones. Patients received antibiotic prophylaxis with cephalosporin preoperatively and 24 h postoperatively, periarticular ossification prophylaxis using diclofenac 50 mg for 3 days, and thrombosis prophylaxis with nadroparine (2,850 IE subcutaneous) during hospital admission and continued for 6 weeks after surgery.

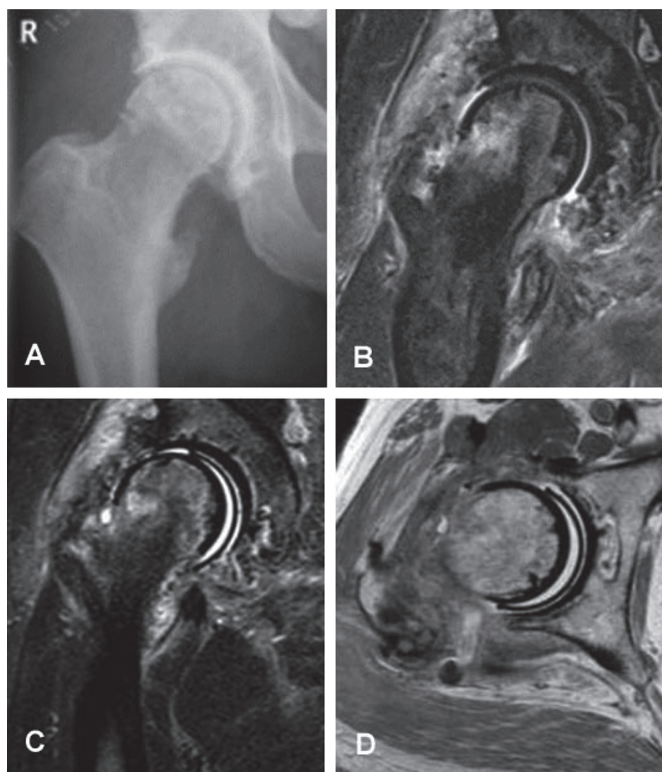
Figure 3.

- A. Postoperative radiographs with the radiolucent resurfacing device in situ. Both the acetabular and the femoral component are cemented.
 B. T2 weighted MRI scan of the hip one day after implantation of the new device. From its non-metallic nature both well-fixed and well-positioned components are clearly visible both on the acetabular and on the femoral side.
 C. Coronal view on the T2 weighted MRI 8 weeks after implantation. The femoral component remained well fixed; however, the acetabular component has come loose from its cement mantle and has rotated dorsal-caudally.
 D. Transverse MRI view showing the loosening.

Postoperative radiographs and MRI revealed well-positioned and well-fixed components in all cases (Figure 3). As expected, the implant was clearly visible on MRI and the cement fixation in the subchondral bone appeared to cover the entire surface of both the acetabular and the femoral component. Also, both components had maintained their spherical contour fitting on MRI.

In the first weeks after surgery the patients performed well and were satisfied with their operation. 8 weeks after the first operation when 4 patients had been operated, the first patient reported recurrence of pain in the groin and limping. A new MRI revealed early loosening of the acetabular component. On both coronal and transverse slices the acetabular component was visible as it had come loose from its seemingly intact acetabular cement mantle (Figure 3). The acetabular component appeared to have decreased somewhat in diameter and as such had detached itself from the cement mantle. The femoral component, on the contrary, was still adequately fixed with a seemingly intact implant–PMMA and PMMA–bone interface. This serious adverse event was immediately reported to the IRB and further enrollment of patients was halted. All 4 patients had a similar early failure mechanism in the same period (8–11 weeks) with acetabular component loosening.

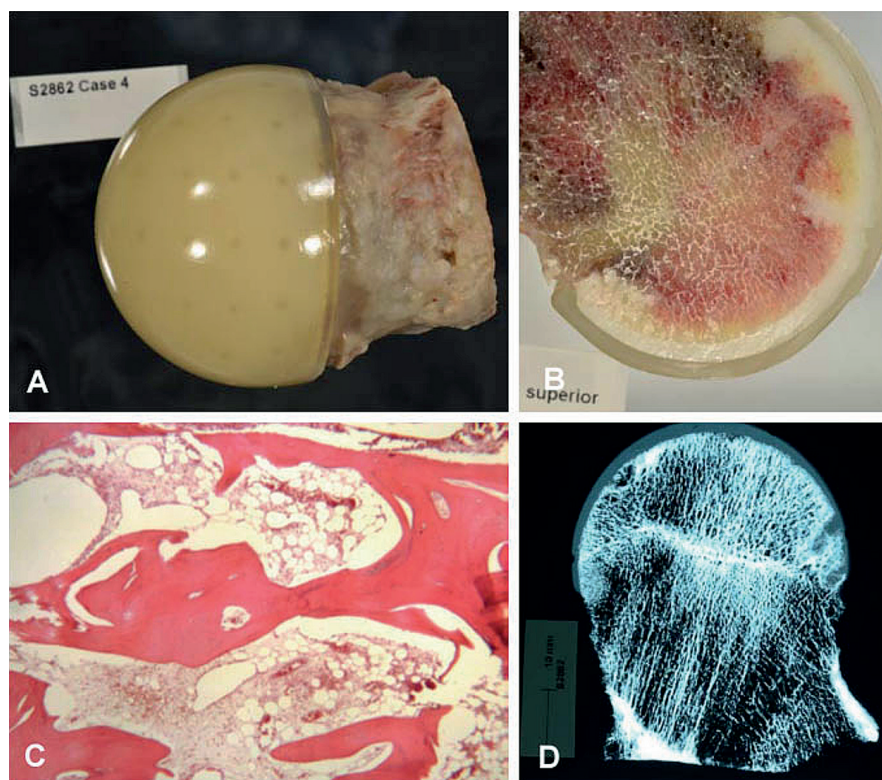
Figure 4.

- A. Specimen of a femoral head with component. The intact femoral component was well fixed to the femur and besides some light scratches on the dome there were no signs of gross wear.
- B. Image following mid-cut sectioning. There is an intact and adequately thick cement mantle visible with keyholes. The bone/cement interface revealed good cement interdigitation and otherwise adequate fixation of the femoral component.
- C. Histology from the bone–cement interface (HE $\times 40$). Bone in the proximal superior interface shows some necrotic core bone as well as evidence of remodeling. The vessels within the fibrotic marrow indicate viability.
- D. Corresponding (B) microradiograph showing intact bone and interdigitation between the cement and the bone.

Retrieval analysis results (Figure 4)

In each case, the acetabular components showed variable amounts of gross damage. This took the form of distortion, abrasion, pitting, discoloration tears, or cracks. This damage appeared to have been the result of moving as a corpus liberum through the hip joint for a period of time between loosening and the revision procedure. The cement spacers on the back of the cups were irregularly textured, reduced in size and in many cases appeared to be abraded or cracked. The bearing surfaces typically showed fine to moderate scratches and occasional small pits or indents. In each of the 4 femoral heads, there was an intact femoral neck and the polymeric device was apparently well fixed to the bone. The bearing surfaces showed removal damage as well as focal, dull areas of moderately deep or light scratches and small pits, also possibly from compressive forces against the loose acetabular component.

The sections revealed variable degrees of cement penetration ranging from several millimeters to poor interdigitation of the cement with clear gaps. The middle sections of 2 of the femoral heads showed the presence of an interfacial fibrous membrane that was verified histologically. This membrane ranged from approximately 130 microns to nearly 0.8 mm thick and was present along nearly all of the convex inter-

face. By contrast the sections from the other 2 femoral heads showed only thin (approx. 100–150 microns thick) intervening fibrous tissue, in less than 10% of the interface.

Microscopic examination of the bone throughout the middle sections of the 4 femoral heads showed that there was necrosis of the bone only at the interface that had been in direct contact with the interdigitating cement. Moderate necrosis (from 40% to 60%) of the bone within 2–3 mm of the interface was noted in 2 cases. In the 2 other femoral heads in which an intervening fibrous membrane had formed, necrosis of the interfacial bone was minimal, less than 10%. All of the other remaining bone in all 4 heads appeared viable.
