Raman Microscopic Studies of PVD Deposited Hard Ceramic Coatings

Christopher Paul Constable

A thesis in part fulfilment of the requirements
of Sheffield Hallam University for the degree
of Doctor of Philosophy

Collaborating Organisation: Renishaw plc

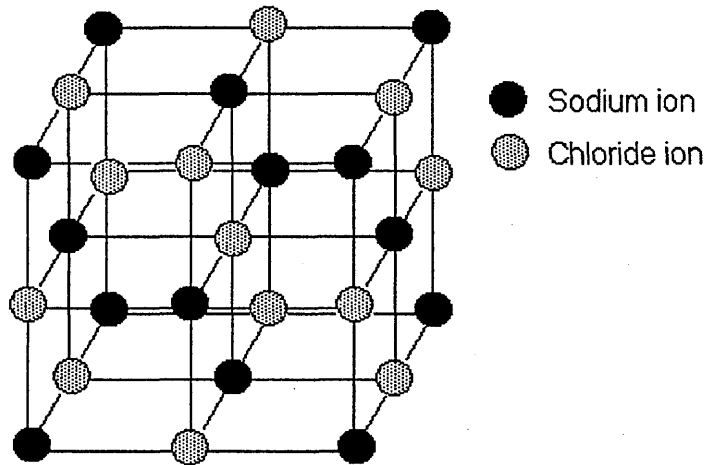
Figure 3.4 Sodium Chloride structure (Two interpenetrating fcc lattices)

A substitutional defect is when impurity atoms replace atoms of the parent lattice lying in lattice sites, and an interstitial defect is when an impurity atom creates a defect at a non-atomic site. All point defects produce a local distortion in the lattice. The amount of distortion and hence the amount of additional energy in the lattice due to the defects depends on the amount of “space” between the atoms in the lattice and the size and number of the atoms introduced. Additional effects are important when the removal or addition of atoms changes the local electric charge in the lattice. This is unimportant in metallic crystals with metallic binding, but can be important in crystals in which the bonding is ionic, such as NaCl shown in Figure 3.4. N.B. the Cl atoms are larger than Na.
