EFFECT OF INGREDIENT PARTICLE SIZES ON SURFACE ROUGHNESS CHARACTERISTICS OF PKS BRAKE LINING

ABSTRACT

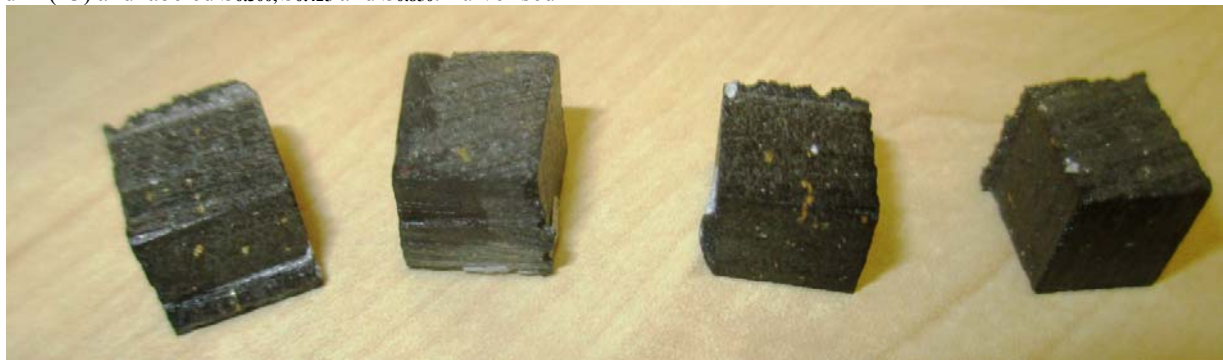
Figure 1: Developed NAO friction lining cut into experimental size of 10 x 10 mm

No prior treatment was done on the samples used as the work focused on as received from factory samples against most of the surface roughness works based on worn or polished brake pads. Samples of 10 mm width and 10 mm length (Figure 1) were cut and used in the experiment. Figure 1 shows the complexity of the friction material with visible mixture of shiny metallic constituents and non-metallic particles within a polymeric binder.
