## **Title:** Reduction of Tribocorrosion Products when Using the Platform-Switching Concept

**Key words:** dental implants, peri-implantitis, alveolar bone loss, titanium, metal ions, metal nanoparticles

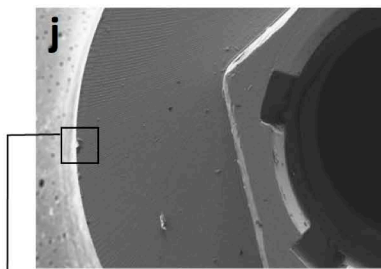
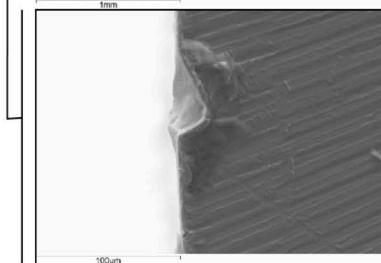
**Figure 3: SEM images of the contacting surfaces of different implants and abutments. (a)**

Pre-immersion image of a pristine implant showing a uniform machined platform surface (x150) **(b)** Post-immersion image of an implant connected to platform-matched zirconia abutment showing pitting corrosion features as black spots on the interfacial surface (x150), **(c)** Surface crack at the hex area of a platform-switched zirconia abutment (x150) **(d)** Permanent damage of the external hex in the form of burnished surface with material delamination of an implant connected to platform-switched Ti abutment (x150) **(e)** Bands of fretting lines towards the compressed side of an implant connected to platform-matched Ti abutment (x500) **(f)** Implant platform devoid of fretting scars on the side opposite to compression of the same implant of fig.3e (x500) **(g)** Irregular crooked outer border at the compressed side of an implant connected to platform-matched zirconia abutment (x500) **(h)** Uniform outer border at the compressed side of an implant connected to platform-switched zirconia abutment (x500) **(i)** A small shiny metal piece chipped off the outer edge of an implant connected to platform-matched zirconia abutment seen under light microscope. **(j)** Delamination of surface layer near the outer implant platform at the compressed side of an implant connected to platform-matched CoCr abutment. (x50 and x500) **(k)** Post-immersion images of on an implant connected to platform-switched zirconia abutment showing fretting lines confined to the implant platform area in contact with the opposing abutment of smaller

diameter, the area beyond the opposing surfaces was devoid of fretting scars (x80 and x500). SEM, scanning electron microscope

Post-immersion SEM images showed surface tribocorrosion features such as pitting, cracks, deformation areas, material delamination and fretting scars compared to pre-immersion images (fig.3a. to 3f.). Images of platform-matched groups showed damaged outer implant border in

the form of crooked irregular outer edge unlike the uniform border of platform-switched groups (fig.3g and 3h.), chipped implant edge (fig.3i.) or delamination of surface layer (fig.3j.). In platform-switched groups, fretting lines were limited to the implant surface in contact with the opposing abutment of smaller diameter (fig.3k.)

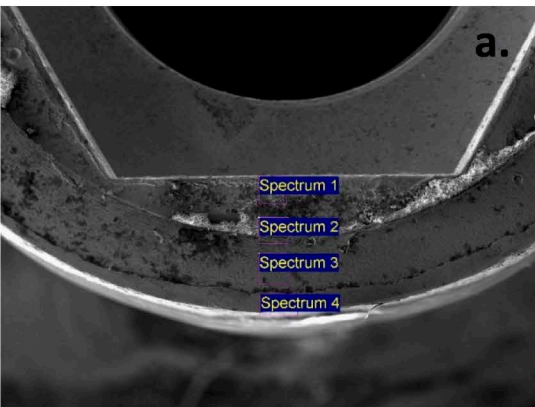
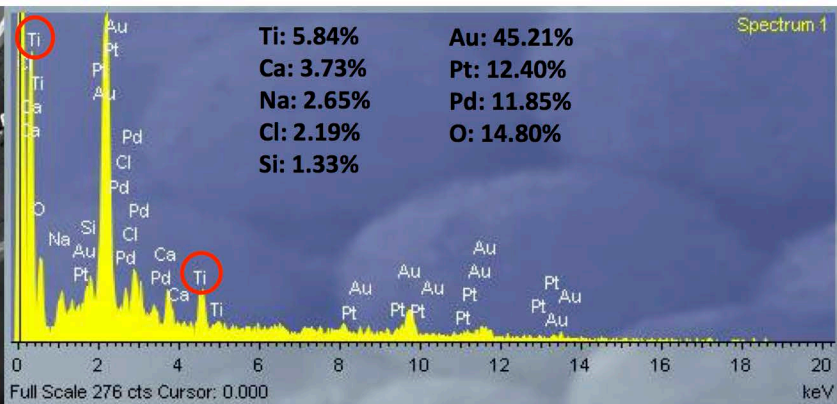
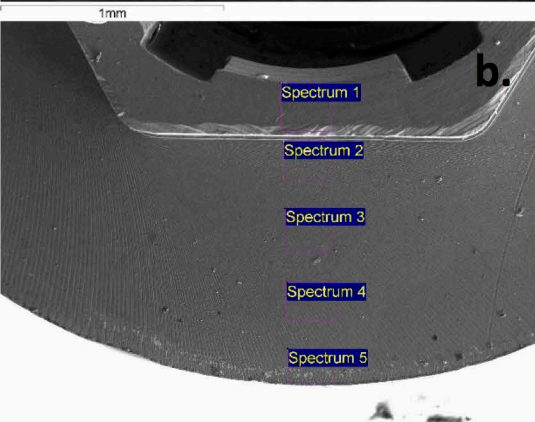
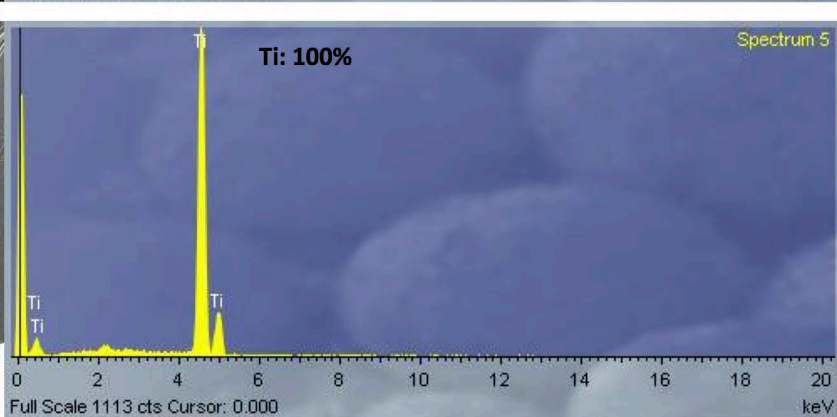
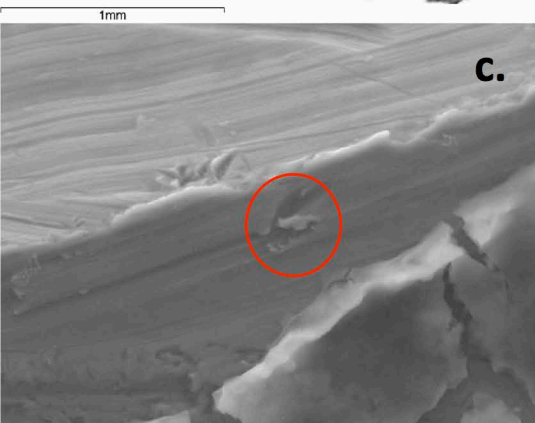
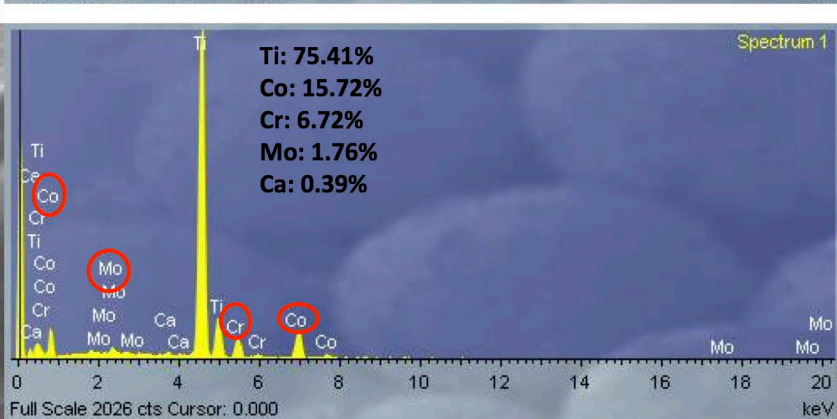
**Figure 4: Post immersion EDX elemental analysis of implant-abutment interfaces. (a)** Deposition of Ti element from the implants on the inner hex area of a platform-switched gold abutment (x50) **(b)** Implant platform consisting mainly of Ti element on most selected areas of an implant connected to platform-matched gold abutment (x50) **(c)** Deposition of trace amounts of Co, Cr, and Mo on the external hex of an implant connected to platform-matched CoCr abutment (x2000). EDX, energy dispersive spectroscopy x-ray

Post-immersion EDX analysis of abutment surfaces revealed deposition of Ti element from implants onto most abutments (fig.4a.). The surface elemental composition of implants mostly consisted of Ti (fig.4b). There were trace amounts of other elements, such as Zr, Co, Cr and Mo deposited on implant surfaces in low weight % composition (fig.4c.)

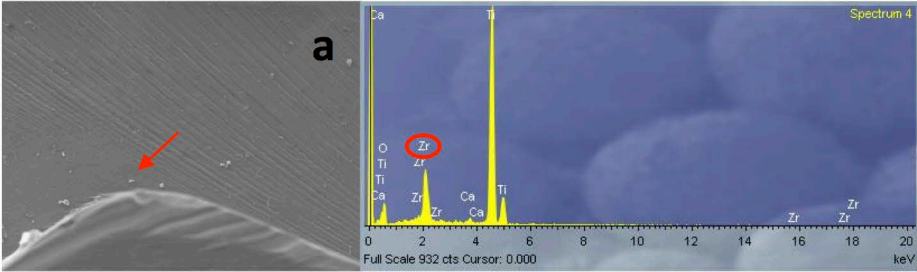
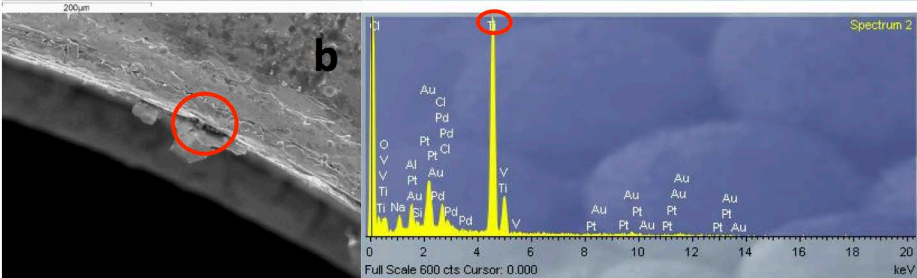
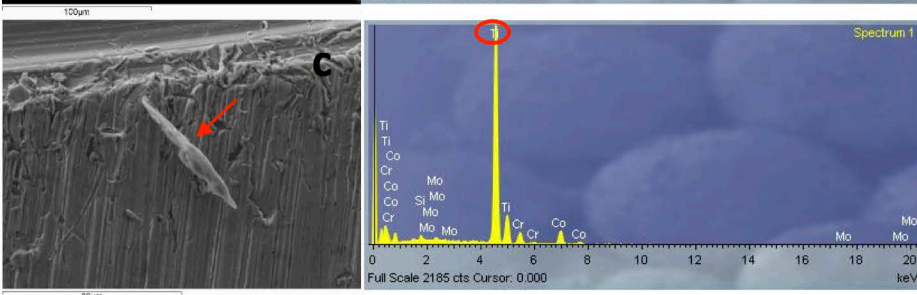
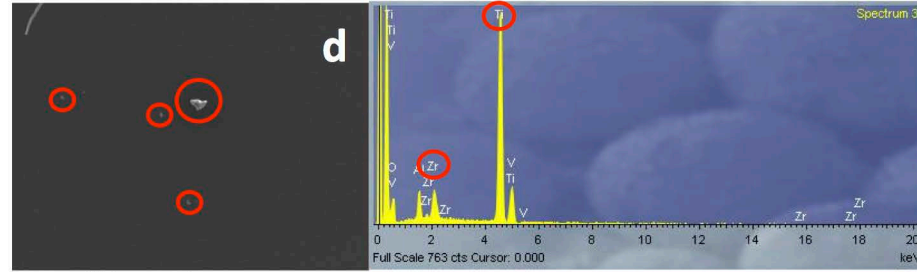
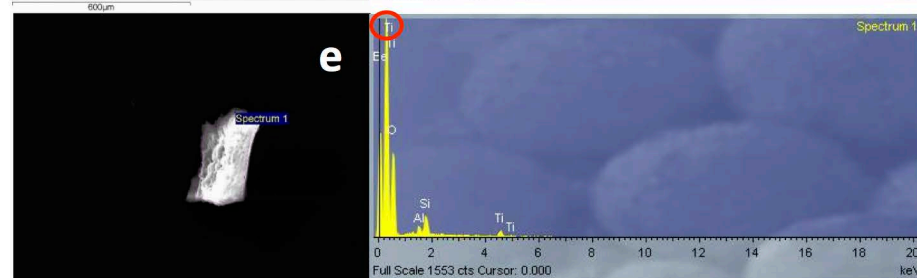
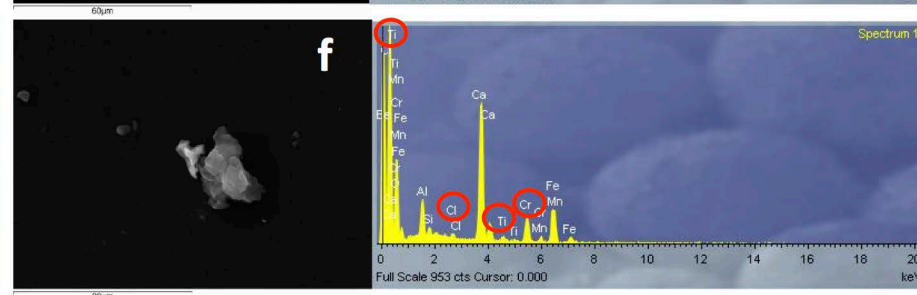
**Figure 5: Post-immersion SEM images and EDX analysis of wear particles on the implant-abutment interfaces and in the filtered extracts of the collected NaCl solutions. (a)** Wear particles adherent to the platform surface of an implant connected to platform-matched zirconia abutment. Few particles were composed of Zr indicating their deposition from the abutment into the implant (x250) **(b)** Ti particles adherent to the hex area of a platform-switched gold abutment (x500) **(c)** Ti particle measuring 48  $\mu\text{m}$  in length adherent to a platform-switched CoCr abutment interface (x1000) **(d)** Numerous particles of various sizes and compositions in the filtered NaCl immersion solution of an implant connected to platform-matched zirconia abutment (x100) **(e)** Ti particle measuring 50  $\mu\text{m}$  in length found in the filtered NaCl immersion solution of an implant connected to platform-matched Ti abutment (x1000) **(f)** Ti and Cr particles engulfed within chlorine crystals found in the filtered NaCl immersion solution of an implant connected to platform-matched CoCr abutment (x1000). SEM, scanning electron microscope; EDX, energy dispersive spectroscopy x-ray

SEM images of interfacial surfaces also showed wear particles adherent to implant and abutment surfaces (fig.5a. and 5b.) Wear particles were observed near the hex and were mostly Ti reaching up to 48 $\mu$ m in length (fig.5c.)

Analysis of the filtered extracts under SEM revealed the presence of numerous particles in the collected NaCl solutions of various compositions and sizes reaching up to 50 $\mu$ m in length (fig.5d and 5e.). EDX analysis of particles revealed their nature to be either metal particles, chlorine crystals or metal particles engulfed within the chlorine crystals (fig.5f.). The majority of wear particles were Ti.
