## The landslide and local tsunami of 13 September 1999 on Fatu Hiva (Marquesas Islands; French Polynesia)

*Abstract.* – On 13 September 1999, a local tsunami, comprising two waves separated by a few minutes, hit the village of Omoa, on the island of Fatu Hiva, French Polynesia. It inflicted serious damages to structures built close to the seashore, in particular to the local elementary school. The tsunami was generated by the collapse of a basaltic cliff, located 3 km to the southeast of Omoa, along the coastline. The volume of the landslide is estimated to range from 2 to 5 million m<sup>3</sup>, of which 60 % fell into the sea. A preliminary simulation of the tsunami provides an acceptable explanation of wave amplitudes, as well as an estimate of the origin time of landslide.

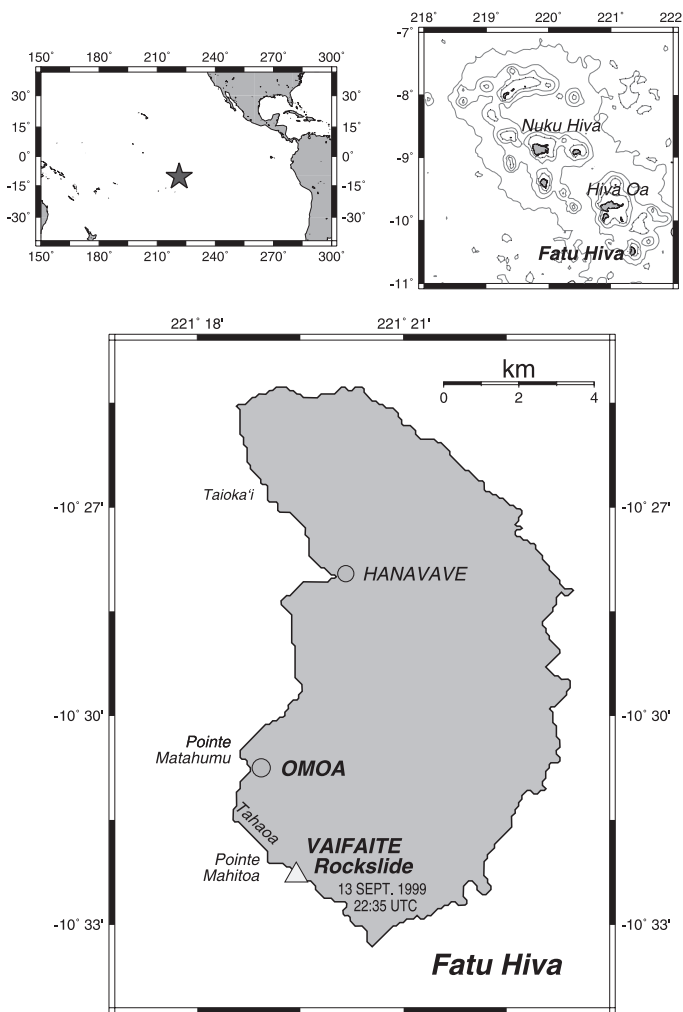
FIG. 1. – *Top* : Maps locating the Marquesas Islands in the Pacific (left), and the island of Fatu Hiva within the Marquesas group (right). *Bottom* : Map of the island of Fatu Hiva, showing the two villages (circles) and the location of the Vaifaite cliff and rockslide (triangle). Other localities referred to in the text are identified.

At Hanavave, the second village of the island, located in the Baies des Vierges, 5.7 km NNE along the western coast (fig. 1), the runup reached only 1.9 m, and the waves penetrated a mere 12.5 m inland, based on witness reports. The waves were not recorded on the other Marquesan islands.

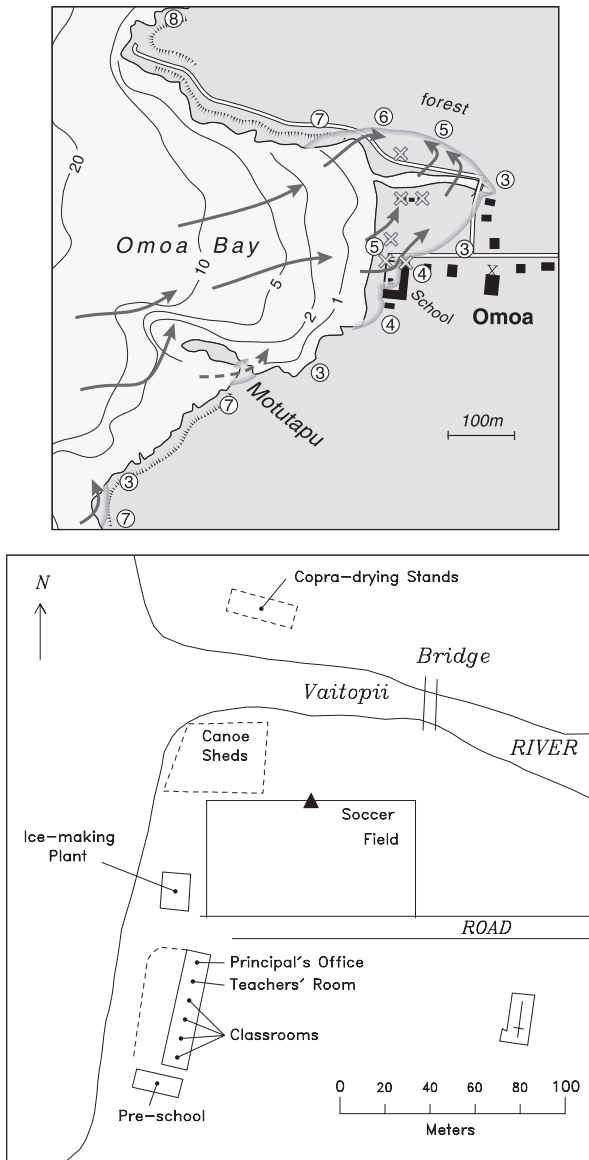
FIG. 2. – *Top* : Map of inundation around Omoa Bay. Circled numbers are runup amplitudes in meters, the thick line is the limit of penetration of the waves, and the arrows sketch the deflection of the waves by Motutapu. Crosses identify damaged or destroyed structures. Bathymetric contours in Omoa Bay are in meters. *Bottom* : Close-up map of the beach front of the village of Omoa. Dashed lines identify structures destroyed beyond repair. The school complex is detailed at lower left, including the destroyed wall around the school yard (dashed). The solid triangle shows the location where the compressor unit from the ice-making plant was deposited.

The most critical damage inflicted by the waves was at the local elementary school, located at the southern end of the waterfront (fig. 2). The school is built on a slight incline rising southward. The first wave totally destroyed the wall surrounding the school's playground, built of reinforced concrete; some of its blocks were carried a distance of 10 m, and rammed the doors to the principal's office at the northern and lower end of the building (fig. 3), which was then flooded and damaged. The school principal, wading waist-deep through the water, ordered the evacuation of the classrooms through the inland-facing back windows before the arrival of the second wave, a few minutes later. The teachers' room was also flooded and heavily damaged, with an estimated 20 cm of sand deposited on its floor. The classrooms, located progressively further south and at slightly higher elevations, were also flooded, but with less damage.

In addition to the school, the ice-making plant (fig. 2) was also severely damaged. While the concrete walls were left standing, the aluminum roof was carried away, and the refrigerating compressor unit was transported to the northern edge of the soccer field, a distance of approximately 60 m. Wooden sheds used to store pirogues (outrigger canoes), located between the soccer field and the Vaitopii river, were destroyed. Twelve pirogues were carried across the river and their wreckage left in the forest on the northern side. A copra-drying stand was also destroyed.

A map of inundation (fig. 2) was compiled, using standard surveying techniques, and based on the recognition of water marks and testimony by witnesses. The methods used follow the experience gained during several post-tsunami surveys [Tsuji *et al.*, 1995; Synolakis *et al.*, 1998]. The runup

height was measured at 4 m at the school, 5 m at the ice-making plant, 5 to 7 m on the northern shore of the river, and up to 8 m immediately north of the launching dock at Pointe Matahumu. South of Omoa Bay, the runup reached 7 m along the elevated shoreline, but only 3 m between the school and Motutapu, an outgrowth of basalt reaching 10 m altitude and protruding 120 m into the sea (220 m at a depth of 10 m below sea level). We attribute the pattern of runup heights, and in particular the lower values on the southern half of the bay, to the presence of Motutapu, which barred the direct progression of the wave, in particular sheltering the school from a more severe attack. A further measurement (7 m) was taken at Tahaoa beach.

The extent of inundation was further documented by fine-grained coral sand deposits at the river bridge (fig. 2), at a distance of 130 m from the shore, and at an altitude of 3 m. According to residents of a nearby house, this corresponded to the limit of onland inundation; as observed universally in other tsunami scenarios, waves penetrate substantially farther inland along river beds.

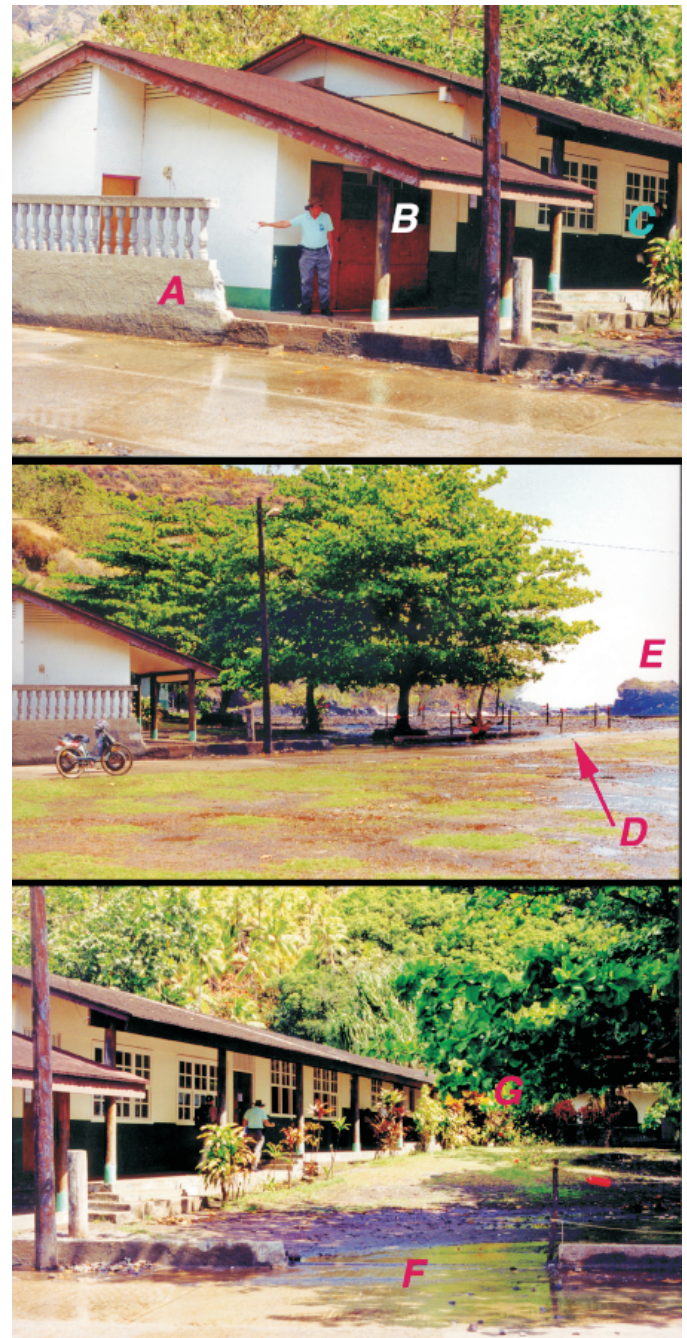
FIG. 3. – The damaged school at Omoa, photographed on 4 October 1999. *Top* (looking SSE) : The wall (A) has been totally destroyed around the playground. The principal's office and teachers' room (B) have been damaged and are now boarded up. Classrooms located at slightly higher elevations (C) were merely flooded. *Center* (looking SW) : The wall (A) used to extend all around the yard (to point D), and has been destroyed. Note the Motutapu promontory in the distance (E), which provided some protection to the southern part of the bay. *Bottom* (looking south) : (F) shows the location of the entrance gate through the wall. Note the slight incline to the south which lessened the impact of the waves on the more distant classrooms, and especially on the pre-school building (G; hidden behind shrubbery).

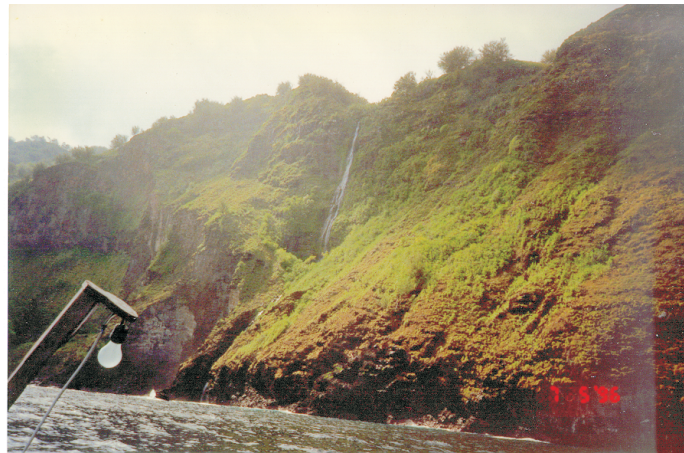
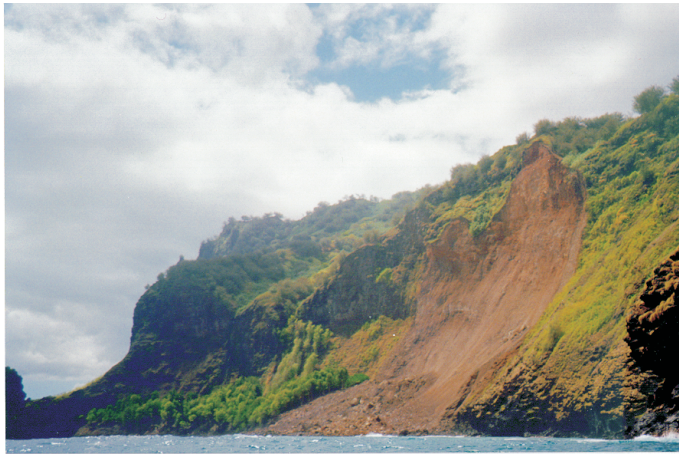
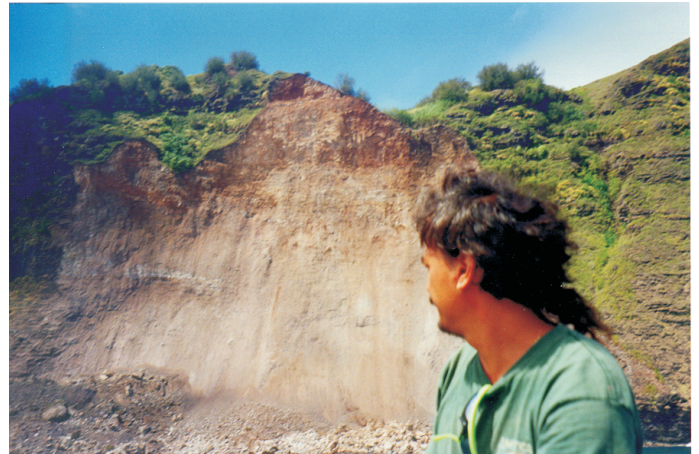
FIG. 4. – Before and after views of the Vaifaite cliff area. The slide is estimated to be 300 m in width and 250 to 300 m high.  
 FIG. 4. – *La falaise de Vaifaite, photographiée avant et après l'éboulement, dont les dimensions sont estimées à 300 m (largeur) et 250-300 m (hauteur).*

We established the origin of the local tsunami as the collapse, in a major subaerial rockslide, of a section of volcanic cliff, approximately 3 km south of Omoa (4.5 km along the coast). Figure 4 shows the Vaifaite cliff, as photographed from a speed boat on 5 October 1999. We were fortunate to be offered a photograph taken by a resident of Omoa at the exact same spot in 1996, which allows a “before-and-after” comparison of the landscape on figure 4. On this basis, we calculated the volume of the slide at between 2 and 5 million m<sup>3</sup>. We estimate that about 60 % of the material entered the sea, displacing a volume of water of about 1 to 3 million m<sup>3</sup>.

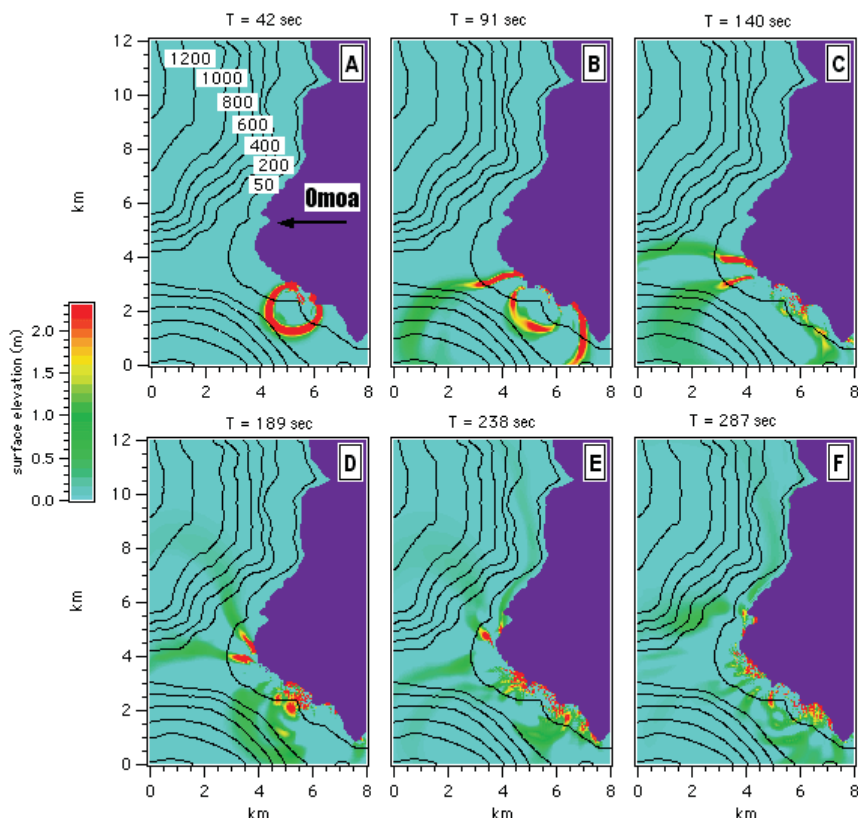
FIG. 5. – Snapshots of the simulated surface of the ocean at selected times following the onset of the wave. Bathymetric contours on frame A are in meters. Only positive wave heights are shown. Note the general confinement of large amplitudes to the shallowest portions of the ocean, and the refraction of the waves around the westernmost tip of the island (frames (C) and (D)), which flings their energy towards Omoa Bay, their amplitude is about 2 meters.

Figure 5 simulates the propagation of the wave on the southern coast for approximately 5 minutes following the slide. The particular timing of the selected snapshots was chosen to illustrate the fundamental features of the simulation. Frames A-C show that this source generates two major waves, separated by approximately 50 seconds. This is in agreement with eyewitness testimonies describing two (and only two) waves. Perhaps the most crucial aspect of the propagation of the tsunami is illustrated on frame D. While to the southeast of the source area, the waves quickly die off, those propagating northwest are strongly refracted around the western tip of the island by the underwater ridge which prolongs, at depths as shallow as 100 m, the main watershed in the south of the island, both features being remnants of the rim of the ancient caldera. On frame E, the

first wave penetrates Omoa Bay, followed about 50 s later by the second wave (frame F).

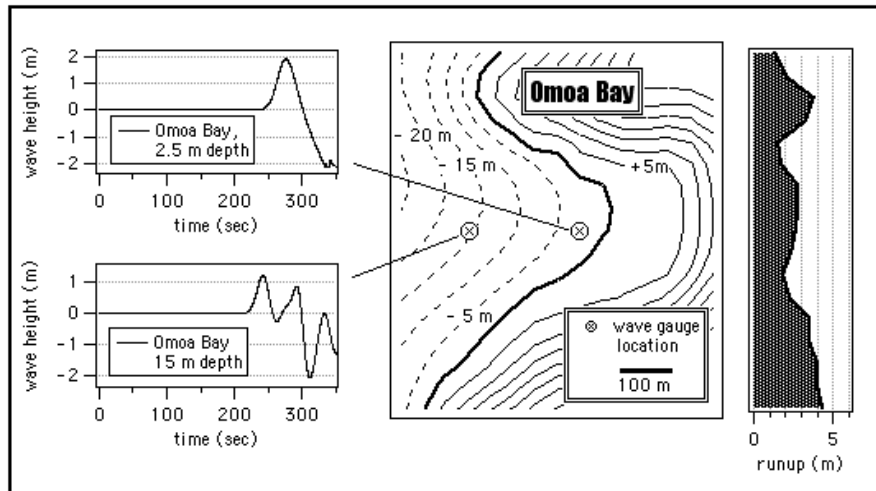
FIG. 6. – *Left* : Time series resulting from the simulation at two virtual gauges located in the center of Omoa Bay, along isobaths 2.5 m (top) and 15 m (bottom). *Center* : Close-up of the bathymetric model of Omoa Bay used in the simulation. *Right* : Profile of maximum runup obtained along the shoreline in Omoa Bay. Note an amplitude on the order of 3 meters in the center of Omoa Bay.

On figure 6, we give two time series of simulated gauges in Omoa Bay, located respectively above isobaths 2.5 and 15 m, as well as a runup profile taken at the shoreline, indicating an amplitude approaching 3 m at the center of Omoa Bay, directly in front of the ice-making plant (see fig. 2). These numbers provide an excellent order of magnitude for the runup values measured at the school (4 m) and at the ice-making plant (5 m), the difference being possibly attributable to the interaction of the wave with built-up structures such as the front wall of the ice house. Other, smaller dimensions of the source bulge were also tested, but they produced runup heights not exceeding 1 m at Omoa.
