# Experimental Analysis of Original and Strengthened Traditional Timber Connections

## Summary

Tests on full-scale unstrengthened connections were performed under monotonic and cyclic loading. Attention has been principally focused on the birdsmouth joint, because of its common use in practice. Different strengthening solutions with metal elements have been evaluated.

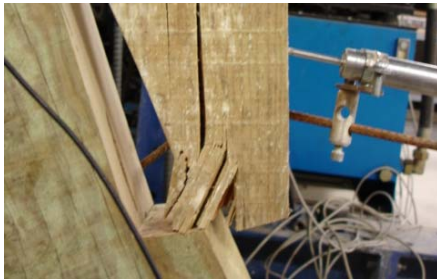
*Fig 7 Damages in the joints observed in the cyclic tests for 2.5 MPa rafter compression stress level*

In Figure 7, the failure modes show compression damages in the joints and the development of a shear failure surface in front of the joint itself.

*(a) Compression damage in A7*

*(b) Shear failure in A9*

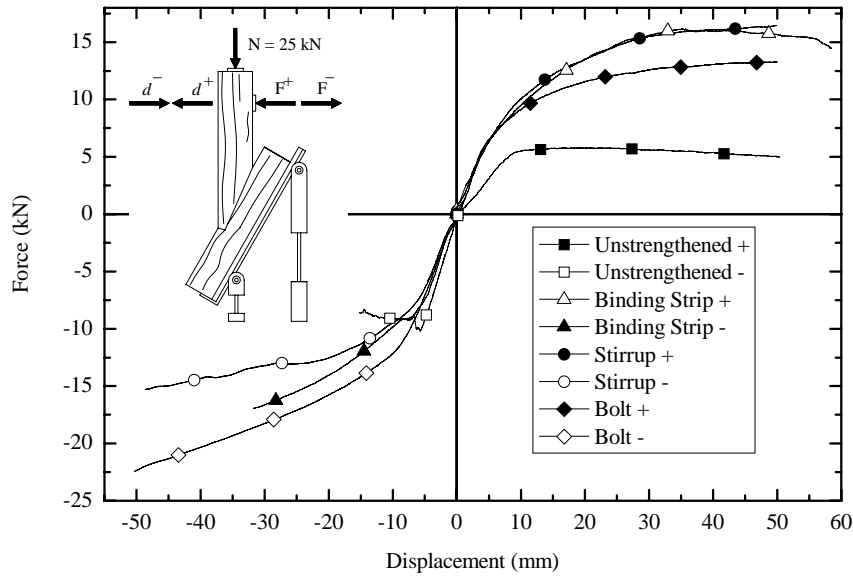
Comparing the tests results in terms of force-displacement curves for the unstrengthened and strengthened connections (Figure 8), it is recognized that all the strengthening schemes analysed increase the stiffness, in particular, in the positive direction and the maximum resistance for both directions. The elasto-plastic behaviour with limited ductility evidenced by the unstrengthened connections is substituted by full non-linear curves exhibiting high ductility in the strengthened connections. Comparing the strengthening techniques evaluated, the less efficient, in terms of maximum resistance, is the internal bolt, while the elastic stiffness are similar. Connections strengthened with stirrups and binding strip attained the same range of maximum force, however, this last scheme has a lower ductility capacity. In particular, the maximum resistance for the strengthened connections with stirrups and internal bolt is achieved near the end of the test. However, in the strengthened connections with binding strip, when the tests were interrupted, the force value was already decreased. Therefore, between the internal bolt and the binding strip, the first one is more efficient in terms of ductility capacity with the goal to assure a better seismic behaviour of the joints. The effect of the strengthening schemes in the negative directions of the monotonic tests is quite obvious: the maximum resistance and the ductility capacity increase. The benefits in terms of stiffness are not so significant. However, the brittle behaviour exhibited by unstrengthened connections disappears in the strengthened specimens. Therefore, the main profit of adding a metal device to the joints is the improvement of ductility with clear advantages in their seismic behaviour. Only the binding strip showed limitations in terms of maximum displacement.

Fig 8 Force-displacement diagrams for unstrengthened and strengthened connections under monotonic loading

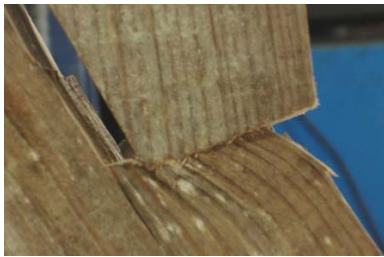
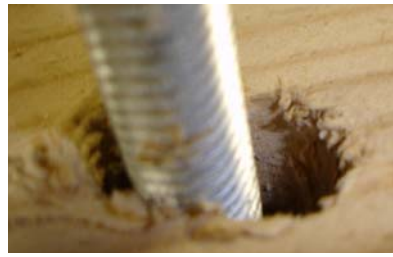
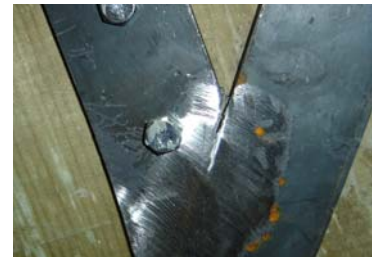
Fig 9 Failure modes and damages detected during the cyclic tests on the strengthened connections

Figure 9 shows the common failure modes and principal damages detected in the cyclic tests on the strengthened connections. Table 3 summarises the main results of the cyclic tests on the strengthened joints.

(a) Compression in the joint with the binding strip

(b) Bending of the bolt with local embedment

(c) Stirrup failure
