Review

Biodiversity of cyanobacteria and green algae on monuments in the Mediterranean Basin: an overview

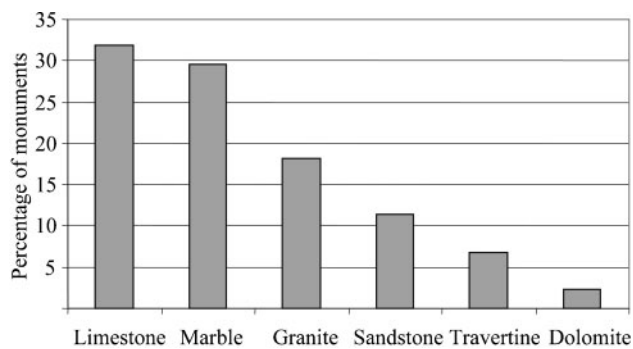
Fig. 2. Percentage of lithotypes present in the monuments, statues and historic buildings reported in this study.

Table 1 lists the monuments, statues and historic buildings reported in the literature covered in this review. Most of these works of art were built in limestone (32%) and marble (30%). Travertine (7%) and dolomite (2%) were less represented lithotypes (Fig. 2).

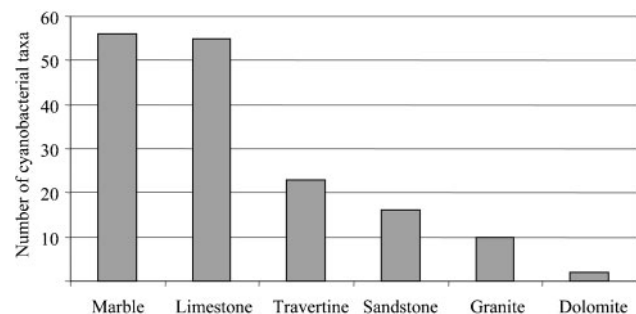
Fig. 4. Number of cyanobacterial taxa found on each lithotype.

Fig. 4 shows the number of cyanobacterial taxa present on each lithotype. According to the literature reviewed in this study, marble and limestone were colonized by about the same number of taxa (56 and 55, respectively). Travertine was a lithotype present only in 7% of the monuments reported but it was colonized by a considerable number of taxa (23). Granite was colonized by a very low number of different taxa (only 10) when compared with limestone or marble. According to Ortega-Calvo *et al.* (1995), granite, with a very low porosity and pH, is an unfavourable substratum for cyanobacteria. In fact, the colonization of stones is closely correlated with porosity, roughness, hygroscopicity and capillary water absorption, which strongly influence water availability for micro-organisms (Urzi & Realini, 1998; Prieto & Silva, 2005; Miller *et al.*, 2006).

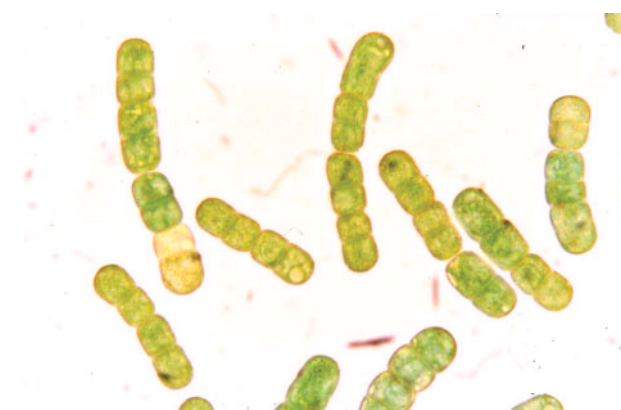
Fig. 6. Light micrograph of trichomes of *Borzia perikleii*, composed of 4–8 cells. Cells are 5–6 μ m wide and 5–11 μ m long.

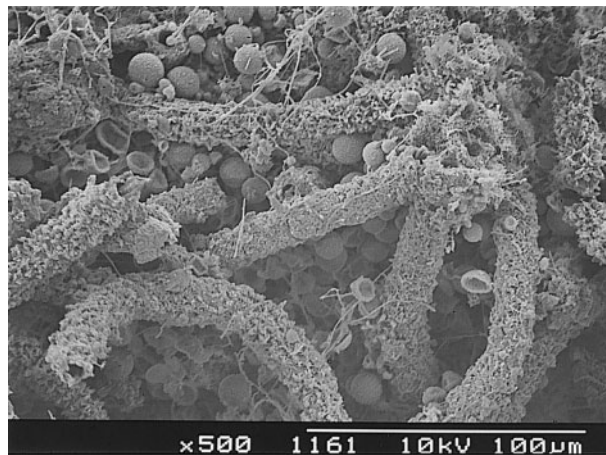
Fig. 10. SEM micrograph of *Scytonema julianum* mat. The calcified sheaths are composed of triradial calcite crystals. Scale bar, 100 µm. Reproduced from Ortega-Calvo *et al.* (1995) with permission.
