## Influence of Openings, With and Without Confinement, on Cyclic Response of Infilled R-C Frames — An Experimental Study

V. Sigmund & D. Penava

Faculty of Civil Engineering Osijek, Josip Juraj Strossmayer University of Osijek, Osijek, Croatia

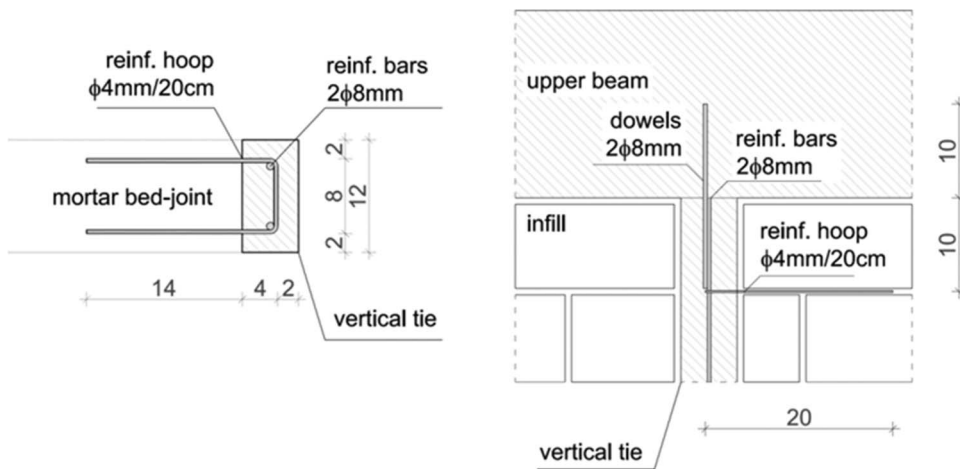
FIGURE 2 Tie-reinforcement details in the cross-section (left) and in elevation (right).

Vertical ties were reinforced with two longitudinal reinforcement bars, each of  $\phi 8$  mm. These were anchored into the beams by dowels nailed 10 cm into previously drilled holes. Dowel stirrups,  $\phi 4$  mm, were anchored into every second horizontal mortar joint. Reinforcing details are presented in Fig. 2. The lintel above the opening was reinforced by four longitudinal bars of  $\phi 6$  mm with stirrups of  $\phi 6$  mm placed at intervals of 9 cm.

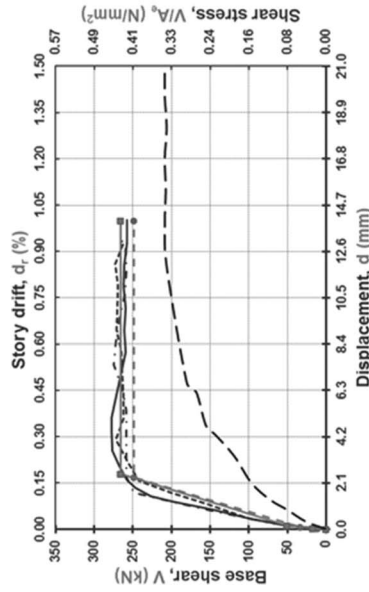
**FIGURE 15** Measured and analytically estimated primary curves (weaker side).

After the ultimate resistance, the envelope extends horizontally up to drifts when the infill collapsed (1.0%). Calculated results are presented in Fig. 15 for the cases with (AWO) and without opening (AWOO), along with the measured primary curves. Differences
