LEVEL II HYDROGEOLOGIC CHARACTERIZATION REPORT:

Apple Creek near Belltown Greene County, IL (US 67, FAP 310)

February 4, 2004

**Illinois State Geological Survey
Open File Series 2004-5**

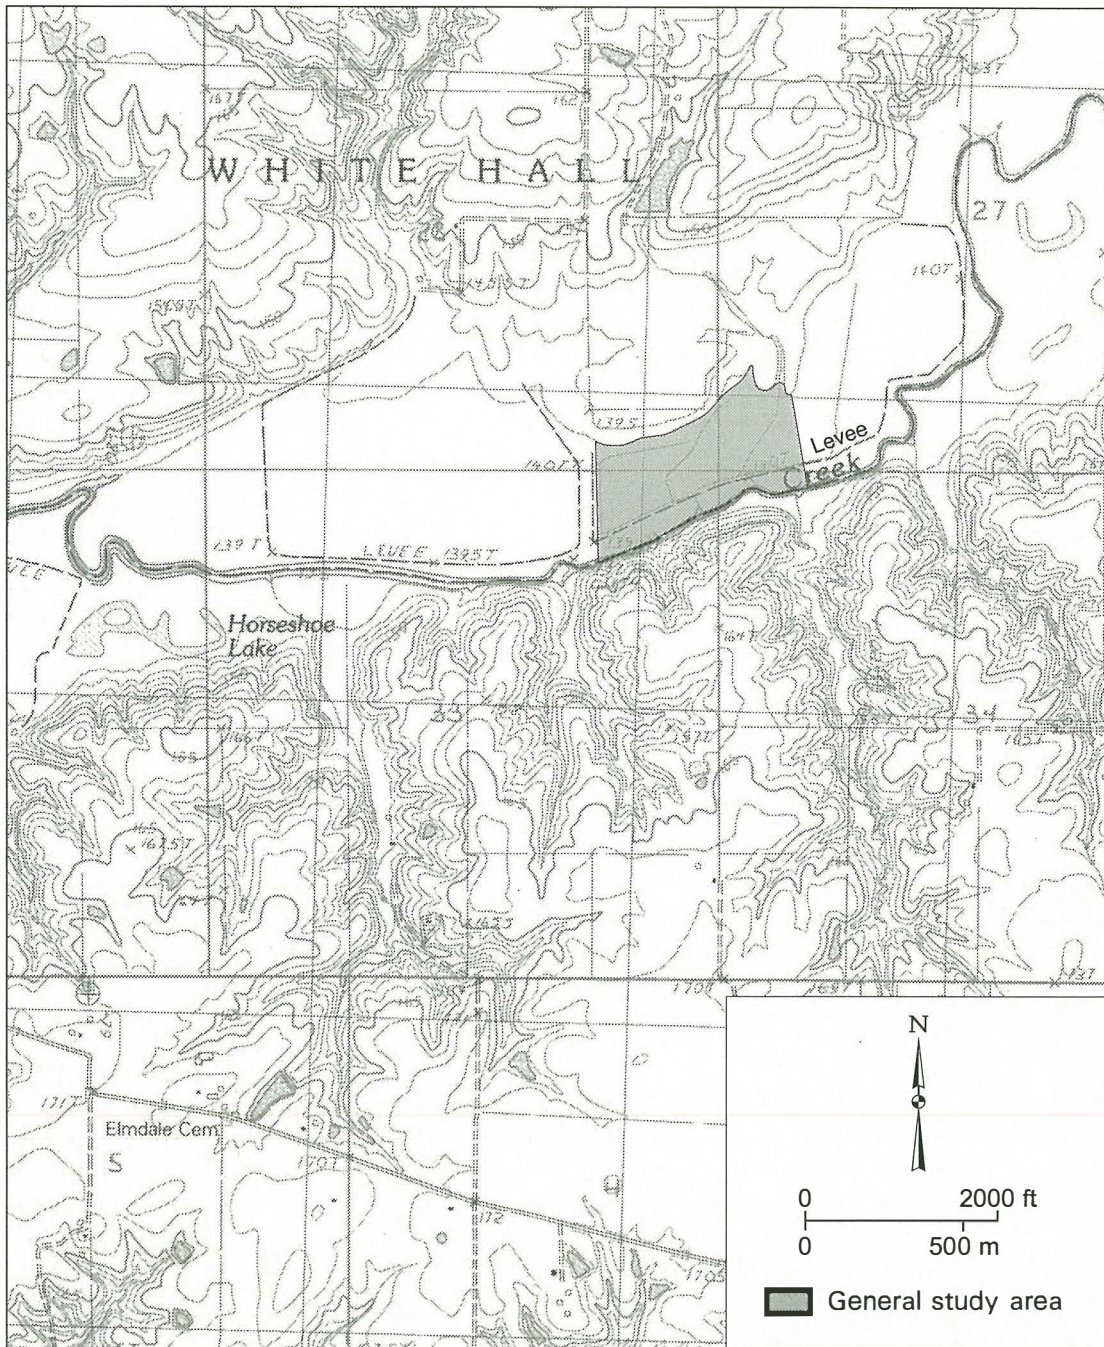
Figure 1. Location of the wetland compensation site (shaded grey) (U.S. Geological Survey 1983).

The potential compensation site is located at the intersection of sections 27, 28, 33 and 34, T11N, R12W, in Greene County, Illinois (Figures 1 & 2). It covers a 21 ha (52 ac), roughly rectangular area on the north bank of Apple Creek, roughly 3.2 km (2 mi) southwest of Belltown, Illinois.

The site is on the north bank of Apple Creek (Figure 1). Most of the site is a farm field protected as part of a large leveed area, but also includes a small portion of floodplain forest not protected by the levee. The levee system includes additional farm fields to the east and connects to the uplands at both ends.

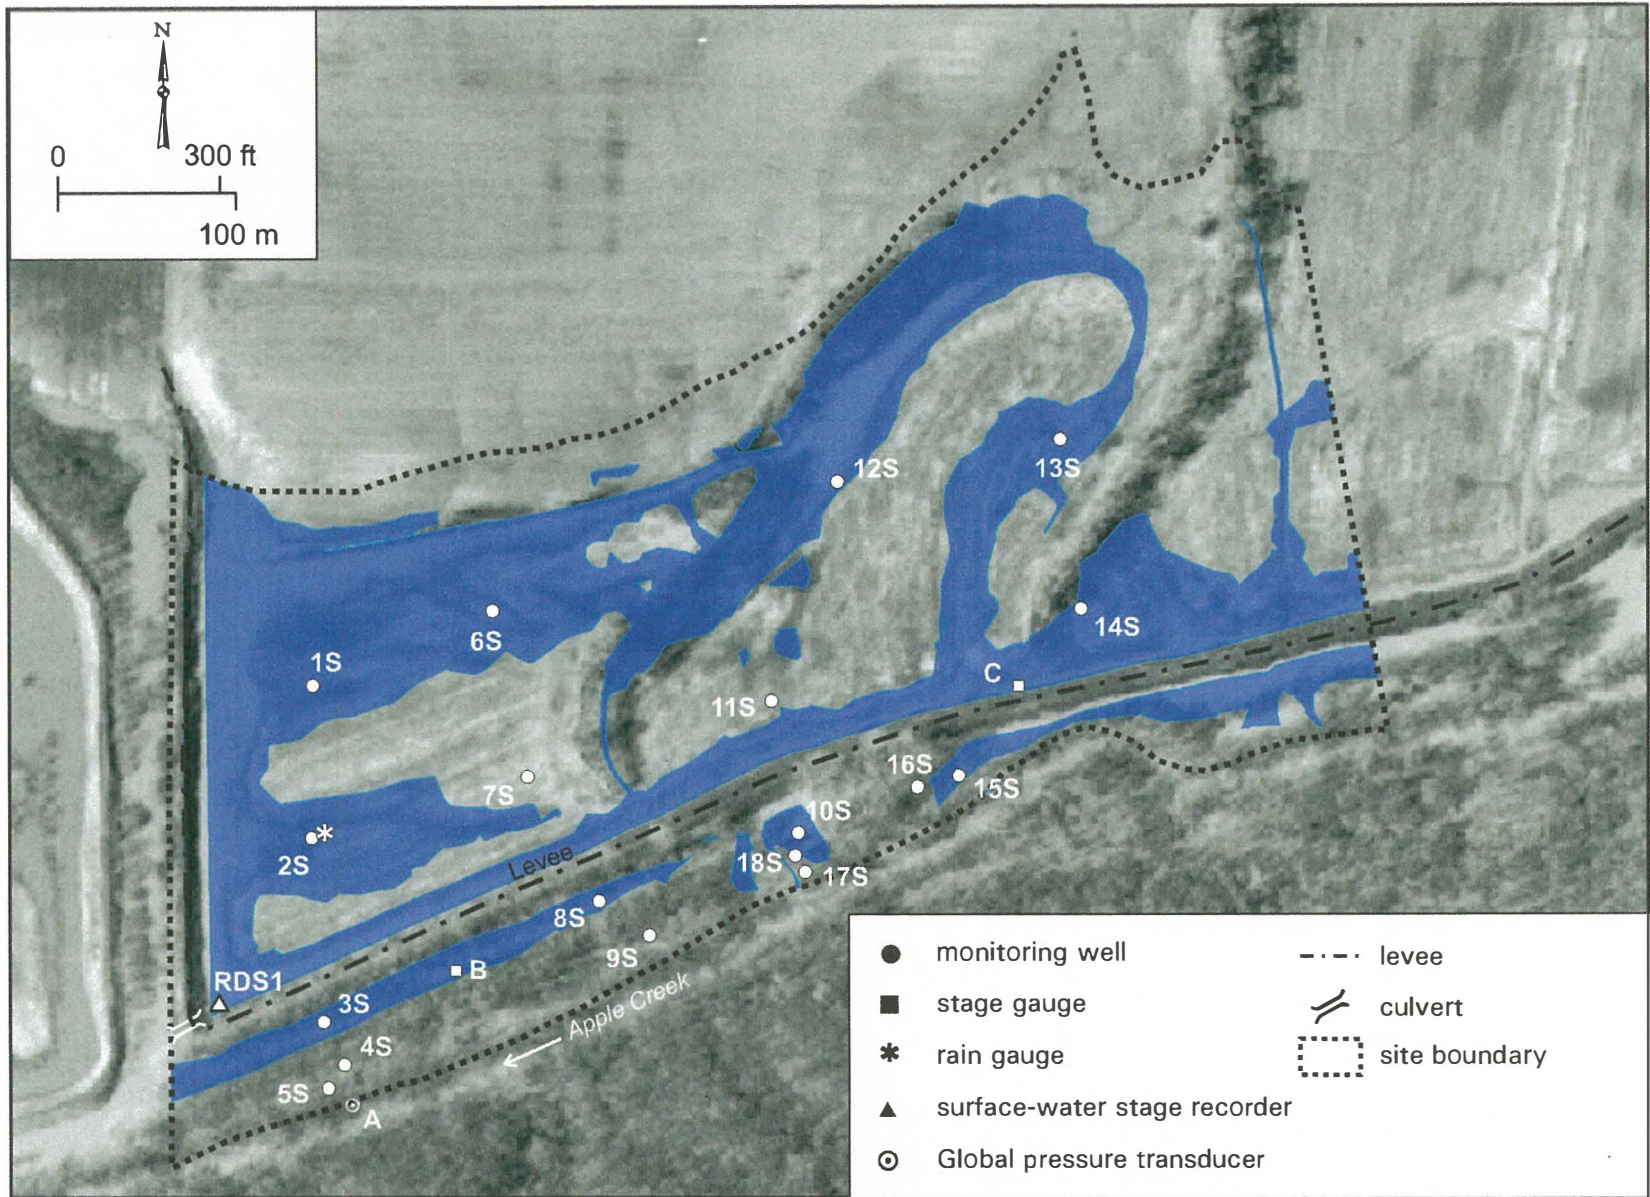
- Hydrologic monitoring determined that 10 of 18 wells, 8.8 ha (21.7 ac), or 42% of the site, conclusively satisfied the criteria for wetland hydrology in 2003 (Figure 3, Illinois State Geological Survey 2003). While the entire 21 ha (52 ac) site conclusively satisfied the criteria for wetland hydrology in 2002 as a result of widespread flooding (Illinois State Geological Survey 2002), it was a direct result of an extreme rainfall event in the spring of that year. In addition, most of the area south of the levee and portions of the drainage system north of the levee are already classified as NWI-mapped wetlands (Figure 4).

While Apple Creek also flooded in 2003, it did not reach an elevation sufficient to overtop the levee. Despite this lack of flooding, water levels in ten wells met wetland hydrology criteria due to the accumulation of runoff behind the levee or in localized depressions, over a total area of 8.8 ha (21.7 ac) (Figure 3). The extent of wetland hydrology was determined using water levels measured during the longest period of sustained high water levels in 2003. Surface-water levels that were recorded on May 5, 2003 were combined with land-surface data and used to mathematically contour the area that met wetland hydrology criteria, using the SURFER™ computer program. Manual interpretations of water levels in wells agreed with this interpretation, finding that all wells located within the polygon shown in Figure 3 met wetland hydrology criteria (Environmental Laboratory 1987), and all wells outside the polygon did not meet the criteria. Manual interpretations are based on multiple springtime measurements.

While the majority [7.8 ha (19.2 ac)] of the area that exhibited wetland hydrology in 2003 was located north of the levee, it is only roughly half of the total area of the 16.6 ha (41.0 ac) farm field. In order to restore wetland hydrology to the remaining portion of the farm field in years with average precipitation, alterations to the site are required.

Only a small portion, 1.0 ha (2.5 ac), of the area exhibiting wetland hydrology is located within the floodplain forest. Only four out of ten wells in the forest conclusively satisfied the criteria for jurisdictional wetland hydrology, and only two additional wells displayed wetland hydrology for periods between 5 and 12.5% of the growing season. The remaining forest wells did not display wetland hydrology at all. It is therefore possible that on this site, areas that demonstrate wetland hydrology for less than 12.5% of the growing season may exhibit characteristics of jurisdictional wetlands, or that much of the floodplain forest does not conclusively meet wetland hydrology criteria under the current flooding regime. No alterations to the floodplain forest are planned.

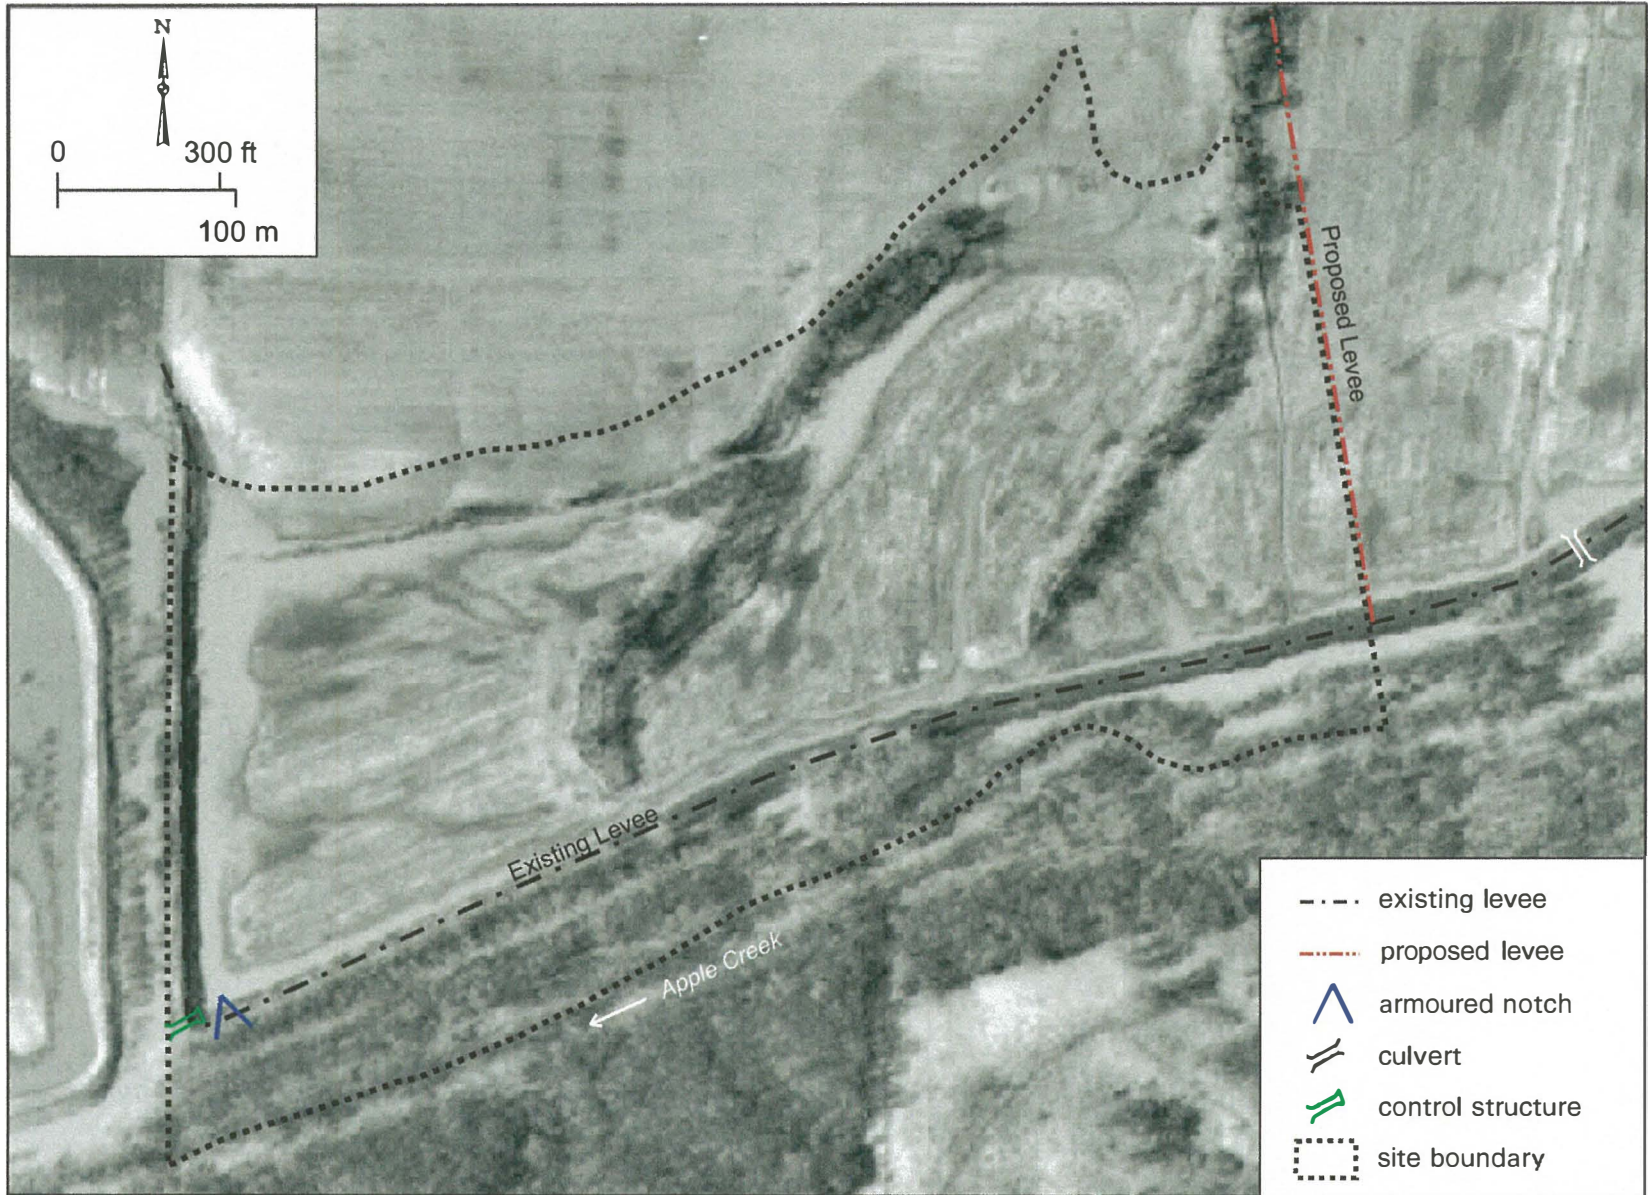
The following considerations and recommendations can be made regarding wetland compensation at this site (Figure 6). These were determined from two seasons of monitoring the water level in Apple Creek, so additional monitoring is recommended to confirm long-term conditions and refine recommended elevations.

- Wetland hydrology would be increased if a portion of the current levee is reduced in height to an elevation of approximately 137.8 m (452 ft). Creation of an armored notch in the levee near the southwest corner of the site would allow floodwaters into the site more frequently, perhaps annually, while retaining the water for a sufficient period of time to expand the area of wetland hydrology. Additional benefits would include sediment reduction in Apple Creek as well as floodwater storage, potentially reducing downstream flooding.

- The current outlet pipe should be modified to allow the control of water levels inside the levee. A gate valve or similar control measure could allow water to enter the site and not drain from it, when desired. In this fashion, the flow of water entering and exiting the site could be controlled based on conditions in Apple Creek and onsite.

- If the entire floodplain area currently protected by the levee is not purchased, a new levee will have to be constructed to protect the remaining farm fields to the east. The new levee will need to be similar in construction as the current levee and extend to the upland, while an outlet pipe from the unpurchased area to Apple Creek will also need to be installed. These structures will require regular maintenance, which may be costly. Therefore, obtaining the remainder of the leveed area to the east would likely be a more economical solution, and would provide additional mitigation acreage.

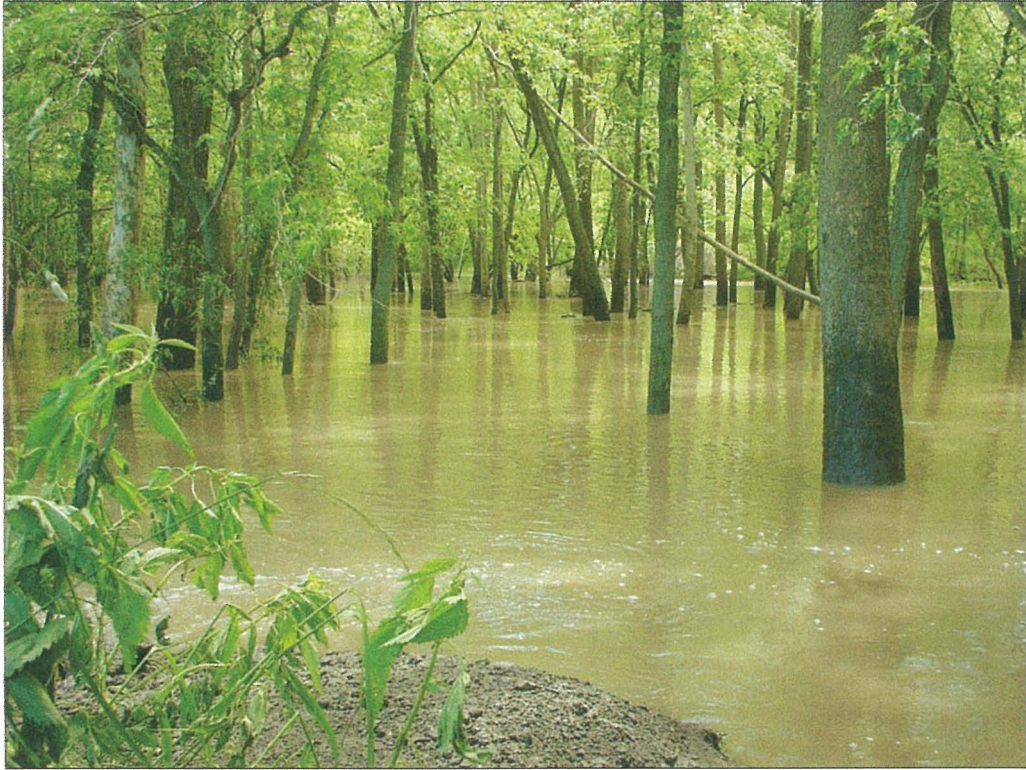
Photo 1. Flooding of the floodplain forest, looking south from the southwest corner of the levee (May 15, 2002).

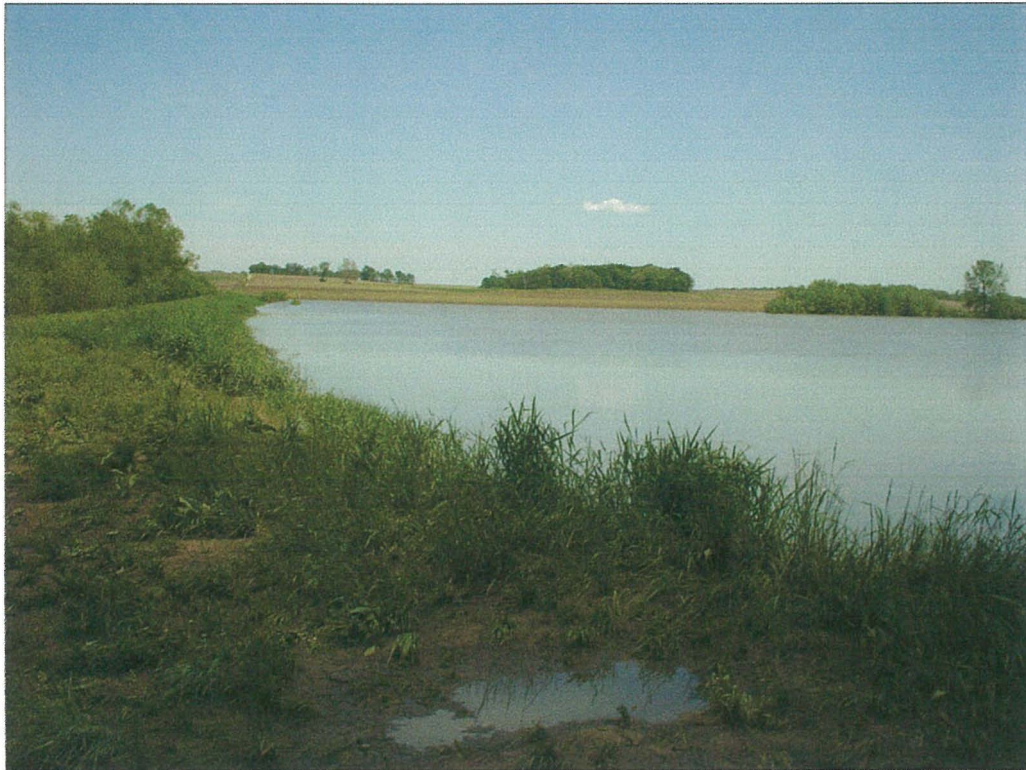
Photo 2. Flooding of the farm field, looking north from the southwest corner of the levee (May 15, 2002).
