# Remodeling and Expanding Carnegie-Era Library Buildings

FRED SCHLIPP

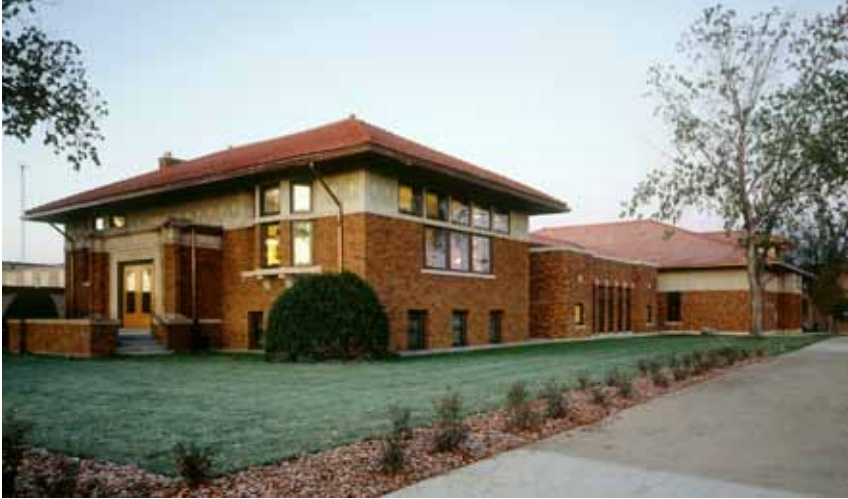
Figure 1. The Detroit Lakes, Minnesota, Public Library is one of a several libraries built using the same plans. It was expanded by MS&R (Meyer Scherer & Rockcastle), architects, Minneapolis, who designed an addition at grade level, making it possible for users to enter the building without using stairs or an elevator and improving exit control. Photograph by Lea Babcock Scherer courtesy of MS&R.

While most additions to Carnegie-era libraries match the floors of the original buildings, another approach is to build a grade-level addition adjacent to the library, with a new grade-level entrance in the new addition. This arrangement makes it possible to have a single service desk that controls all accessible access to the building. The resulting split-level structure may have open stairs leading from the new addition to the historic first floor (and to the basement, if codes permit), greatly reducing the isolation of these older floors in the expanded building (figs. 1 & 2).

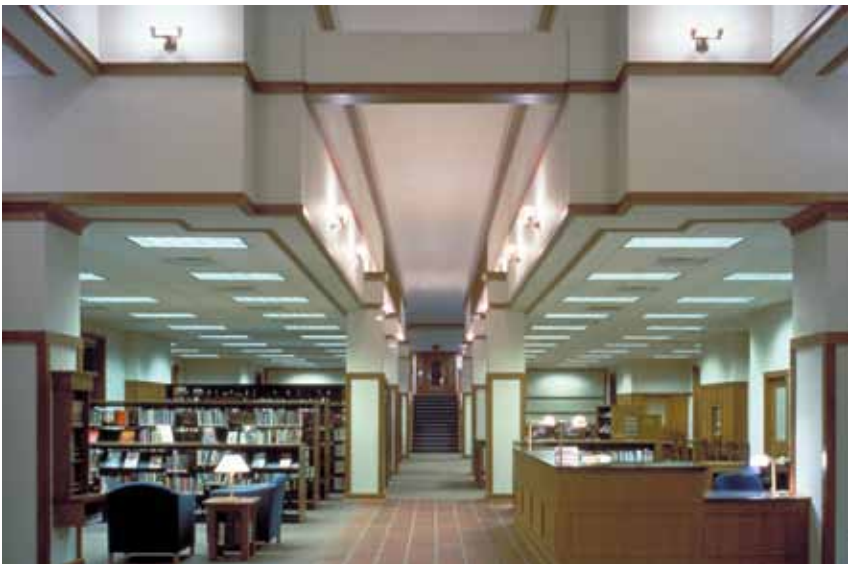
Figure 2. A view of the interior of the new addition to the Detroit lakes Public Library. Steps up to the original first floor are visible at the rear. The elevator and the steps to the basement cannot be seen from this angle. Photograph by Lea Babcock Scherer courtesy of MS&R.

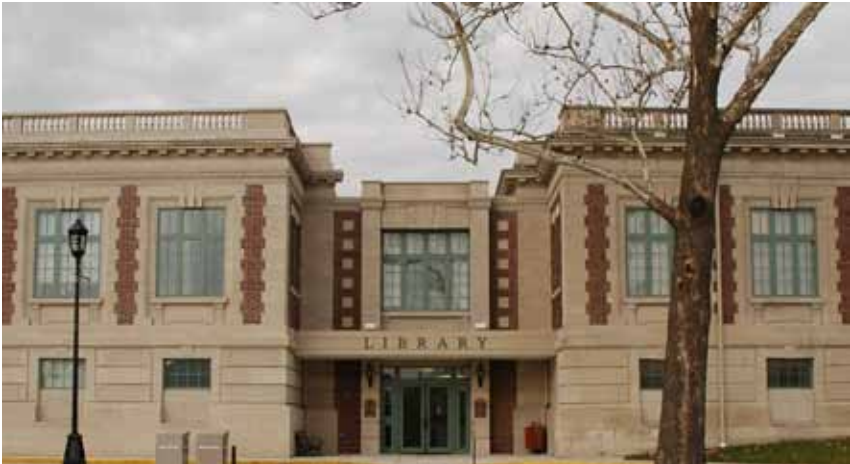
Figure 4. The brickwork of the new wing of the expanded LaSalle Public Library closely matches the building's original brickwork, but any difference is made less noticeable by separating the two areas of brickwork by the new, accessible entrance. The original building is on the right. Photograph courtesy of apaceDesign, architects and engineers, Peoria.

Matching exterior brickwork is a special problem, since many types of brick used a century ago are not easily available. For example, the slender Roman bricks with thin horizontal mortar joints that are sometimes found in late nineteenth and early twentieth century buildings are particularly hard to match. Taking the time to thoroughly investigate brick sources is important, and the rush to select brick quickly may lead to gross mismatching that grates on the eyes forever. One standard approach to satisfactory expansions of historic buildings is to never place new and old bricks directly adjacent to each other. If a new architectural element perhaps 10 to 20 feet wide separates the two areas of brick, it is much harder to tell that the two types of brick do not match (Fig. 4).
