Contract Report 2017-03

# **Continued Operation of a 25-Raingage Network for Collection, Reduction, and Analysis of Precipitation Data for Lake Michigan Diversion Accounting: Water Year 2016**

REPORT

U.S. Army Corps of Engineers, Chicago District

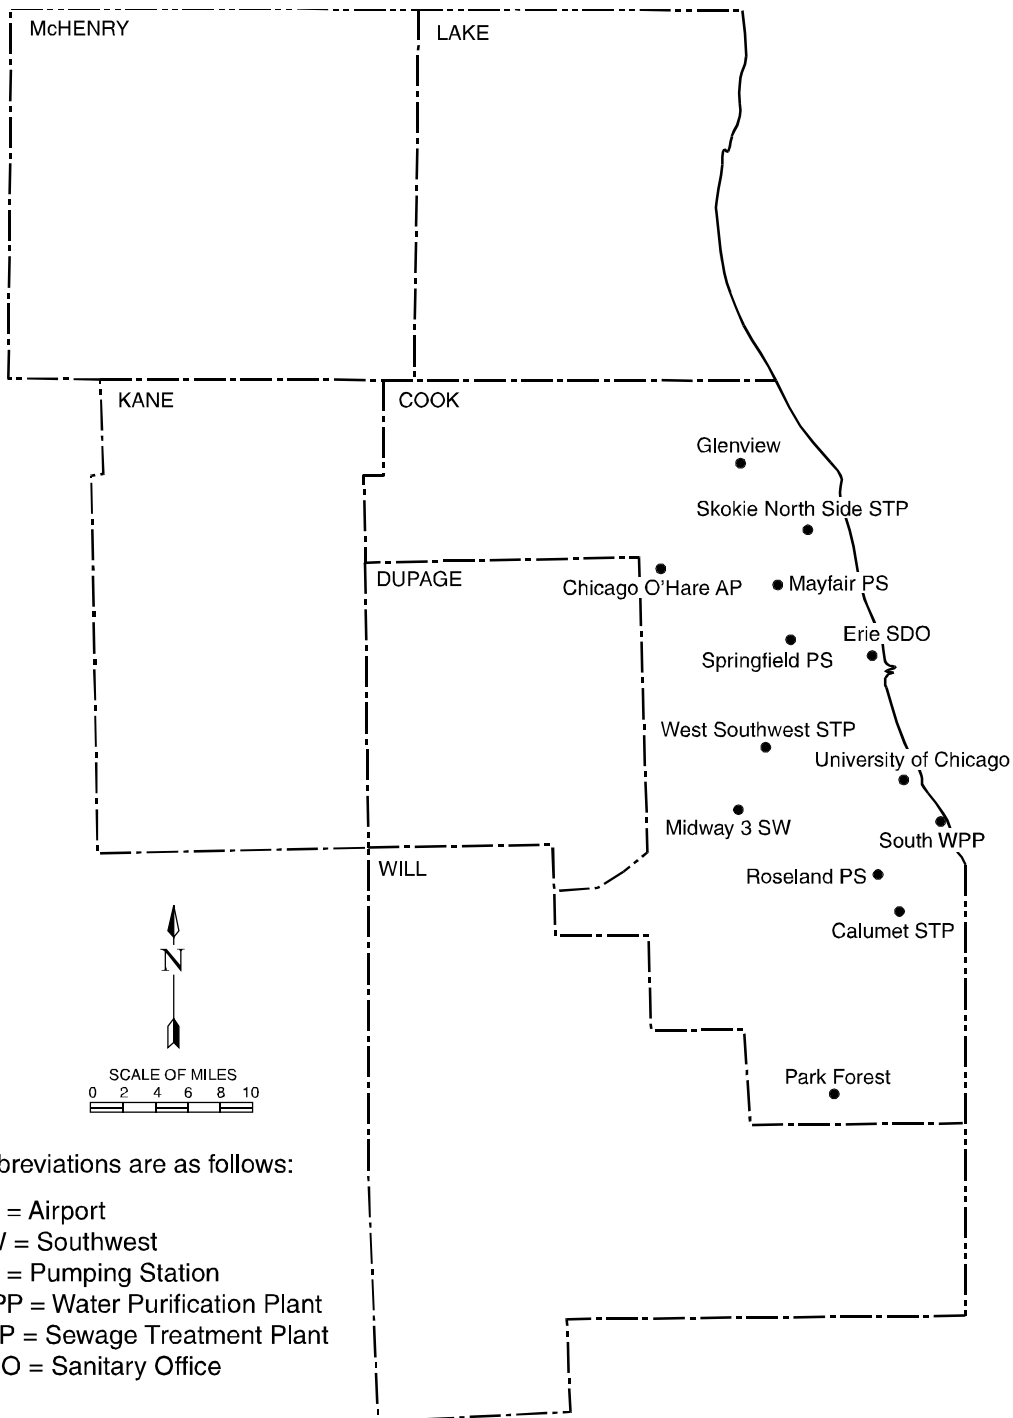
Figure 1. Raingage locations used for diversion accounting purposes prior to WY 1990. These include National Weather Service gages located at Chicago O'Hare AP, Midway 3 SW, University of Chicago, and Park Forest; City of Chicago gages located at Mayfair PS, Springfield PS, South WPP, and Roseland PS; and Metropolitan Water Reclamation District of Greater Chicago gages located at Glenview, Skokie North Side STP, Erie SDO, West Southwest STP, and Calumet STP.

The unusual patterns were caused by abnormally low precipitation totals at a select number of the 13 sites used by the accounting procedure (Figure 1). Inspection of these sites (Vogel, 1988), which are irregularly distributed over the region, revealed that low precipitation totals were caused by 1) inadequate gage exposure (e.g., gages situated on rooftops or too close to natural or artificial air flow-restricting obstructions) and 2) different observation, data reduction, and quality control practices used by the individual groups responsible for raingage operation and data collection (National Weather Service - NWS, Metropolitan Water Reclamation District of Greater Chicago - MWRDGC, and City of Chicago - CC). Vogel (1988) established that the unusual precipitation patterns began occurring in the late 1960s when some changes were made in data collection and reduction.

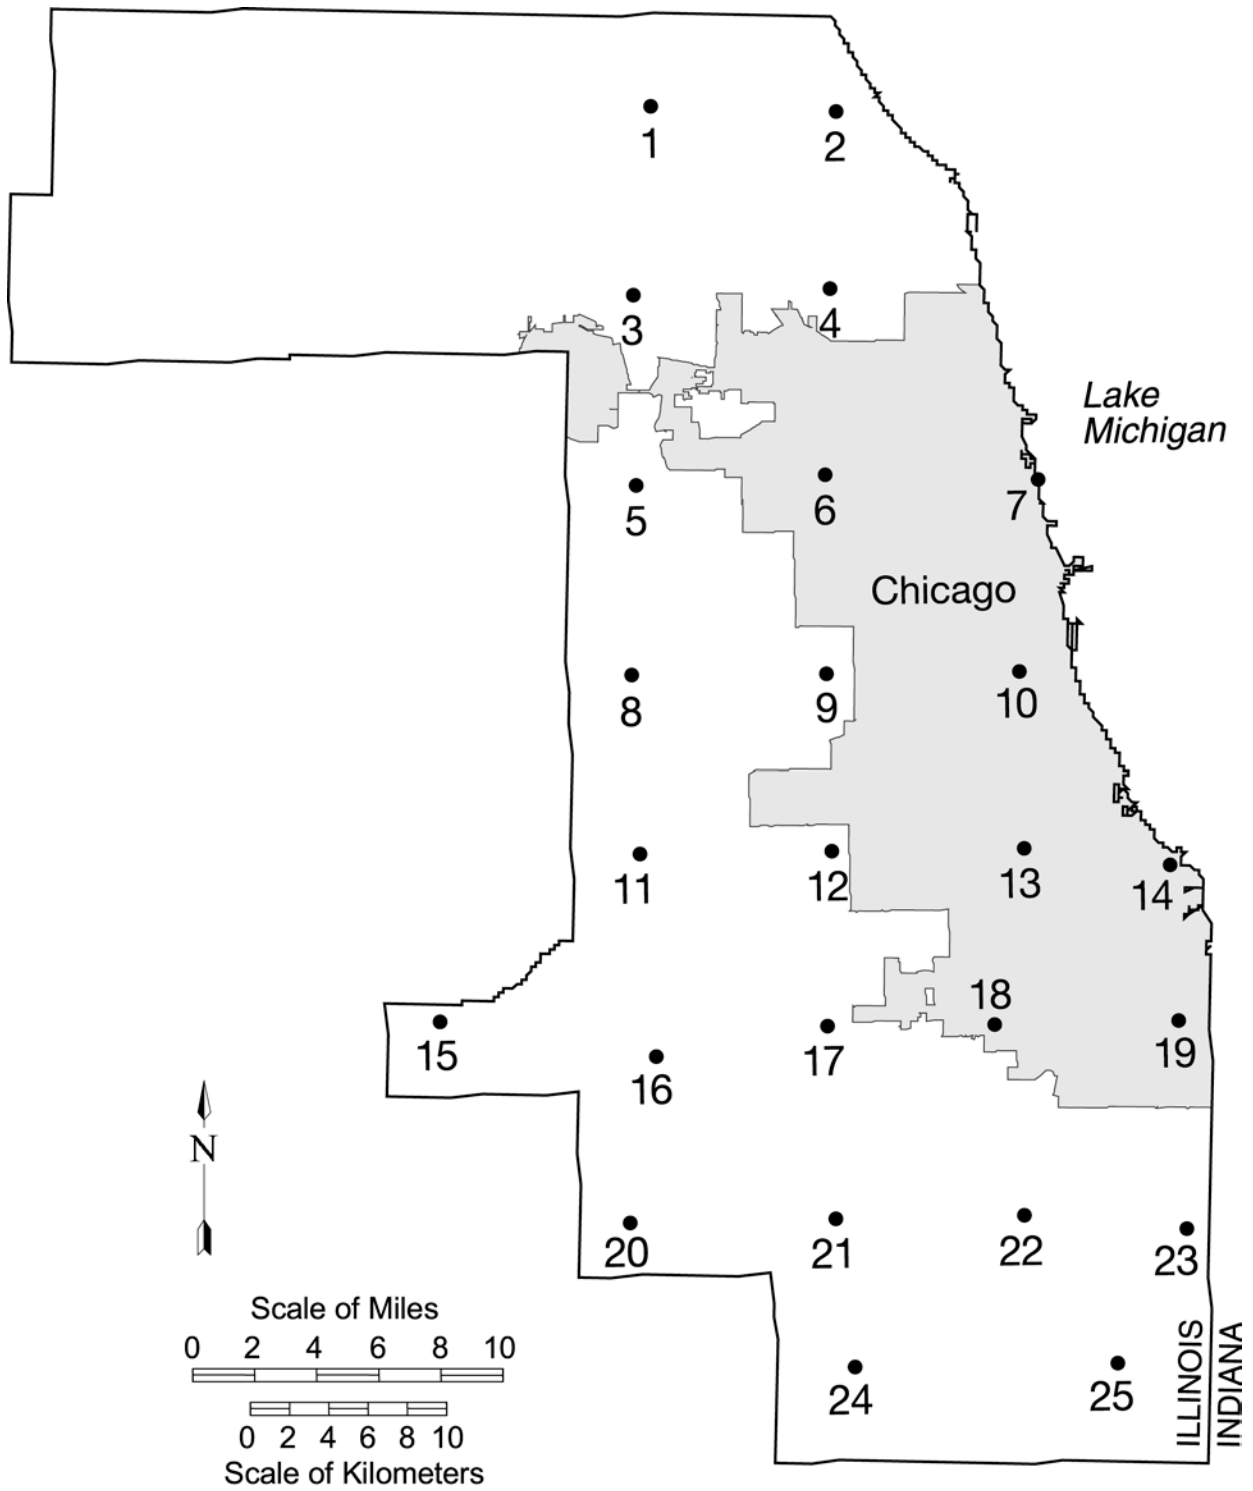
Figure 2. The Cook County 25-site raingage network for WYs 1990-2016. City of Chicago indicated by shading.

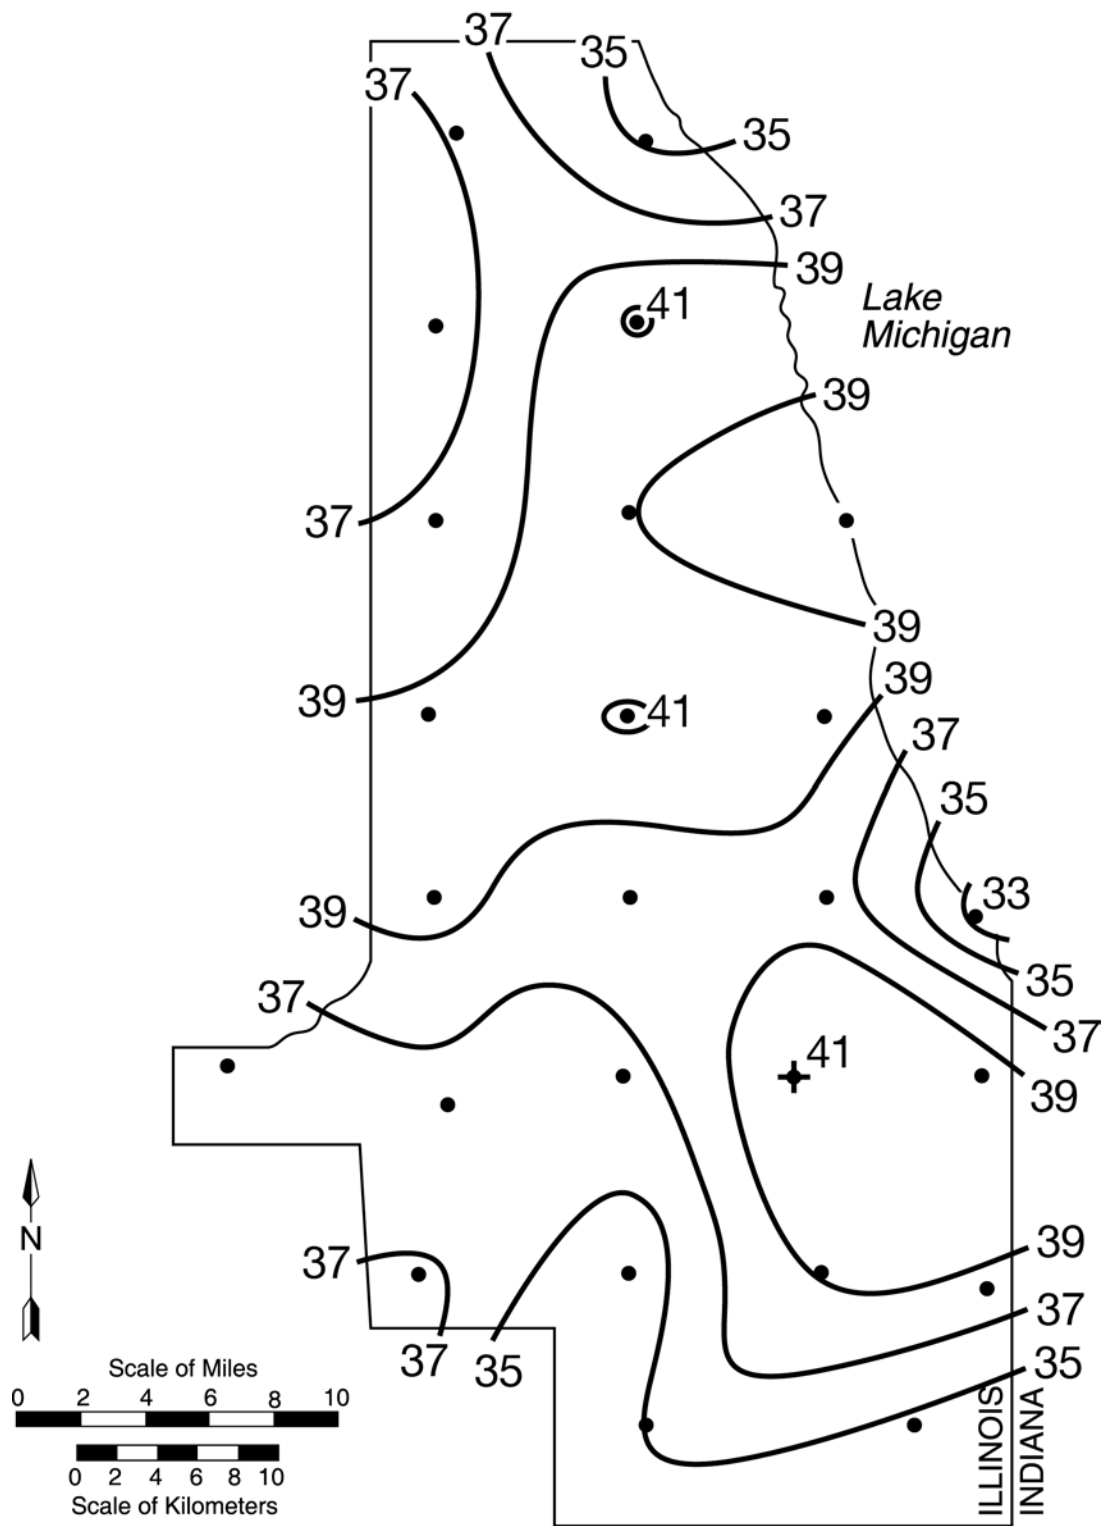
Figure 3. Precipitation pattern (inches) for WY 2016

The spatial pattern of annual precipitation for WY 2016 (Figure 3) does not contain the anomalies found in an analysis using sites operated by the MWRDGC, the NWS, and Cook County for WYs 1984–1989 (Vogel, 1988; Peppler, 1993b). Gradients of 15 to 20 inches were common in those analyses. Precipitation data from those sites were the input for diversion accounting before construction of the present network (Peppler, 1993b). For WY 2016, there was a 7.58-inch gradient between sites 14 and 19. Lower values may be due to storm location or siting issues. Site 14 is near Lake Michigan in a very windy location, but has an Alter shield to help reduce wind loss. These siting differences may accentuate actual precipitation gradients between nearby gages.

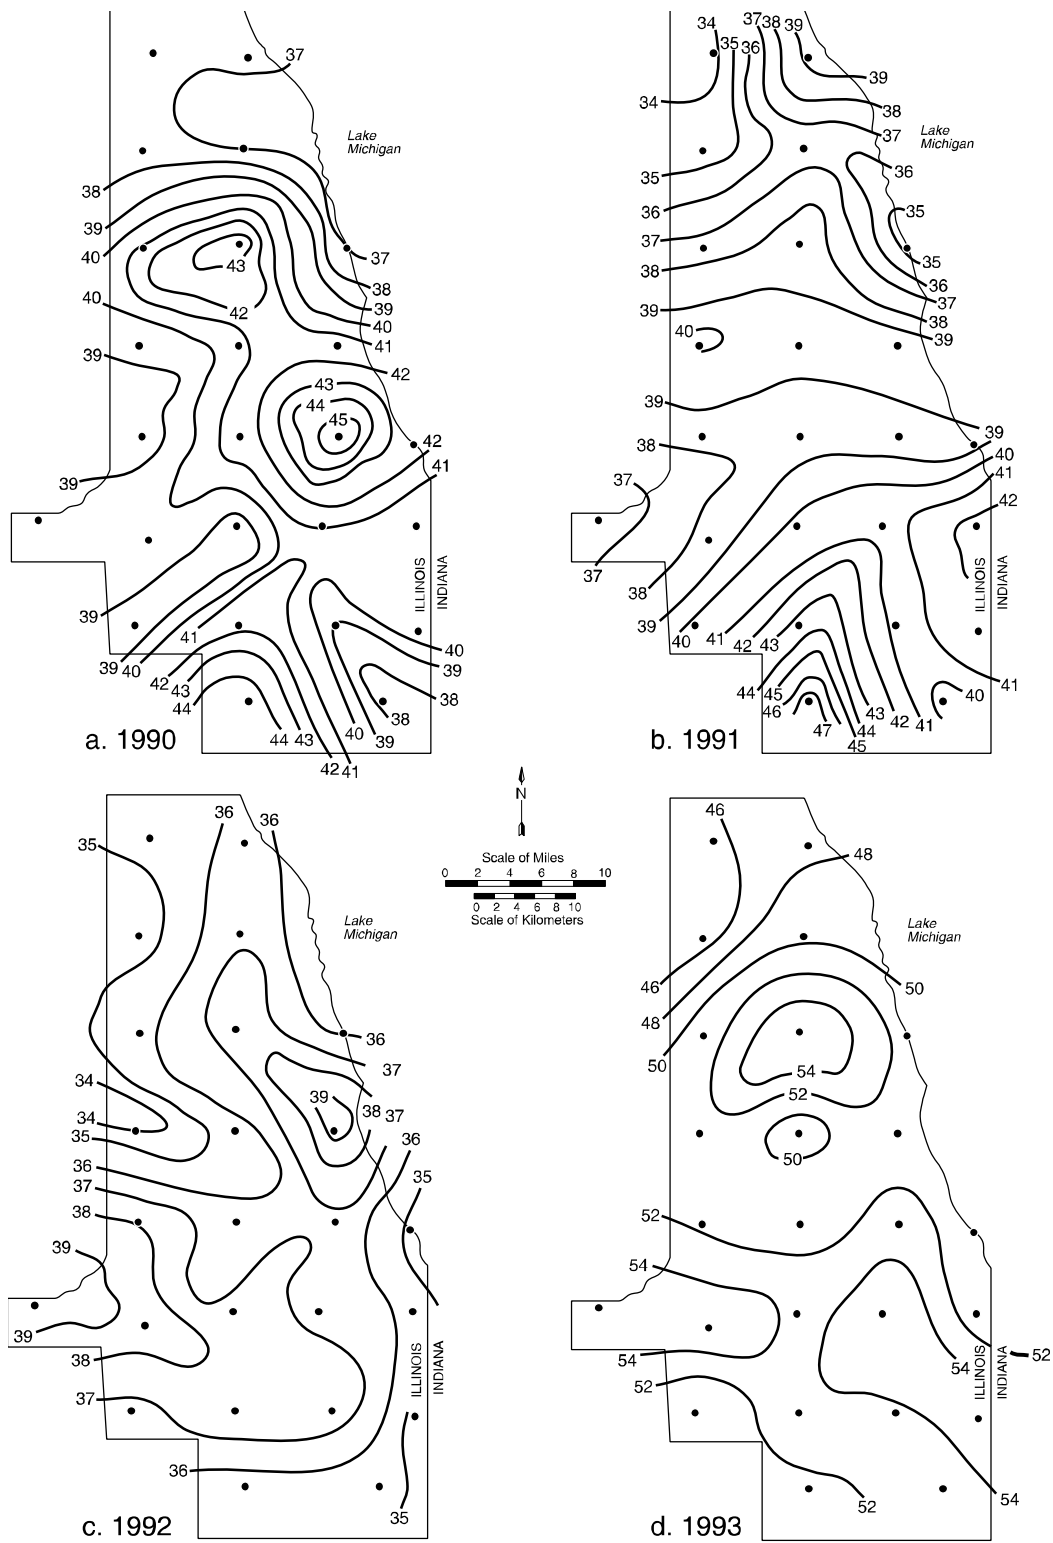
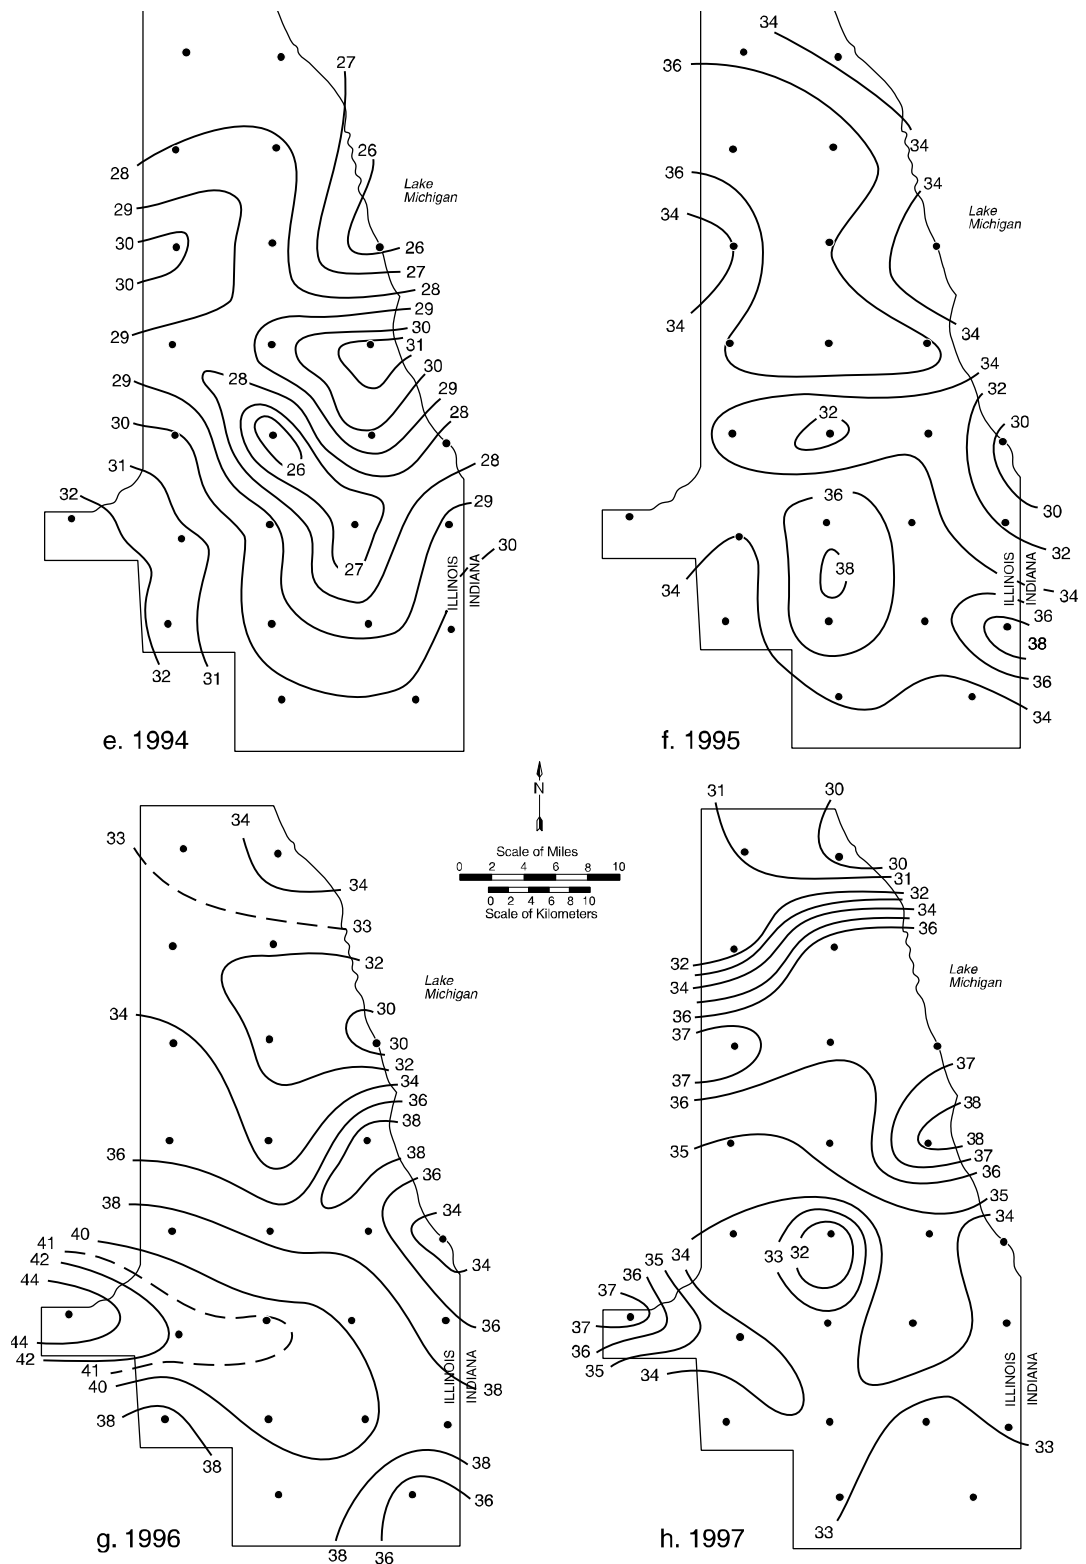
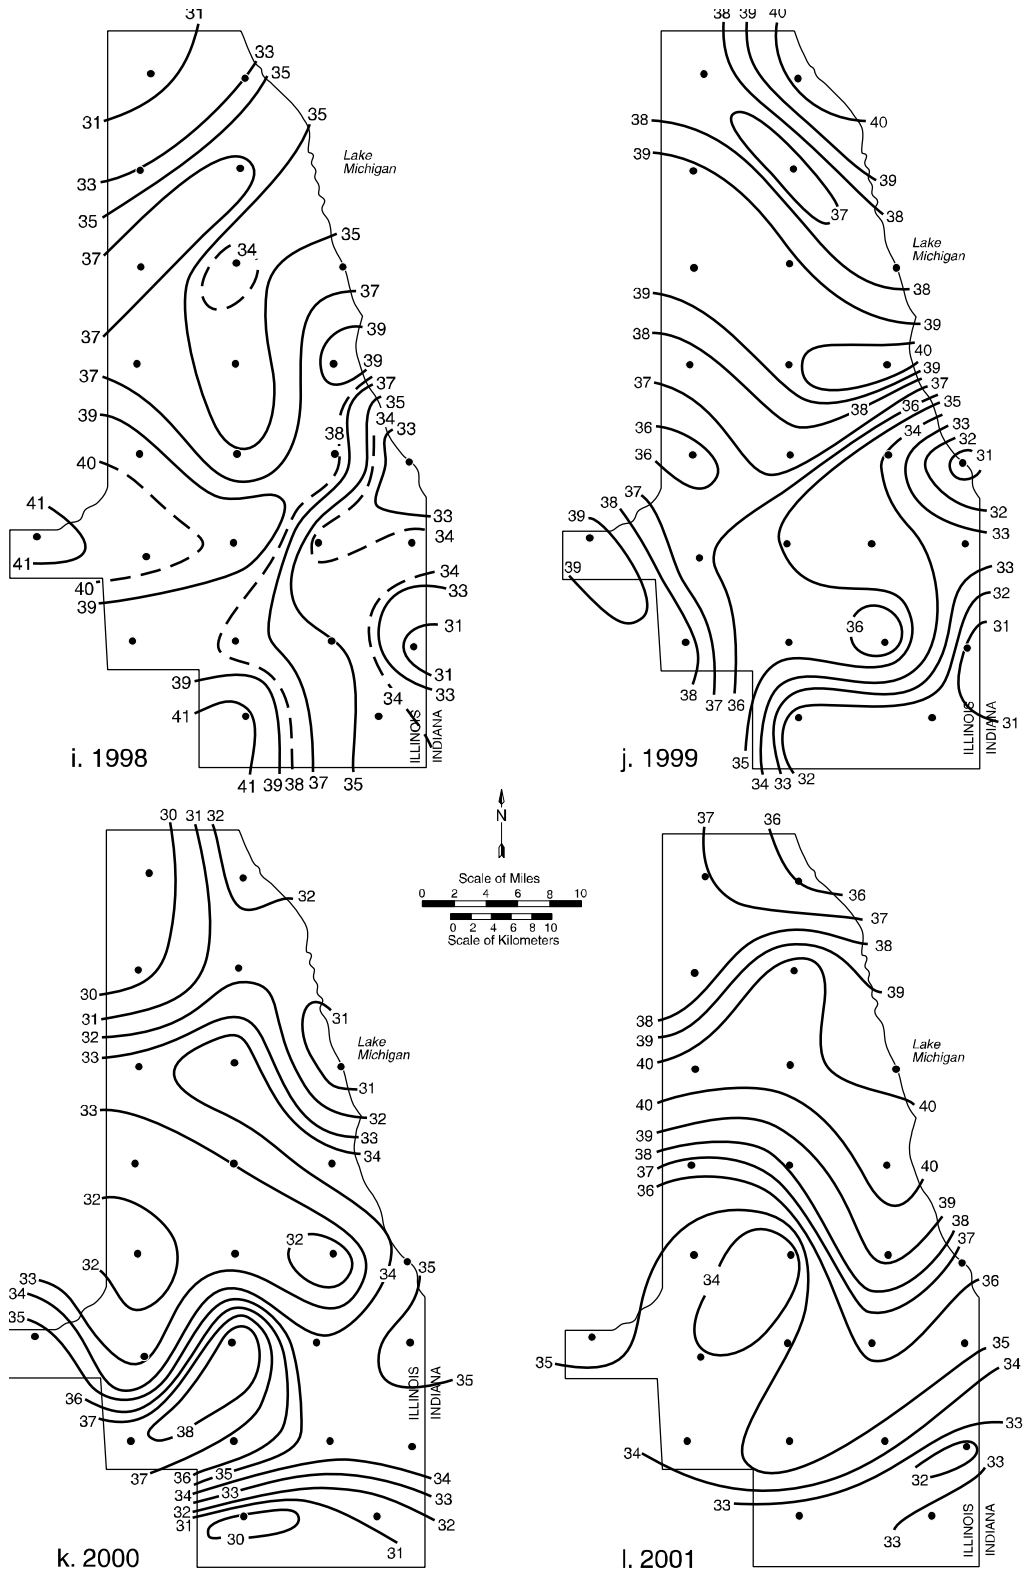
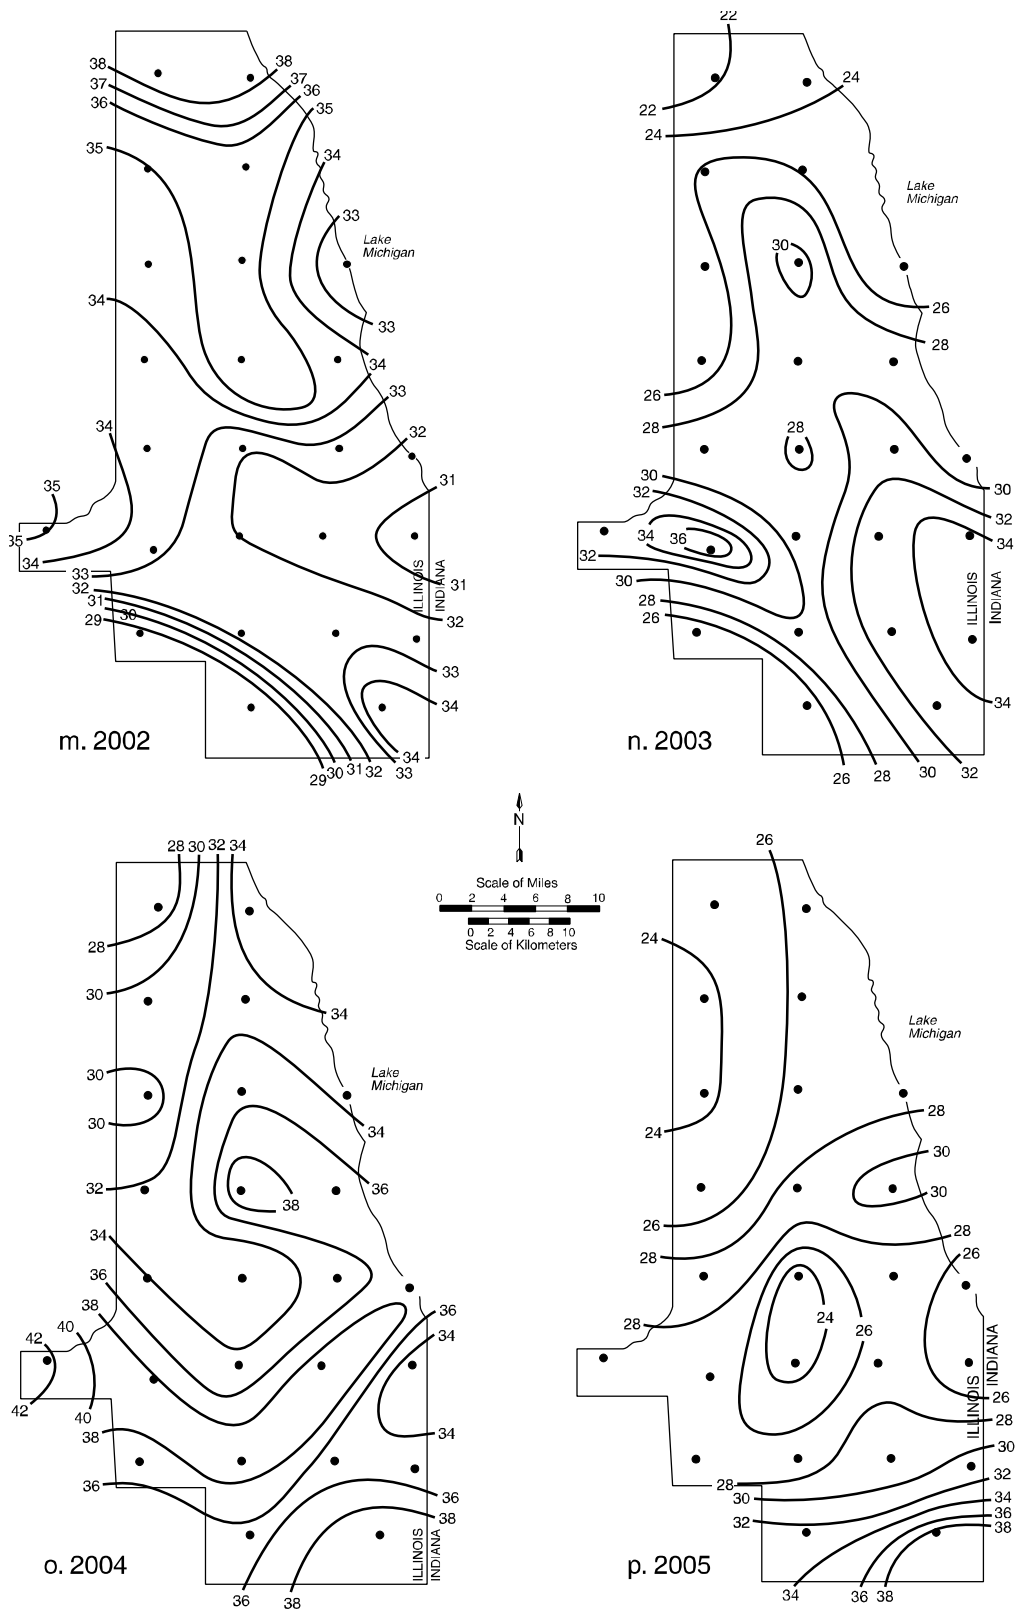
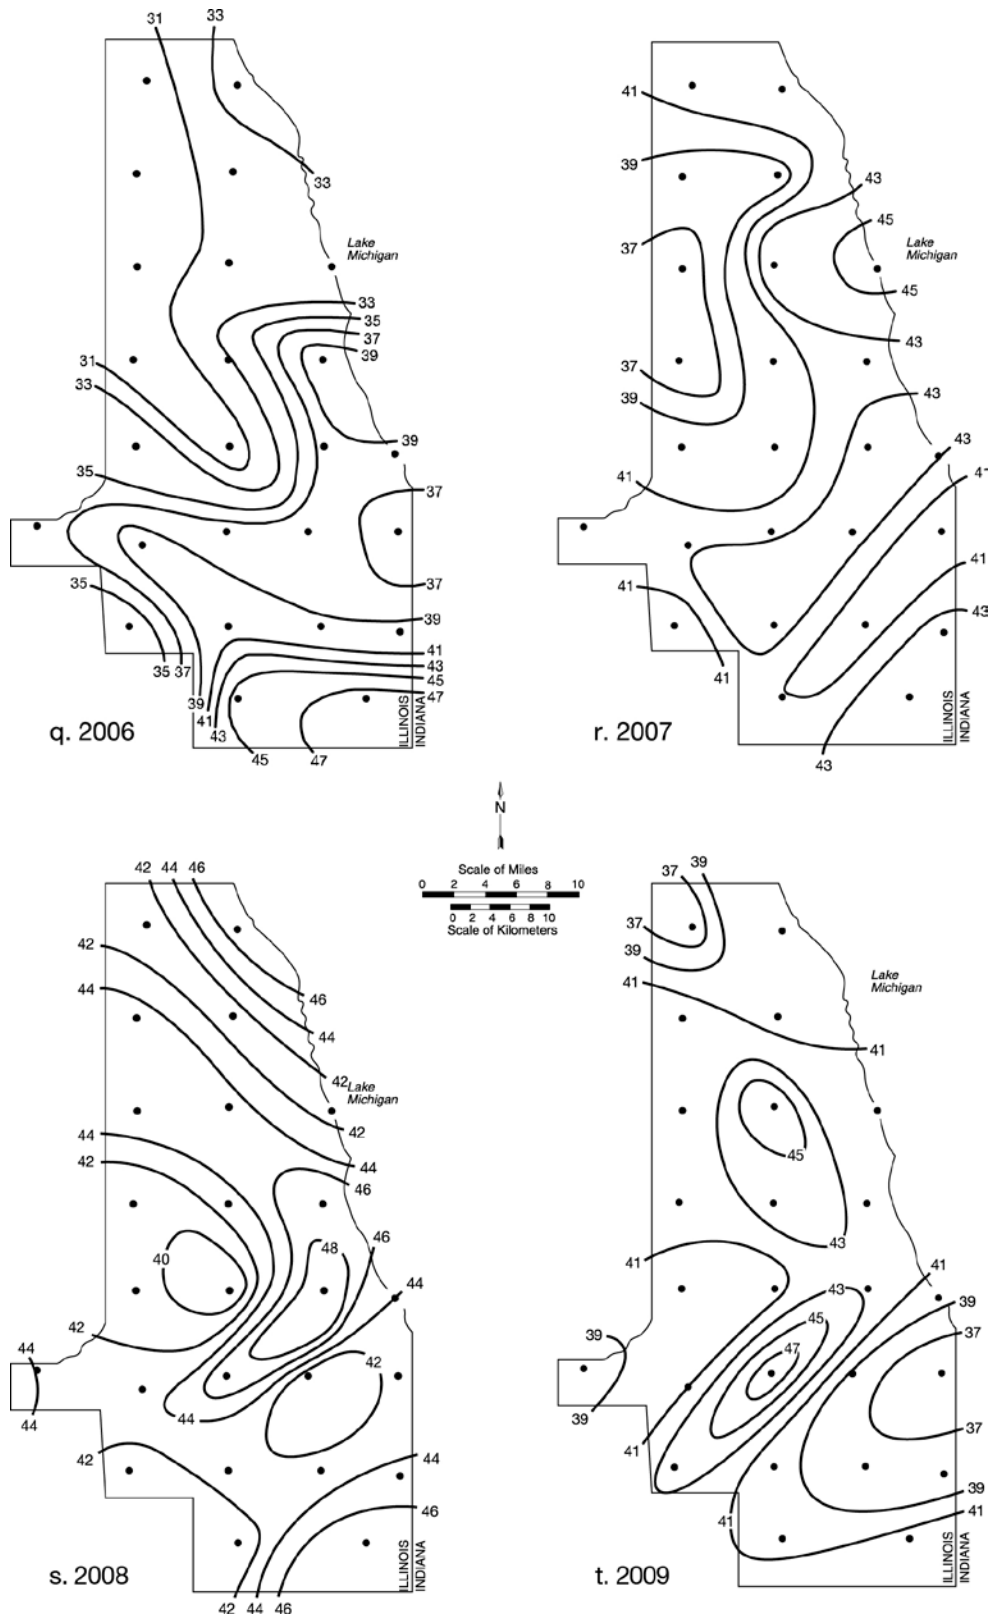
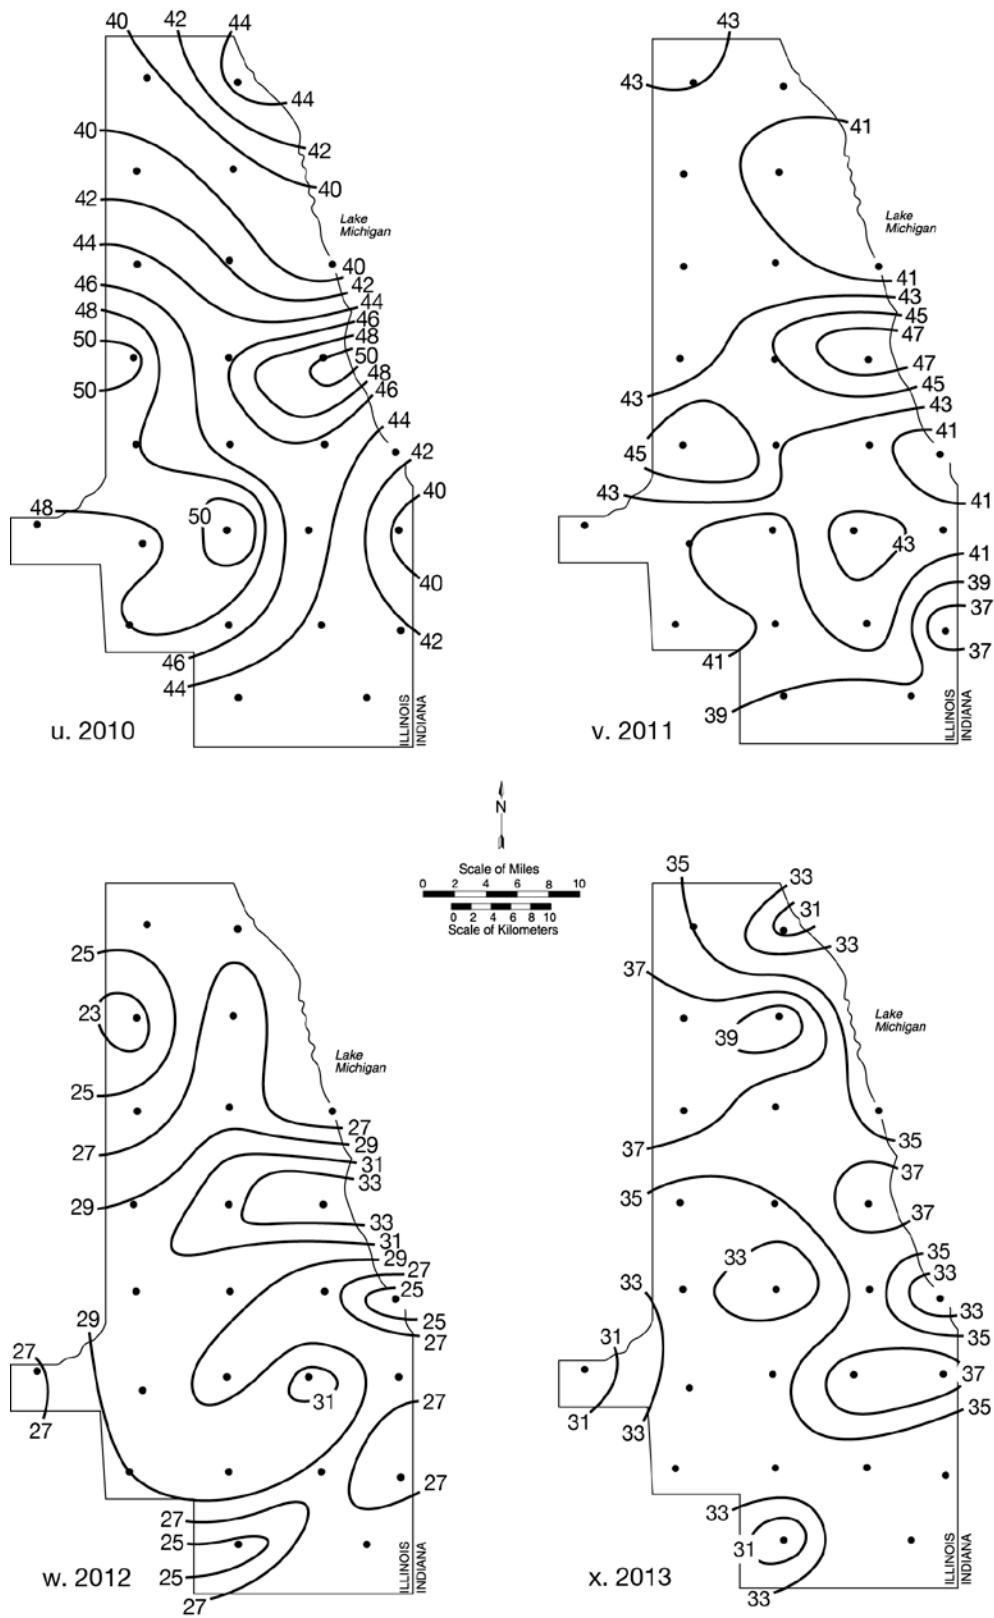
Figure 4. Precipitation pattern (inches) for WYs 1990–2015

Figure 4 provides maps of precipitation amounts for individual WYs 1990–2015. The general pattern of precipitation greater than 38 inches in WY 2016 is a broad arch, parallel to the lakeshore. From the north, the arc begins between sites 4 and 6 near Edgebrook, near Interstate-94 and the North Branch Chicago River, to south of site 22 in Harvey just north of Interstate-294. Broad areas of lower to average precipitation are along the northern and southern perimeters of the network, with two localized lows along the lakeshore at sites 7 and 14.

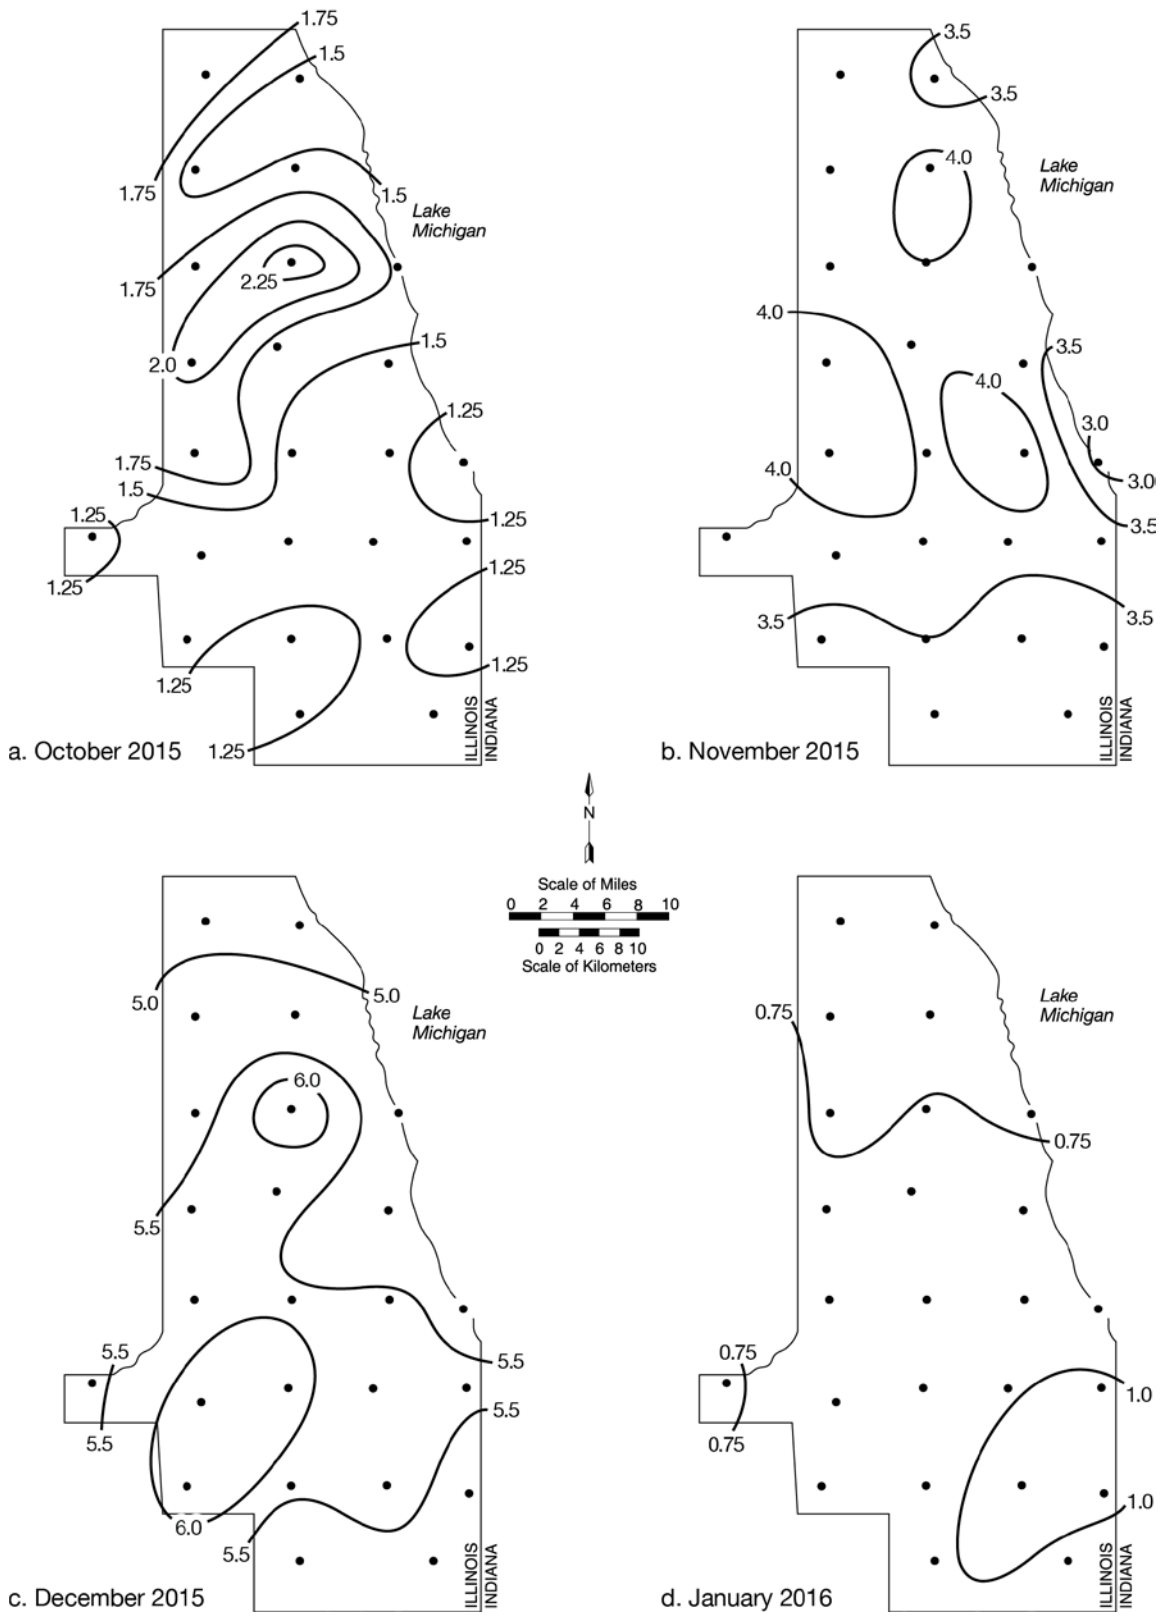
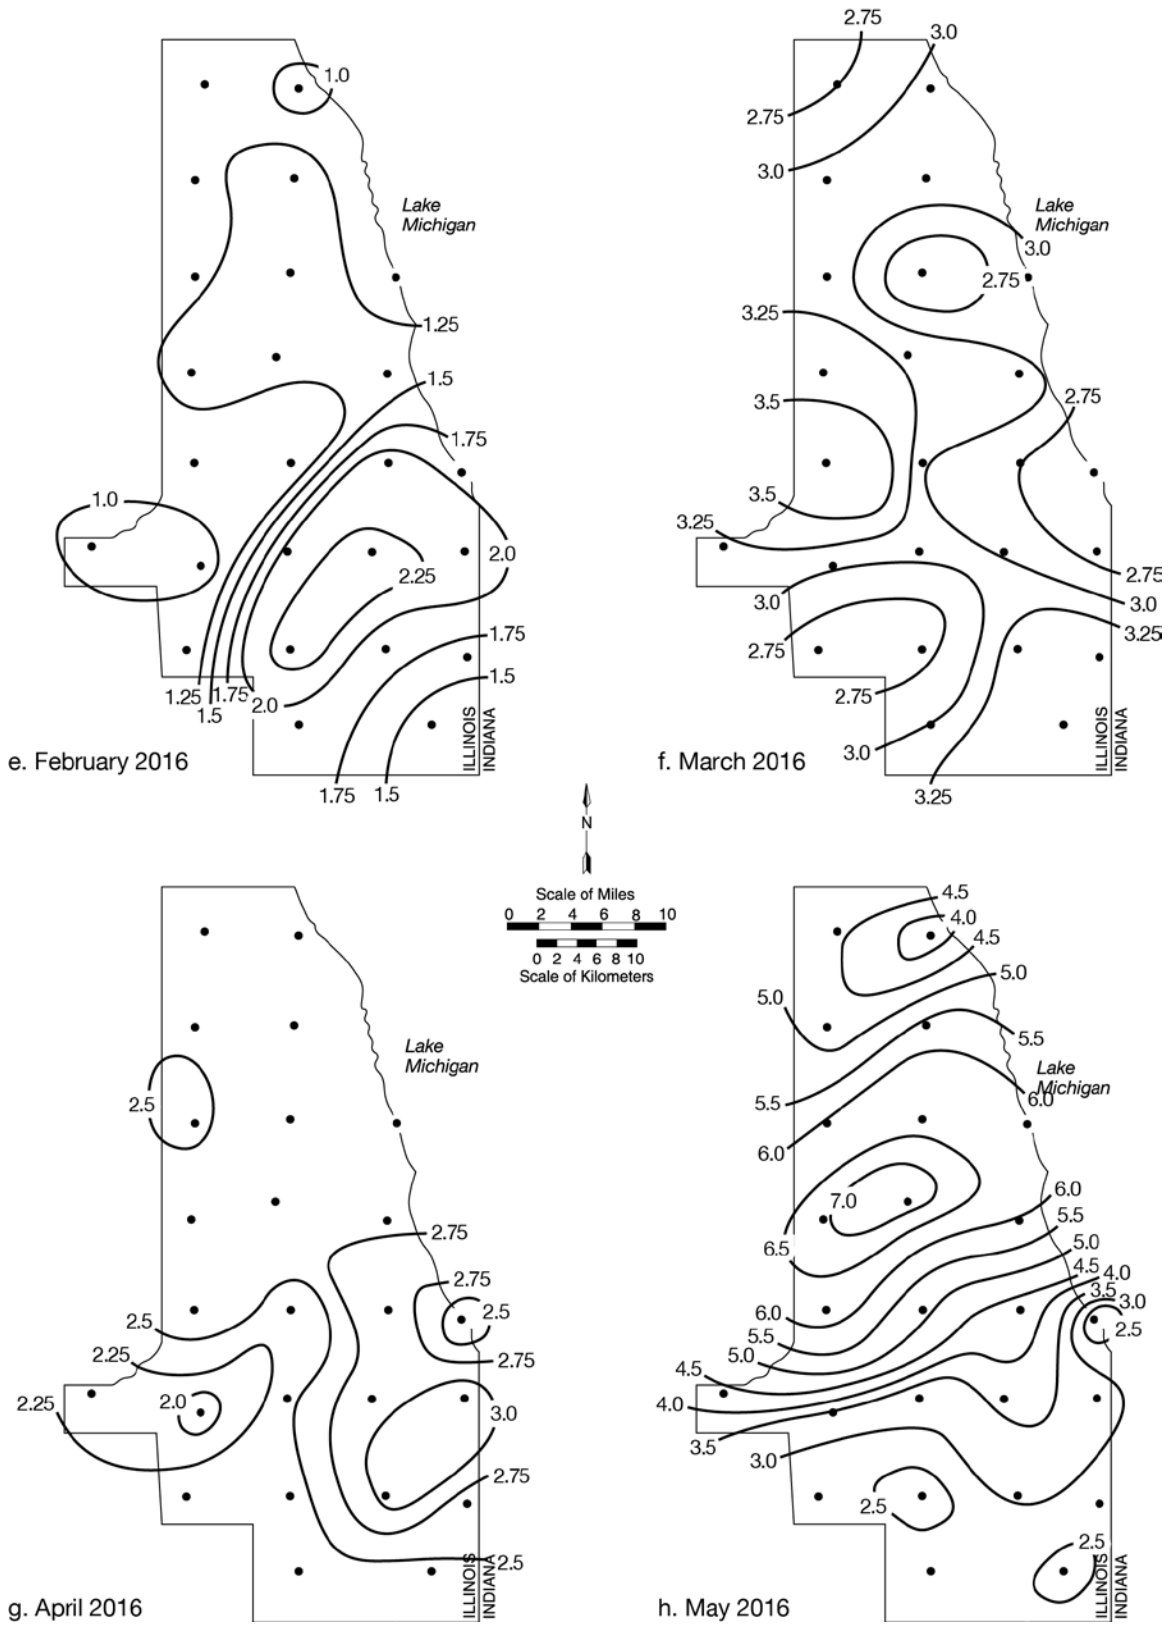
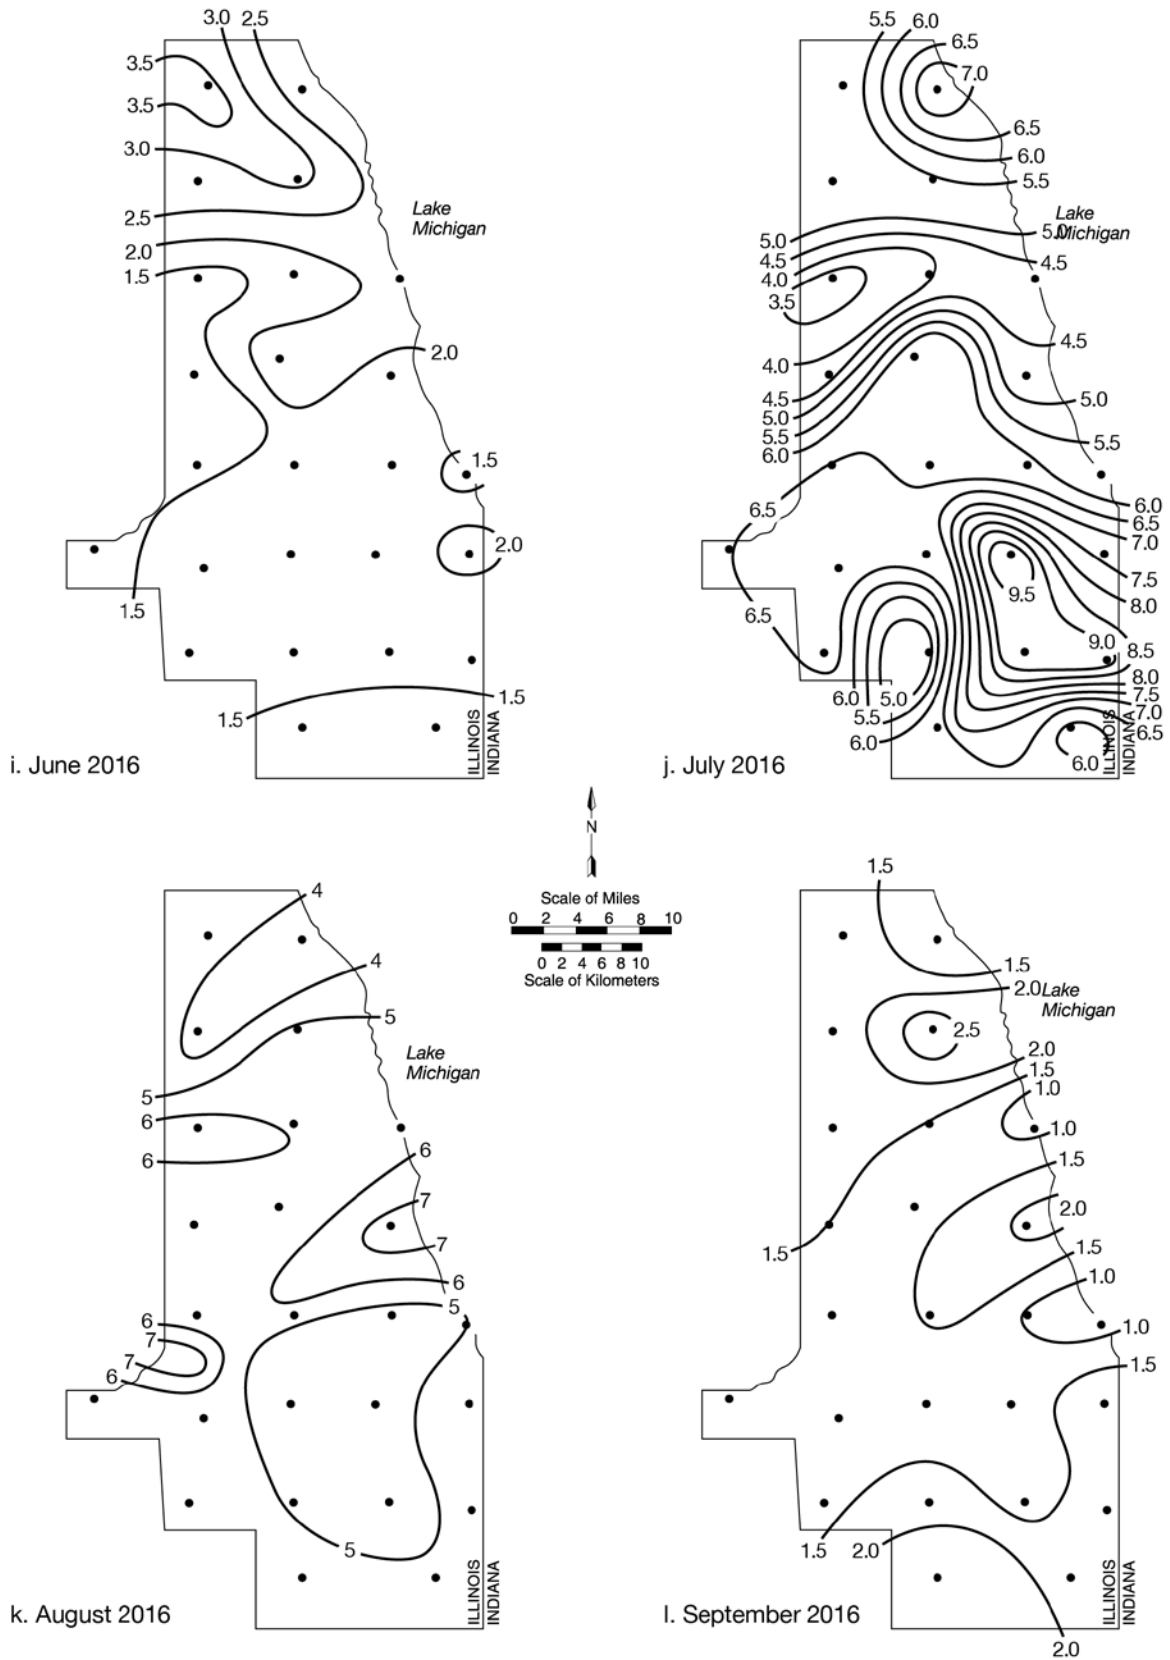
Figure 5. Precipitation pattern (inches) for October 2015–September 2016

Figure 5 presents the monthly precipitation patterns for WY 2016. The ranges of monthly precipitation were greatest in July, May, and August 2016 with differences in monthly precipitation between gages of 6.37, 4.78, and 4.17 inches, respectively. In July, three adjacent gages collected more than 9 inches of precipitation, while another neighboring station collected less than 5 inches. Also, there were several precipitation gradients of over 1 inch between adjacent gages across the network in July, indicating localized precipitation. The May 2016 precipitation pattern and gradients were broadly distributed across the network with a larger region of higher precipitation in the center of the network and lower amounts to the north and south. January 2016 had the least monthly precipitation with a variation of 0.51 inches across the network. The remaining months had precipitation variations between 1.24 and 2.52 inches.

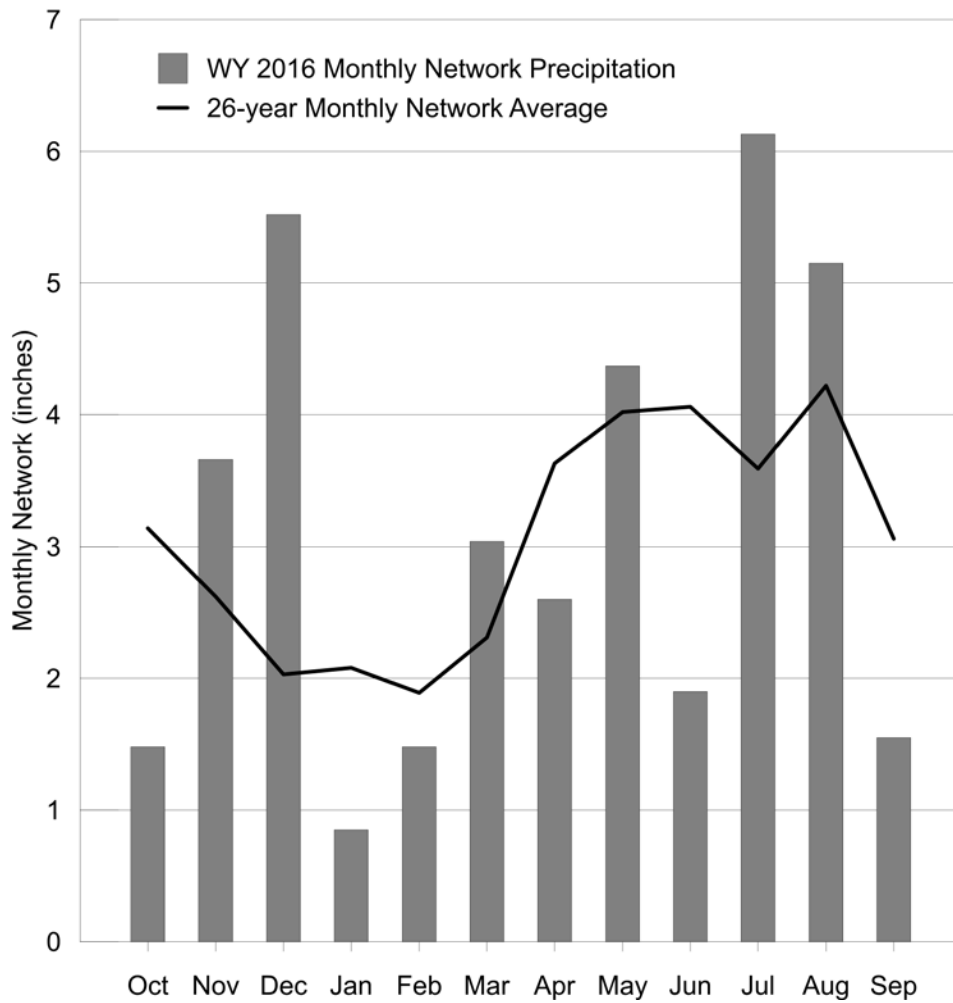
Figure 6. WY 2016 monthly network precipitation compared to the 26-year monthly average network precipitation

Figure 6 presents the WY 2016 monthly average network precipitation with the 26-year monthly average precipitation. For WY 2016, the monthly precipitation was greatest in July 2016 with 6.26 inches at 157 percent of the 26-year average of 3.59 inches. December 2015 and August 2016 had 5.52 inches and 5.13 inches, respectively. December precipitation was 272 percent of the 26-year average compared to 122 percent for August.
