Contract Report 2017-03

# **Continued Operation of a 25-Raingage Network for Collection, Reduction, and Analysis of Precipitation Data for Lake Michigan Diversion Accounting: Water Year 2016**

REPORT

U.S. Army Corps of Engineers, Chicago District

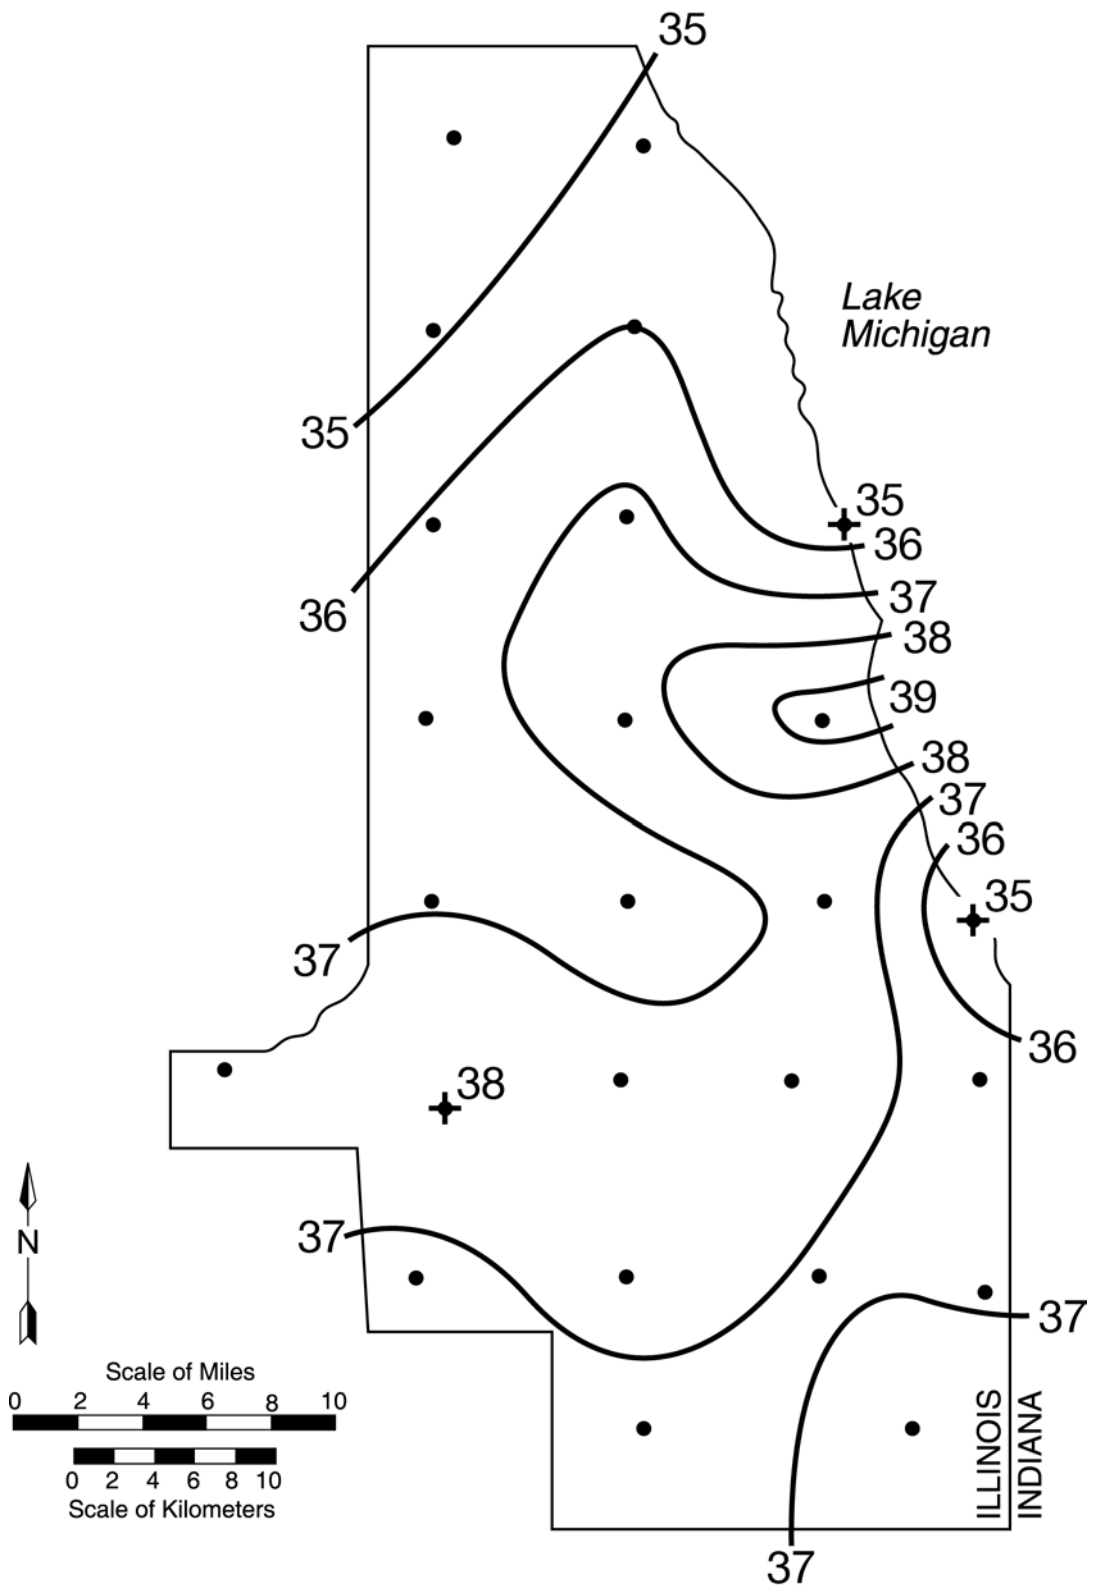
Figure 7. The 26-year average precipitation pattern (inches), WYs 1990–2016

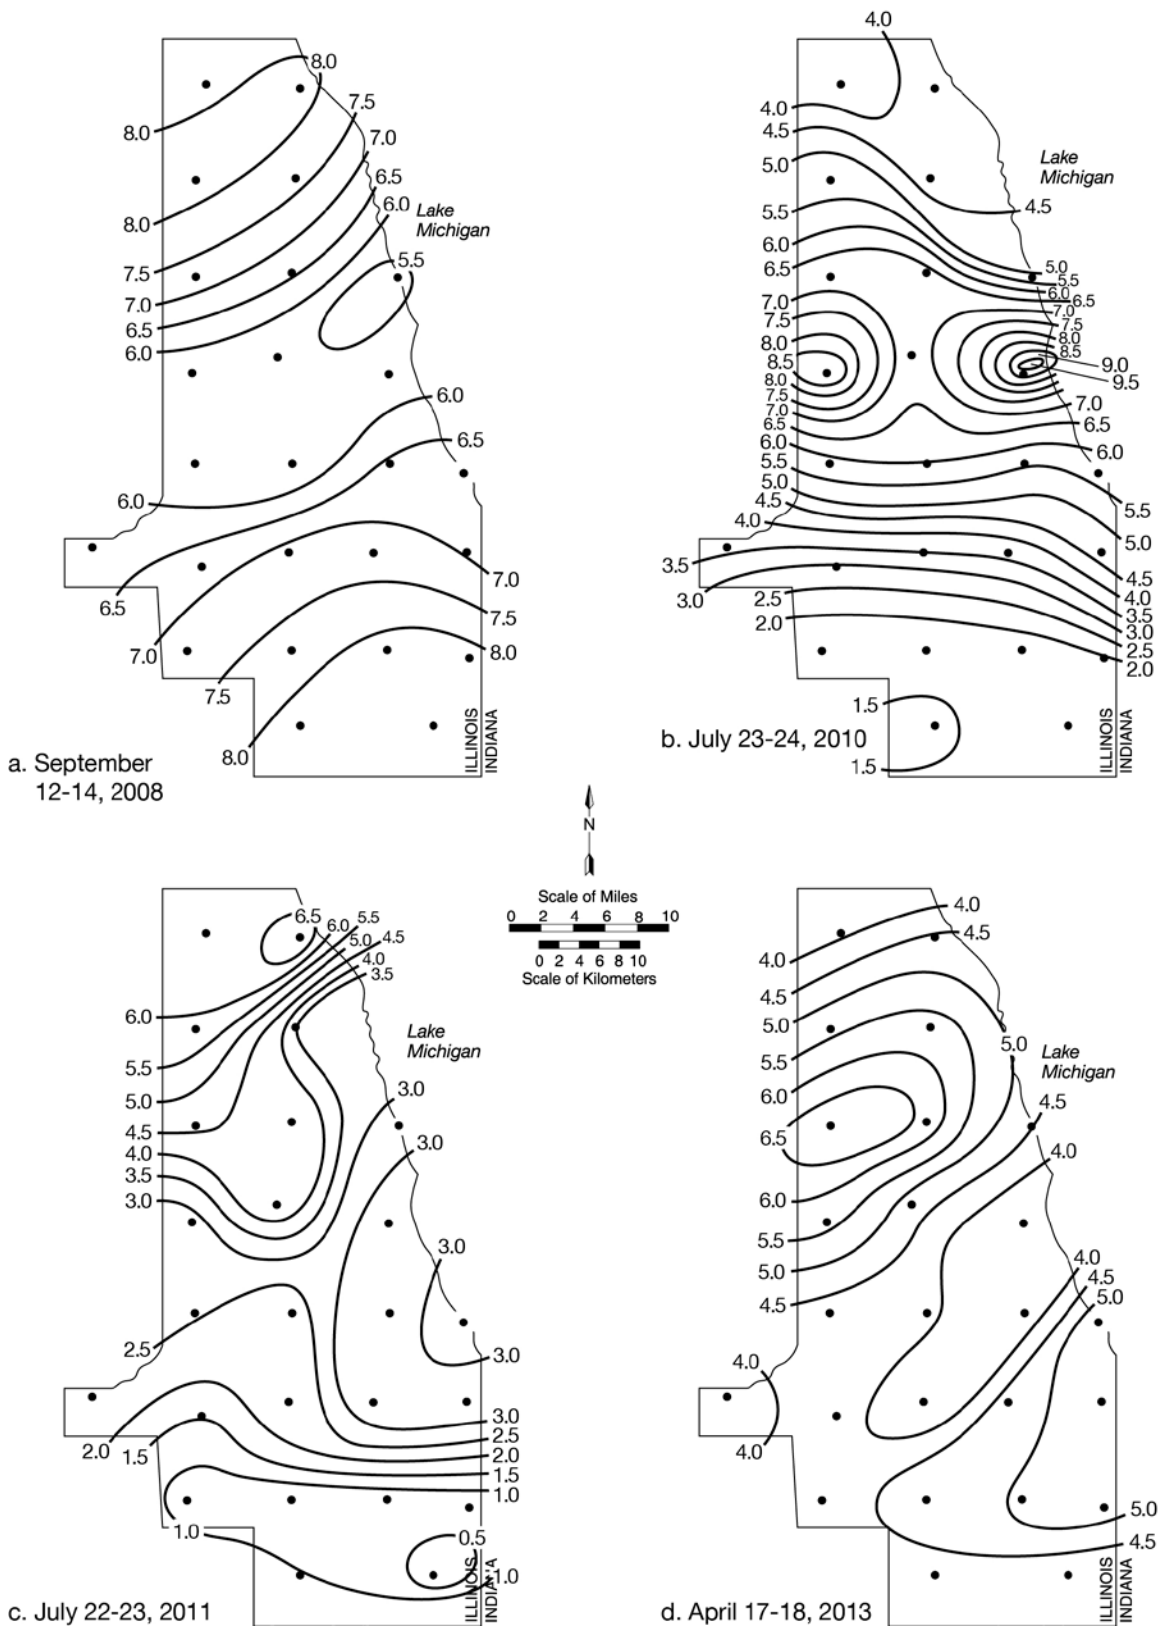
Figure IV-1. The four most intense storm events during WYs 2008–2016

One heavy precipitation event occurred during the winter, December 2015, while the other heavy precipitation events of WY 2016 occurred in the spring and summer months, May through August. Appendix IV contains specific information concerning the WY 2016 precipitation events for gages that exceeded the one-year recurrence interval. The appendix also presents information concerning the four largest storm events that occurred in Cook County during the period October 2007 to September 2016.
