Strengthening Performance of PALF-Epoxy Composite Plate on Reinforced Concrete Beams

To cite this article: Siew C Chin *et al* 2018 *IOP Conf. Ser.: Mater. Sci. Eng.* **318** 012026

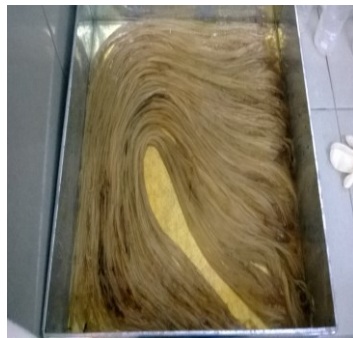
Figure 1. Fibers treated in NaOH solution.

The fibers were then alkali-treated with three levels of NaOH concentration (2%, 5% and 8%), respectively at 30 °C for an hour as shown in figure 1. The ratio of the fibers and the solution was 1:20 (w/v). After treatment, the fibers were washed and rinsed with tap water several times. The fibers were then dried in an oven at 70 °C for 24 hours.

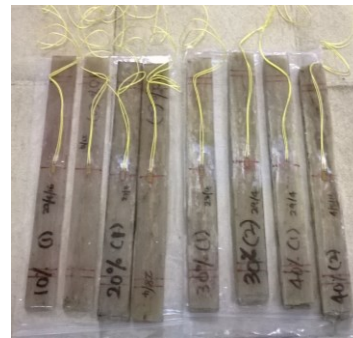
Figure 2. Composite samples with different fiber volume ratios.

The composite samples with fiber volume ratios of 0, 0.1, 0.2, 0.3 and 0.4 were fabricated (25 mm wide x 6 mm thick x 200 mm long), respectively by hand-laying technique as illustrated in figure 2. The specimens were tested under ASTM D790. The crosshead speed was set at 5 min⁻¹.

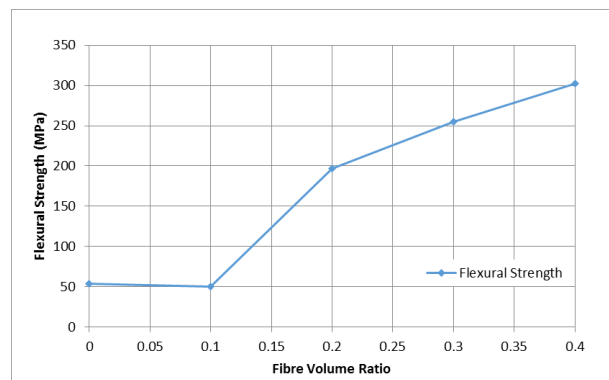
Figure 6. Load versus strain of composite plates.

Figure 6 shows the relationship between the flexural strength versus the fiber volume ratio. The flexural strength increases as the fiber volume ratio increased from 0.1 to 0.4. However, the fiber volume ratio of 0.1 did not exhibit significance difference compared to the neat epoxy sample.

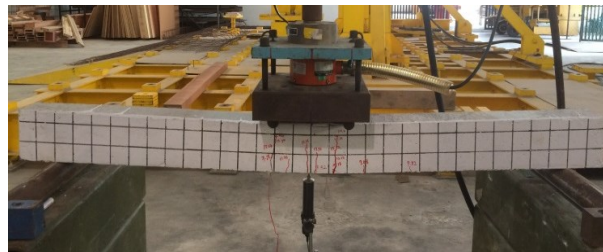
Figure 8. Crack patterns of control beam.

Figure 8 shows the crack pattern of the control beam. When a load was applied to the control beam, cracks started to appear starting from the soffit of the beam and then widened when the load increased as the bottom surface of the beam was weak in tension. The first crack of the control beam appeared at the mid-span of the beam. The first crack occurred at the load of 5.72 kN. Cracks started to appear continuously as the load increased. The appearance of cracks and propagation of cracks continued to the point load with the increased of load. It was observed that a large amount of crack propagation around 13 kN of load. The propagation of cracks continued until the failure of the beam. The cracks happened at the middle of the tension zone. All the cracks were vertical flexural cracks.

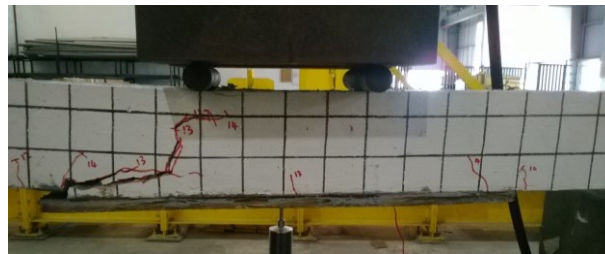
Figure 10. Crack patterns of beam PALF B2.

Figure 10 shows the crack pattern of beam, PALF B2. The first crack appeared at the load of 10 kN and followed by the increasing of diagonal cracks as the load increased. The cracks propagated through the neutral axis of the beam in a diagonal direction at the load of 13 kN. More cracks were developed and appeared at both ends of the plate. Very little vertical cracks were seen at the flexural zone. Wider cracks formed as load applied continuously. The beam fails with a detached of PALF-

epoxy composite plate from the concrete surface as depicted in figure 10. The plate has the ability to resist and transfer the load to the region without strengthening. This caused fewer flexural cracks found at the mid-span of the beam. Large crack width identified upon beam failure at the left end of the plate was possibly due to plate end interfacial debonding.
