ENVIRONMENTAL ANALYSIS OF WATER AND SEDIMENT SAMPLES IN LAKE MEZŐLAK AND MARCAL RIVER

BALÁZS SOÓS, GYÖRGY HELTAI, ORSOLYA SZÉCSY, MÁRK HORVÁTH, ILONA FEKETE

Szent István University
Faculty of Agricultural and Environmental Sciences
Department of Chemistry and Biochemistry
2100 Gödöllő, Páter K. u. 1.
soos.balazs87@gmail.com

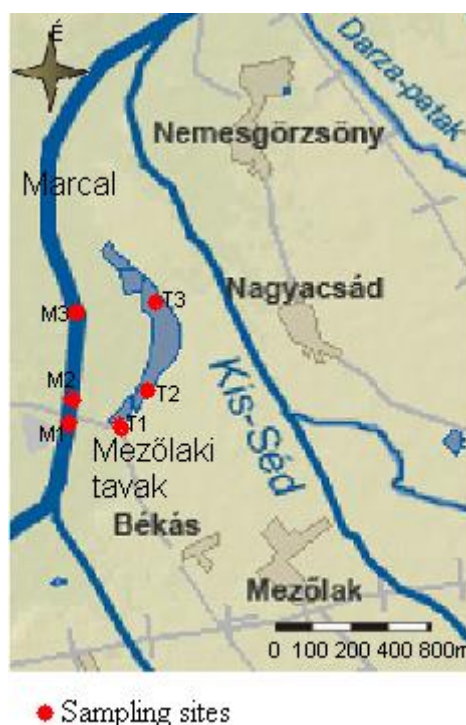
Figure 1. Sampling sites in Marcal River and Mezőlak Lake

Three sampling points were determined for the studies of the lake and river. Sampling sites were situated nearly parallel to each other (*Figure 1.*). These are connected to each other via subsurface channels and coastal vegetation (reed, bulrush) extends between them.

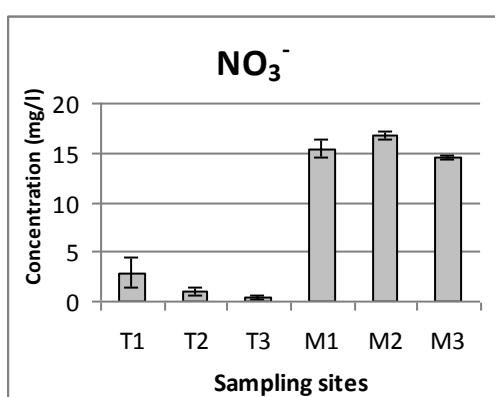
Figure 2. Water Nitrate content

Nitrate content of lakes is several orders of magnitude lower and significantly different from that of the Marcal River (Figure 2). This is explainable by the fact that the lake system has 15–20% of open surface and it is covered mainly by woody vegetation (reed, rush, bulrushes). These plants play a key role in the consuming of surplus quantities of nutrients, nitrate, and in filtering and absorbing of harmful substances (FEKETE ENDRE, 1991). Through taking up and building in their bodies relatively high loads of nitrate these plants not only decrease the quantity of dissolved nitrate in waters, but also prevent algae from multiplying. Algae could otherwise cause eutrophication in waters as a result of high nitrogen and phosphorus loads. Reeds are especially valuable through representing

Higher nitrate concentration of Marcal might be caused also by extended agricultural lands the river runs through (from the Keszthely Mountains to the confluence with Rába River at Koroncó) as these fields are being fertilized or treated with liquid manure usually yearly. Besides, Marcal is a recipient of treated communal wastewater as well. These materials contain high amounts of nitrogen which can be leached to larger basins via subsurface water flow systems or via precipitation. Therefore it has a higher concentration as opposed to a closed water body like a lake surrounded by coastal vegetation.

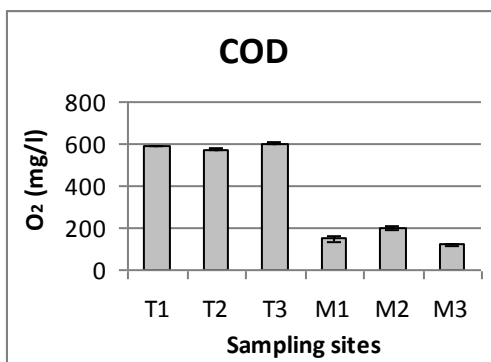
Figure 4. Water COD

Owing to the peat-based environment, these lakes have high organic matter content. Constant siltation (nutrient production under anaerobic conditions) leads to decrease of open water body and accumulation of organic matter. As a consequence, water level of the lake decreases. Due to increase in organic matter content more O_2 is needed for oxidation processes. Arising from this, it has great carbon storage capacities as well. Data shown on diagram indicate that organic matter content of the lakes is three times higher than that of the river. This parameter proved to be nearly the same at the first (T1) and the third sampling points, as there is an extended land of aquatic and coastal vegetation nearby. Owing to flowage, high amounts of organic matter can not be accumulated in Marcal River. It appears to have highest values at the second sampling point (M2) after the bridge, because of leaching from the road. Downwards it becomes diluted and shows lower values (*Figure 4.*).

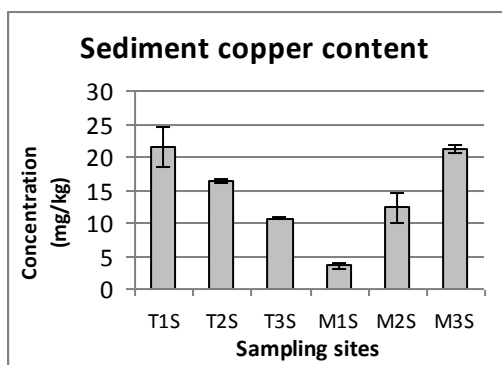
Figure 5. Sediment copper content

According to the water sample analyses results heavy metal concentration show low values in dissolution form (Figure 6). Sedimentation of heavy metals is more common as regards to sluggishly flowing rivers than transportation by sedimentary processes. This might be the reason for the several magnitudes higher heavy metal content in sediment samples (Figure 5).

Heavy metal concentration proved to have a regular pattern in the cases of lakes and rivers. As for the lakes, constant decrease could be observed towards eastern direction, in relation to traffic and anthropogenic impacts. From the route at the western site of the lakes heavy metals can be transported to the water via wet and dry sedimentation processes through subsurface flow systems.

In the case of Marcal River heavy metal concentration increases with streamline probably as a result of features of the terrain, as elevation of the area decreases constantly together with river velocity. Arriving to even flatter terrains, heavy metals settle down resulting in constantly higher concentration in the sediments. Regarding waters with high oxygen content (like Marcal River) compounds of heavy metals dissolve poorly and precipitate in the mud. This is why dissolve and total heavy metal concentration is lower in Marcal River. Metal ions carrying multiple positive charges bind to particles with negative charges (e.g. clay particles) and settle down impacting plants rooted in the bottom as well as bentic fauna.
