SULFATE REDUCING BACTERIA AS BIO-CLEANING AGENTS: DEVELOPMENT OF NEW METHODOLOGIES AND STUDY CASES

Keywords: sulfation; *Desulfovibrio vulgaris*; bio-cleaning; SRB; artwork

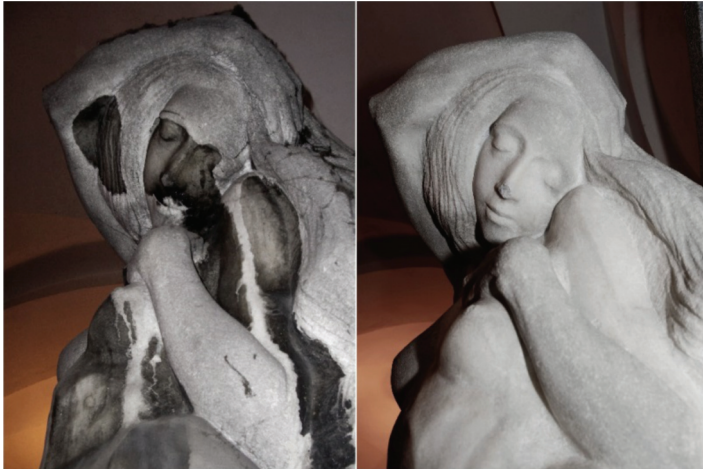
Figure 1. Upper body of the statue of Anna Zuccari, pen name Neera. On the left: before restoration; on the right: after restoration.

In accordance with the results obtained from the biocleaning tests and with the *So-rintendenza*, a proper restoration strategy was designed for the entire statue surface (Figure 1), and was performed by the restorer Dr. Eleonora Gioventù. The restoration procedure consisted of different steps, summarized as follows:

- removal of dust and micro-suction;
- stone surface cleaning and removal of black crusts using a Tween20 pack and following application of Micro4Art-sulfates bio-formulation, provided by Micro4yoU;
- removal of base stucco and reintegration;
- surface and aesthetical trimmings.

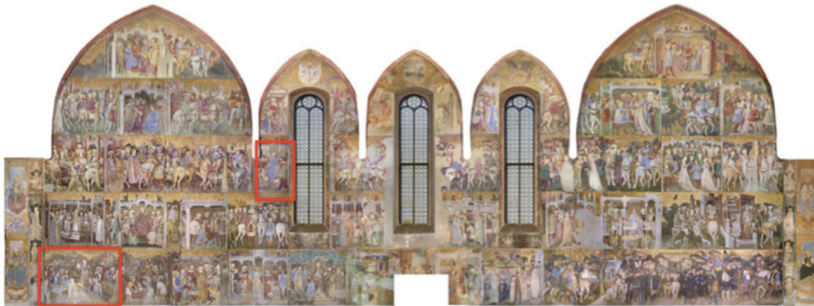
Figure 2. Pictorial cycle decorating the Queen Theodolinda Chapel situated in Monza Cathedral.

The object of the experimentation was the pictorial cycle decorating the Queen Theodolinda Chapel situated in Monza Cathedral (Figure 2). The artwork was subjected to an intervention of mild conservation, involving the most prestigious Italian research Institutes¹ and important sponsors. The experimentation carried out until now is not exhaustive and is still in progress and is intended to be a first innovative approach to the delicate issue of sulfate removal from mural paintings.

The trial with sulfate-reducing bacteria was carried out on two scenes belonging to the pictorial cycle of the Queen Theodolinda Chapel: Scene 16 (upper rectangle in Figure 2) and 33 (lower rectangle in Figure 2).
