The International Journal of Nautical Archaeology (2018) 47.2: 343–356
doi: 10.1111/1095-9270.12322

A Report on the late 1st–2nd-century-AD Venice Lido III Sewn Timber Assemblage

Key words: Sutiles Project, sewn boat, ship construction, Venice, Adriatic, Roman-era.

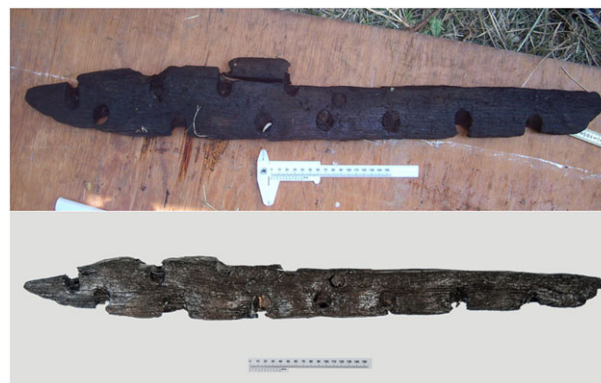
Figure 2. Comparison of F5 from the 2013 (top) to 2014 (bottom) field seasons (photo by S. Willis and M. Cusin with permission from the Soprintendenza per i Beni Archeologici del Veneto).

During the 2014 research season, it was noted that one of the timbers (F5) had suffered distortion and shrinkage over the course of the preceding year (Fig. 2). The warping of this fragment highlights the importance of expedient and efficient examination of archaeological materials. General measurements were

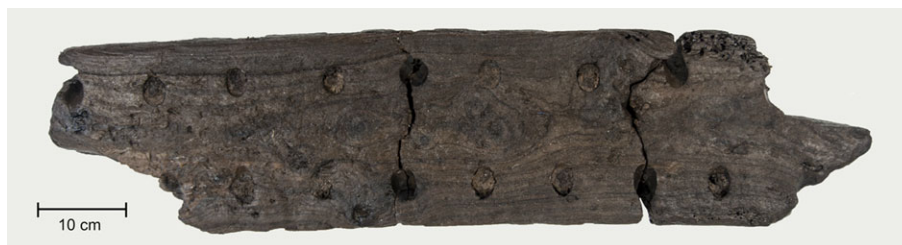
Figure 5. Photograph of the interior face of F1; note the oval shape of the sewing holes (photo by M. Cusin with permission from the Soprintendenza per i Beni Archeologici del Veneto).

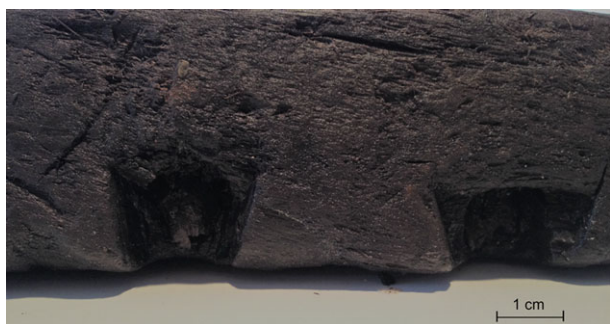
Figure 6. Edge cavities of F1 (photo by S. Willis with permission from the Soprintendenza per i Beni Archeologici del Veneto).

(see Fig. 6, Table 4). Deterioration of the edges may have reduced the preserved dimensions on all timbers except F1. The edge cavities may have facilitated the sewing process as they permitted a larger margin of error when aligning the planks. The edge cavities are generally trapezoidal in shape and range widely in overall dimensions, generally correlated to the thickness of the timber. This is particularly seen in F1, which

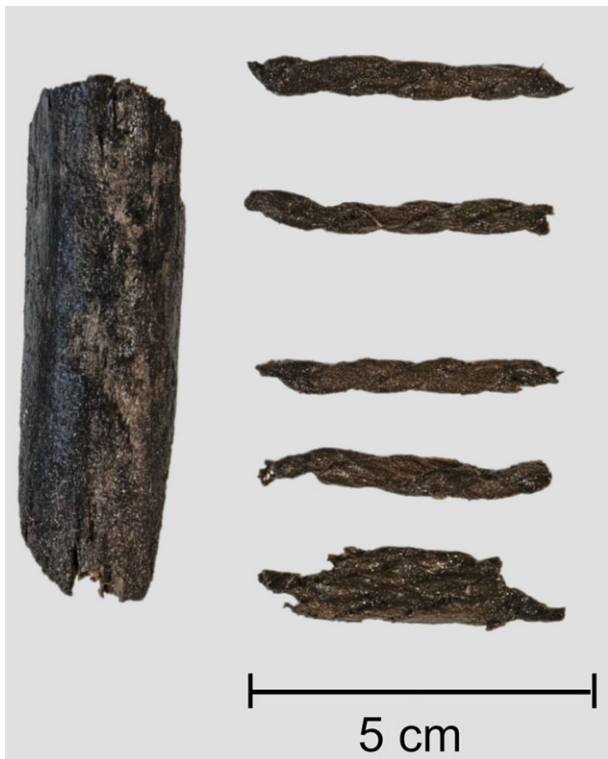
Figure 7. Peg and pieces of cordage from F1 of the Venice Lido III timber assemblage (photo by M. Capulli with permission from the Soprintendenza per i Beni Archeologici del Veneto).

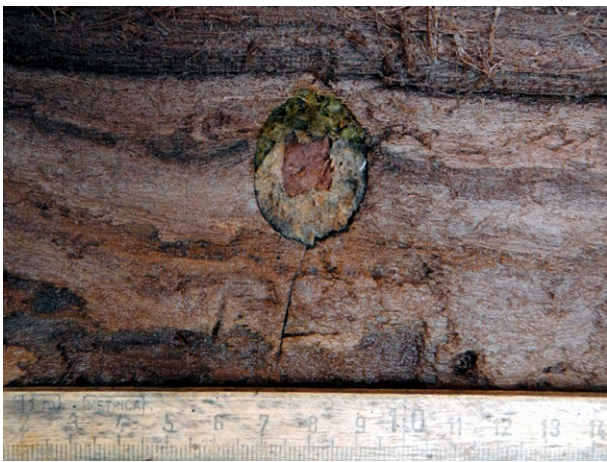
Figure 8. Chock in one of the pegs of F1 (photo by Mirco Cusin with permission from the Soprintendenza per i Beni Archeologici del Veneto).

larger pegs corresponding to greater plank thickness and sewing hole dimensions within the assemblage. Some of the pegs of F1 exhibit the use of chocks, here angular wedges (Fig. 8), made of the same material as the pegs themselves—dogwood. They were used to tighten the joint and are most often observed in use with treenails. This is the first known instance of chocks used with pegs in a sewn construction. [S.W.]
