Texture evaluation in ductile fracture process by neutron diffraction measurement

H Sunaga¹, M Takamura¹, Y Ikeda¹, Y Otake¹, T Hama², M Kumagai³,
H Suzuki⁴ and S. Suzuki⁵

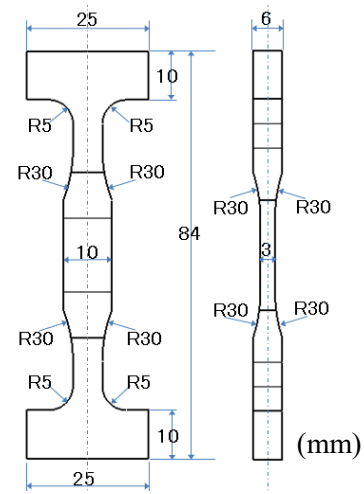
(a) Dimensions of a tensile specimen

(b) Specimen fixed to the tensile machine

Figure 1. Tensile specimen used in this study

The material used in this study was JIS-SS400, which is a rolled steel used in general structures. The dimensions of the JIS-SS400 steel specimen used in this study are given in Figure 1. The shoulders of the specimen used for gripping are machined to have dimensions fully consistent with the specifications of the tensile testing machine. The most important part of the specimen is the middle section. The cross-sectional area of the middle section was designed to be smaller than that of the other sections, because necking and ductile fracture were expected to occur in the middle section, for which a width of 10mm was determined to provide sufficient area for the diffraction of the incident beam.

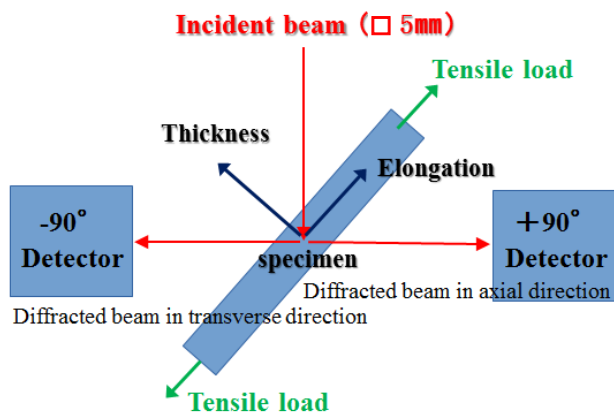
Figure 2. Schematic view of neutron diffraction measurement

The tensile testing machine was oriented at an angle of 45° to the incident beam. The diffraction patterns both parallel and transverse to the loading axis were measured simultaneously by using two detector banks which were oriented at angle of $\pm 90^\circ$ to the incident beam as shown in Figure 2. A movable crosshead was controlled to move at a constant speed (0.005 mm/s) and the tensile testing machine itself moved to the opposite direction to the crosshead movement to allow the incident beam to be diffracted in the middle section of the specimen during the tensile loading. The neutron data were collected continuously throughout the entire tensile test when the JIS-SS400 steel specimen was loaded under uniaxial tension until the fracture occurred.

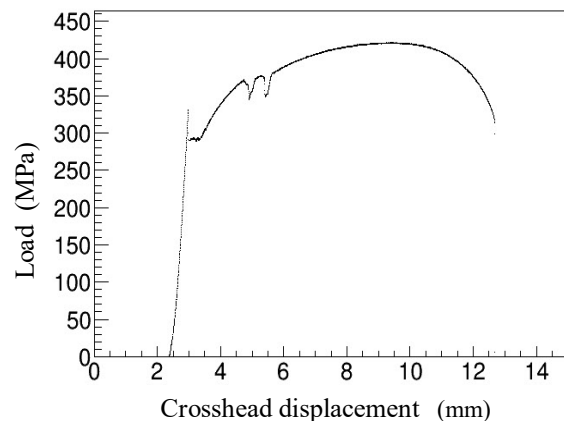
Figure 3. Load-crosshead displacement diagram

Figure 3 shows the tensile load vs crosshead displacement obtained by the tensile test during the neutron

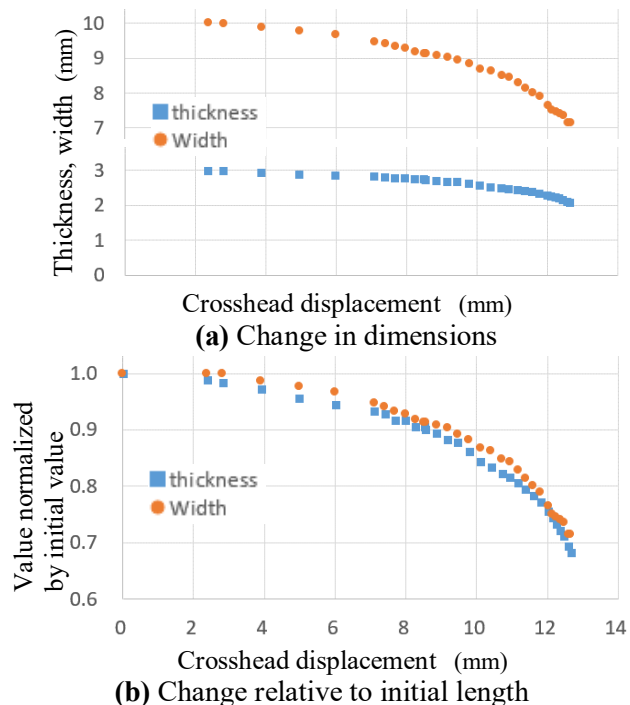
Figure 4. Changes in the thickness and width at the most reduced section of the specimen

diffraction measurement. Figure 4 shows the changes in the thickness and width at the most reduced section of the specimen where the incident beam was diffracted during the tensile loading, as shown in Figure 5. It was measured with the photographs taken from the front and side of the specimen during the tensile test, which was performed under the same condition as the diffraction measurement. Both the width and thickness decrease at the same rate relative to the initial size, and the maximum load corresponds to the point at which the deformation starts to localize in the middle of the specimen. It was also confirmed that neutron diffraction could measure the material elongation during necking and ductile fracture, because necking occurred in an area of the square equal to the incident beam size ($\square 5$ mm).

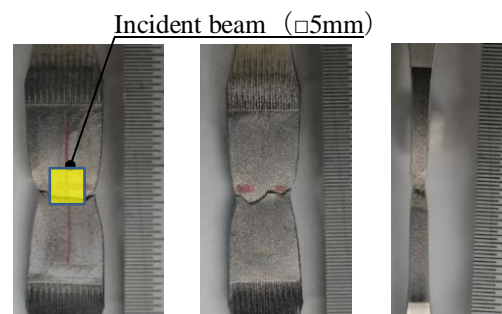
Figure 5. Photographs of specimen after fracture

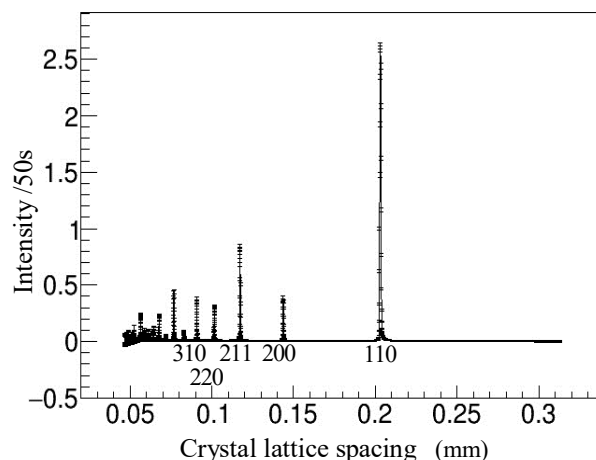
Figure 6. Diffraction pattern in the axial direction taken before deformation

The neutron data were sliced every 30 sec to calculate the diffraction patterns in each detector bank. Figure 6 shows the diffraction patterns for the axial direction parallel to the loading axis taken before deformation. Here, we discuss the texture evolution based on changes in the peak intensity of the 110, 200, 211 and 220 reflections during deformation. The peak intensities were normalized by a sampling volume which was estimated from a change in thickness at the center of the specimen.

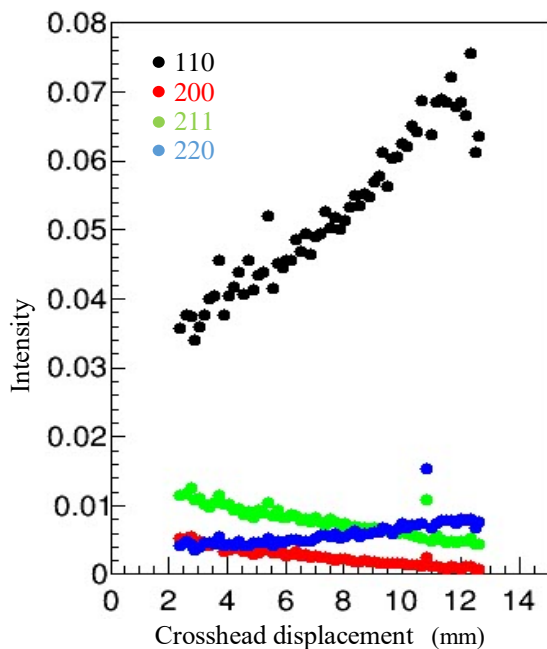
Figure 7. Change in diffraction intensity in the axial direction

Figure 7 shows the change in the diffraction intensity in the axial direction as a function of crosshead displacement. Initially, the intensity of 110 increased while those of 200 and 211 decreased with increasing applied load. A transition from an increase to a decrease in the intensity occurred for 110 prior to the fracture.

The volume fraction of (110)-oriented grains increased when the texture evolved as a result of plastic deformation. But the mechanism of texture evolution may be changed during necking, decreasing an increase rate of the volume fraction.

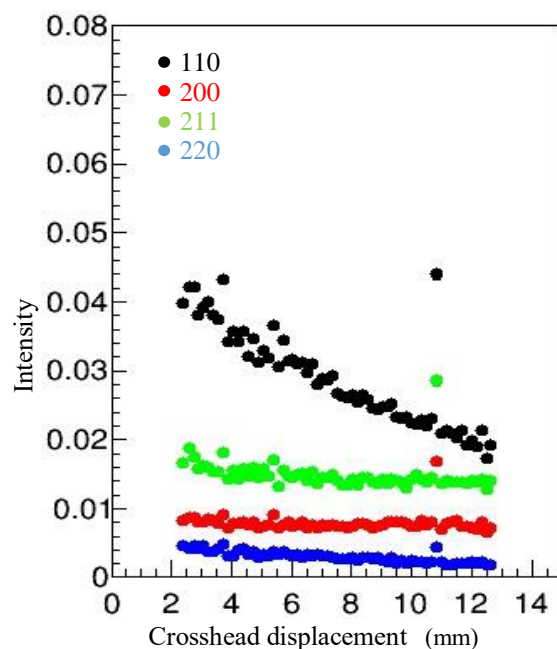
Figure 8. Change in diffraction intensity in the transverse direction

Figure 8 shows the change in the diffraction intensity in the transverse direction as a function of crosshead displacement. In contrast of the result for the axial direction, the intensity of all the lattice planes including 110 decreased monotonically. No behavior

that could be ascribed to the effect of fracture was observed.
