**Performance appraisal of sportshall and swimming pool buildings in Greece**

Bourdakis, Vassilios

# **Performance Appraisal of Sportshall and Swimming Pool Buildings in Greece**

**1994**

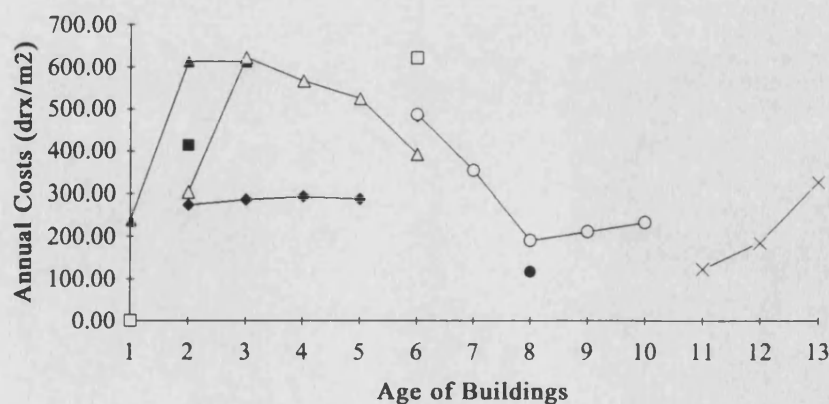
Focusing on maintenance, the annual expenditure varies with the age of the building, described as "maintenance profile" Lee (1981). It is high at the first years of the life of the building (especially when the contractor's liability ends) until various minor, or even major, details are sorted out, drops substantially in the coming years only to increase again when materials become older and need attention. This is described as '*the bathtub curve*' (Bargh, 1987). The only problem is that annual maintenance expenditure varies according to the use, type and assemblies of the building.

Figure 5.1: Maintenance Costs for the Sample

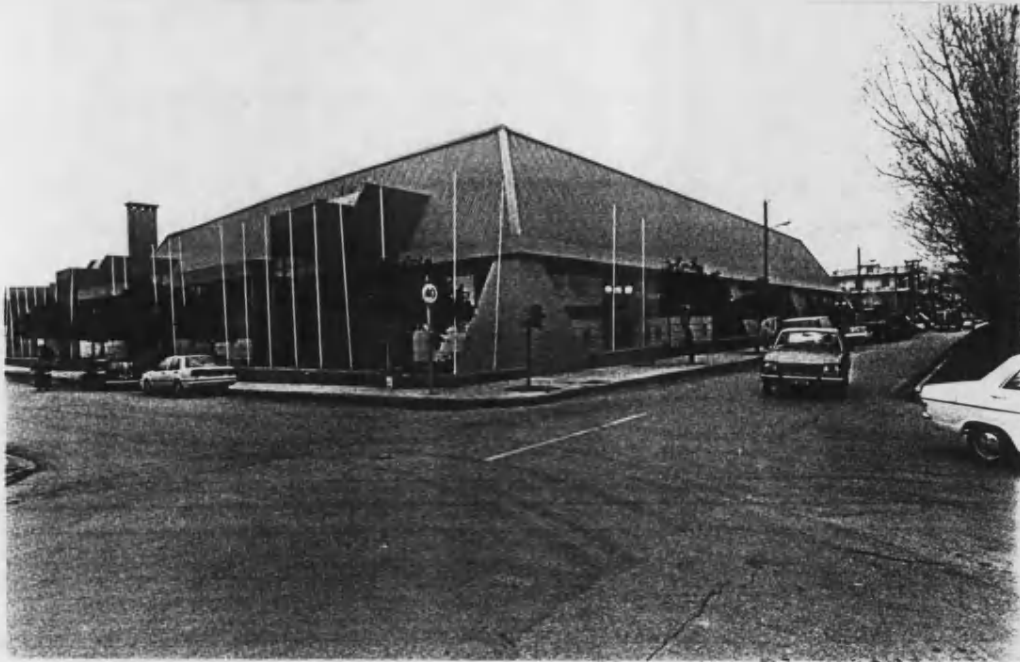
Figure 6.1. Peristeri Sportshall

Users unanimously rated this hall as the best of the sample, far ahead of the second—the Glulam structured Loutraki sportshall. Peristeri is a clear leader both in terms of HVAC and lighting and on the top three on the other HUS parameters. This justifies the extra cost of the air-conditioning system and shows the effects of an unconventional—for Greece—lighting approach. However, further examining of its cost performance shows that these same factors are responsible for its bad cost rating, seventh out of ten. Peristeri has the second highest capital cost in the sample (after Hios pool) and below average servicing costs following the other two pools (where a substantial amount is spent on the pool related installations). Finally, the very poor rating in technical terms leads to the overall fourth place according to the GSS model of quantification and very close to the third building (Hios) according to the Survey's model—where cost has less impact.

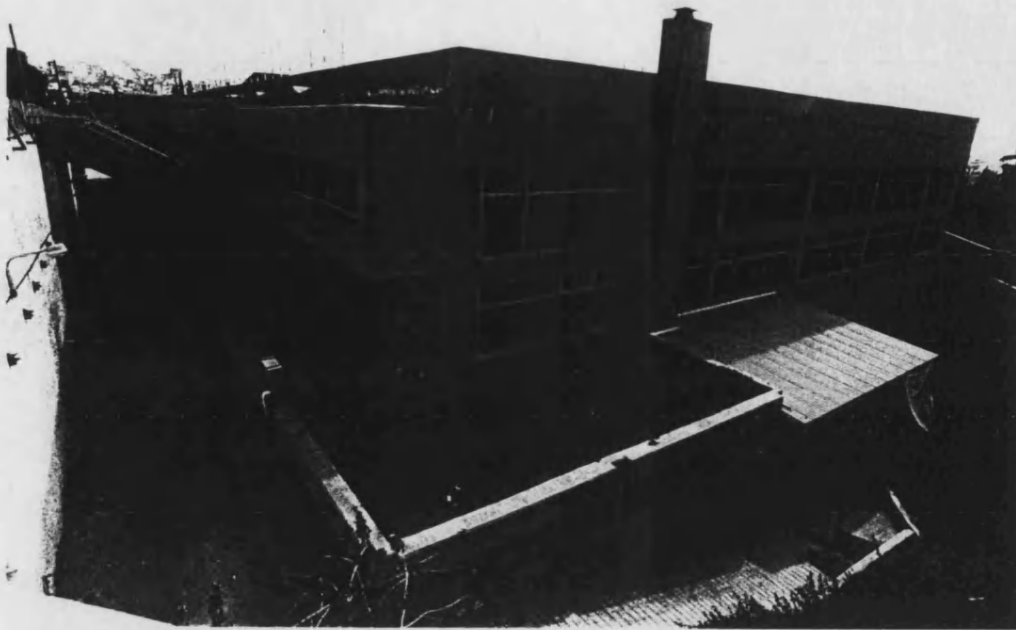
Figure 6.2. Mets Sportshall

Mets' cost performance is average—the two main pitfalls being the roofing capital cost and the heating running costs. As far as HUS is concerned, Mets' performance is also average, with an exceptionally good rating in acoustics and aesthetics whereas HVAC and lighting is fair. In technical terms, it is the worst performer; the prestressed reinforced concrete techniques and the imported insulation and waterproofing of the roof being the main reasons. Following this analysis it is in sixth place overall.

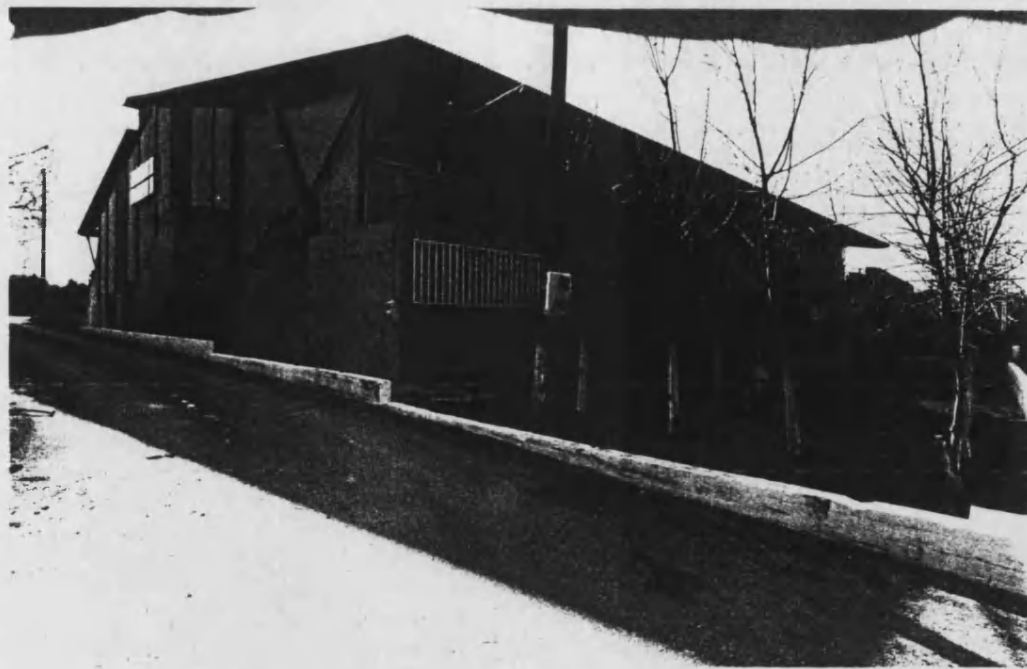
Figure 6.6. Loutraki Sportshall

Built in a small city thirty kilometres to the west of Athens, this hall is, considering the small population of the area, at a low level of utilisation. It is the second least used sportshall; on average 12 hours a day. The structural material used is glue-laminated timber, forming both the beams and columns of the structure. The three-pinned portal frames used span just under 40 metres. Their structure enables the incorporation of rooflights, made out of a specially imported synthetic material, "*isobelek*". The north facing windows improve natural lighting, both quantitatively and qualitatively. Another advantage of this structure is the low cost of the roofing (structure and covering)—less than 25% of the total capital cost.

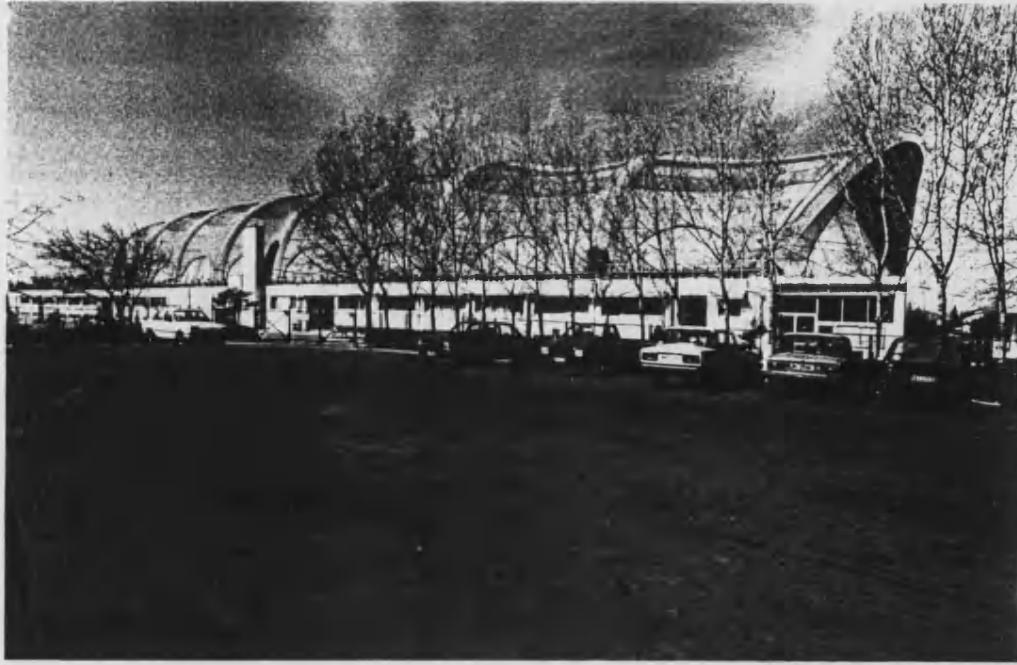
Figure 6.7. Posidonio Swimming Pool

As far as HUS is concerned, functionality and aesthetics rating is similarly low for both buildings. In terms of HVAC and acoustics Posidonio is marginally better rated. This is mainly caused by the better overall condition of the building as well as the ventilation and heating. Lighting performance is an exception—it is in the third place together with the other tent Hios. The reason being the better condition of the fabric. (Maybe self cleaned by the strong winds as well as the lower solar radiation). Finally this pool is rated in the seventh place out of ten—just in front of the identical Patra Swimming Pool.

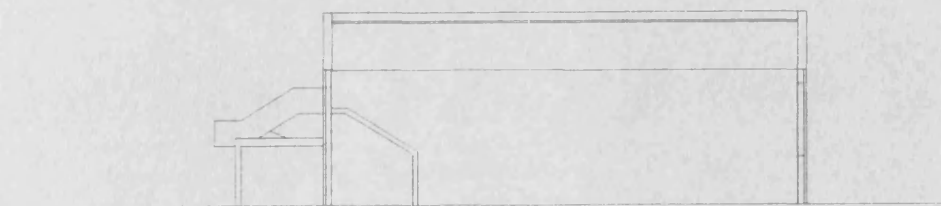
Figure 6.10. Arta Sportshall

Structurally, the roof has no problems at all; 14 years after erection and there is not even need for repainting of the structural frame. However, the actual covering and waterproofing have failed repeatedly leading to extensive unsuccessful repairs wrongly designed and/or executed. The main problem is the minimal slope of the roof. As a result there are serious problems of decay and mould in the walls (especially in the changing rooms) as well as the roof. Another problem observed is cleaning the windows. In order to overcome glare-related problems, the designer specified very high-mounted windows which are extremely difficult to clean and, as the personnel explained, they have to set up a whole scaffolding system. The result is that the windows are usually dirty reducing the amount of light and, since there is no rooflighting, the lighting is—partially—on for the whole day. Users rated this hall as the worst of the sample together with Byron hall except for aesthetics and acoustics where Patra, and to a lesser extent Posidonio, were considered as even worse. The heating is used during official games only (as reported by the committee) whereas the ventilation is carried out from only two fans which are insufficient during summer. As a result, windows and doors are opened to improve air circulation causing more problems of lighting, glare etc. The lighting is inappropriate, using fluorescent lamps instead of more powerful ones.

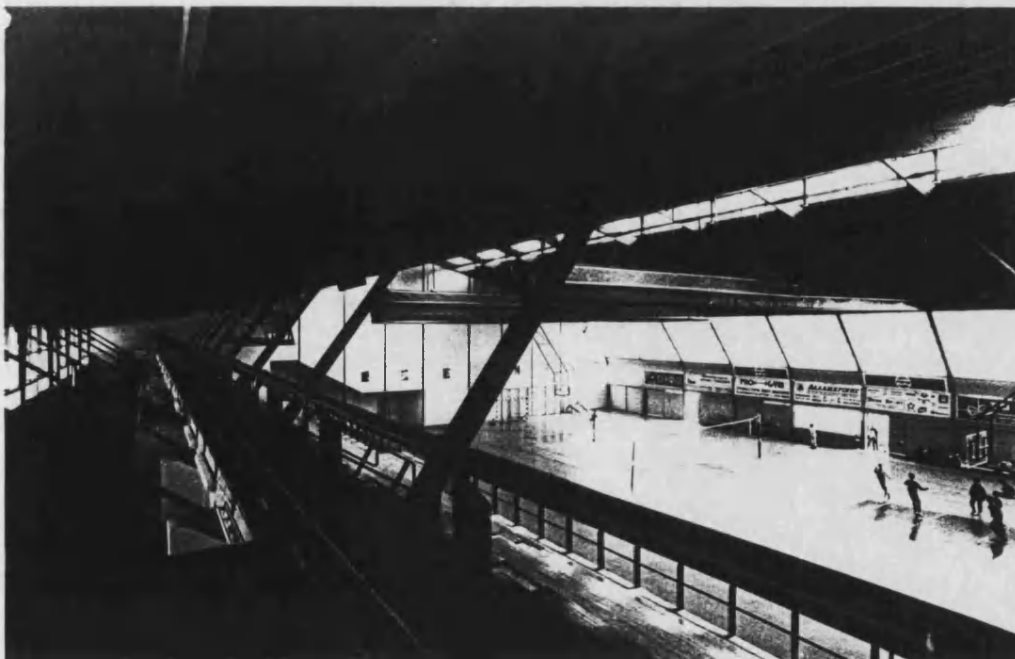
Figure E.12 Interior View of Loutraki Sportshall from the Seating Area (high contrast between natural lighting in seating versus playing area)

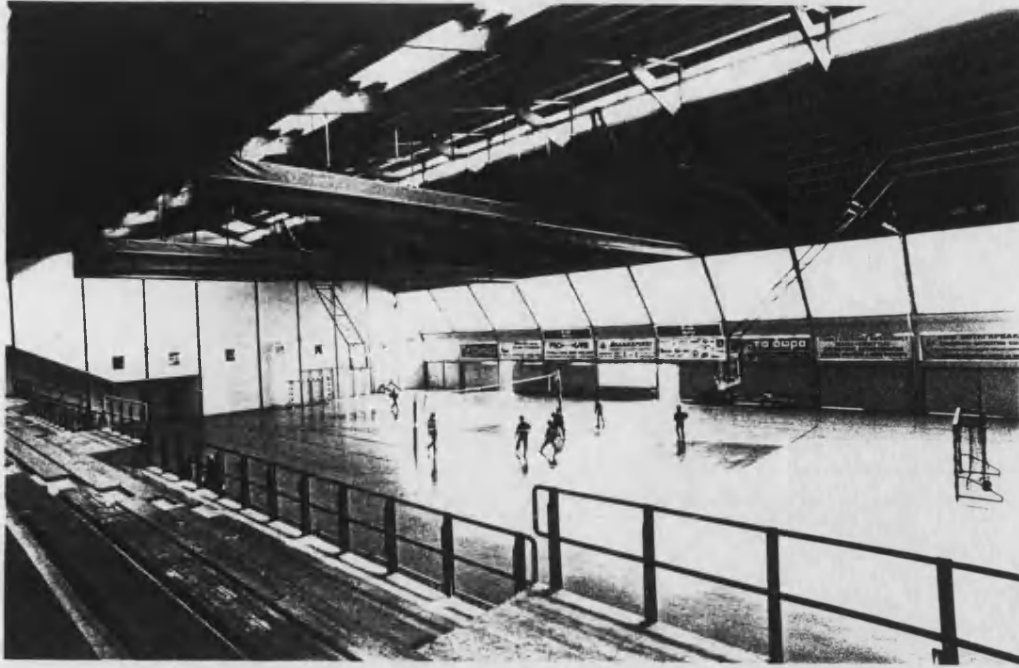
Figure E.13 Interior View of Loutraki Sportshall from the Seating Area (note two sources of natural lighting, north windows and north rooflight)

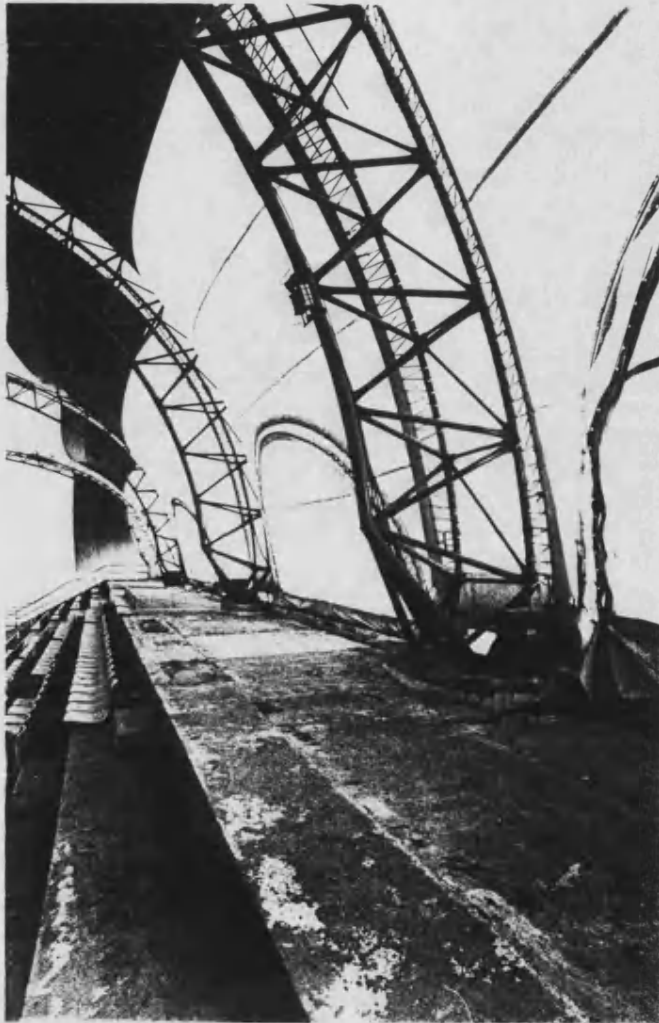
Figure E.16 Interior Detail of Beam Mounting in Posidonio Swimming Pool

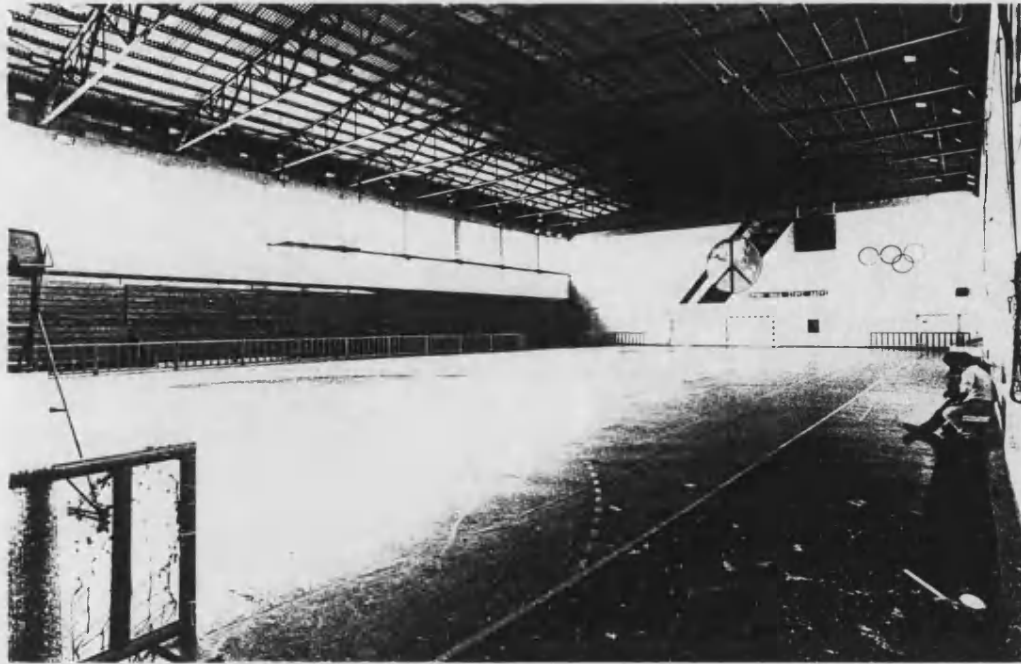
Figure E.21 Interior of Byron Sportshall from the Playing Area (early afternoon view, glare from the southwest facing windows)
