Radon gas as a constructive element in the chilean pacific coast the case of a manor house in Viña del mar (valparaíso).

Carlos Rizo Maestre ^{1*}, Claudio A. Sáez ², Ángel B. González-Avilés ², Antonio Galiano-Garrigós ², Víctor Echarri-Iribarren ²

¹ Department of Architectural Constructions of Alicante University

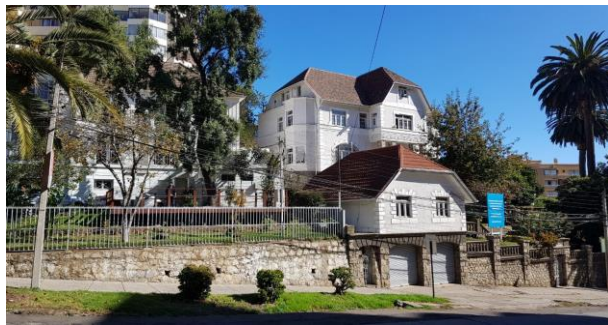
Fig. 2: Image of the Building Studied, Located in Traslaviña 450 Street in The City of Viña del Mar. It Currently Serves as the Center of Advanced Studies for the Universidad De Playa Ancha.

The construction studied on the radon gas indicator present in the interior was a 19th century manor house in the city of Viña del Mar, on the Chilean Pacific coast. This building currently serves as the headquarters of the Universidad de Playa Ancha and the former premises have been converted into research laboratories and management offices. (Fig. 2).

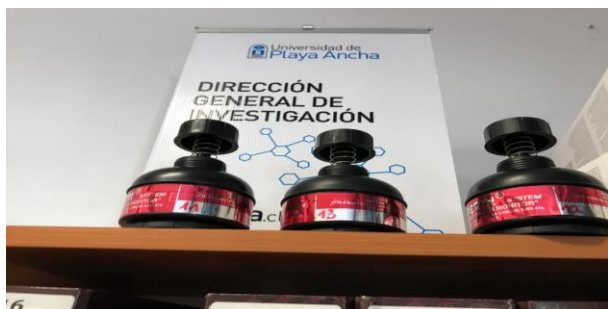
Fig. 3: Image of the Ionic Chamber of Electrete Placed in One of the Zones of Measurement.

The air quality study conducted with radon gas as an indicator was conducted using Ion Chamber Ionic Electret (CIE), a system that combines a chamber (plastic box of known volume) with a device or electret. CIE chambers are passive devices that function as integrator detectors to measure the average radon gas concentration during the measurement period. The electret works both as an electric field generator and as a sensor in the ion chamber. The radon gas, but not the disintegration products, enters the chamber by diffusion through an inlet equipped with a filter. Radiation emitted by radon and its disintegration products formed inside the chamber ionizes the air contained inside the chamber by reducing the detector surface voltage. A calibration factor then relates this voltage drop to the radon concentration in the space studied. Fig. 3 shows the elements used in one of the areas measured during the study.

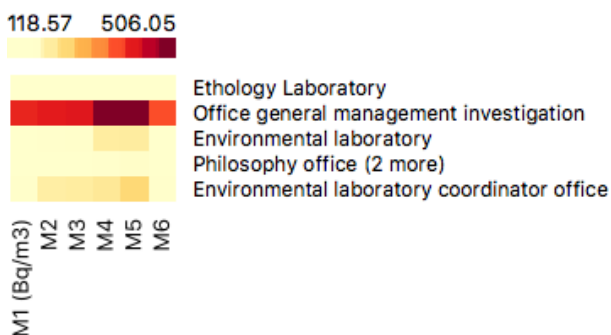
Fig. 6: Heat Plot of the Different Measurement Zones.

From the results obtained during the study in the Chilean manor house studied, a comparison is made between the different places measured with a short camera and a short electrete (used type of the CIE). As shown in Table 1 of the results, the values of radon gas in the air of the first five zones are similar (between 130 and 220 Bq/m3). The measuring zone six corresponding to the Office general management investigation have the highest presence of radon gas, with an average of more than 400 Bq/m3. Figure 6 shows the results with a Heat Plot.
