River–floodplain hydrology of an embanked lowland Chalk river and initial response to embankment removal

Citation Clilverd, H.M., Thompson, J.R., Heppell, C.M., Sayer, C.D., and Axmacher, J.C., 2013. River–floodplain hydrology of an embanked lowland Chalk river and initial response to embankment removal. *Hydrological Sciences Journal*, 58 (3), 627–650.

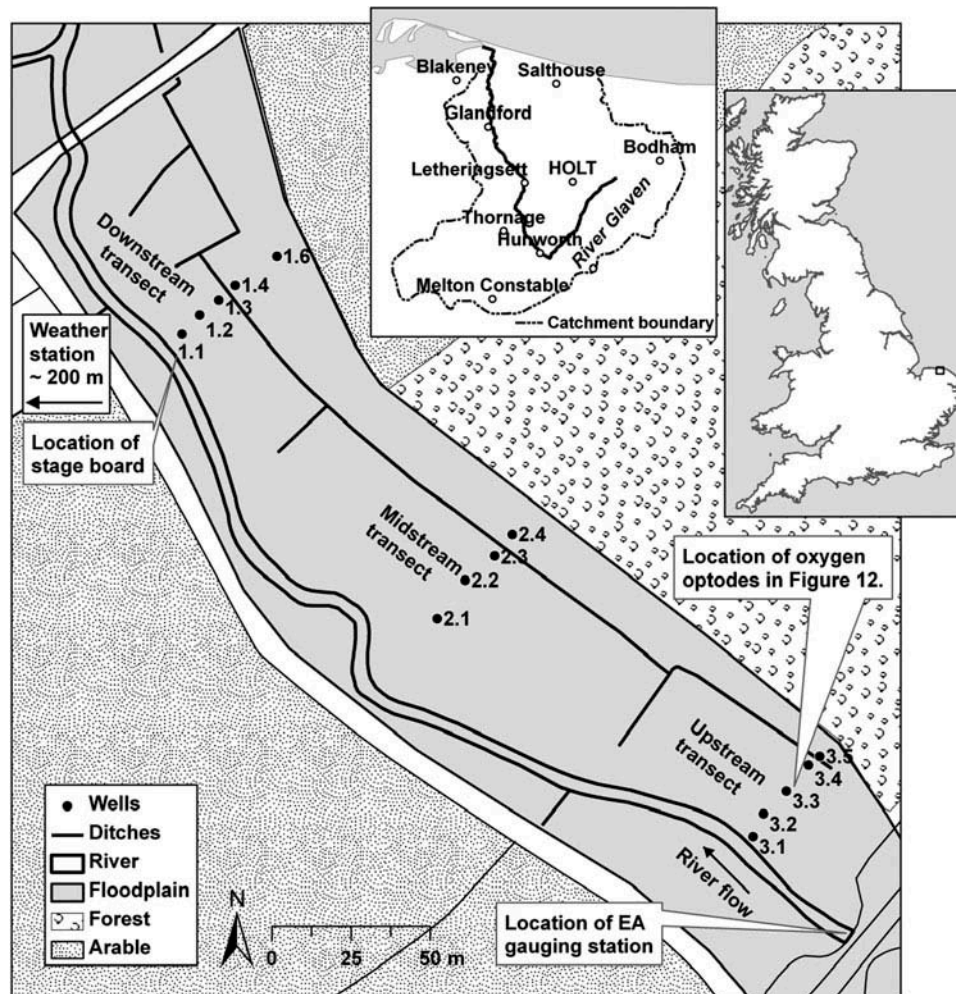
Fig. 1 The River Glaven restoration site at Hunworth, north Norfolk. The woodland and arable border along the northeast of the meadow delineates the base of a hillslope. Well 3.1 (upstream transect) was located on the river embankment; and Well 1.1 (downstream transect) behind the river embankment. The River Glaven catchment is shown inset, with the location of the study site at Hunworth.

The study was conducted at Hunworth Meadow on the River Glaven, north Norfolk, approximately 34 km northwest of Norwich ($52^{\circ} 52' 55.53''$ N, $01^{\circ} 03' 55.45''$ E; elevation approx. 20 m). Average temperatures range from approx. 4°C in January to 17°C in July (date range 1950–2010, British Atmospheric Data Centre 2010). Mean annual precipitation is approx. 660 mm (date range 1950–2010), with highest rainfall typically occurring during the autumn and winter months (British Atmospheric Data Centre 2010). The River Glaven is 17 km in length, has a catchment area of 115 km² and flows southwest from headwaters in Lower Bodham before taking an acute turn at Hunworth to continue northwards to Blakeney Point, where it discharges into the North Sea (Fig. 1) (Pawley 2008, Jacklin *et al.* 2010).

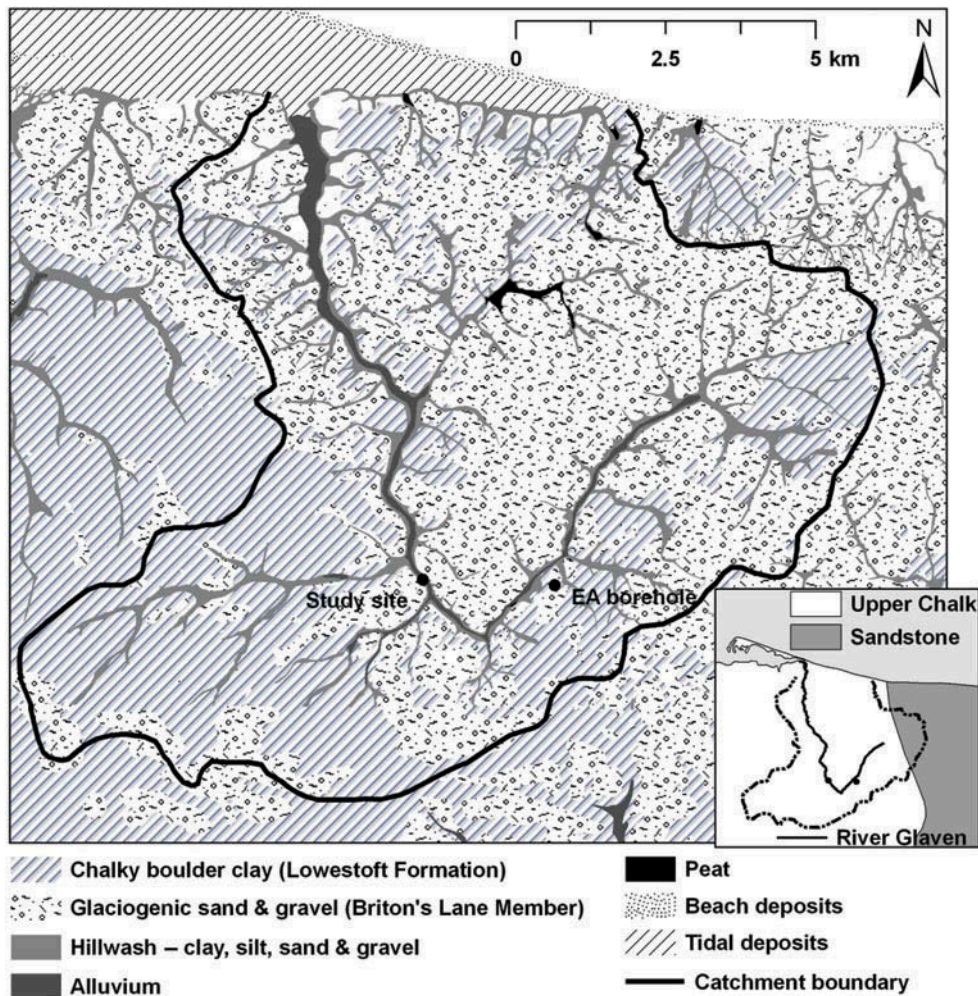
Fig. 2 Superficial geology of the River Glaven catchment, and regional bedrock geology (inset), based on British Geological Survey 1:50 000 map data.

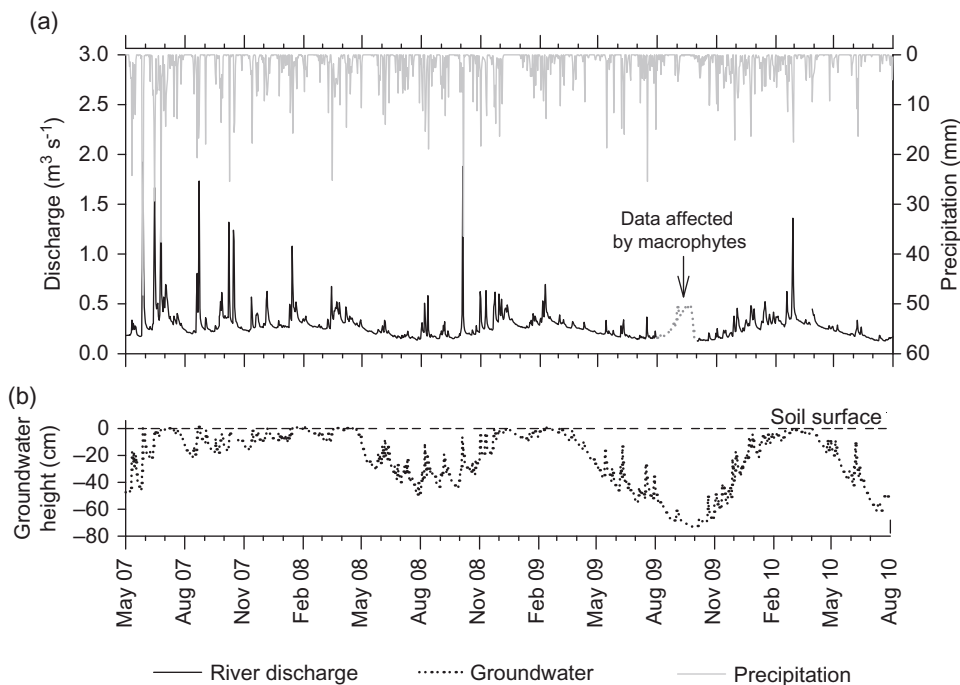
Fig. 3 Temporal variation in (a) mean daily river discharge and total daily precipitation, and (b) representative mean daily groundwater height (downstream Well 1.6) for the four study years (2007–2010). The river discharge data affected by aquatic macrophyte growth (August–October 2009) are highlighted in (a).

This is typical of permeable chalk streams, which average 0.83 BFI (range: 0.53–0.99) and >30% Q95 (Gustard *et al.* 1992, Sear *et al.* 1999). River flow at the study site, in general, followed the characteristic annual hydrograph of a chalk stream, with increased discharge over the winter from early December until March. However, some of the highest recorded river flows occurred during the summer (Fig. 3(a)).

The period of observation prior to the restoration (2007–2008) was characterised by cooler, wetter spring/summers (Fig. 3(a) and Table 2). Summer (June–September) precipitation in 2007 and 2008 totalled 393 and 281 mm, respectively and exceeded potential evapotranspiration, which totalled 248 and 262 mm, respectively (Table 2). Summer precipitation in 2007 was highest of the four-year study period, which resulted in a shallow water table within 10 cm of the ground surface for much of the growing season between March and September (Fig. 3(b)). In comparison, water table elevations in 2008 were typically within 10 cm of the ground surface between March and May, due to a period of prolonged precipitation and high river discharge (Fig. 3(a) and (b)), and were slightly lower during the summer, averaging 33 cm below the ground surface (Fig. 3(a) and (b)).

average between 2009 and 2010, water table height was on average 13–17 cm higher in 2008 compared to 2009 and 2010 (Fig. 3(b)).

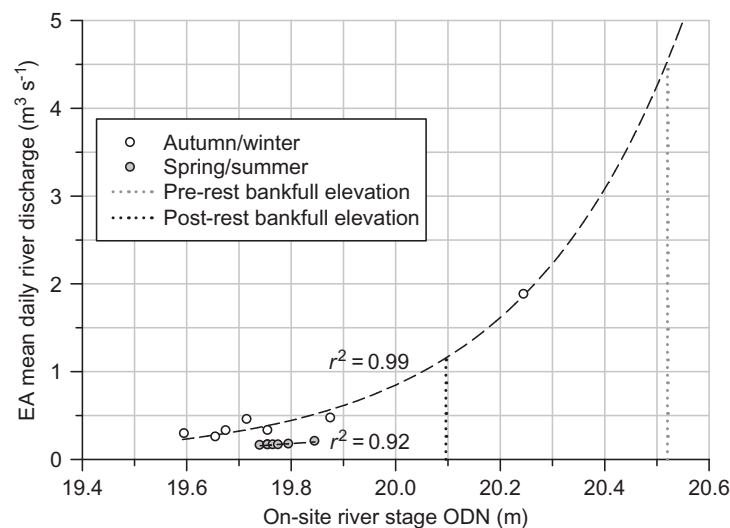
Fig. 4 Relationship between on-site river stage Ordnance Datum Newlyn (ODN) and mean daily river discharge used to determine bankfull capacity. Lines indicate statistically significant regression at $p < 0.05$, $y_{\text{autumn/winter}} = 7.6795 \times 10^{-29} e^{3.2285x}$, $y_{\text{spring/summer}} = 0.415x - 8.0379$.

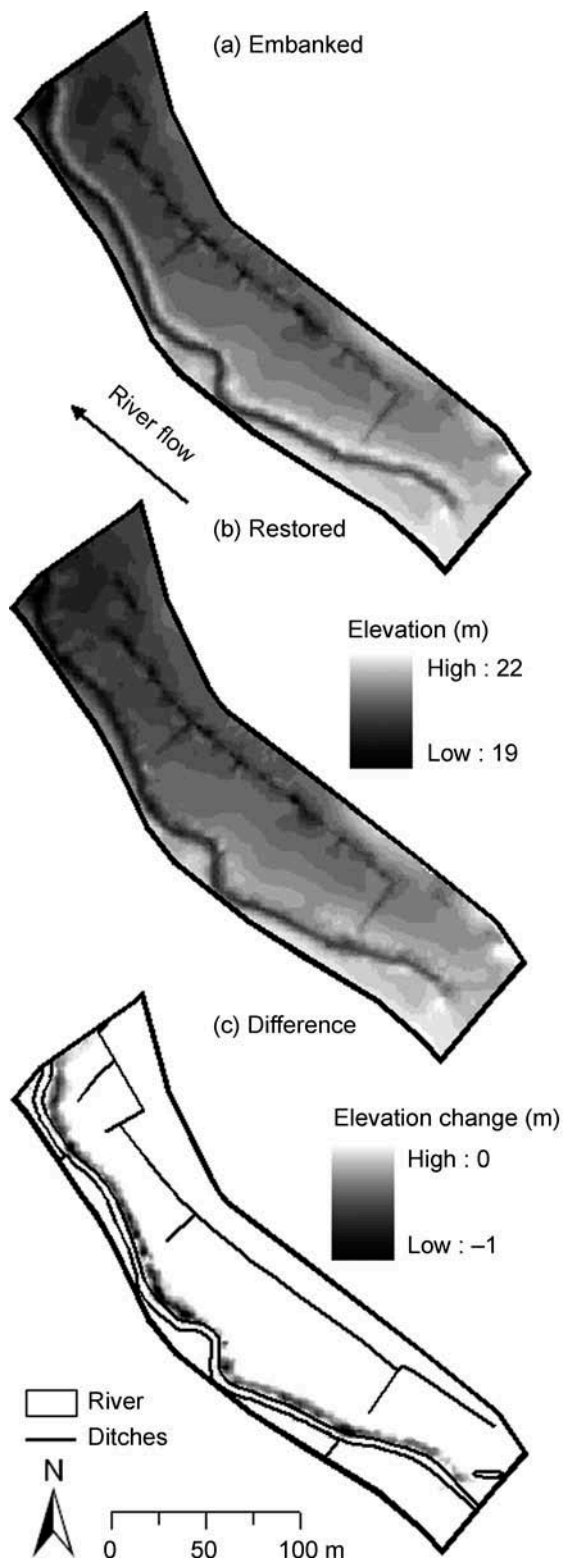
Fig. 5 Elevation of Hunworth Meadow study site showing (a) before and (b) after embankment removal, and (c) the difference in elevation. The DEMs were created using dGPS survey data collected in (a) June 2008 and (b) July 2009.

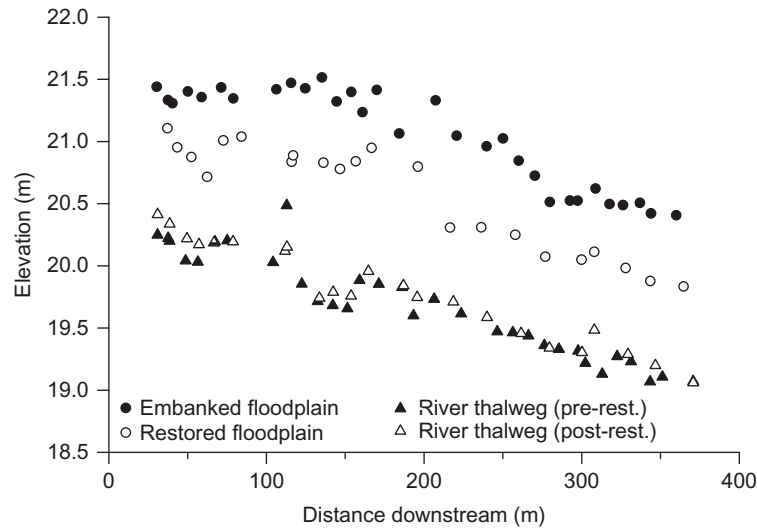
Fig. 6 Comparison of floodplain elevation adjacent to the river channel along the study reach before (embanked) and after (restored) embankment removal. The embanked floodplain data represent the highest point on the embankments, and the restored floodplain data represent the closest corresponding sample location after embankment removal. The river thalweg (pre- and post-restoration) is also plotted with distance downstream.

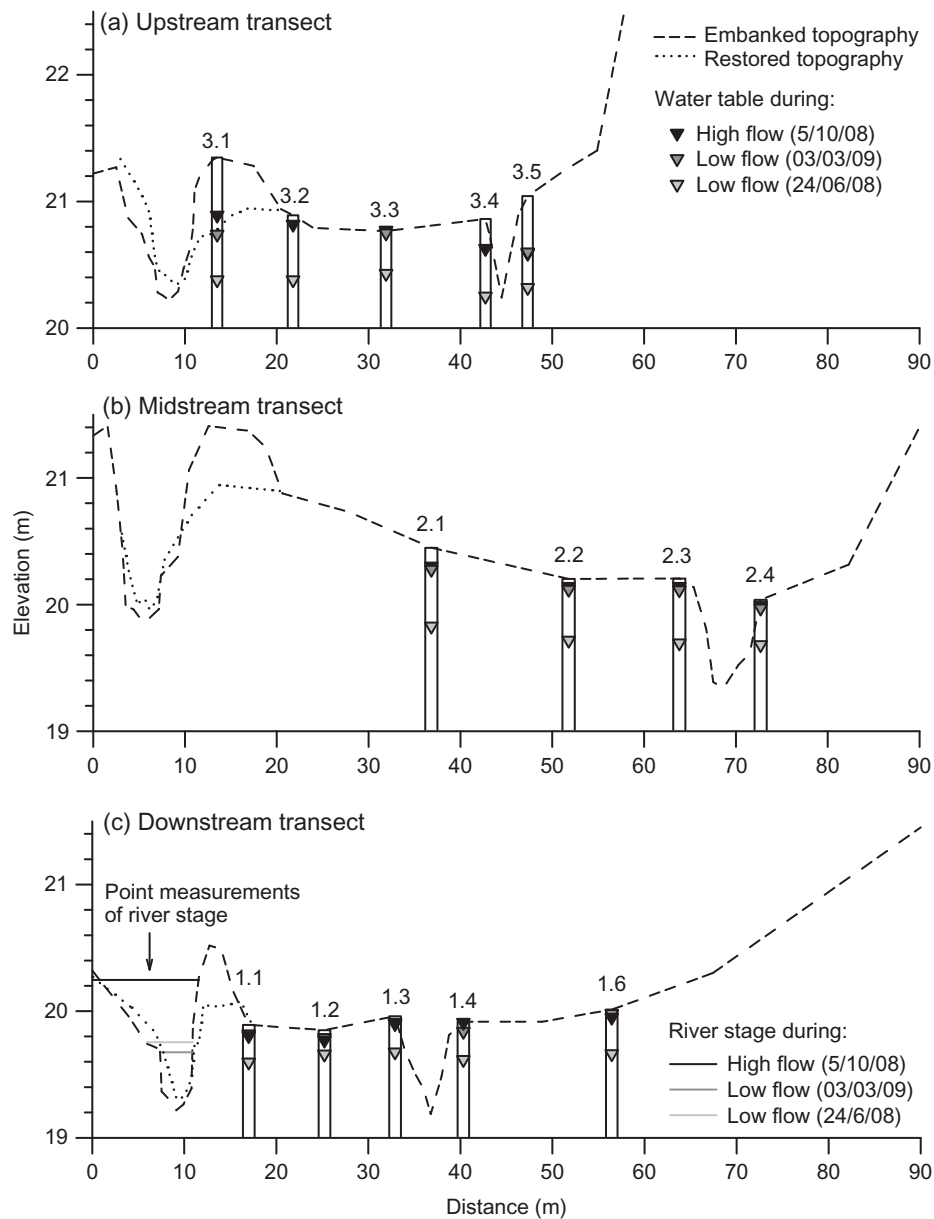
Fig. 7 Cross-sections of the meadow and river channel before (embanked) and after (restored) embankment removal. Typical mean well water levels are shown along the three transects in relation to low and high river stage. River stage measurements at the downstream transect are single point measurements.

Figure 7 shows groundwater levels on the floodplain during three different river flow conditions; high flow in autumn (October 2008), low flow in spring (March 2009) and low flow in summer (June 2008). The hydraulic gradient across the floodplain is relatively flat, averaging 6.1–9.4 mm m⁻¹ (Table 3). Groundwater levels at the upstream transect indicate complex movements of groundwater, with shifts in hydraulic gradient observed between periods of different river flow. In general, at the upstream and midstream transect, groundwater levels decreased from the river towards the ditch, which was located at the lowest point of the floodplain (Fig. 7(a) and (b)). This was most apparent at the midstream well transect, where the river thalweg was above the ditch thalweg (Fig. 7(b)). Convergence of floodplain and hillslope flowpaths in the region of the ditch would explain the saturation of surface soils in this area of the floodplain. Conversely, at the downstream transect, where the topography flattens, groundwater levels tended to flow from the base of the hillslope towards the river (Fig. 7(c)).

Groundwater levels measured in wells next to the river (wells 3.1 and 1.1) were not always lower than river stage, indicating temporal changes in hydraulic gradient (Fig. 7(a) and (c)). During peak discharge conditions, river stage was above the water table in the floodplain and flow was directed away from the

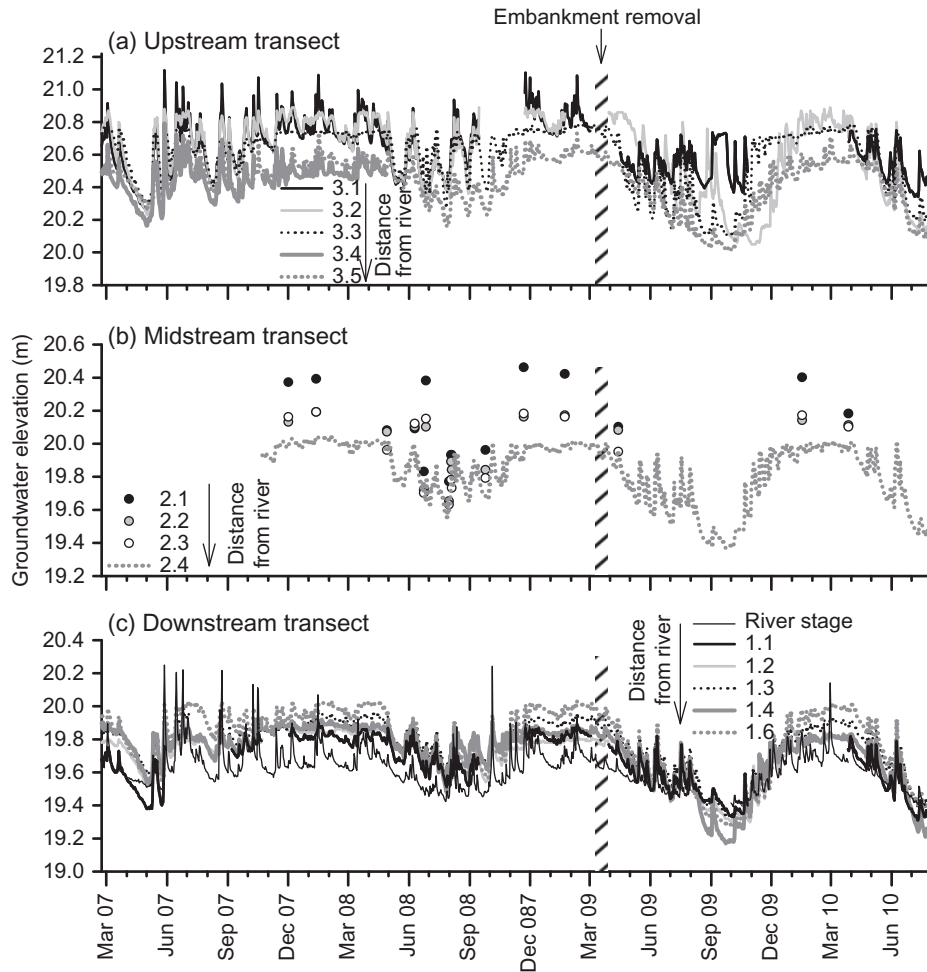
Fig. 8 Temporal variation in mean daily groundwater height above Ordnance Datum Newlyn (ODN). Well 3.1 (a) was located on the river embankment; wells 3.5 (a), 2.4 (b) and 1.6 (c) were located at the base of the hillslope (see Fig. 1). Continuous measurements of groundwater height were not available for all of the wells at the midstream transect, hence, hand measurements are also plotted (circles). River stage is plotted at the downstream transect (c).

2009 (Fig. 8(a) and (c)). In contrast to the observations close to the river, water levels in all the other wells were approximately 10–60 cm lower during the summers following the restoration (Fig. 8(a)–(c)). Winter water table elevations remained unchanged following the restoration (Fig. 8(a)–(c)), with water levels within 10 cm of the soil surface in all wells. Furthermore, embankment removal lowered the soil elevation to within 0–50 cm of the water table at Well 3.1. This resulted in increased saturation of surface soils on the restored river banks for much of the summer in 2009 and 2010 (winter 2009 data not available), which is likely to have important effects on soil physicochemistry in this region of the floodplain.

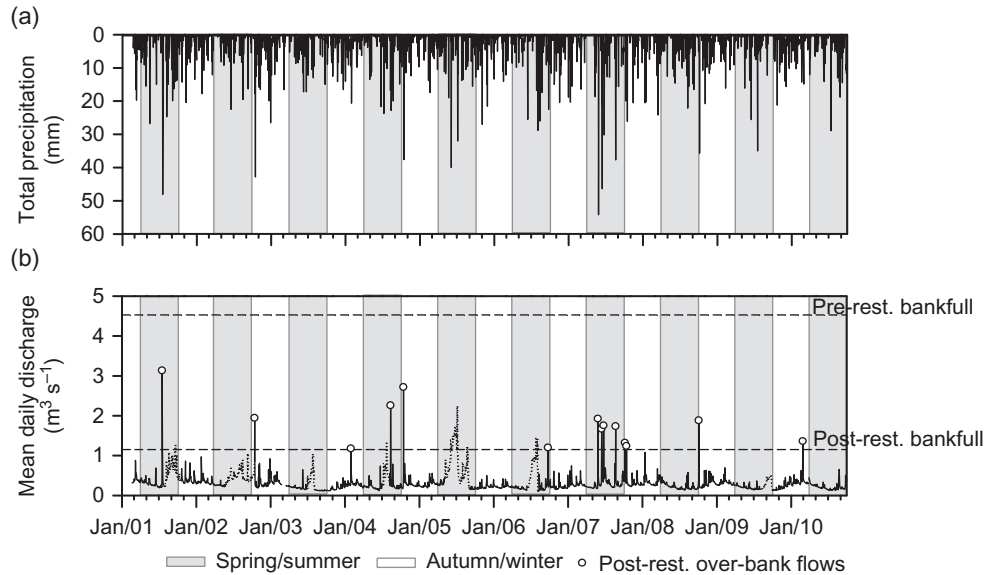
Fig. 9 Time series of (a) total precipitation, and (b) mean daily river discharge from 2001 to 2010. Pre- and post-restoration bankfull capacity at the downstream river stage is shown in (b), above which inundation of the floodplain would have occurred. River discharge data affected by aquatic macrophyte growth have been highlighted with dotted lines and were not included in the analysis of bankfull discharge.

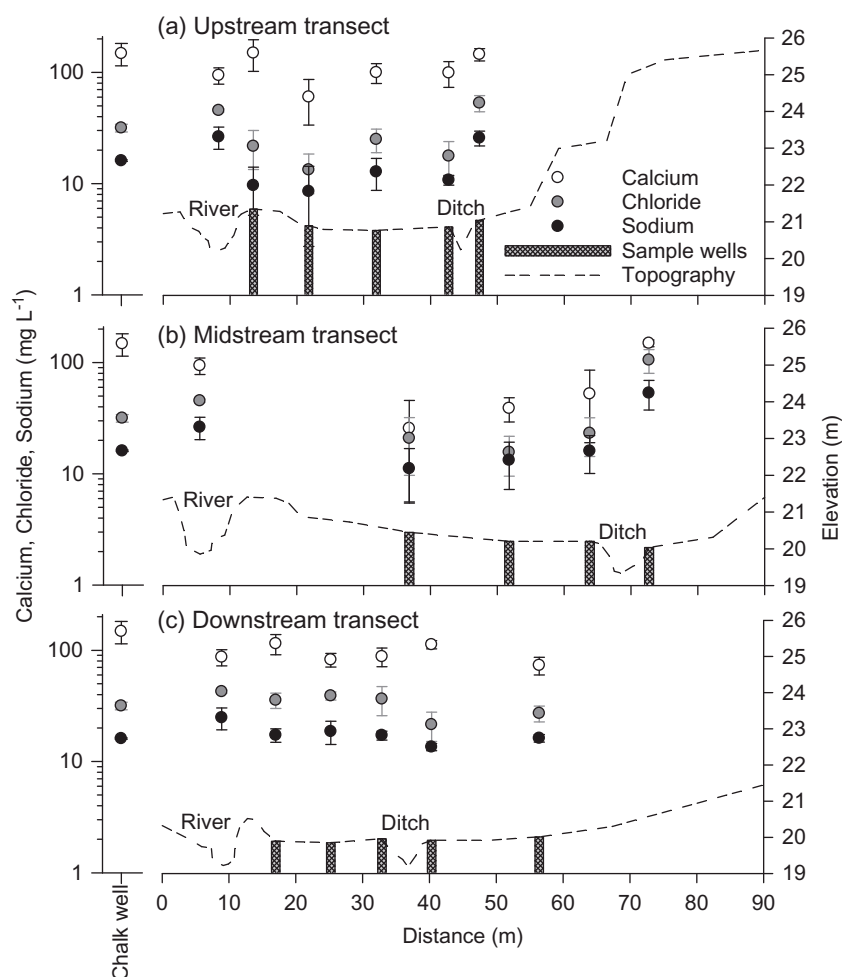
**Fig. 10** Spatial variation of selected ions (mean \pm 95% confidence interval; log scale) along subsurface flowpaths at the upstream, midstream and downstream well transects for 2007–2008. Pre-restoration topography is plotted to identify the sample locations in relation to the river and hillslope.

from the river (Fig. 10). One exception was the chemistry in wells 2.4 and 3.5, located at the base of the woodland hillslope (Fig. 10(a) and (b)), which

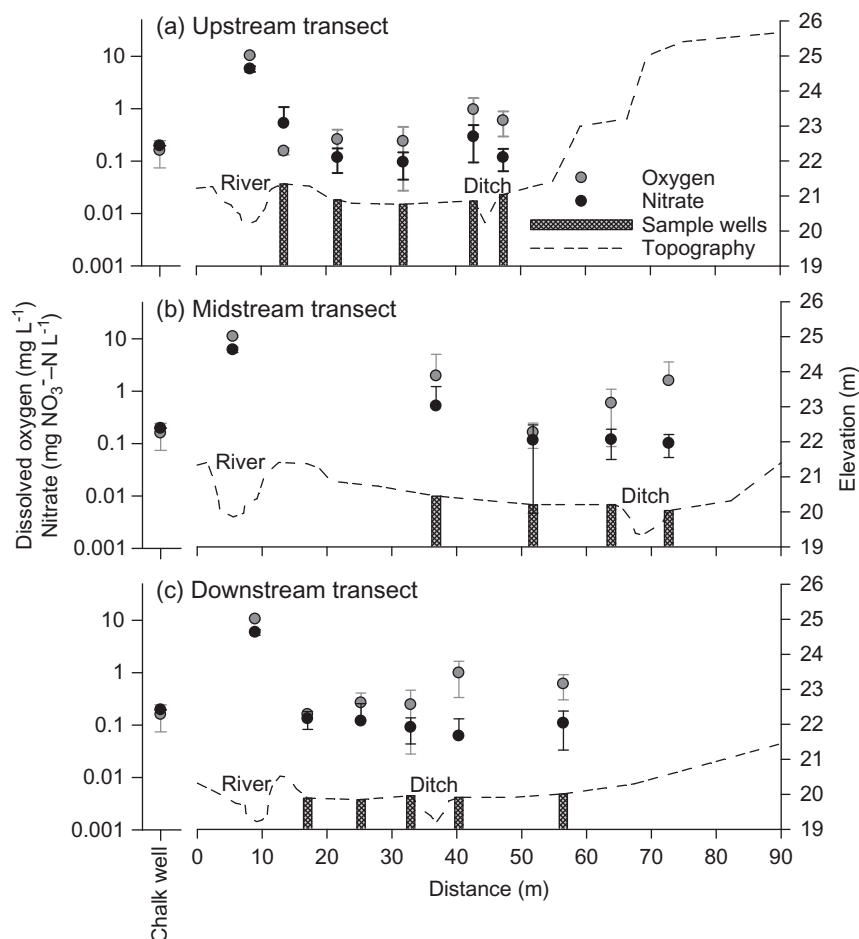
Fig. 11 Nitrate and DO concentrations (mean \pm 95% confidence interval; log scale) in river water and groundwater along subsurface flowpaths at the upstream, midstream and downstream well transects for 2007–2008. Concentrations in the EA borehole (instrumented in the chalk) are also shown. Pre-restoration topography is plotted to identify the sample locations in relation to the river and hillslope.

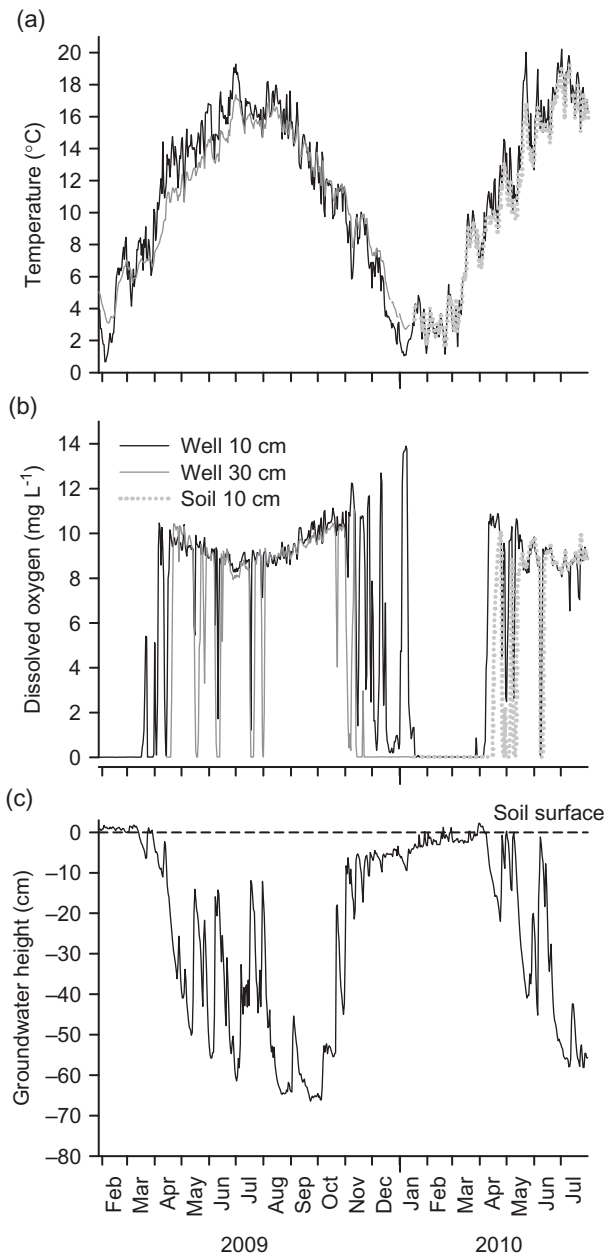
Fig. 12 Temporal variation in (a) temperature and (b) DO concentration in well water and soil in relation to (c) changes in groundwater height. When groundwater height is below the respective oxygen optode installation height (10 and 30 cm; see text for details), optode data represent atmospheric temperature and saturated DO conditions.

Dissolved oxygen concentration in surface soils (top 10–30 cm) was strongly coupled with water table height (Fig. 12(b) and (c)). As groundwater rose vertically through the soil profile and surface soils became saturated, DO concentration decreased

rapidly within a day to 0–2 mg L⁻¹, indicating reduced conditions (Fig. 12(b)). As the water table height fell once again, DO concentration increased at a rate of about 0.8–1.4 mg L⁻¹ d⁻¹ to atmospheric saturation (Fig. 12(b)). Groundwater DO did not increase at any point during periods of high river flow and elevated water table, suggesting that oxygen-rich river water did not inundate (via over-bank flow) the
