Remoulding of the Mercia Mudstone Group around CFA pile shafts

Observations of the remoulded zone around continuous flight auger piles constructed in the Mercia Mudstone Group

Abstract: A field test has been undertaken to investigate changes to *in situ* Mercia Mudstone at the pile soil interface after installation of four 5.5 m long 350 mm diameter CFA piles. The test investigated whether a remoulded zone exists, the extent of the zone, changes caused by remoulding and the effect of the installation method. The piles and surrounding soil were excavated after installation to a depth of just under 2 m. The sections of pile and surrounding soil were returned to the laboratory where a variety of detailed observations at both micro and macroscopic scales were undertaken, together with chemical and mineralogical analysis. It was found that a remoulded zone existed in all piles but that this varied in thickness both laterally and vertically around a pile. Across all piles the maximum thickness observed was 55 mm. The average thickness, fabric and texture were all affected by installation method. A distinctive vertically orientated fabric was observed in which up to four vertically orie

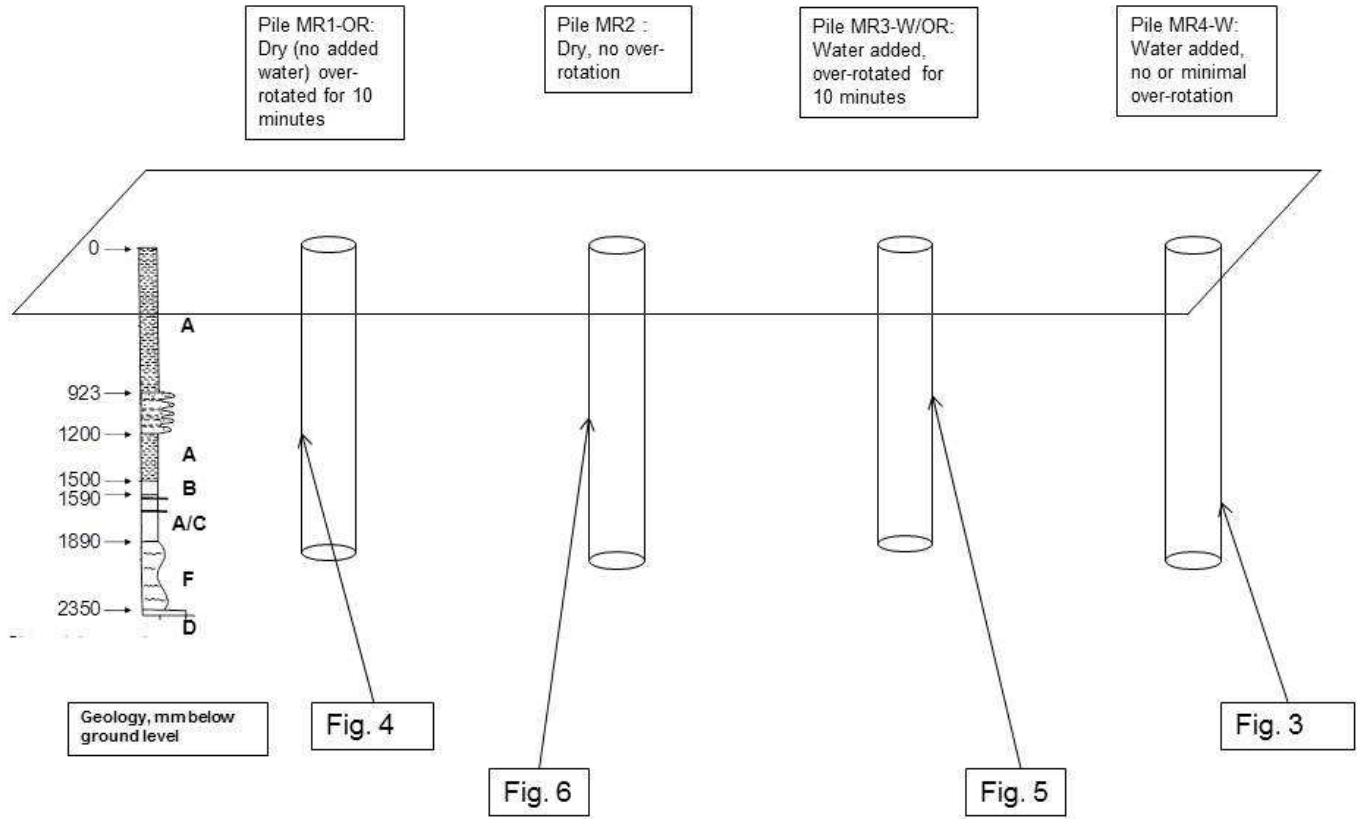
Figure 2a Schematic figure showing placement of piles in the ground, relative lengths of piles, approximate locations of figures 3-6 and stratigraphy (see figure 2 for stratigraphy).

The field test required the construction of a line of continuous flight auger piles, which would be left to cure and then excavated so that the pile-soil interface and any zone of remoulded soil could be examined. The method used to install each of the piles was varied to investigate the effect that this might have on the pile soil interface and remoulded soil zone. None of the piles were loaded.

The piles were all installed on 26th June 2007 between 13:00 and 16:00. There were four test piles 5500 mm deep and 350 mm in diameter and one practice pile 2000 mm deep and 350 mm in diameter. They were all installed using a Casagrande B125 rig in Continuous Flight Auger (CFA) mode. The concrete used was a C28/35 strength structural concrete with a pumpable mix.

The different installation methods used for the four test piles were as follows:

- MR1-OR: Dry (no added water) and with the auger over-rotated at the toe for ten minutes
- MR2 : Dry and with no or minimal over-rotation of the auger
- MR3-W/OR: Water added and over-rotated at the toe for ten minutes
- MR4-W: Water added and with no or minimal over-rotation

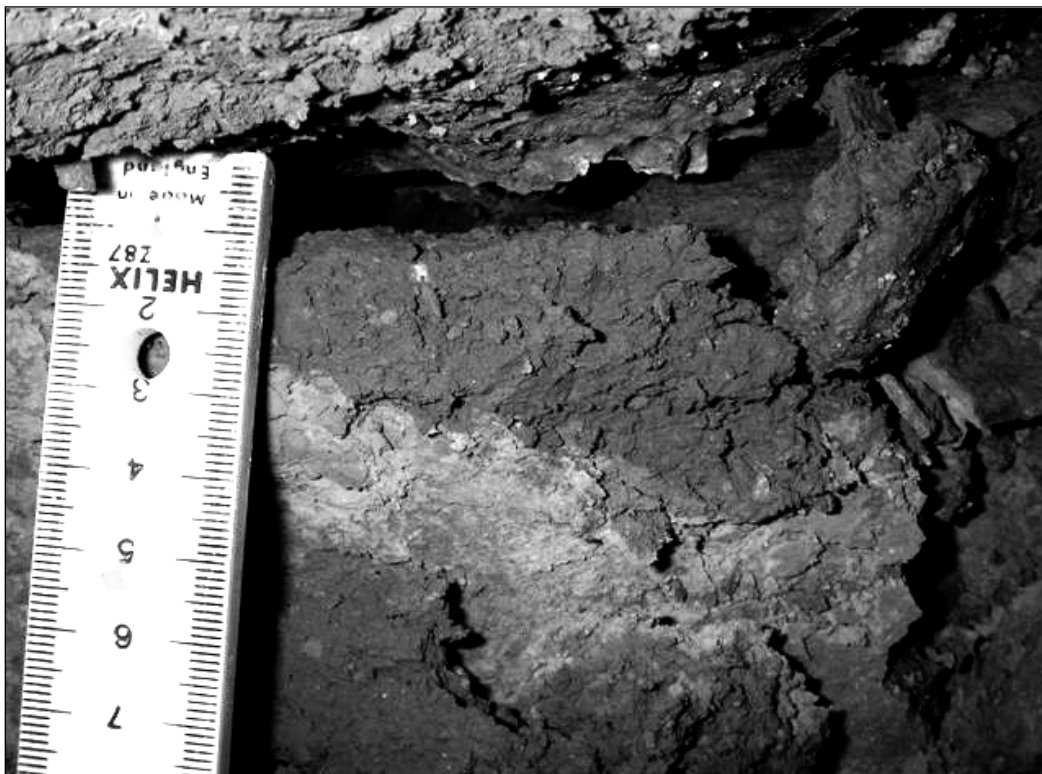
Figure 4 The boundary between the host soil and remoulded soil around pile MR1-D/OR, 819-1277mm bgl as viewed from above. The lateral variation in remoulded zone thickness can be seen.

The observations reported above can be explained by considering the continuous flight augering process. The often uneven boundary between the remoulded and undisturbed soil indicates that because of the layered nature of the *in situ* soil the auger breaks rather than cuts through some layers with the cutting teeth at the end of the auger. The size of remoulded zone, as much as 55 mm that is equivalent to an approximately 30% increase in radius, also indicates that material is being broken away. It is unlikely that the auger would move laterally by that amount whilst creating the cavity and if it did so the sides of the cavity would not change in dimension so dramatically over such a short distance, see Figure 4.

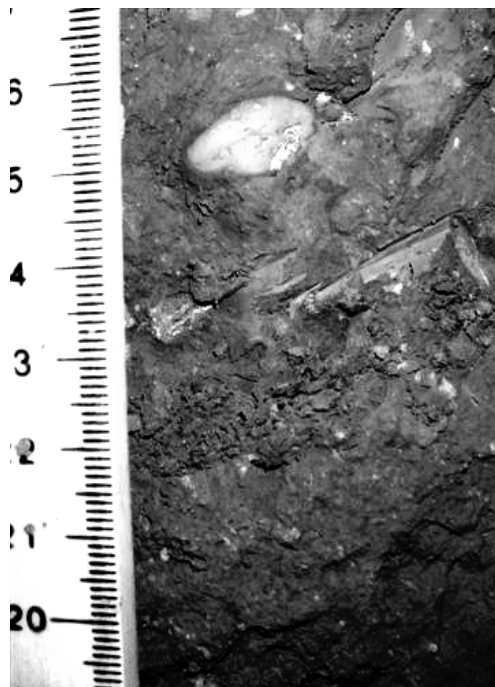
Figure 6 The vertical elevation of the remoulded surface of pile MR2 showing free aggregates within the remoulded layers. 1000-1457mm bgl.

Around all piles, pieces of aggregate were found within the remoulded zone, which were unlike anything occurring naturally in the geology on site (Figure 6). These aggregates have therefore been assumed to
