Investigation of the Rail-induced Vibrations on a Masonry Historical Building

Train-induced Vibration Measurement on Little Hagia Sophia Mosque

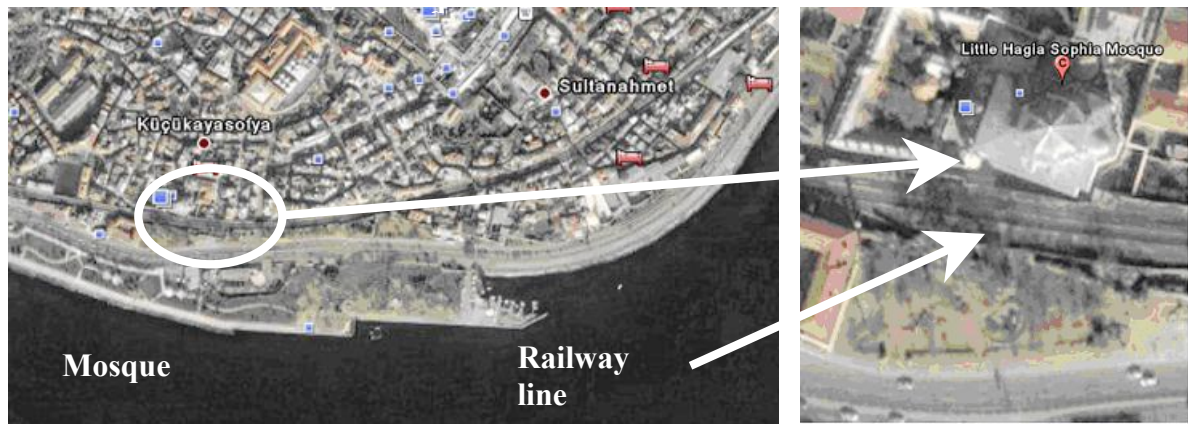
Figure 1. Bird's eye view of Little Hagia Sophia Mosque

Turkey. Although previous analyses of the building have been published [7, 8, 9], transmission characteristics of nearby rail-induced vibrations have not been presented before. The Mosque is located in the district of Eminonu in Istanbul, close to the Marmara Sea from which it is separated by the Sirkeci-Halkalı railway line and the coastal road (Fig. 1). The site soil is composed of clay and marl of early Pliocene period. It is a cohesive type of soil composed of fine particles. A plan view of the building and the proximity to the transport lines, along with instrumentation in the garden of the mosque can be seen in Fig. 2. At their closest points, the mosque is 4.8 m from the railway line. Two tests are presented herein.

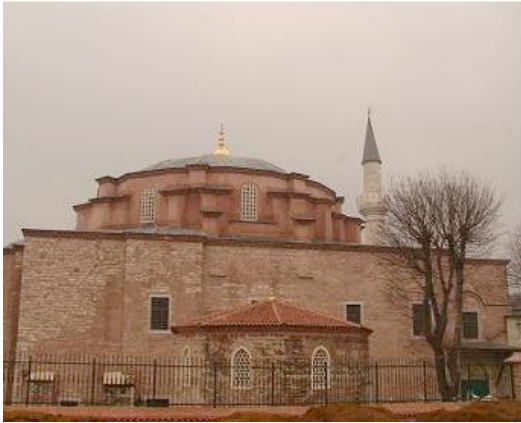
a) Overview

Figure 2. Close-up of Little Hagia Sophia Mosque

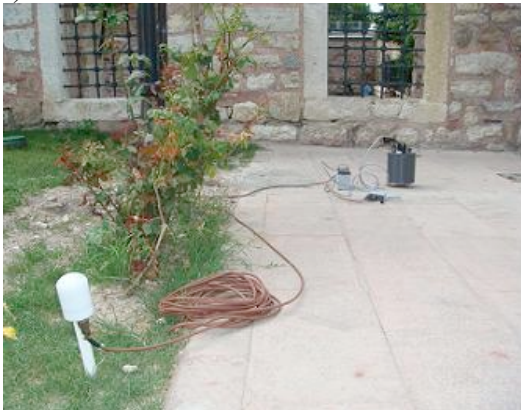
b) Sample instrumentation in the garden

For Test 1, within the physical constraints of the site, an area was chosen where 4 instruments could be placed in a straight line. For each passing train, ground vibration measurements were taken at 4 equidistant offsets from the railway. Seismographs are labelled as A-D, and each preceding number indicates the test [e.g. 1A means instrument A in Test 1]. Instrument A was the closest seismograph to the railway, while instrument D was the furthest (Fig. 3a). For Test 11, instrument C was placed next to the structure and A and D were placed in windows of ground and first floor respectively, while B was placed on the mid-slab close to the railway line to evaluate floor vibrations (Fig. 3b).

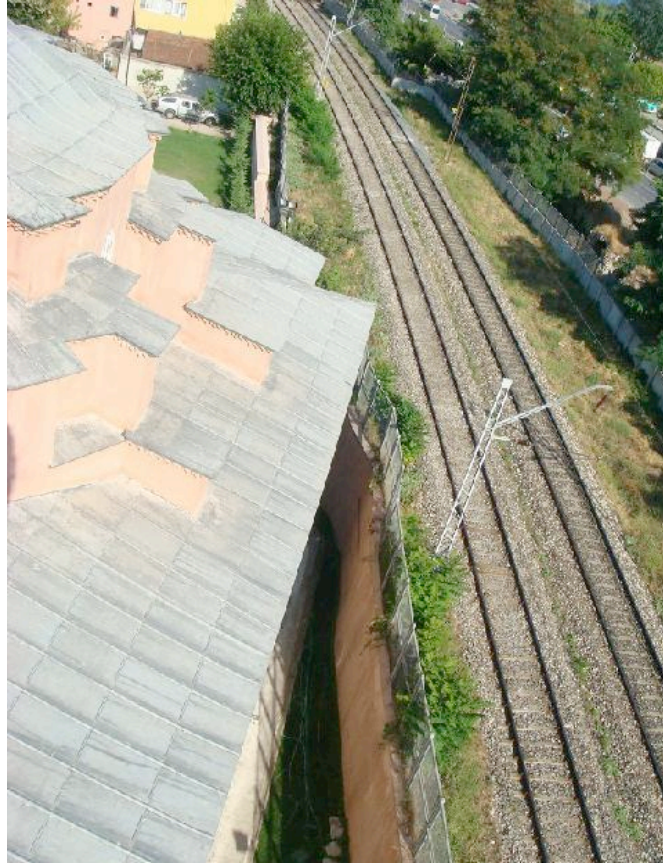
c) Proximity of the mosque to the railway line

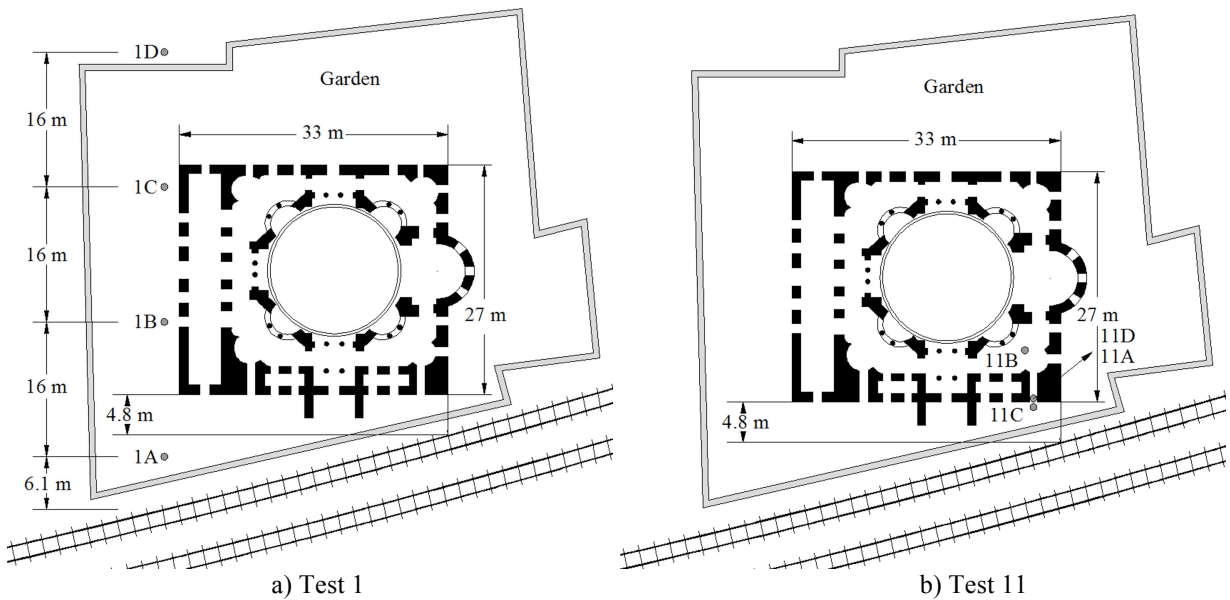
a) Test 1

b) Test 11

Figure 3. Measurement points locations

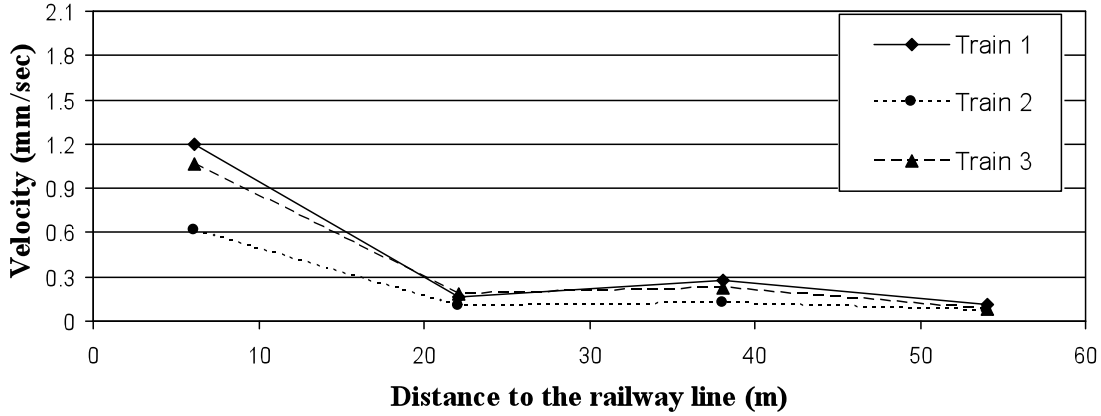
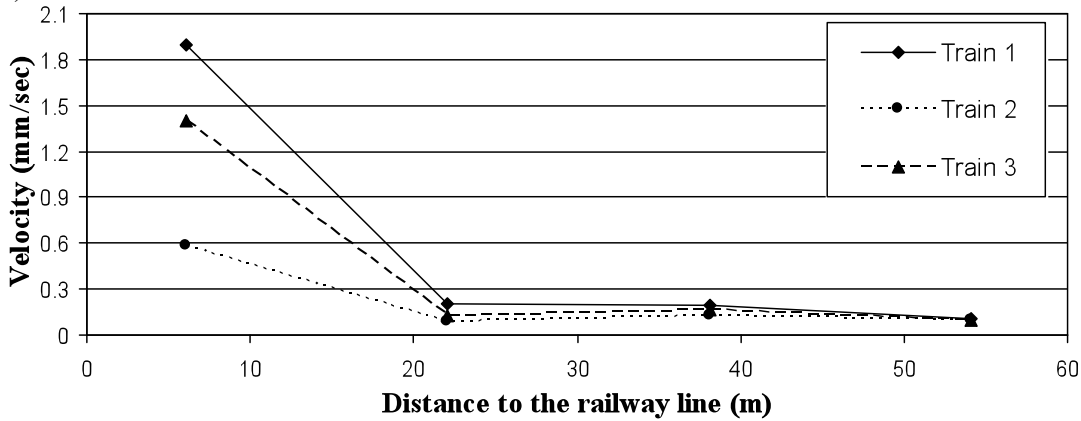
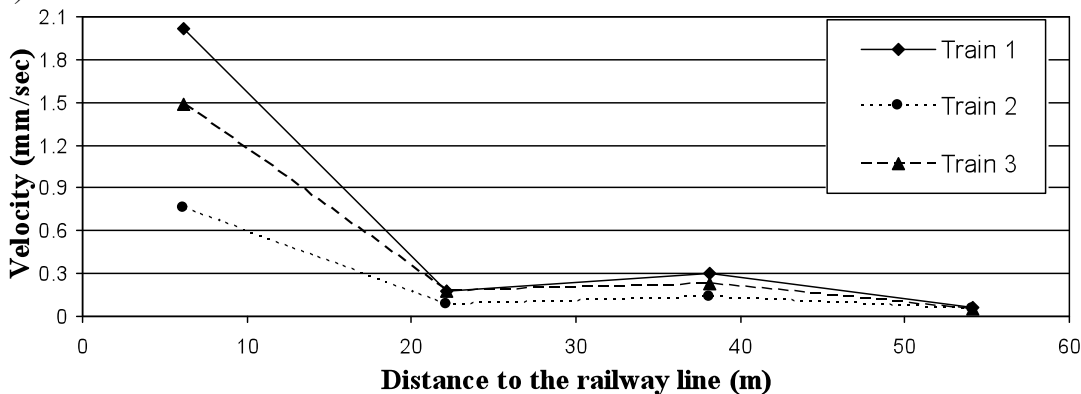
a) East-west

b) North-south

c) Vertical

Figure 4. Wave transmission of train-induced ground vibrations during Test 1

Peak particle velocities in 3 vertical directions at each point for 3 trains are presented for Tests 1 and 11 (Figs 4 and 5, respectively). In Fig. 4, ground surface wave transmission patterns comprised 2 regions. Up to ~25m from the source, amplitudes varied significantly depending on train input,

thus representing a critical region. Beyond this point, response was quite uniform, although of importance's is that in this second region amplitudes exceeded 0.3mm/sec, putting them within human perception and possible structural damage, if building amplification occurs [12]. Vertical vibration components were slightly larger than the east-west and north-south components. This is attributable to the fact that Rayleigh waves predominate on the ground surface, and their vertical components are dominant over horizontal components. Moreover, the anisotropy and heterogeneity of the soil may also cause that [13].

Additionally, an amplification zone in the ground was discovered 35-45m from the source (Fig. 4). Similar to that reported by Xia et. al. [11]. Such amplification zones may be critical during design. Furthermore, source vibration levels varied greatly (Fig. 4). For example, vertical vibration level differences between trains 1 and 2 in Test 1 was about 62%. The variation is mostly attributable to train speed (generally varying 70-90km/h) as equipment and live loading changed little as reported by Xia et. al. [11]. Measurements of ground-borne vibrations showed slight dominance of the vertical component on the ground (Fig. 4). This was more noticeable in falling weight studies [14].

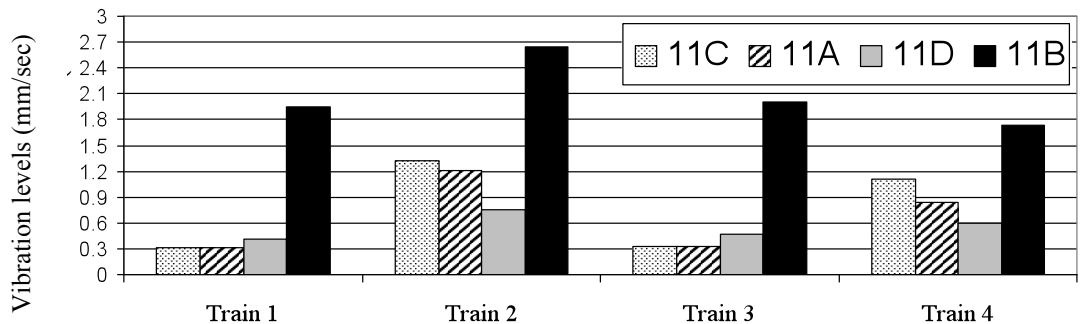
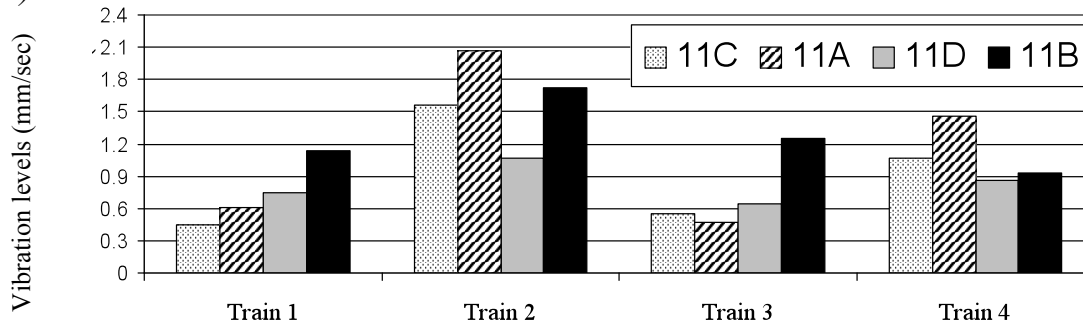
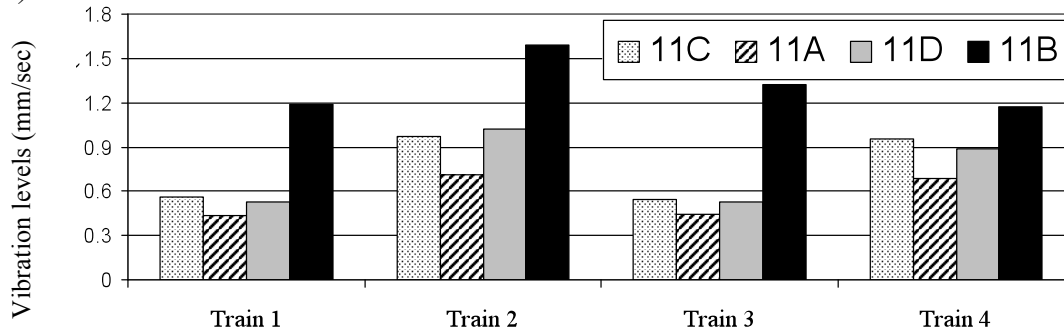
a) East-west

b) North-south

c) Vertical

Figure 5. Vibration levels on the structural system of the Mosque during Test 11.

Most codes and studies rely on a maximum PPV to evaluate the severity of traffic-induced vibrations. Figure 5 depicts PPV values of vibrations on the building (Test 11). Although the PPV are not sufficiently large to generate severe structural damage, in some cases the vibration levels exceeded the lowest damage PPV threshold found in literature (1mm/sec) [6], All PPV values were larger than 0.3mm/sec as perceptible to human body [5] and many of them larger than 0.8mm/sec as distinctly perceptible [16]. Furthermore, in each direction, mid-slab vibrations predominate, due to the flexibility of the slab compared to heavy carrying system of the masonry building. Vibration levels was as high as 2.65mm/sec on mid-slab on the first floor and 2.06mm/sec on the structural core of the building. Since human beings are very sensitive to traffic-induced vibrations and are often disturbed by intensities well below those required to overstress structures, in the retrofit of old masonry structures, human response to traffic-induced vibrations should be considered as a serviceability limit state.
