Evidence for significant heat losses through party wall cavities in load-bearing masonry construction

Short Title: Significant Heat Loss via Party Wall Cavities

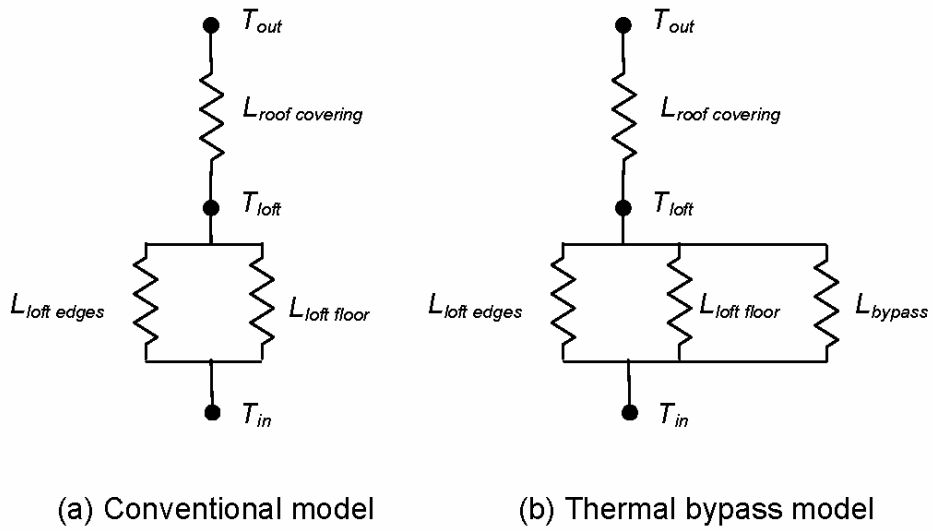
Figure 9 shows two simple models of heat flows between the inside and the outside of a dwelling through the loft.

Solving the equation implied in Figure 9(a) for T_{loft} we get:

$$T_{loft} \approx T_{out} + (T_{in} - T_{out}) \cdot (L_{loft\ floor} + L_{loft\ edges}) / L_{roof\ covering} \quad (6)$$
