Reversible Rail Shear Apparatus Applied to the Study of Woven Laminate Shear Behavior

T. Rouault · C. Bouvet · V. Nègre · P. Rauch

Keywords Three-rail shear test · Woven composite · Notch · Fatigue crack growth

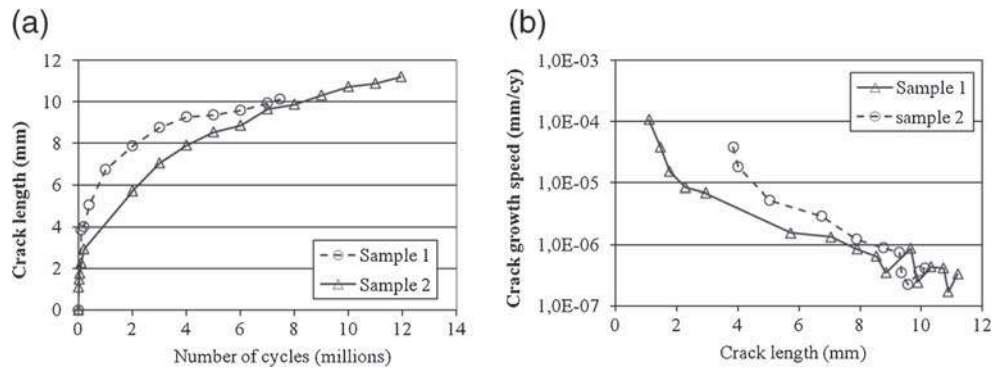
Fig. 18 Experimental results of fatigue crack growth for 2 different samples: (a) crack length versus number of cycles, (b) crack growth speed versus crack length

us to measure the crack length at regular intervals which was plotted against the number of cycles for the two samples (Fig. 18(a)). Then the crack growth speed was computed and plotted against the number of cycles for the two samples in Fig. 18(b), showing the speed decrease when the crack tip came close to the fixture.
