Development and Recommendations for a Non-Proprietary, High-Tension, Cable End Terminal System

DEVELOPMENT AND RECOMMENDATIONS FOR A
NON-PROPRIETARY, HIGH-TENSION, CABLE END
TERMINAL SYSTEM

A THESIS

Presented to the Faculty of
The Graduate College at the University of Nebraska
In Partial Fulfillment of Requirements
For the Degree of Master of Science

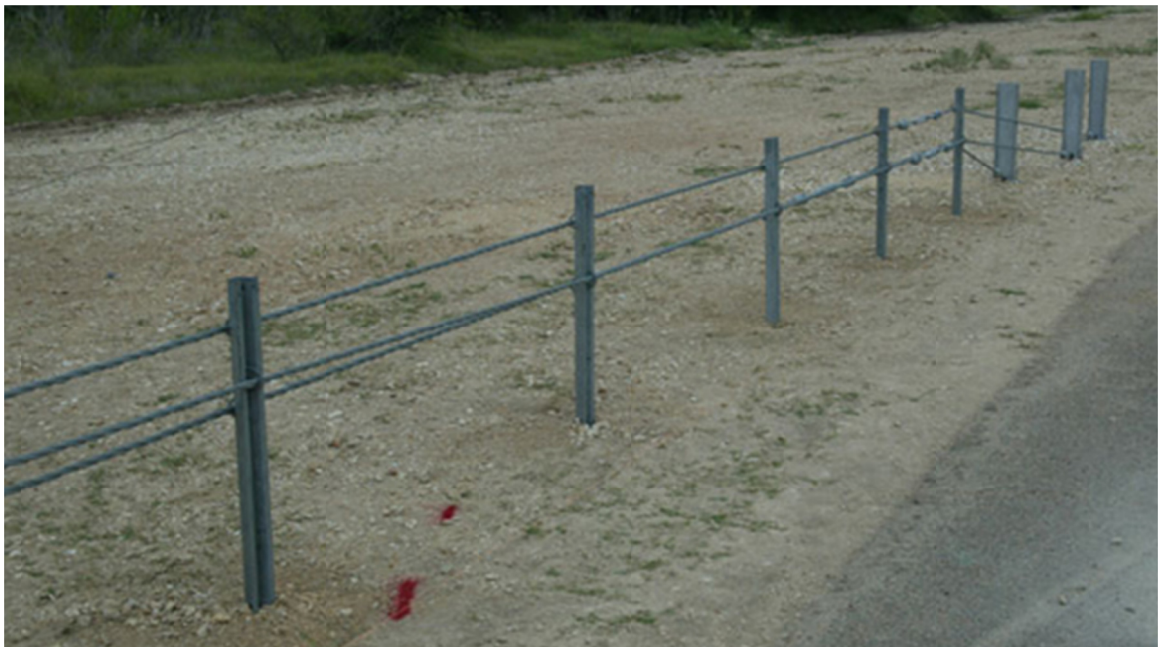
Figure 1. TTI End Terminal

The Texas Transportation Institute (TTI) designed and successfully tested a high-tension cable barrier end terminal in 2002 [8]. TTI's end terminal incorporated proprietary breakaway posts in the end terminal section, followed by Rib-Bak, U-Channel posts for the line posts. The breakaway terminal posts are designated as Cable Release Posts (CRP). Each CRP is used to anchor one of the cable guiderails used in the system. The crash tested barrier system utilized three cables. The end terminal, as tested, is shown in Figure 1. Technical drawings of the system layout are shown in Figures 2 and 3.

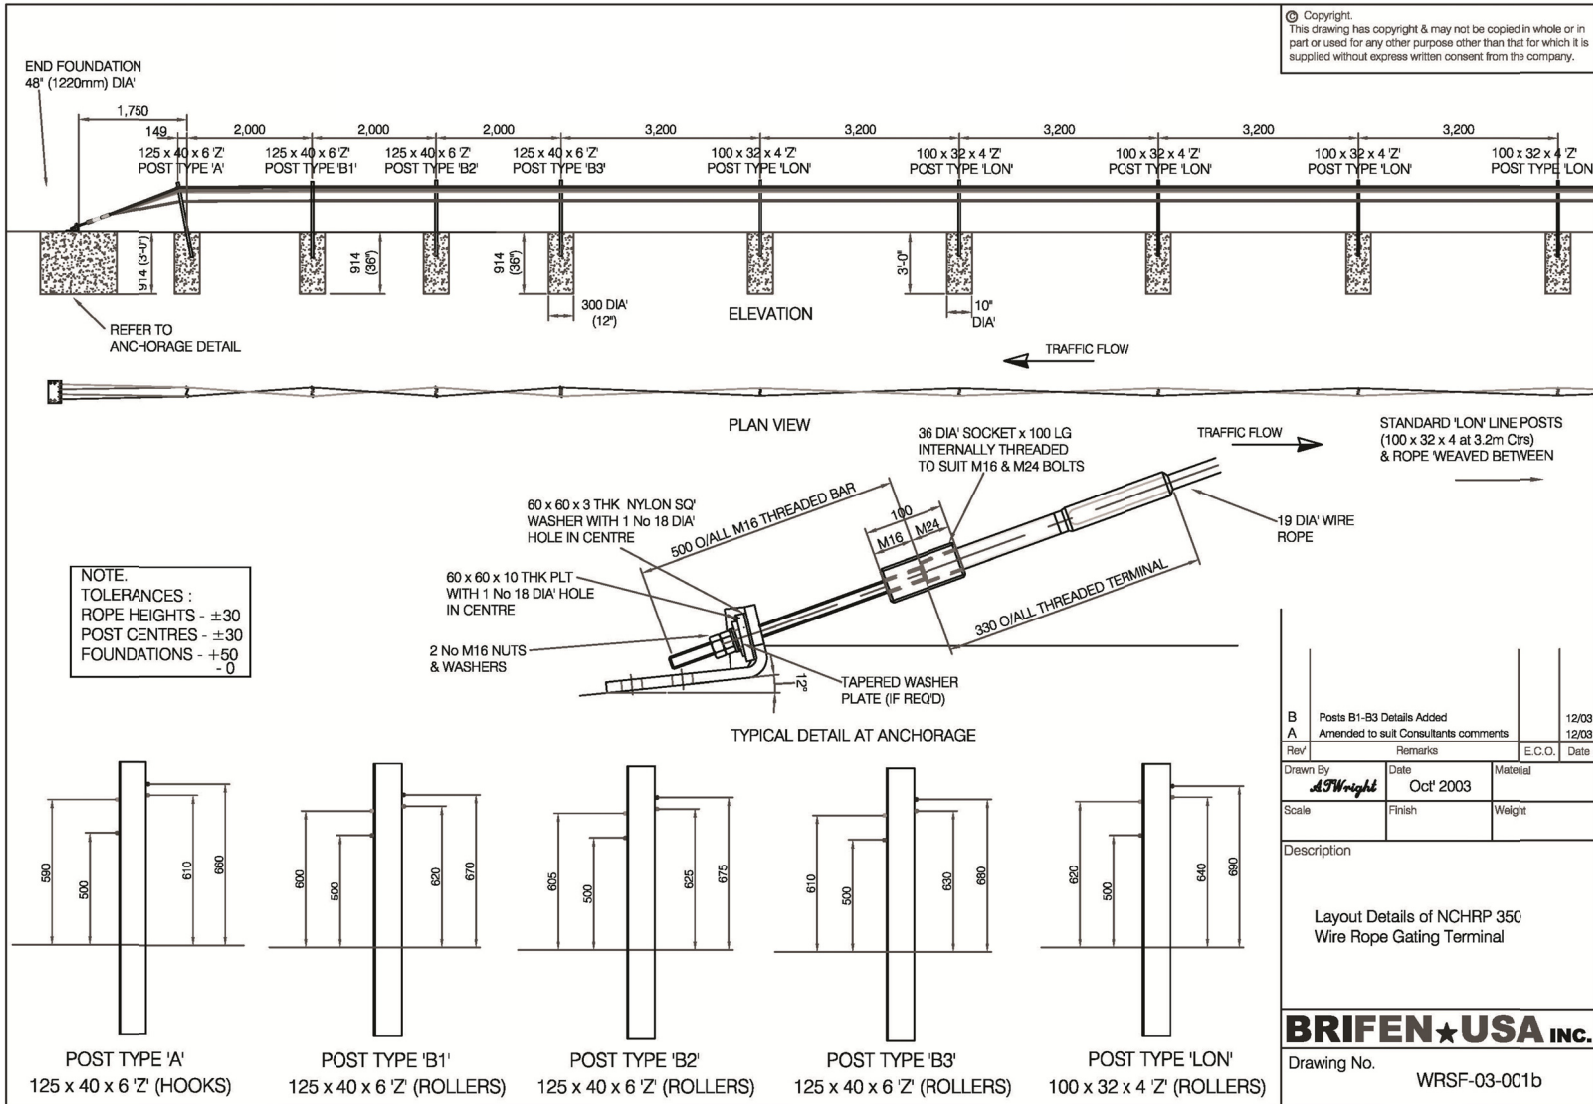
Figure 4. Brifen End Terminal, Technical Drawing

At the present, there is no mechanism to release the cables during end-on impacts with the terminal. In the case of a centerline vehicular impact on the end terminal system, it is possible that the vehicle could ramp up the cables and land on top of one or more line posts, possibly puncturing the undercarriage of the occupant compartment. Such an occurrence would be hazardous to occupants for several reasons. First, a penetrating post could directly cause harm to an occupant. Second, the airborne vehicle could become entangled within or snagged on system components, thus resulting in rapid decelerations and/or vehicle instabilities, such as rollover.

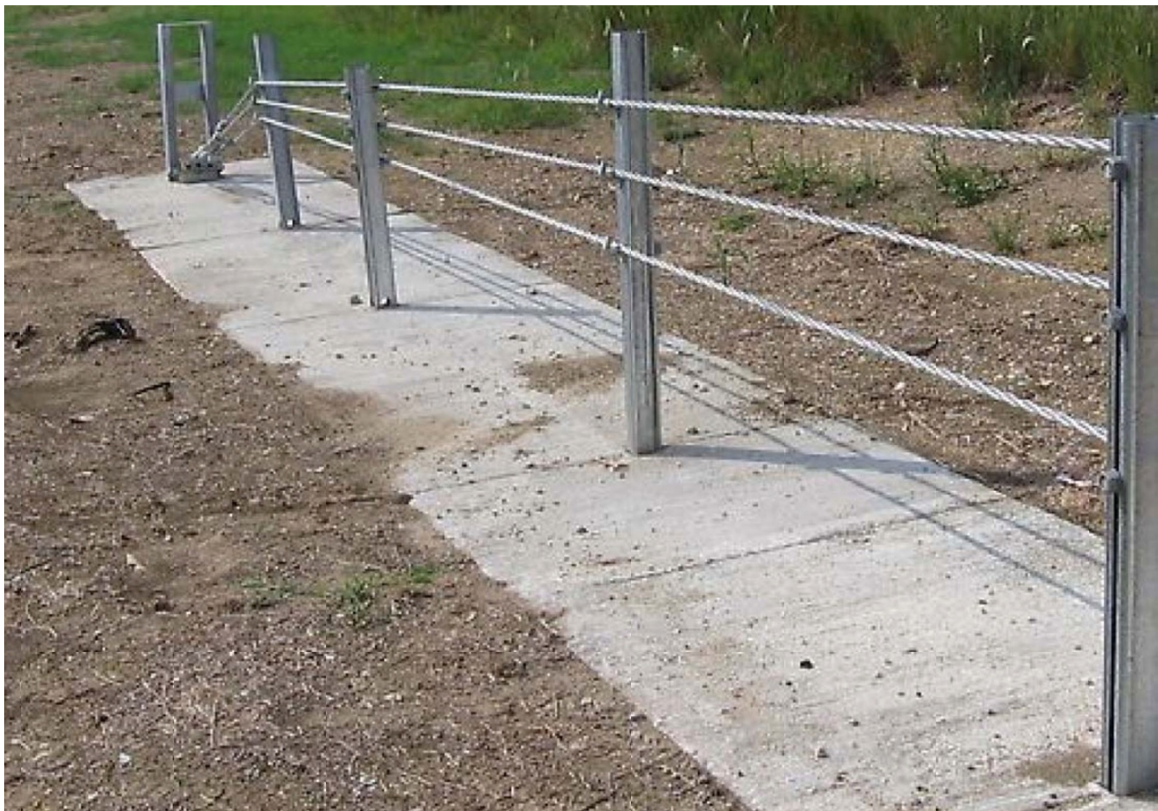
Figure 5. Gibraltar End Terminal

Gibraltar Cable Barrier Systems, L.P. designed and successfully tested a three-cable, high-tension end terminal in 2005 [10]. Gibraltar's design incorporated a cable release anchor post which was designed to release the cables in the case of an end-on impact with the terminal. The barrier system consisted of "C" section posts throughout the terminal region as well as for line posts. Post no. 2 was angled at 6 degrees with respect to vertical, and post nos. 2 and 3 utilized holes at ground level to weaken the terminal posts.

A Gibraltar cable barrier end terminal installed in a median application is shown in Figure 5. Technical drawings of the system layout and photographs of the constructed end terminal are shown in Figure 6.

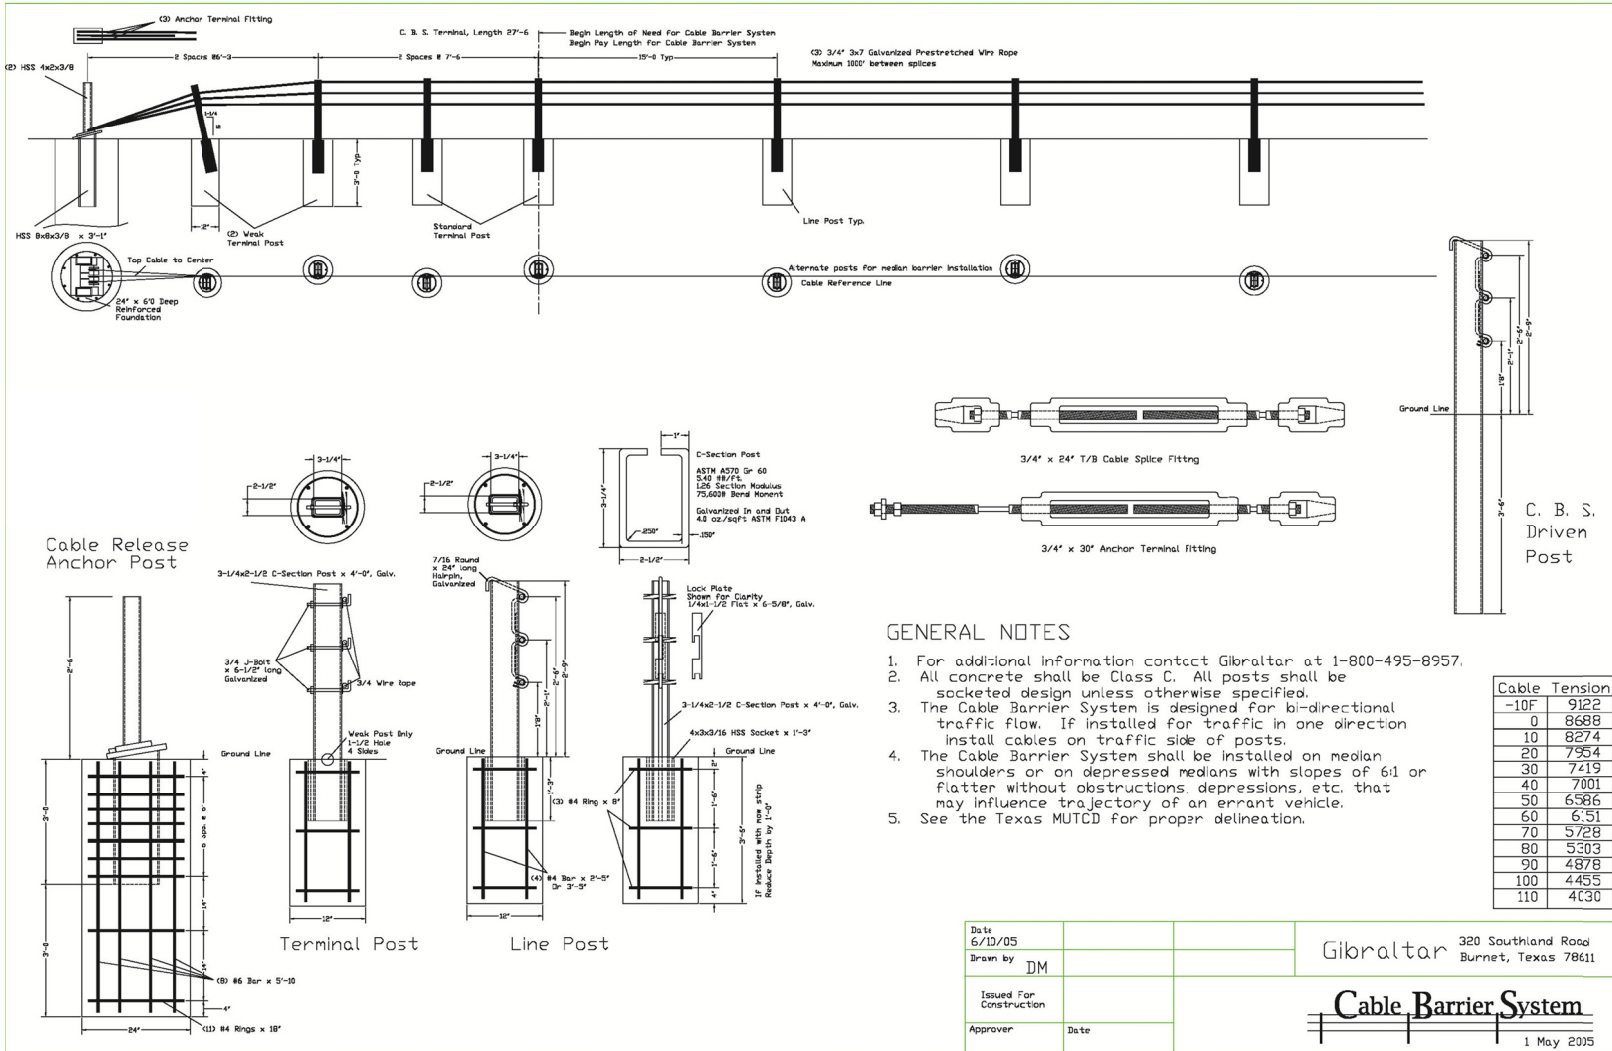
Figure 6. Gibraltar End Terminal, Technical Drawing

Gibraltar's end terminal system exhibited good control of the vehicle and performed well in all end terminal testing. In Test 3-30, the cable release anchor post functioned as designed and allowed the vehicle to travel through the system without ramping up the cables. However, the vehicle did rollover during this test, which was subsequently attributed to the vehicle's tires tripping on loose soil. Following a review of the test details, it was observed that the end terminal used in Test 3-30 was a shortened version of the system. As such, there is concern that small car testing on a longer, more realistic system length may result in increased roll motion and vehicle instabilities. However, it is unknown as to how these changes would affect the stability of the vehicle and the overall success of the crash test.

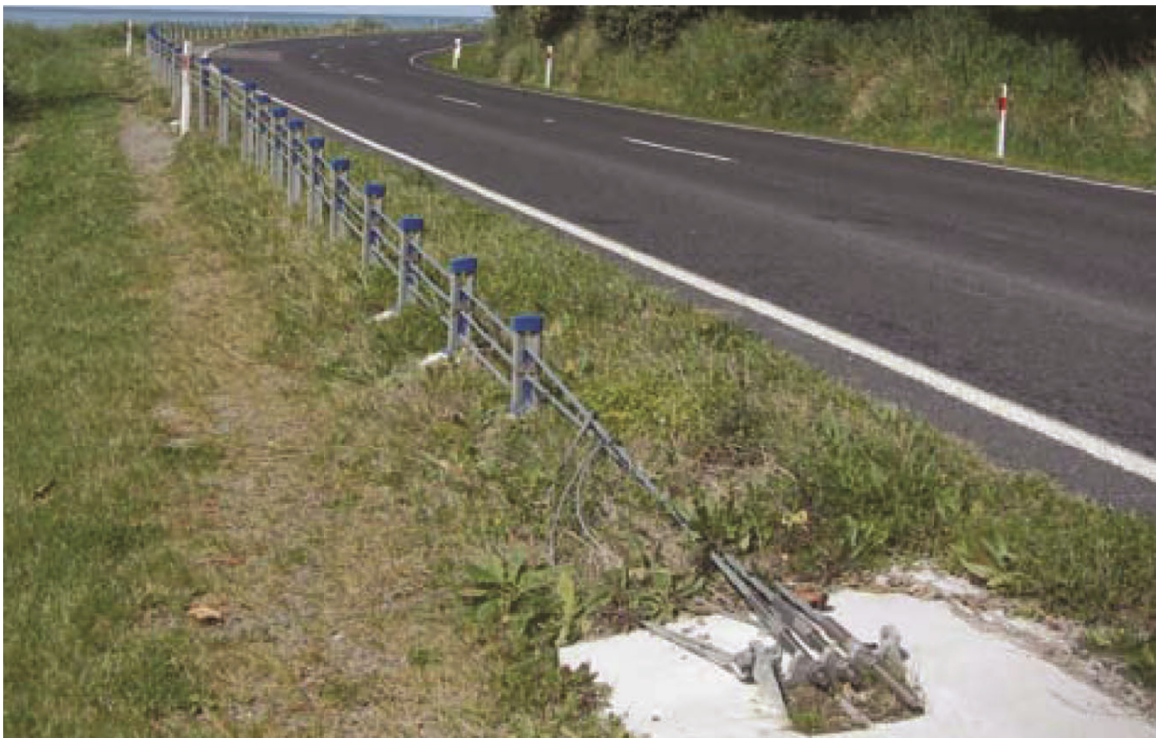
Figure 7. Safence End Terminal

A Safence end terminal installed in a roadside application is shown in Figure 7. A technical drawing of the system layout is shown in Figure 8.

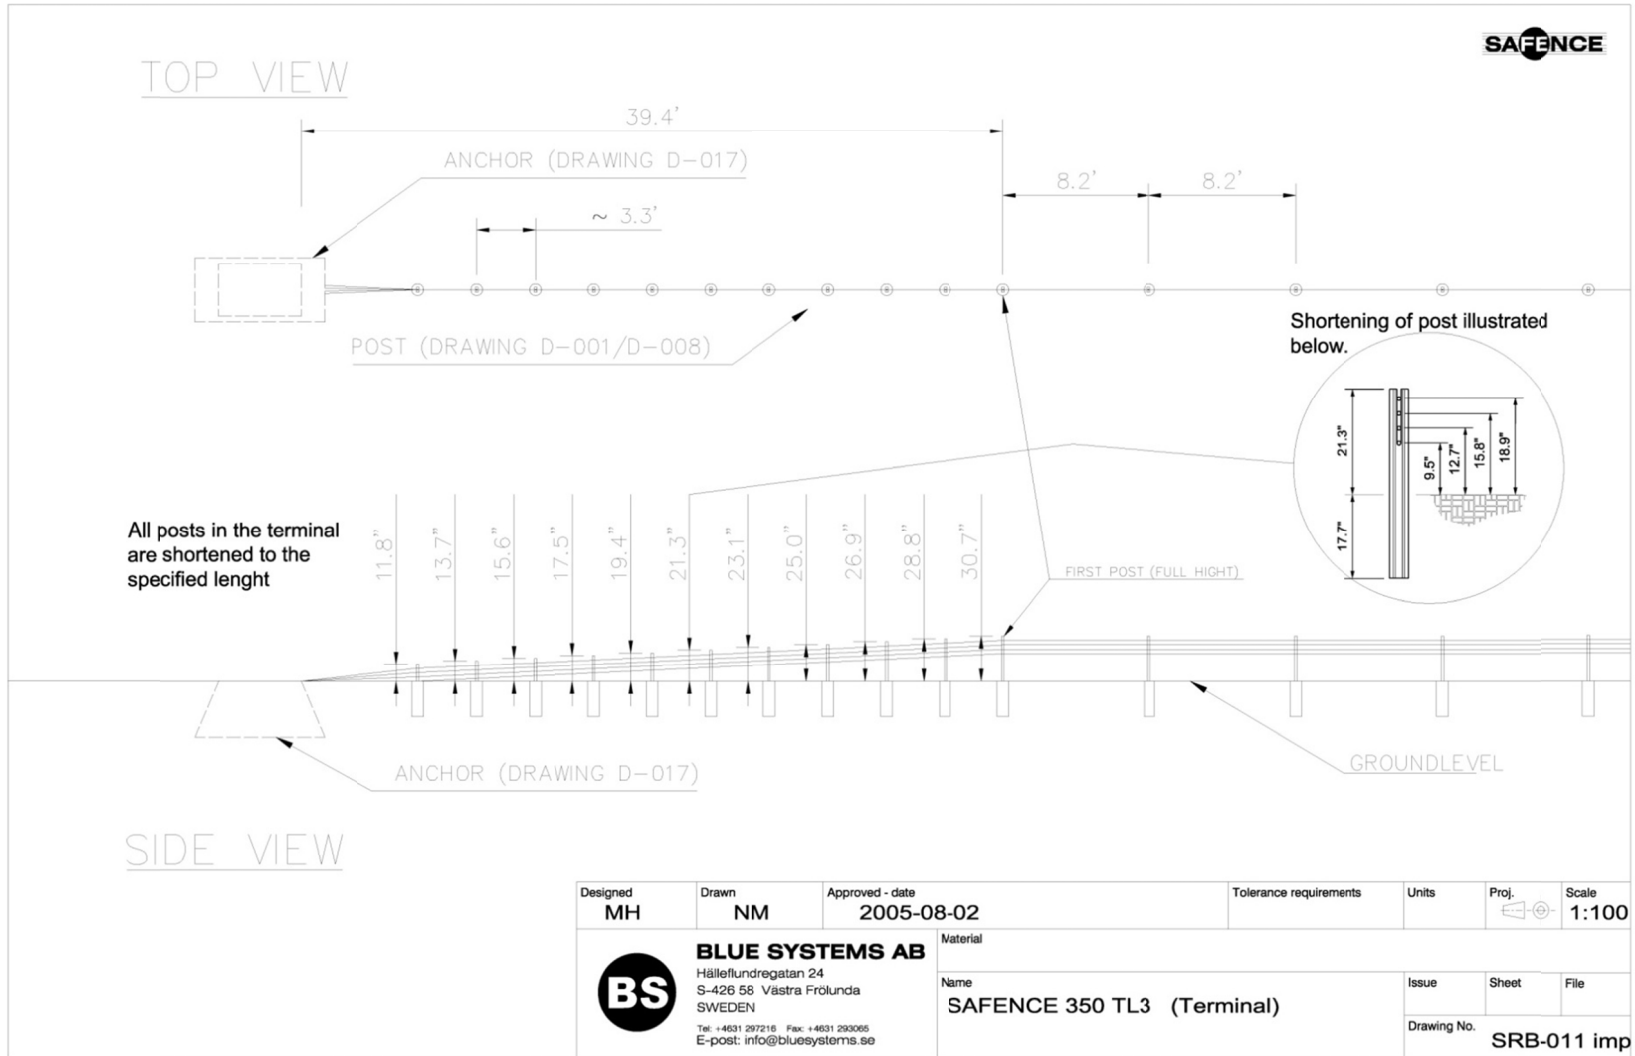
Figure 8. Safence End Terminal, Technical Drawing

Safence, Inc. designed and successfully tested a four-cable, high-tension end terminal in 2005 [11]. The Safence end terminal design used 11 posts ranging in heights from 11.8 in. to 30.7 in. to transition the cables from the block anchor to the tangent system height. The system utilized a proprietary C-shaped section for both terminal and line posts. Like the Brifen design, Safence's design did not incorporate a method to release the system cables in the case of an end-on impact. As such, similar concerns to those noted for Brifen would exist for centered vehicle impacts on the end of the terminal.

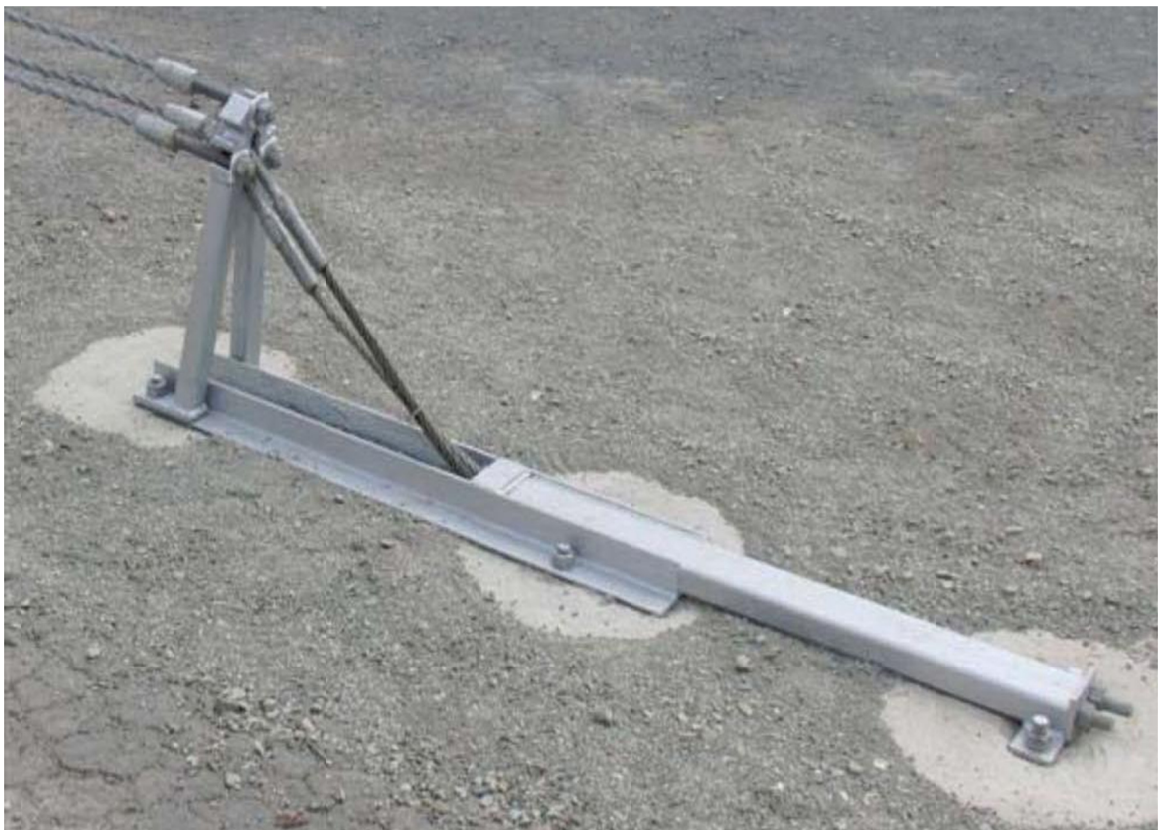
Figure 9. ArmorflexEnd Terminal

Armorflex designed and successfully tested a four-cable, high-tension end terminal in 2008 [12]. The Armorflex end terminal consisted of a trigger post and line posts with oval shaped cross sections. The unique trigger post design consisted of an angled post assembly that was used to connect anchor cables to the line cables. The trigger post was designed to release the line cables when impacted by a vehicle. The trigger post assembly is shown in Figure 9. Technical drawings of the system layout and photographs of the constructed end terminal are shown in Figure 10.

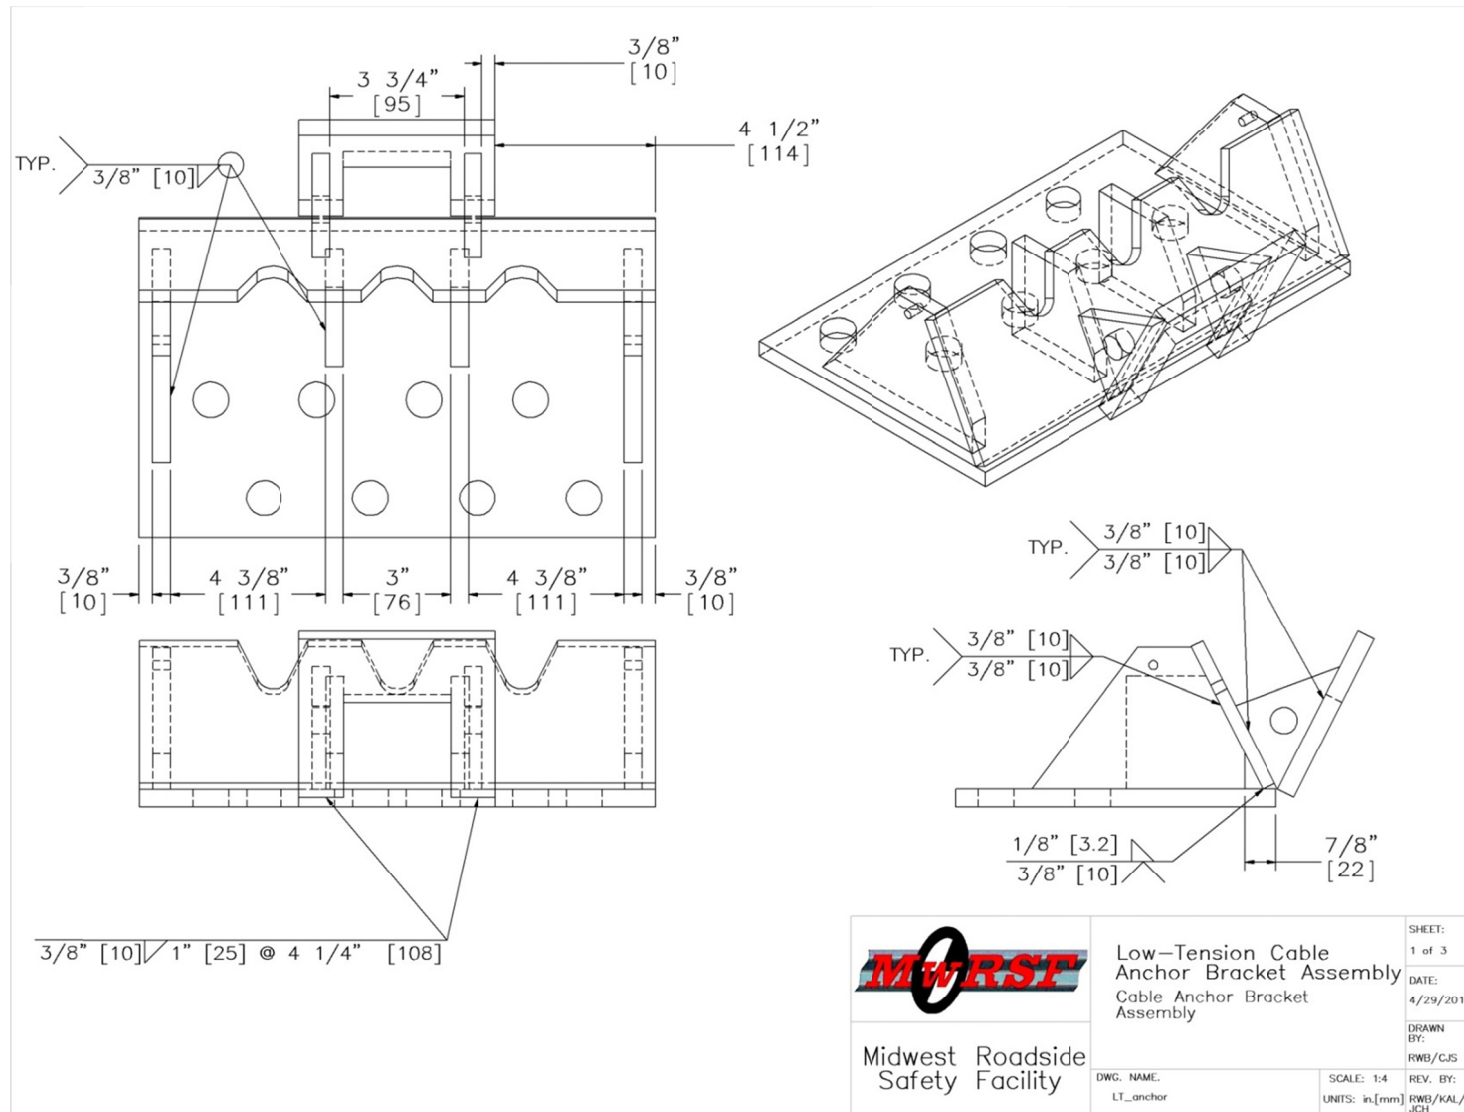
Figure 11. Low-Tension, Cable Anchor Bracket Assembly Details

Technical drawings of the three-cable, low-tension anchor bracket assembly are shown in Figures 11 through 13. Shell elements were used to create all parts of the anchor bracket assembly. A Belytschko-Leviathan shell formulation was selected based on previous parameter testing [14]. The nodes on the base plate of the cable anchor

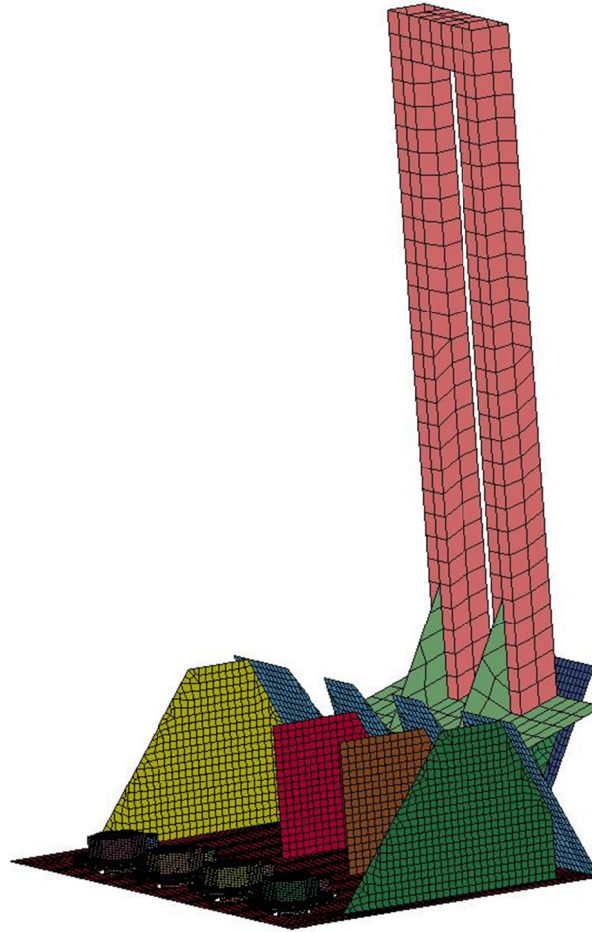
Figure 14. Cable Anchor Bracket Assembly

bracket assembly were fully constrained to prevent any movement by the baseplate during the simulation. The model of the anchor assembly is shown in Figure 14.

An elastic piecewise-linear, plastic material model was specified for all anchor bracket components. The yield strength, Young's Modulus, and Poisson's Ratio for the material model were specified as 54 ksi, 29,008 ksi, and 0.293, respectively, to reflect ASTM A36 steel material properties. Material properties for the anchor bracket model were taken from a previous study [15].

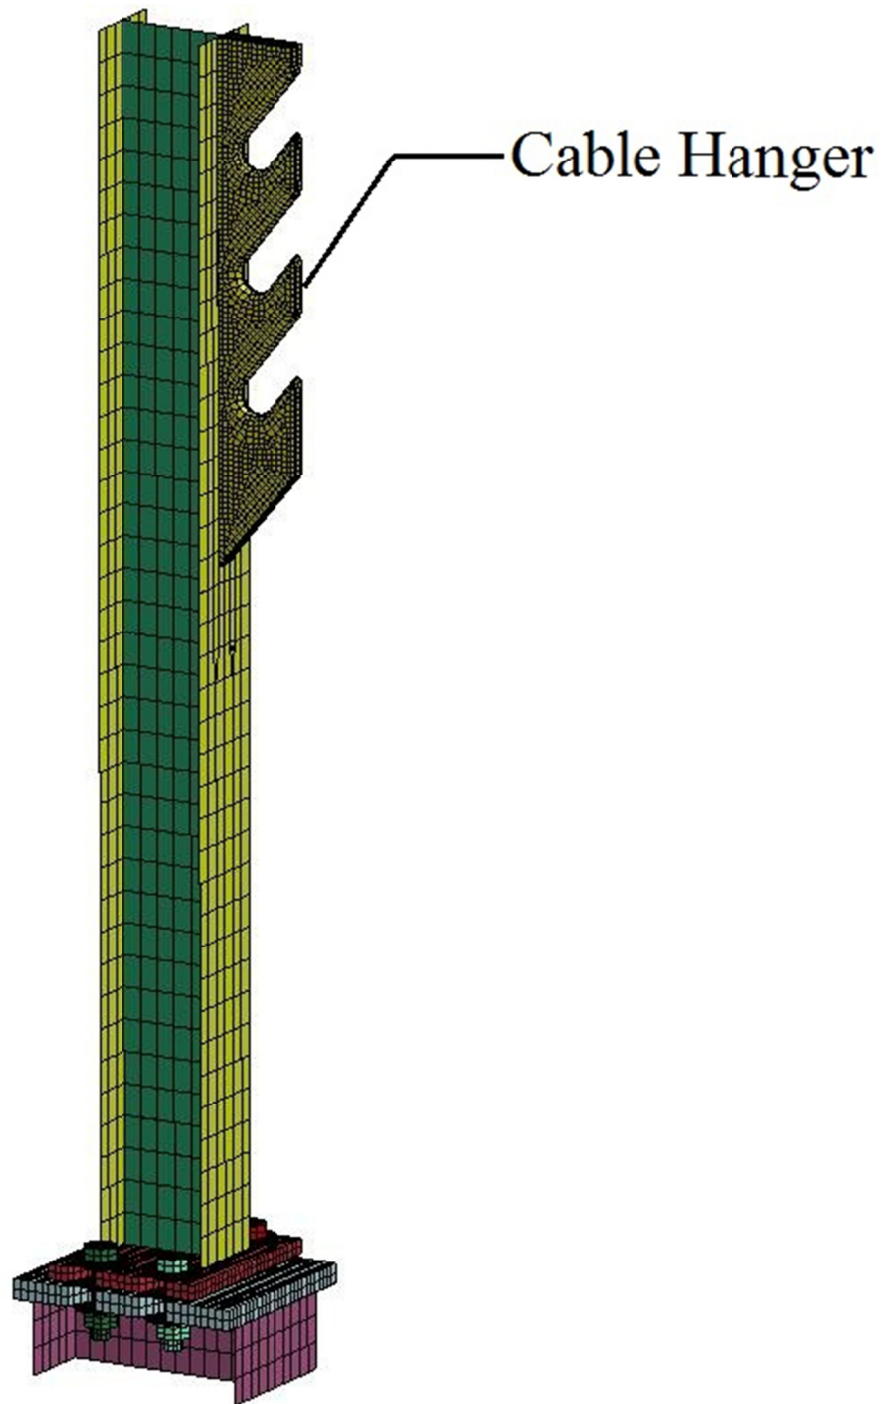
Figure 15. Slip Base Post No. 1 Model

and a description of the development of the model can be found in Nick Hiser's Master's Thesis [15]. The post model is shown in Figure 15.

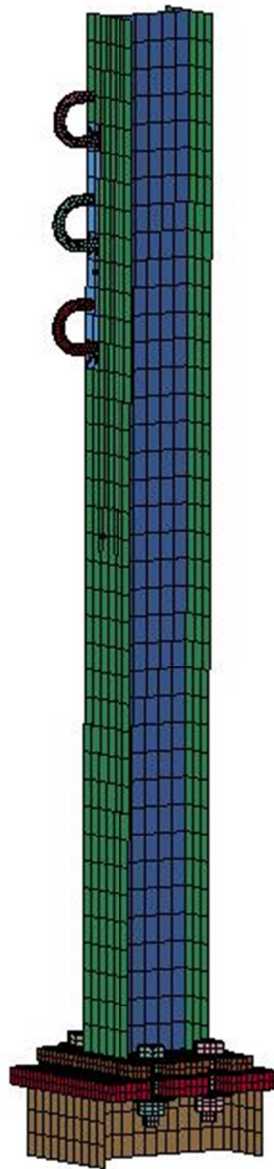
Figure 16. Slip Base Line Post Model

The slip base line post model was similar to the slip base post no. 1 model. However, the line posts utilized three cable hook bolts to secure the system cables to the post, in lieu of the cable hanger bracket. The hook bolt model had 9 solid elements in its cross section and was developed by Reid and Coon [16]. The slip base line post model is shown in Figure 16.

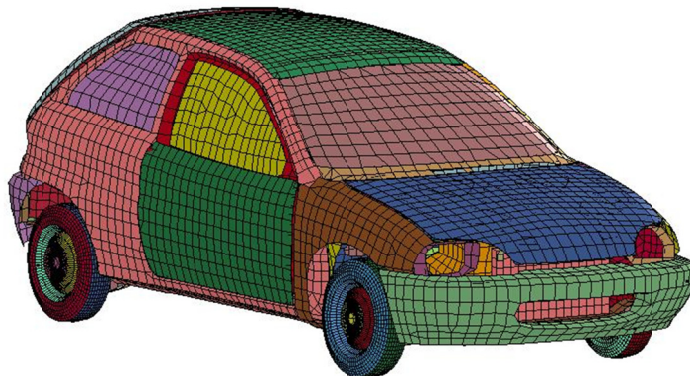
Figure 17. Geo Metro Vehicle Model

A Geo Metro vehicle model was utilized as the impacting vehicle for the validation simulations. The Geo Metro model was obtained from Politecnico di Milano, Italy and subsequently modified by for use in MwRSF's roadside safety applications. The original Metro model that was improved by Politecnico di Milano was developed by the National Crash Analysis Center (NCAC). The Geo model is shown in Figure 17.

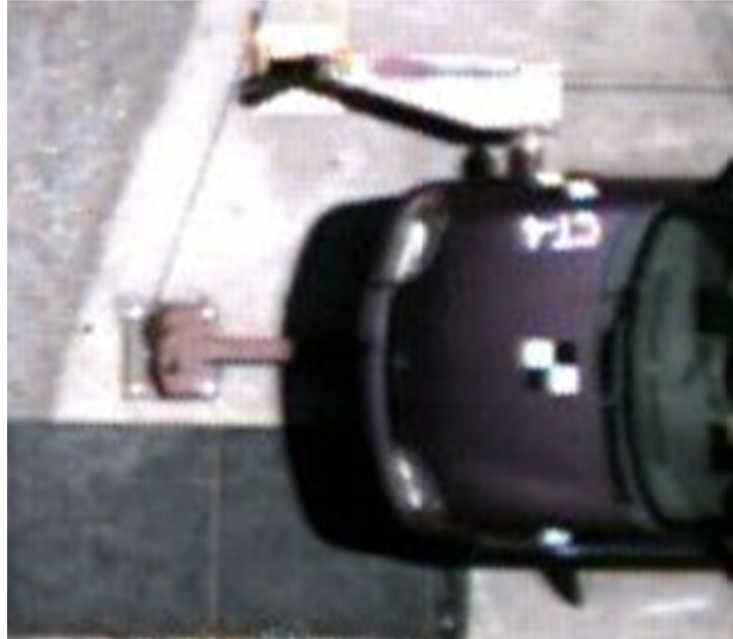
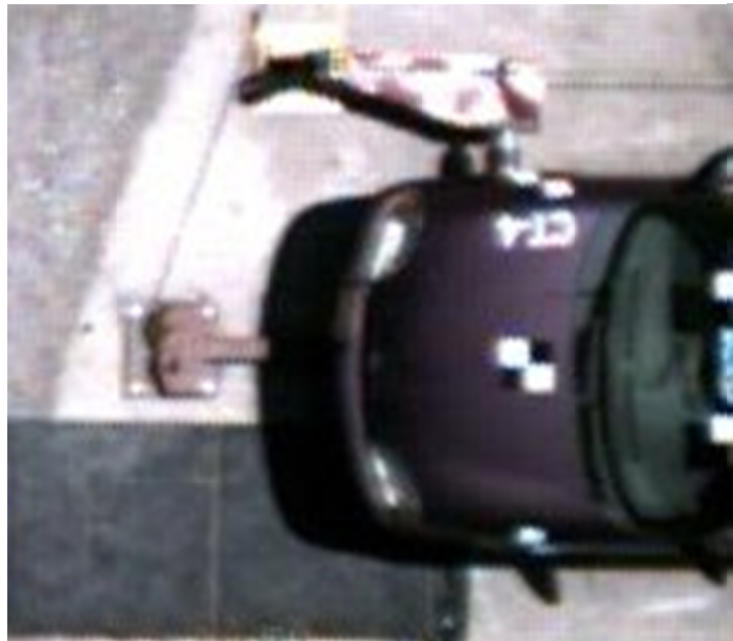
Figure 18. Shear Post Impact with Guide Flag, Test No. CT-4

To further investigate the guide flag/shear post impact, the accelerometer data from the test was reanalyzed to examine events prior to the vehicle entering the guardrail system. At approximately the same time as the guide flag/shear post impact, there was a 1.8 g deceleration applied to the vehicle. At the point of the application of that deceleration, the applied force was approximately 2.5 kips. Due to the off-center point of application, it is possible that the resultant force imparted an initial yawing motion to the vehicle. Overhead photographs of the guide flag impact are shown in Figures 18 and 19.

During the initial simulations, the initial yaw of the Geo Metro did not match the test results obtained from CT-4. Upon further examination of the high-speed video from CT-4, it was determined that an initial yaw motion was imparted to the vehicle as a result of the tow and guidance process. As the vehicle neared the impact point, the guide flag, which maintains the vehicle's heading angle during towing, was detached from the vehicle. The guide flag release was accomplished through an impact with a shear post on the right side of the vehicle. Ideally the guide flag/shear post impact will be trivial. However, during test no. CT-4, the impact may have been significant enough that the vehicle began to yaw prior to impacting the cable anchor's release lever.

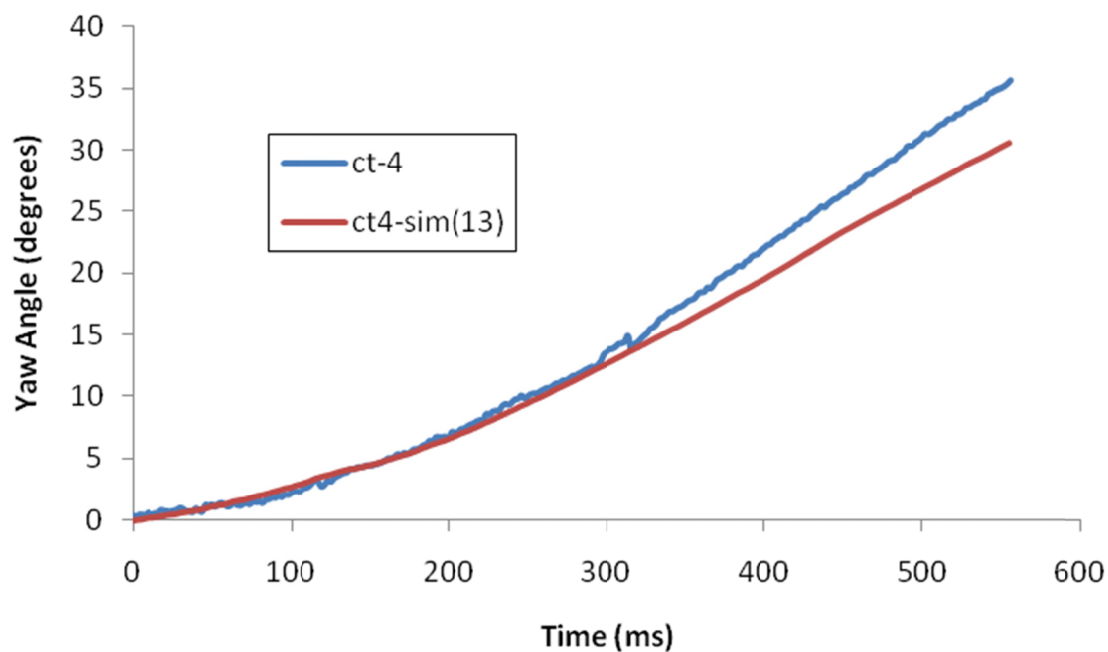
Figure 20. Comparison of Actual and Simulated Vehicle Yaw – Test No. CT-4

In order to match the initial yaw motion of the vehicle as it impacted the cable release lever, an initial yaw rate of 15 deg/s was applied to the Geo Metro model. After the initial yaw was applied to the vehicle, the simulated trajectory of the Geo Metro more closely matched that observed in test no. CT-4. Vehicle yaw data from the simulation and test no. CT-4 are shown in Figure 20. Sequential images for the simulated and actual vehicle trajectories are shown in Figure 21.

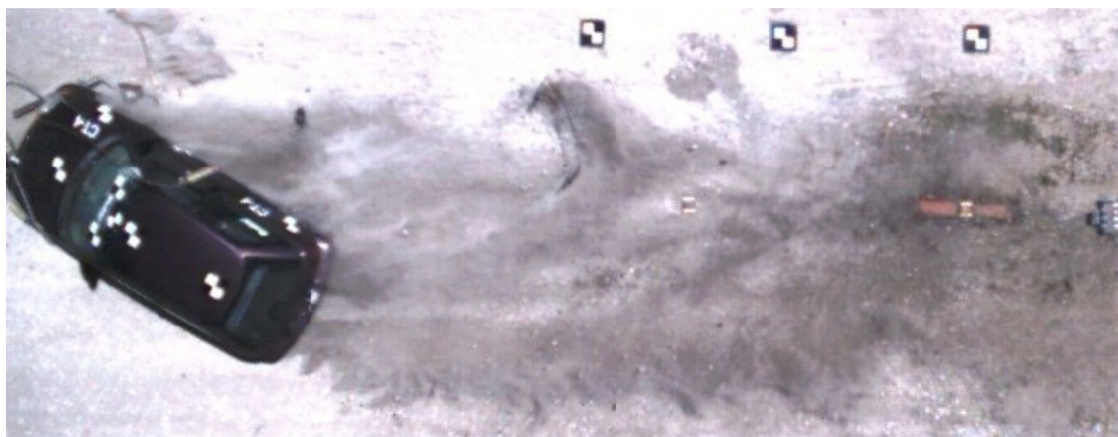
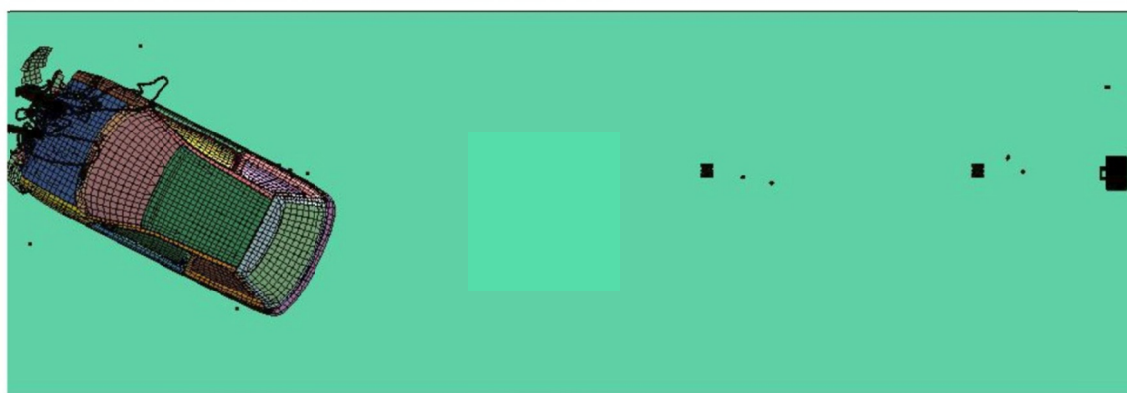
Figure 22. Vehicle Trajectory Comparison – 500 ms After Impact

Geo Metro vehicle positions at 500 ms after impact are compared between the actual test and simulation results and are shown in Figure 22.

Although the first portion of the simulation matched well with test no. CT-4, the vehicle trajectories began to diverge after 300 ms. A review of the high-speed video of test CT-4 revealed that this divergence in vehicle trajectories was partially due to vehicle contact with system debris. The debris included top sections of slip base posts, cable compensators, and the cable release lever from the end anchor. During test CT-4, this debris was overridden by the Geo Metro, thus resulting in increased vehicle yawing and

Through 300 ms, the simulated vehicle trajectory and yaw motion observed in the three cable, low-tension end terminal model matched well with the actual results obtained in test CT-4. Although the trajectories began to diverge as the vehicles exited the terminals, valuable information was obtained from the simulation. The main cause of the divergent exit trajectories and near rollover in test no. CT-4 was likely due to the actual Geo Metro contacting and overriding the debris from detached end terminal components. The movement of the system debris and location of the vehicle-to-debris contact is highly dependent on ground conditions as well as bumper characteristics. As such, these vehicle-to-barrier interactions are very difficult to accurately simulate. Improvements to the simulation model could be made with further development of the ground and bumper models. For the current application, however, the utilized models proved sufficient.

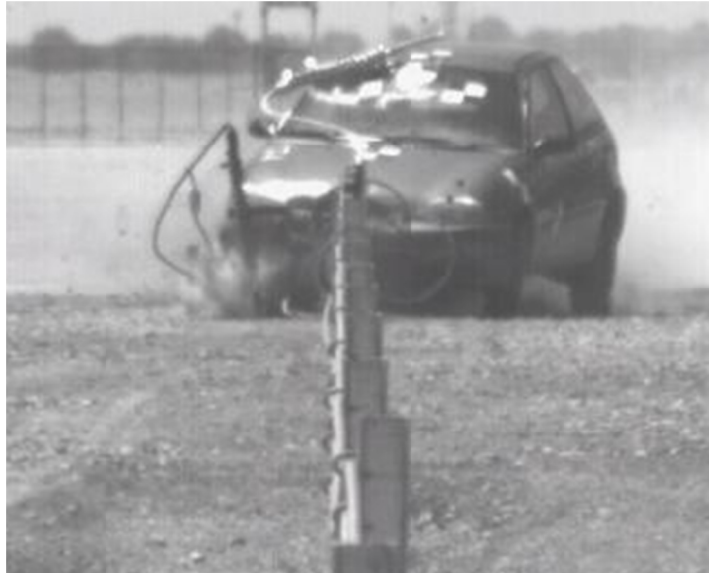
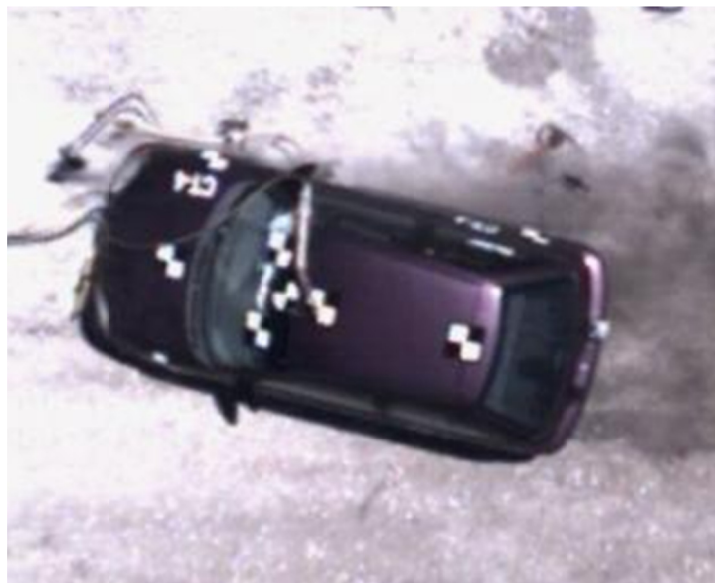
Figure 23. Geo Metro Overriding System Debris

also vehicle roll toward the driver's side that nearly led to rollover. As shown in Figure 23, the yawed vehicle has contacted and begun to override the system debris in test CT-4.

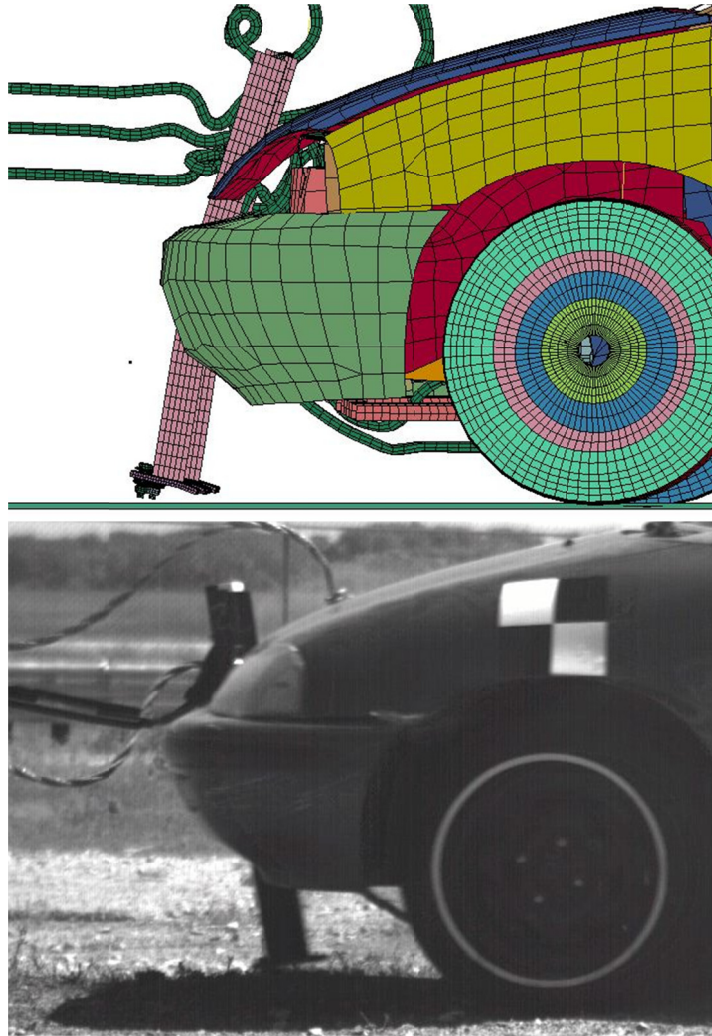
Figure 24. Cable Interaction with Slip Base Post No. 1

Another sensitive part of the end terminal system was the interaction between the cable compensators and slip base post no. 1. In the “best” simulation model, it was discovered that the cables immediately downstream from slip base post no. 1 coiled on the downstream face of the web. This action forced the detached slip base post section up onto the hood of the vehicle, which prevented the simulated vehicle from overriding the post section. In test CT-4, the cable compensators located between slip base post nos. 1 and 2 similarly impacted the downstream face of the web on slip base post no. 1 and forced the post section onto the hood of the vehicle. The vehicle-to-post interactions for both the simulation and test CT-4 are shown in Figure 24.

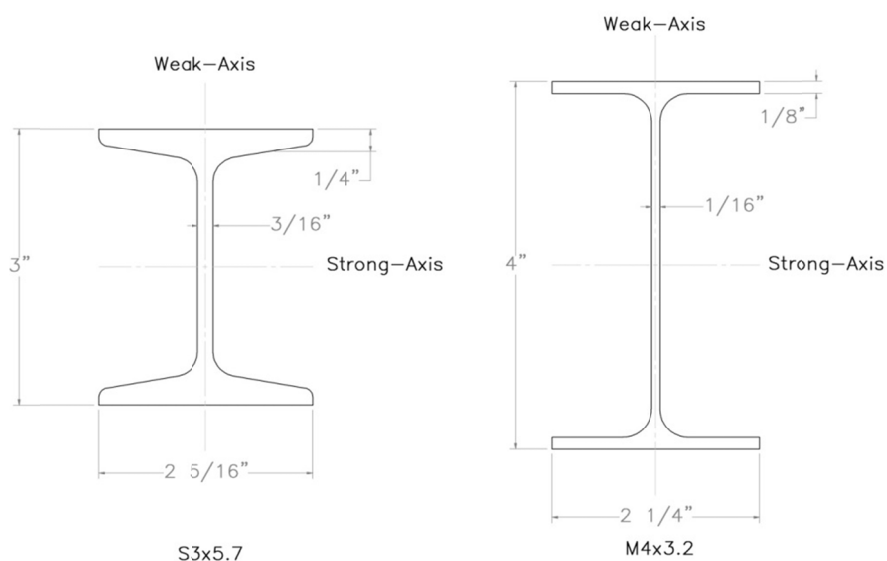
Figure 25. Post Cross Section Dimensions

One terminal post replacement option is the M4x3.2 post section. The M4x3.2 section was selected to analyze due to its similar strong-axis bending strength as compared with the S3x5.7 section. The M4x3.2 section also has the greatest weak-axis bending strength reduction (compared to S3x5.7) relative to other standard M section post options. The M4x3.2 section post has a 47 percent reduction in weak-axis bending strength, and an 18 percent reduction in bending strength in the strong-axis direction, as compared to the S3x5.7 post section.

Although the M4x3.2 section has comparable strong-axis strength in pure bending as compared with the S3x5.7 post, the M4x3.2 section has an 86 percent reduction in torsional stiffness. The torsional stiffness of the terminal post section will have a significant effect on angled terminal impacts downstream of the cable anchor. With the reduced torsional stiffness, it is possible that posts downstream of the impact will twist due to cable deflection, thus reducing its strength. The reduction in post bending strength will reduce the likelihood of vehicle rollover, but it will also reduce the post's capacity to support the cables during redirection. Therefore, if an M4x3.2 section is selected for terminal posts, a relatively short post spacing may be necessary to adequately support the cables during redirection terminal impacts. A comparison of the S3x5.7 and M4x3.2 post cross sections is shown in Figure 25.

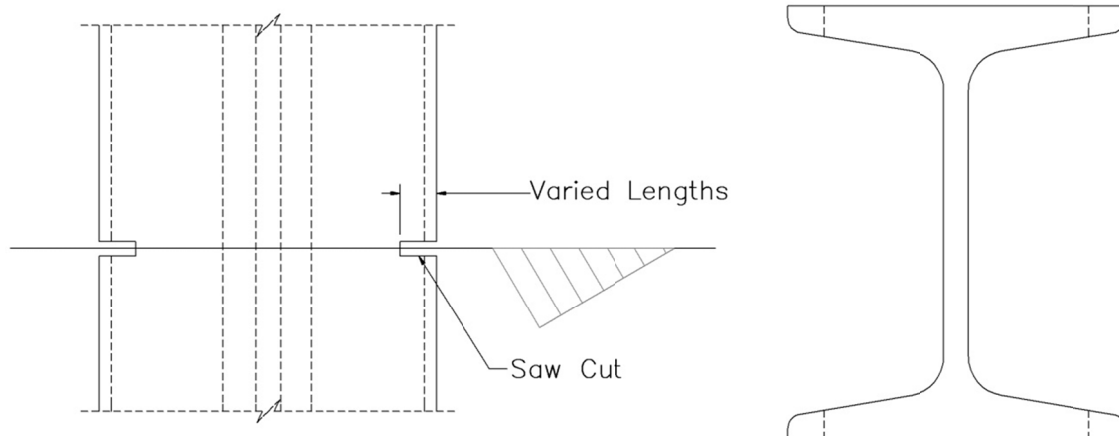
Figure 26. S3x5.7 Post with Cut Flanges

In 2004, a testing program was accomplished at MwRSF to evaluate the directional strength properties of modified S3x5.7 posts [18]. Posts with varying length cuts into the ends of the flanges were impacted in both strong-axis and weak-axis orientations. These results were compared with impact data obtained from unmodified S3x5.7 posts [19]. A technical drawing of a sample post modification is shown in Figure 26.

An S3x5.7 post with 1/8-in. cuts in each flange exhibited desirable strength characteristics for a terminal post. The modified post had similar maximum impact force values in both the strong-axis and the weak-axis orientations as compared with an unmodified S3x5.7 post. The vertical impact force, however showed a 54 percent decrease in weak-axis strength. The vertical impact forces are important in this case since these are indicative of the posts ability to impart uplift forces on a vehicle and subsequently, which could result in pitching and rolling if the force is high enough. Since the vertical impact forces were reduced by 54 percent in the weak-axis direction, the modified posts will be less likely to cause rollover in the event of a terminal impact. The vertical force data from bogie testing of the cut post section as compared to a non-cut section is shown in Table 3.

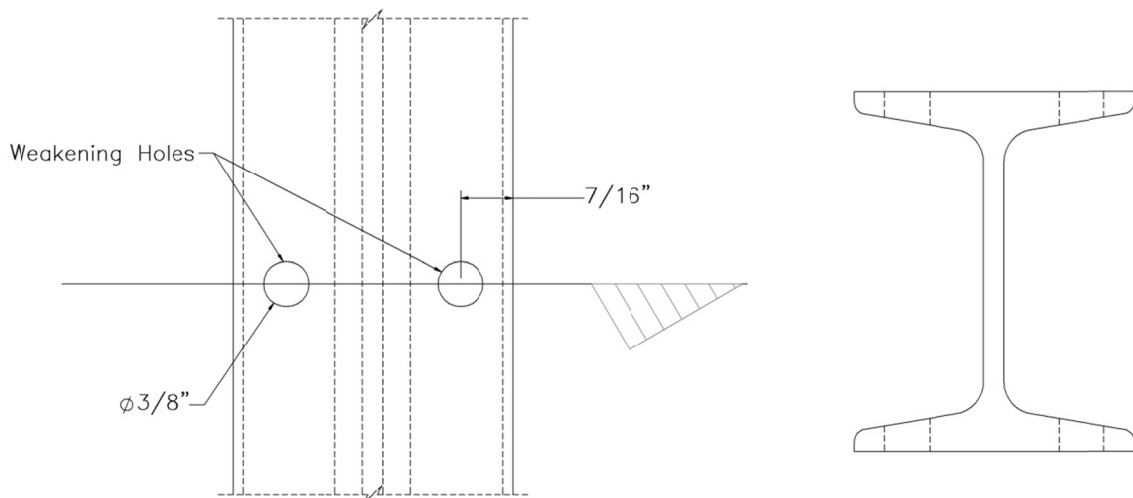
Figure 27. S3x5.7 Post with Weakening Holes

Weakening holes measuring $\phi 3/8$ -in. diameter would result in a weak-axis bending strength reduction of 40 percent, and a 25 percent reduction in the strong-axis bending strength. The decreased weak-axis bending strength would aid in the reduction of vehicle roll motion. Unlike the cut flanges option, no bogie tests have been performed on S3x5.7 posts with weakening holes. Thus, physical testing and evaluation will be required prior to moving forward with this option. The weakening hole option is shown in Figure 27.
