Development and Recommendations for a Non-Proprietary, High-Tension, Cable End Terminal System

DEVELOPMENT AND RECOMMENDATIONS FOR A
NON-PROPRIETARY, HIGH-TENSION, CABLE END
TERMINAL SYSTEM

A THESIS

Presented to the Faculty of
The Graduate College at the University of Nebraska
In Partial Fulfillment of Requirements
For the Degree of Master of Science

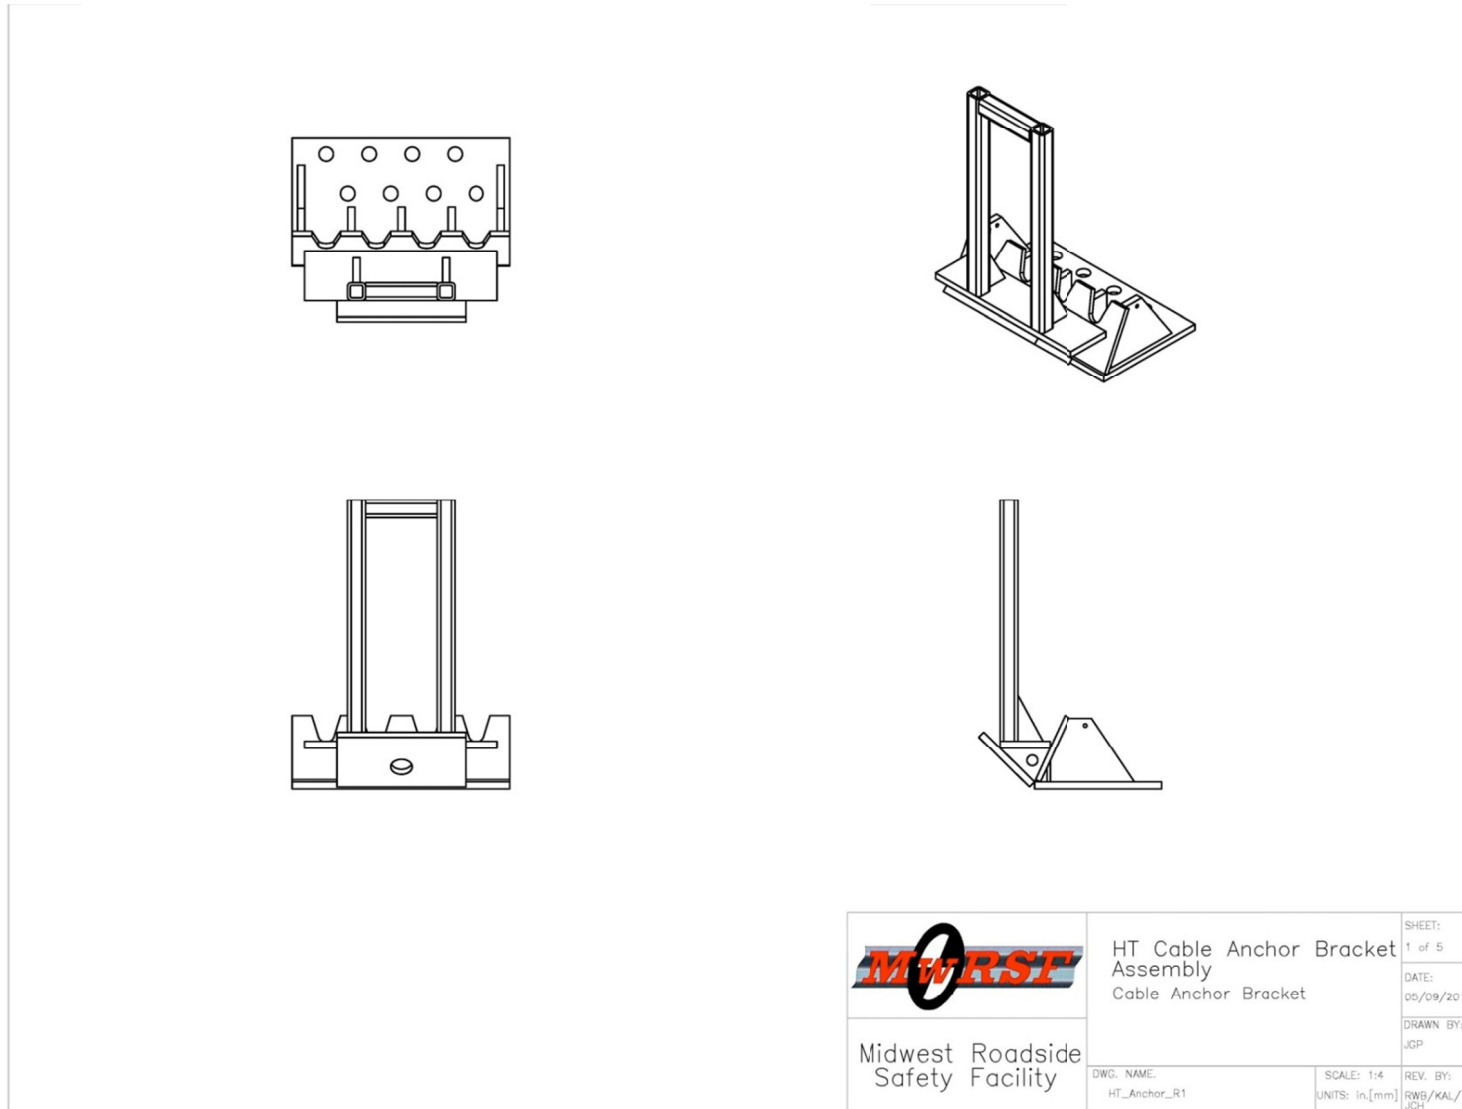
Figure 28. Cable Anchor Bracket Assembly Drawings

- widening the entire anchor bracket assembly to accommodate an extra system cable;
- adding a 4th slot on the cable plate to accommodate 4th system cable;
- adding extra internal gussets to strengthen the assembly against increased cable loading;
- increasing the height of outer gussets to provide extra support for the cable plate; and
- altering the release lever and release lever support geometry to accommodate the revised slope of the end cables that are terminated at the cable bracket assembly.

Detailed drawings of the high-tension, cable anchor bracket assembly are shown in Figures 28 through 32.

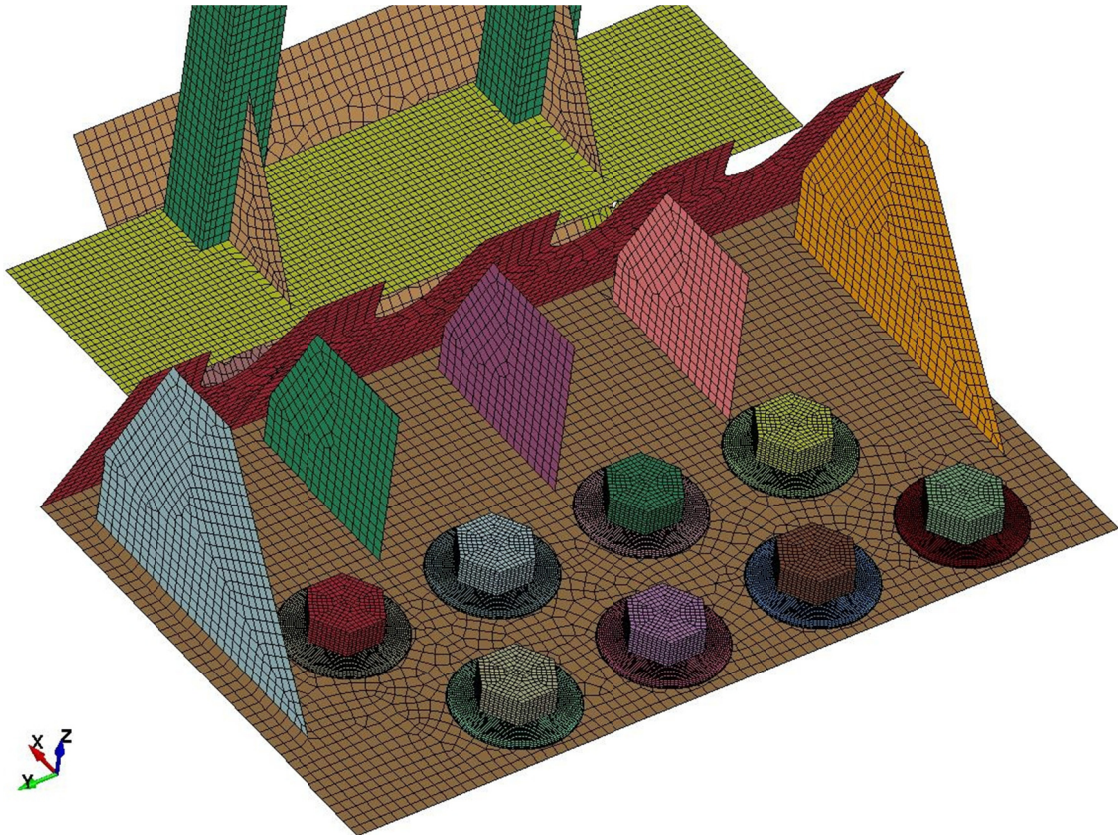
Figure 33. Cable Anchor Bracket Component Mesh

cable anchor bracket and its finite element model as well as a close up of the component meshing is shown in Figures 33 and 34.

Part Name	Element Type	Element Formulation	Material Type	Material Formulation
Interior Cable Plate Gusset	Shell	Belytschko-Leviathan	ASTM A36	Piecewise, Linear Plastic
Exterior Cable Plate Gusset	Shell	Belytschko-Leviathan	ASTM A36	Piecewise, Linear Plastic
Base Plate	Shell	Belytschko-Leviathan	ASTM A36	Piecewise, Linear Plastic
Cable Plate	Shell	Belytschko-Leviathan	ASTM A36	Piecewise, Linear Plastic
Release Lever Support Plate	Shell	Belytschko-Leviathan	ASTM A36	Piecewise, Linear Plastic
Release Lever Support Gusset	Shell	Belytschko-Leviathan	ASTM A36	Piecewise, Linear Plastic
Release Lever Vertical Tube	Shell	Belytschko-Leviathan	ASTM A36	Piecewise, Linear Plastic
Release Lever Connecting Tube	Shell	Belytschko-Leviathan	ASTM A36	Piecewise, Linear Plastic
Release Lever Base Plate	Shell	Belytschko-Leviathan	ASTM A36	Piecewise, Linear Plastic
Release Lever Gusset	Shell	Belytschko-Leviathan	ASTM A36	Piecewise, Linear Plastic

Anchor Bolts	Solid	Fully Integrated, S/R	ASTM A307	Piecewise, Linear Plastic
Washers	Solid	Fully Integrated, S/R	ASTM A36	Rigid

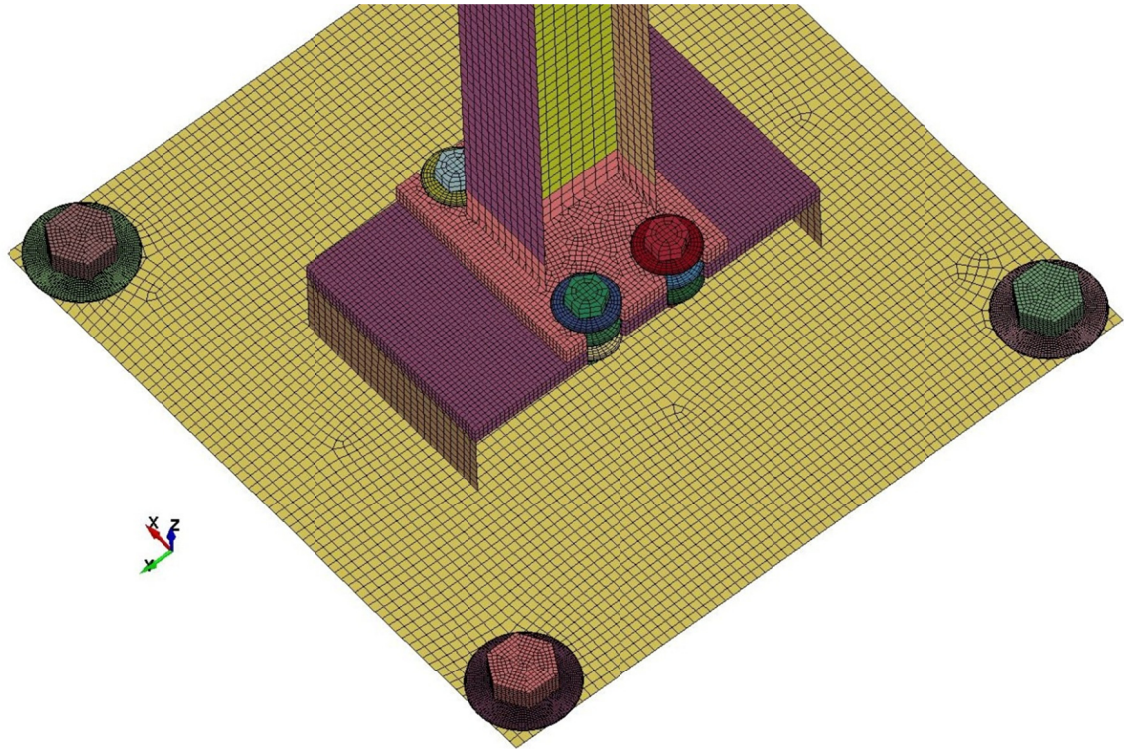
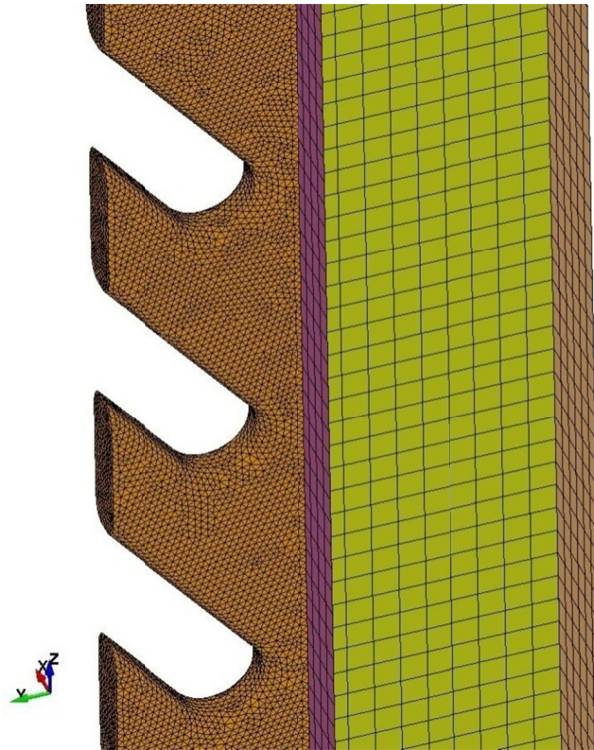
Figure 35. Slip Base Post Assembly Component Mesh

ASTM A36 steel material properties were specified for all steel plate components and ASTM A307 steel material properties were used for the slip base bolts and the wedge bolts. Component modeling information is tabulated in Table 6. A comparison of the physical cable anchor bracket and its finite element model as well as a close up of the component meshing is shown in Figures 35 and 36.

Part Name	Element Type	Element Formulation	Material Type	Material Formulation
S3x5.7 Post	Shell	Belytschko-Leviathan	ASTM A36	Piecewise, Linear Plastic
Cable Hangar	Shell	Belytschko-Leviathan	ASTM A36	Rigid
Top Slip Base Plate	Shell	Belytschko-Leviathan	ASTM A36	Piecewise, Linear Plastic
Bottom Slip Base Plate	Shell	Belytschko-Leviathan	ASTM A36	Piecewise, Linear Plastic
Slip Base Bolts	Solid	Fully Integrated, S/R	ASTM A307	Piecewise, Linear Plastic
Slip Base Washers	Solid	Fully Integrated, S/R	ASTM A36	Rigid
Slip Base Support Plates	Shell	Belytschko-Leviathan	ASTM A36	Piecewise, Linear Plastic
Post Assembly Base Plate	Shell	Belytschko-Leviathan	ASTM A36	Piecewise, Linear Plastic
Wedge Bolt Anchors	Solid	Fully Integrated, S/R	ASTM A307	Piecewise, Linear Plastic
Anchor Washers	Solid	Fully Integrated, S/R	ASTM A36	Rigid

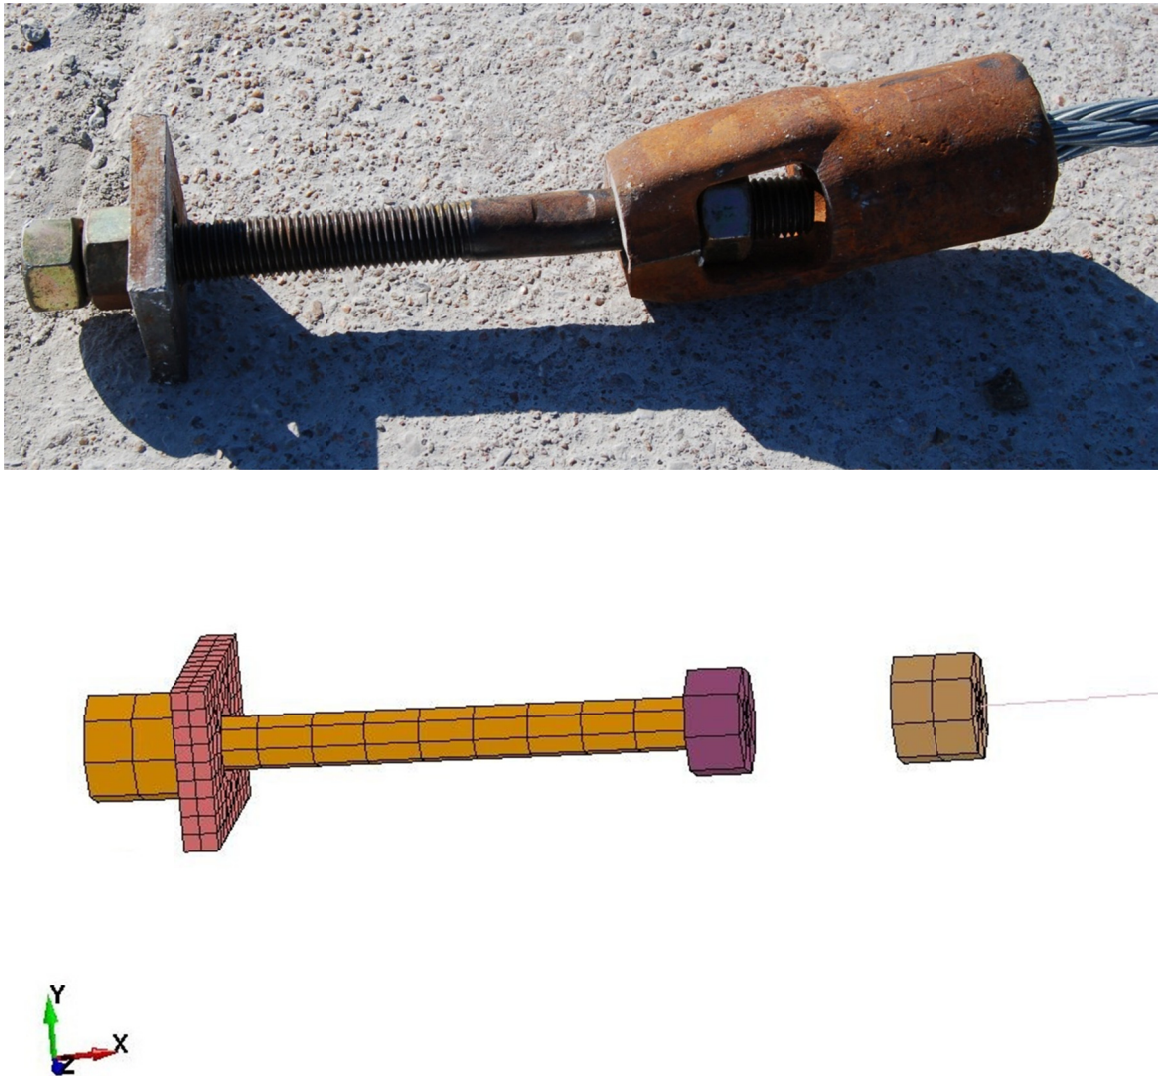
Figure 37. Cable and End Fitter Component Model and Mesh

The plate washers were modeled using 8-noded solid elements. It was expected that the plate washers would not sustain any plastic deformation; therefore a rigid

material type was specified to reduce computational time. Subsequent physical testing was later used to verify this assumption. A comparison of the physical system components and their finite element models is shown in Figure 37.

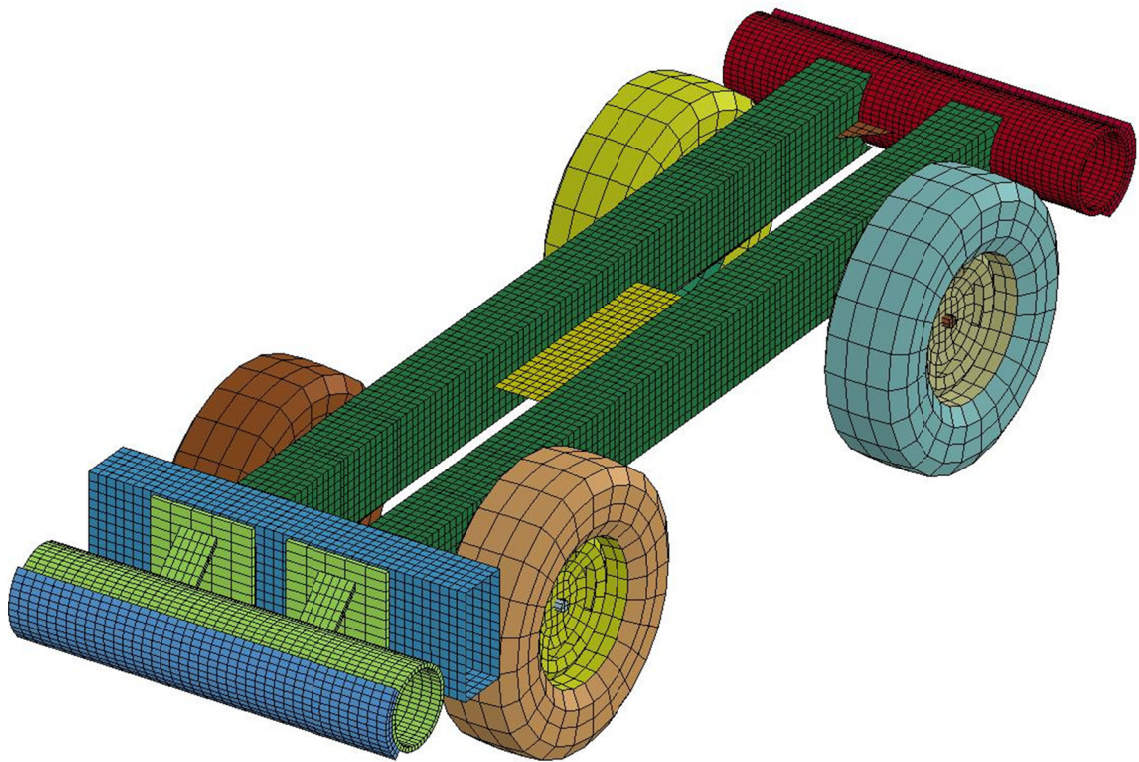
Figure 38. Bogie Finite Element Model

The bogie model used for the simulation was previously developed by the MwRSF. Only slight modifications were made to the bogie model (i.e. impact head mounting height and bogie mass) in order to more closely represent the physical bogie. The final mounting height of the impact head was 19 in. and the bogie weight was 1794.2 lbs. The bogie model is shown in Figure 38.

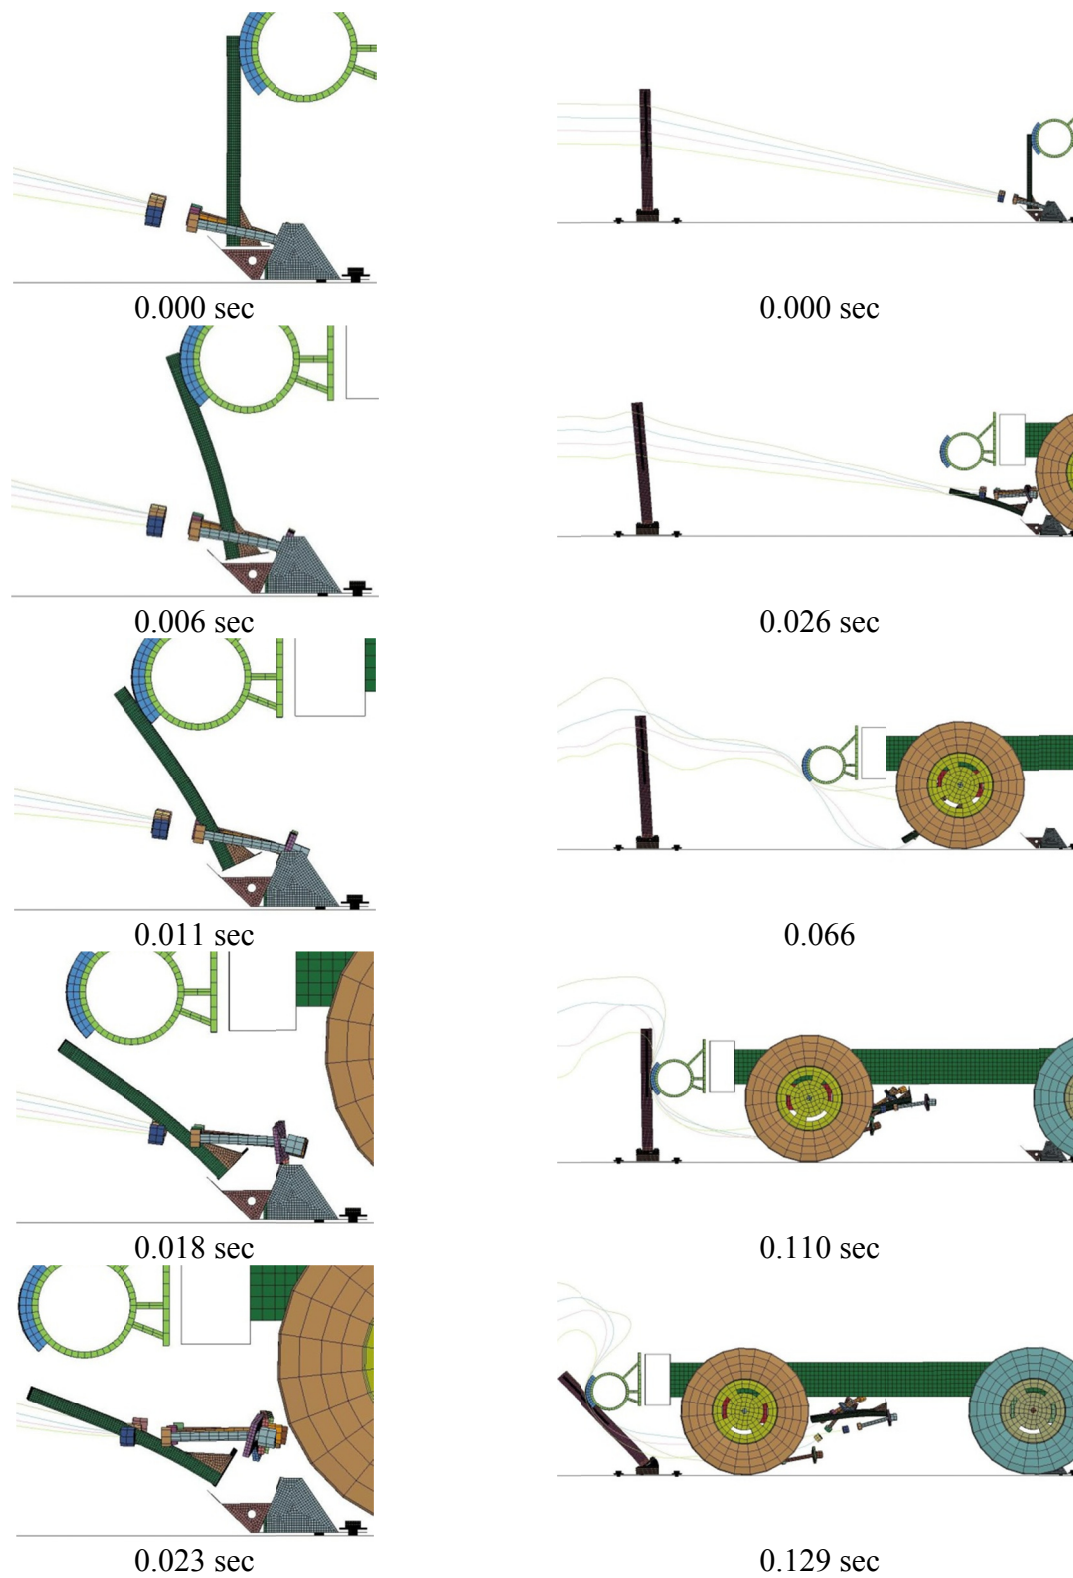
Figure 39. Sequential Photographs, Bogie Test Simulation

Initial impact was between the center of the bogie head and the center of the cable release lever. A sequential description of the simulated impact events is contained in Table 7. Sequential images of the simulation are shown in Figure 39.

A finite element model of the current, high-tension cable anchor bracket was created and analyzed using a simulated dynamic bogie test. The simulation was conducted in order to obtain a numerical model to compare to subsequent physical bogie testing. The initial simulation of the current, high-tension cable anchor bracket exhibited good cable release mechanics as the cable release lever was impacted and rotated backwards, releasing the system cables as designed.

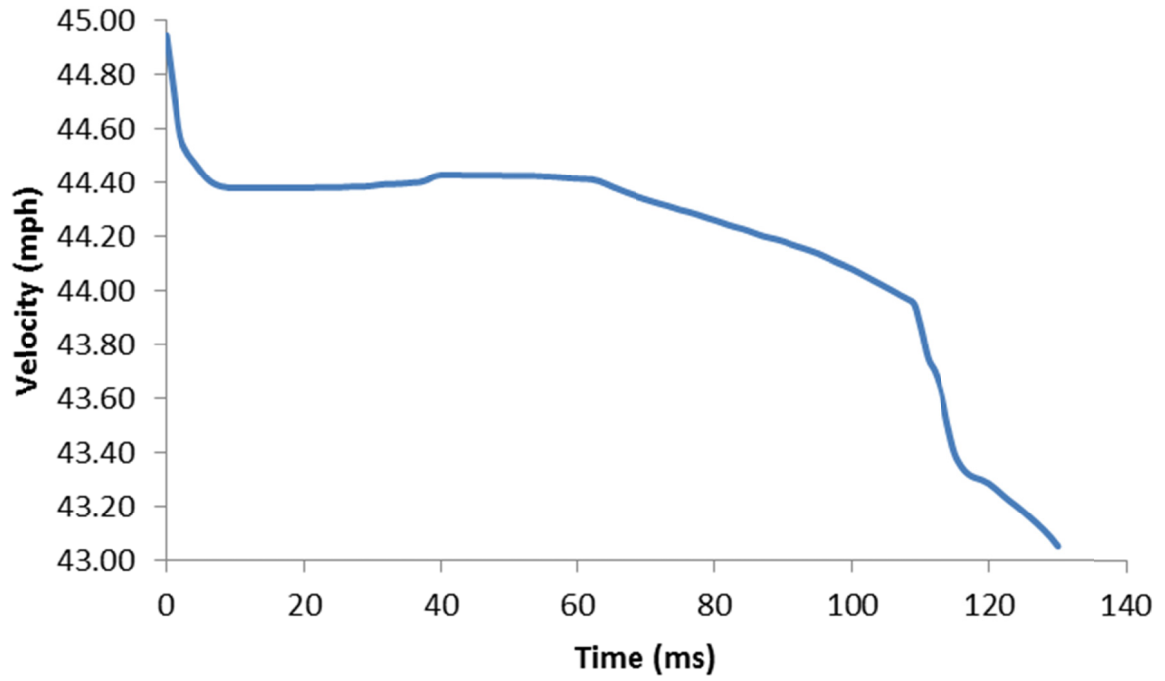
Figure 40. Longitudinal Bogie Velocity, Initial Simulation

anchor bracket components. The simulated bogie velocity after impact with the cable anchor bracket stabilized to 44.4 mph. The associated change in velocity due to the anchor impact was 0.6 mph. The bogie head impact with the system cables resulted in a linear decrease in velocity beginning at roughly 61 ms. The total loss in velocity from the cable impact was 0.5 mph. The bogie then impacted the slip base post, thus resulting in an additional bogie velocity reduction of 0.9 mph. The velocity data from the simulation is shown in Figure 40.

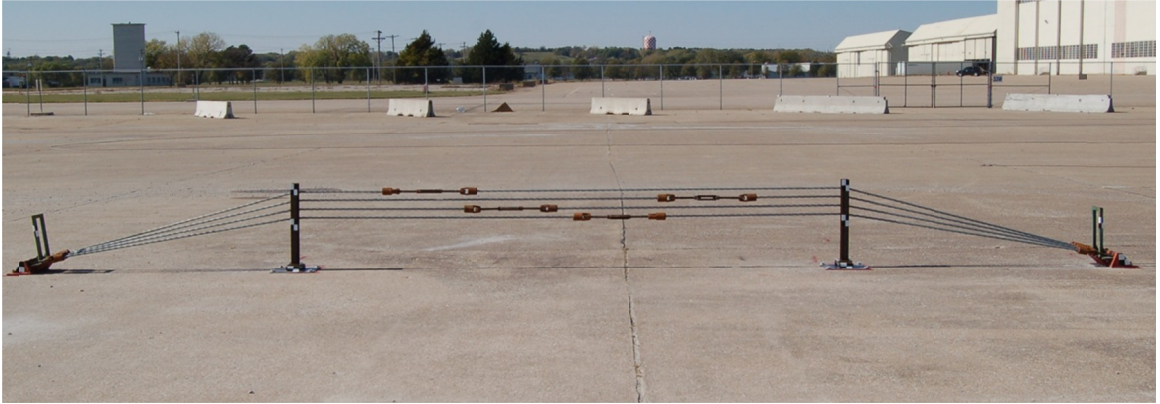
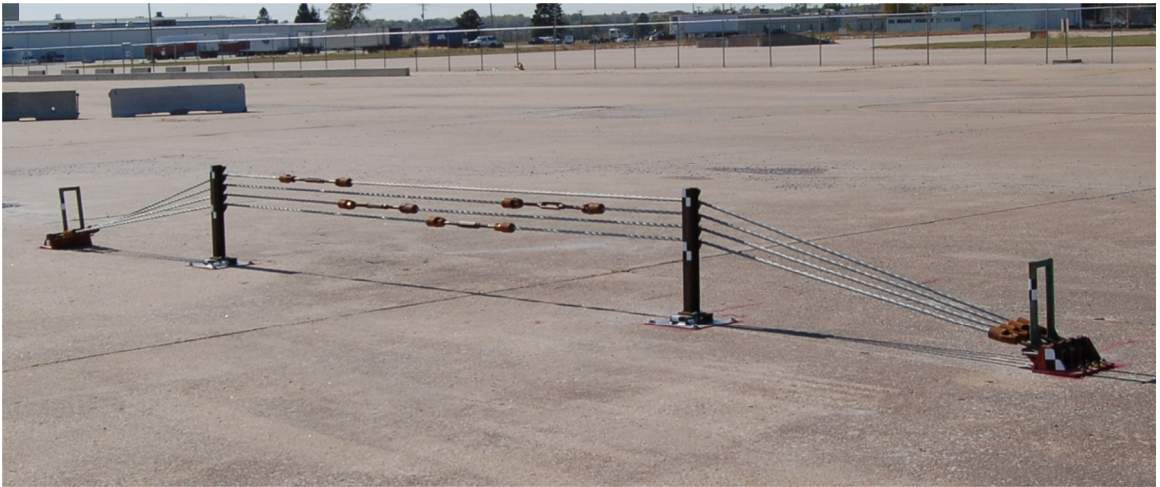
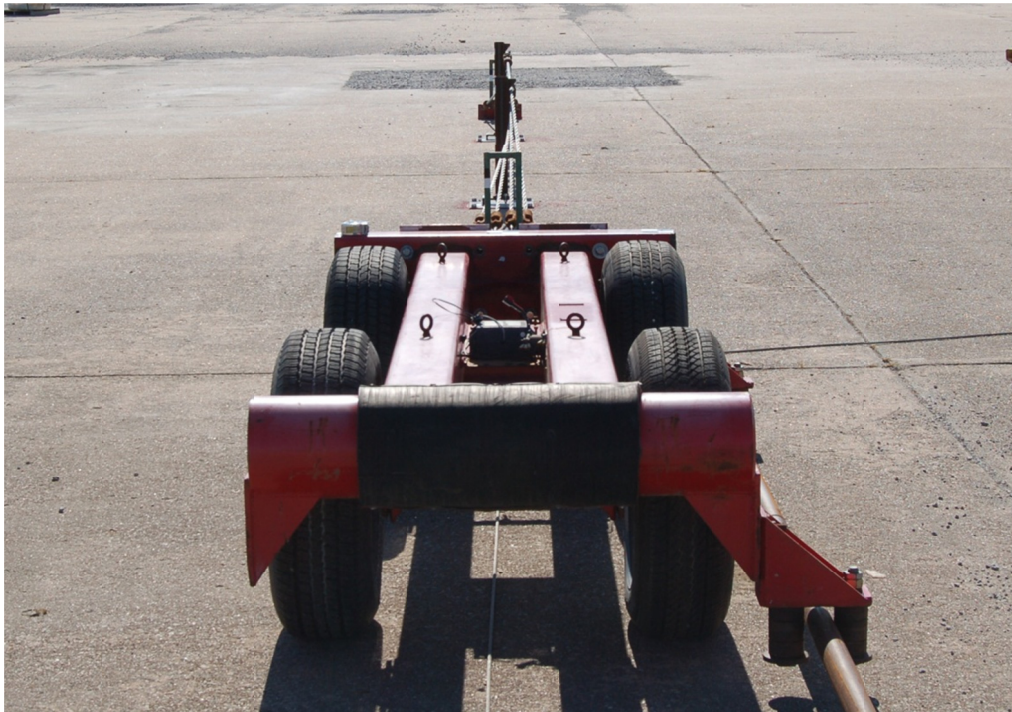
Figure 41. Bogie Test System Setup, Test No. HTCT-1

The cable barrier test system used for the bogie test consisted of three main components: (1) cable anchor bracket assemblies; (2) slip base post assemblies; and (3) system cables. Descriptions of each of these assemblies and the components that comprise the assembly can be found in the following sections. Photographs of the system prior to testing are shown in Figure 41. Design drawings for the test articles are shown in Figures 42 through 48.

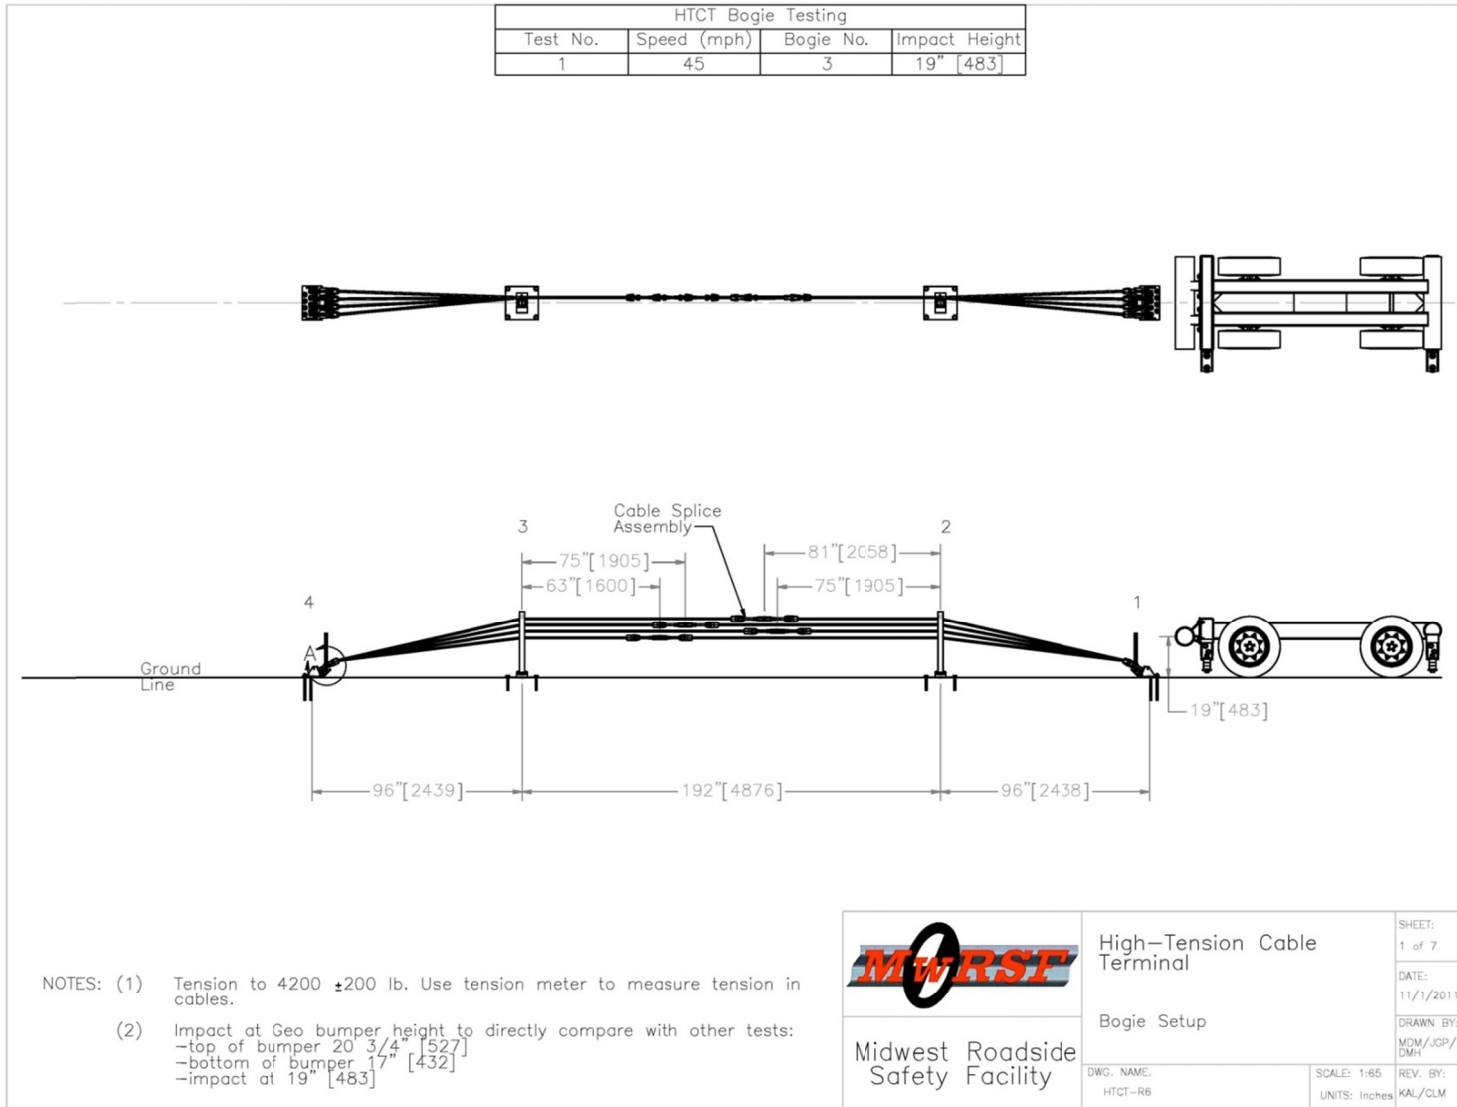
Figure 42. Bogie Test Layout, Test No. HTCT-1

A bogie test was conducted on an abbreviated version of a high-tension, cable end terminal. The abbreviated system consisted of two high-tension, cable anchor brackets, two slip base post assemblies, and four system cables. The system was installed on a concrete tarmac at MwRSF's outdoor testing facility. The target test conditions consisted

of an impact speed of 45 mph with the bogie's impact head centered and aligned with the center of the cable release lever on the cable anchor bracket. The targeted impact height for the test was 19 in., as measured from the ground to the horizontal centerline of the bogie impact head. This height was selected to simulate the bumper height of a Kia Rio. The test matrix is shown in Figure 42.

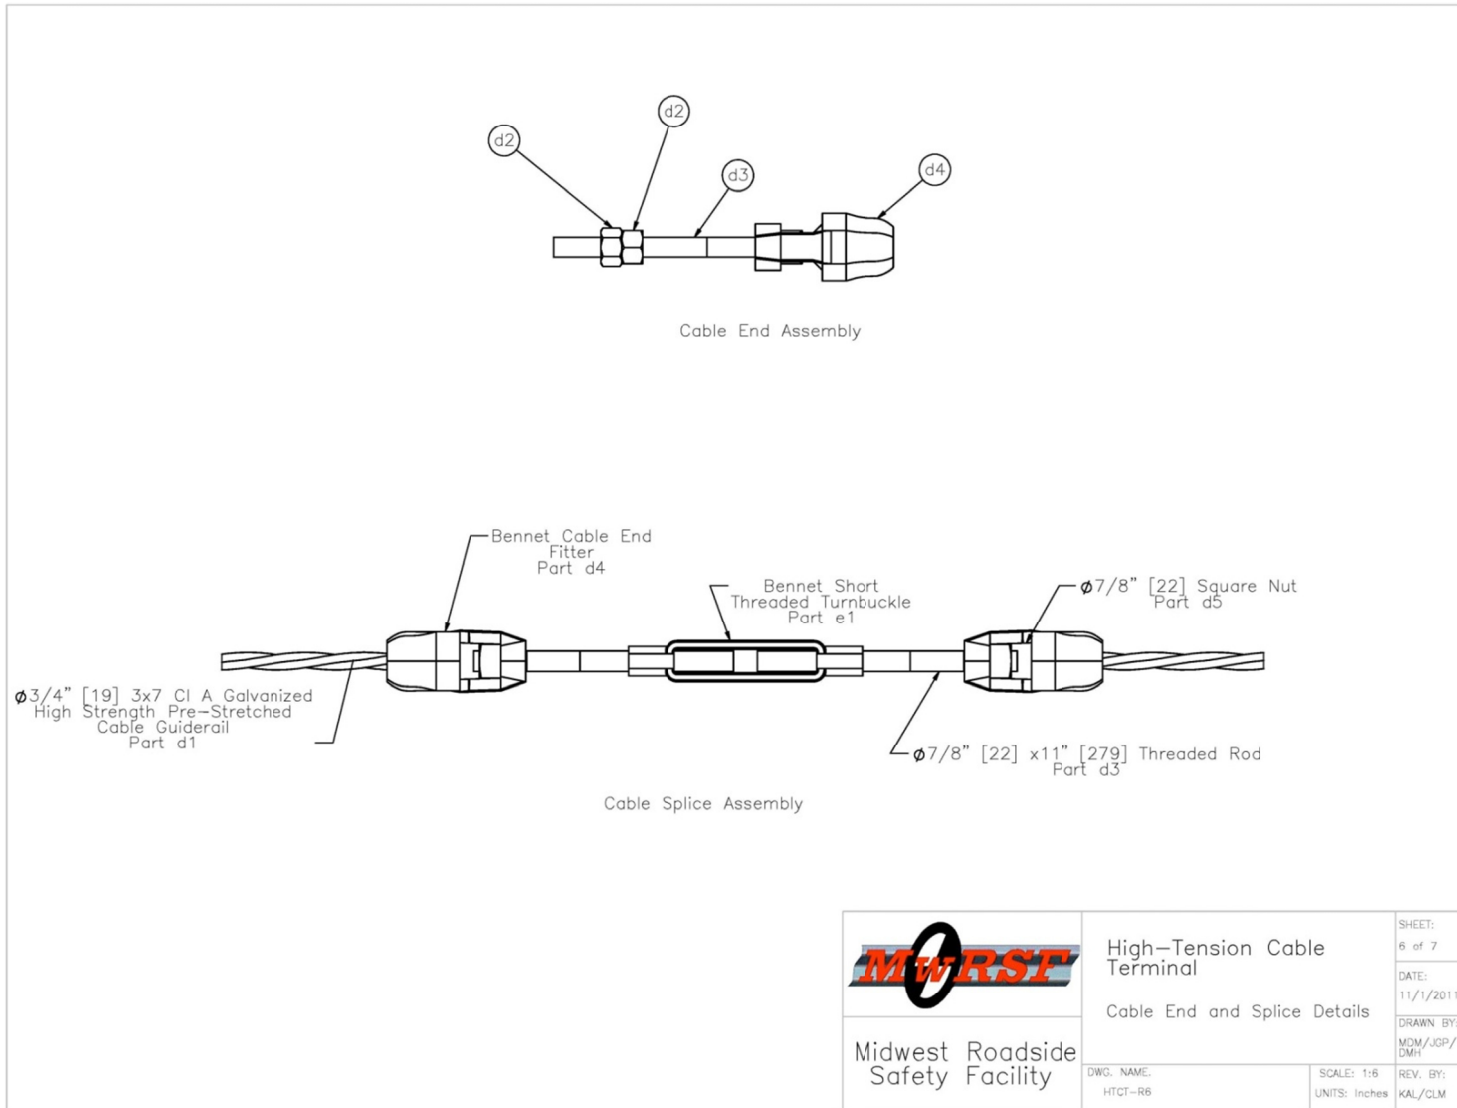
Figure 47. Cable End Fitters and Turnbuckle Details, Test No. HTCT-1

Four $\frac{3}{4}$ -in. diameter, 3x7 wire rope cables were used in the barrier system. The cables were tightened through the use of cable turnbuckles. The ends of the cable contained threaded rod fittings that terminated in the cable anchor bracket. Each threaded rod was secured in a cable anchor slot with a 3-in. x $2\frac{3}{8}$ -in. x $\frac{1}{2}$ -in. thick plate washer and two $\frac{3}{4}$ -in. diameter heavy hex nuts.

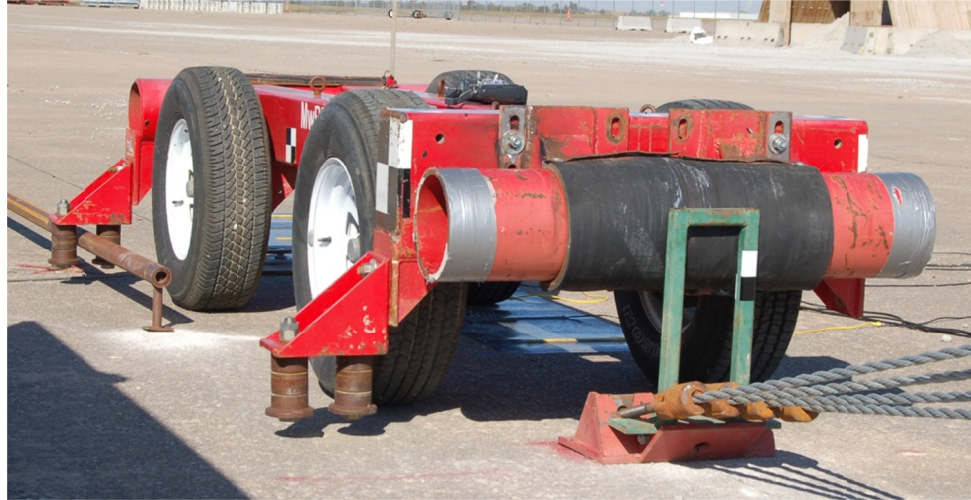
Figure 49. Rigid Frame Bogie on Guidance Track

A pickup truck with a reverse cable tow and guide rail system was used to propel and direct the bogie. The bogie was accelerated toward the system along the guidance system, which consisted of a steel pipe anchored above the tarmac. The bogie wheels were aligned for caster and toe-in values of zero so that the bogie would track properly. When the bogie reached the end of the guidance system, it was released from the tow cable, allowing it to be free rolling when it struck the cable release lever. A remote braking system was installed on the bogie to provide for safe deceleration of the bogie after the test.

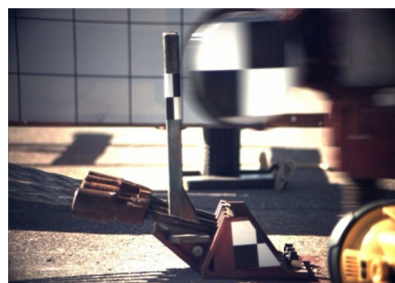
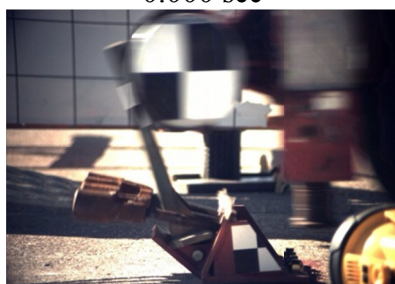
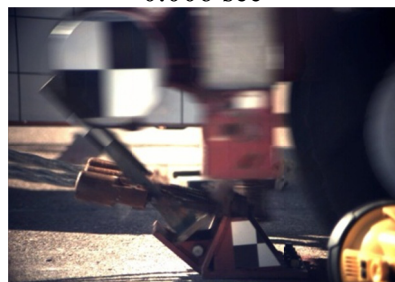
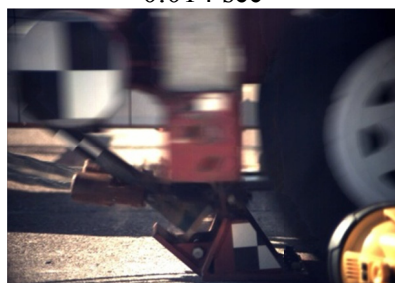
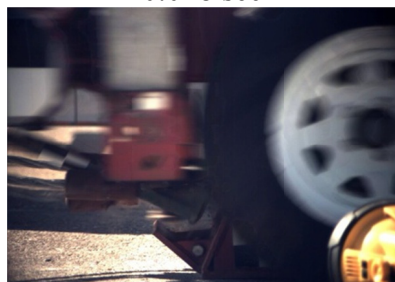
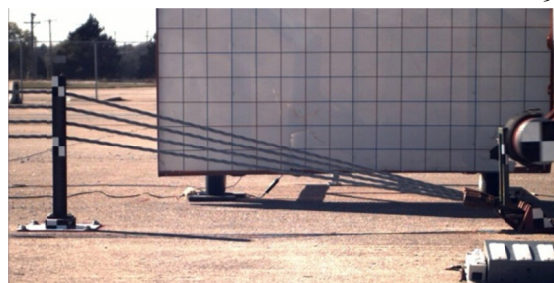
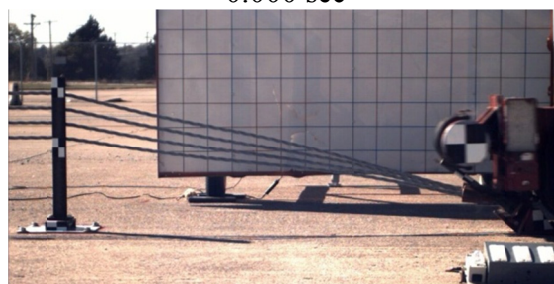
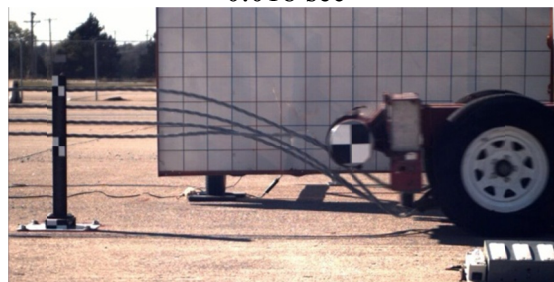
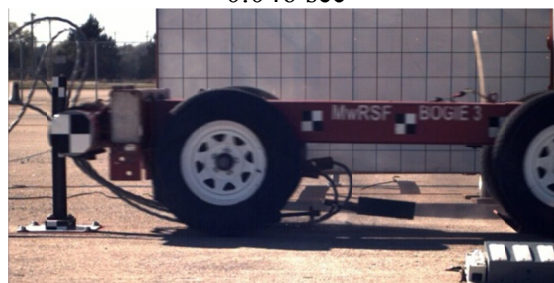
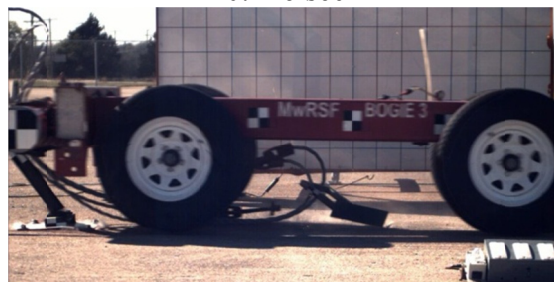
Figure 50. Sequential Photographs, Test No. HTCT-1

Test no. HTCT-1 was performed at 0 degrees and 44.9 mph with the bogie impact head centered on the cable release lever. A sequential description of the impact events is contained in Table 9. During the test, the guide bracket and roller bearing on the bogie snagged on a concrete edge after exiting the test setup, and the bogie came to a rest roughly 43 ft downstream from the downstream anchor bracket. Time-sequential documentary photographs of the test are shown in Figures 50 and 51.

0.124	The welds between the top S3x5.7 post section and the slip plate broke causing the post to fail prior to activation of the slip base mechanism.
0.200	The bogie head impacted the cable turnbuckle from the second highest mounted cable.

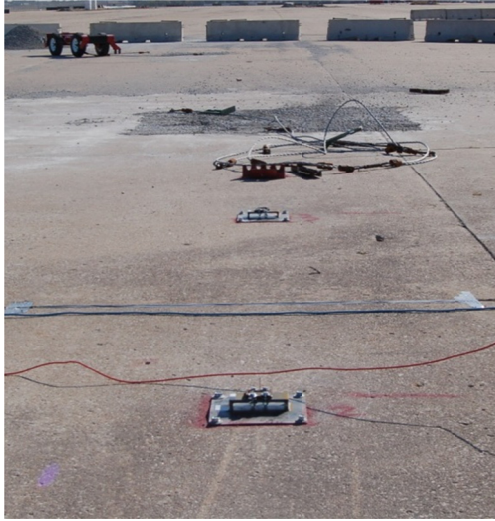
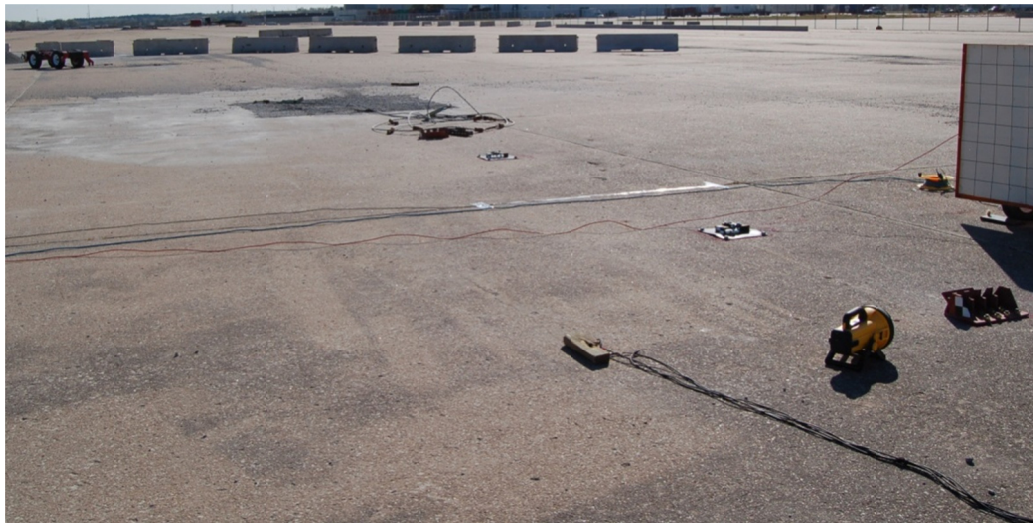
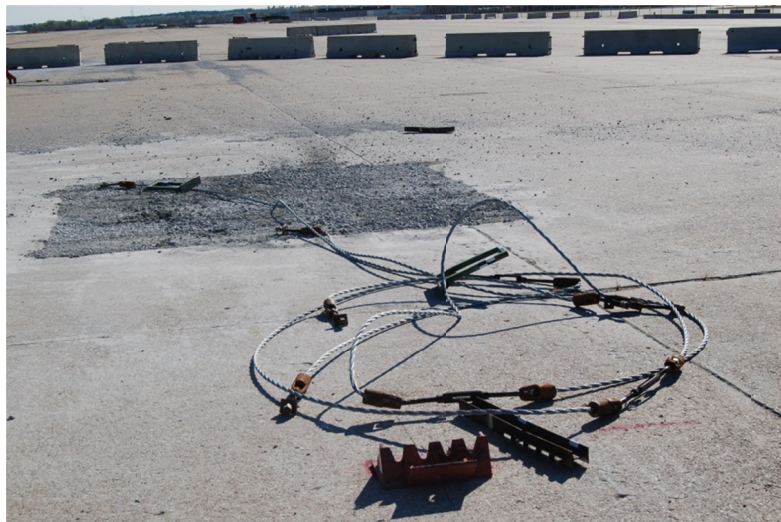
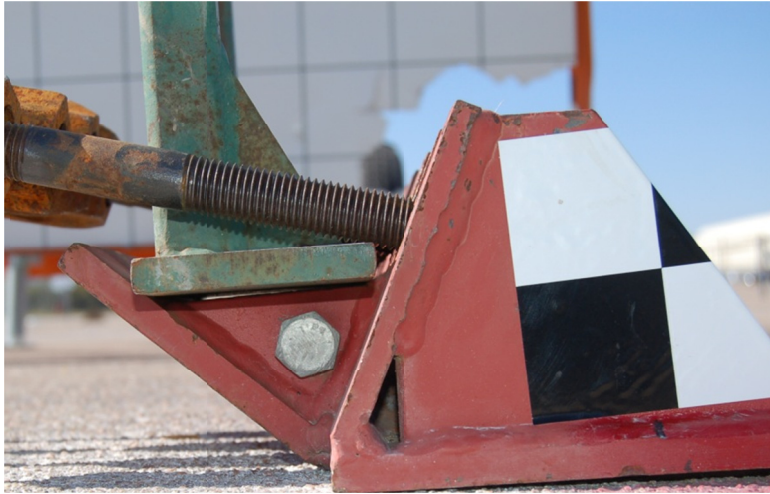
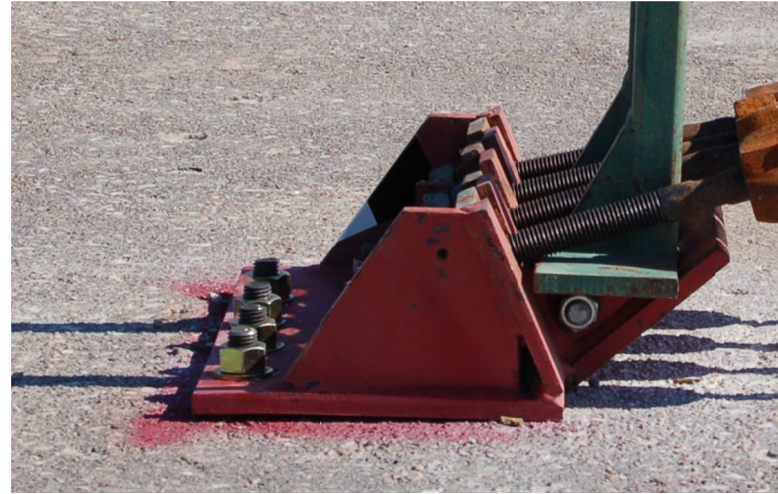
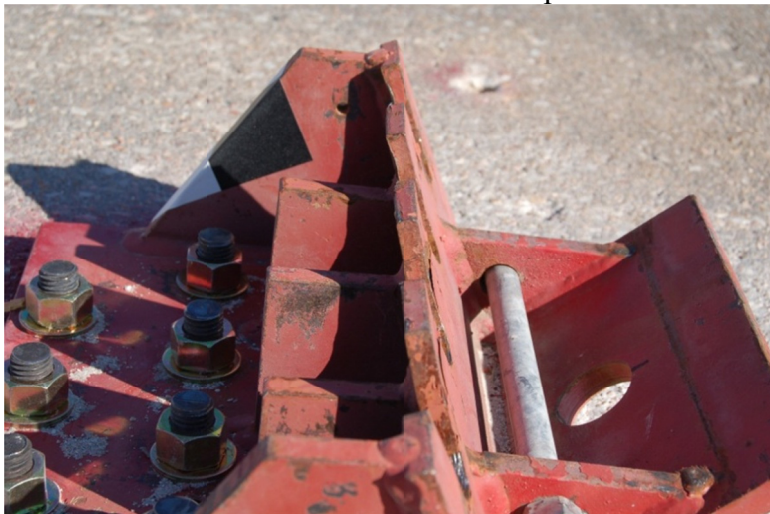
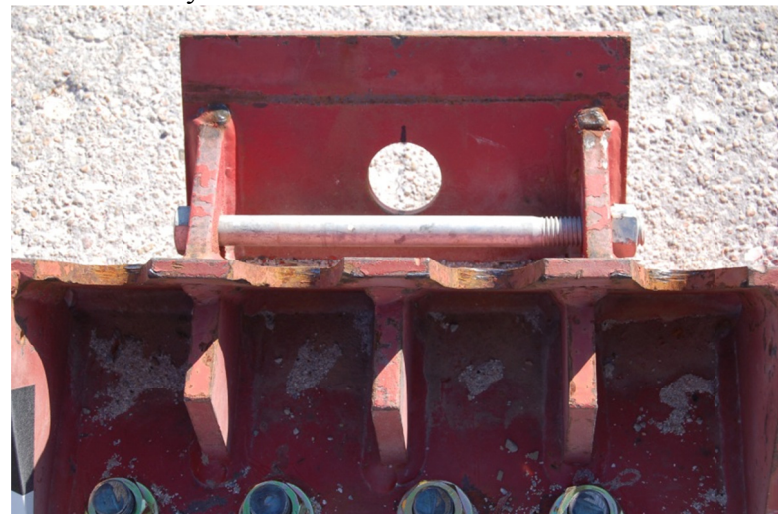
Figure 52. System Damage, Test No. HTCT-1

components of the cable anchor bracket assembly were undamaged. There was some contact and/or gouging on the base plate of the upstream cable release lever due to highly concentrated contact forces with the cable end fitters. However, there was no plastic bending in the base plate or the vertical impact tubes. Damage photos are shown in Figures 52 through 58.

Upstream Cable Anchor Bracket Assembly – Pre-Test

Upstream Cable Anchor Bracket Assembly – Post-Test

Figure 53. System Damage, Test No. HTCT-1

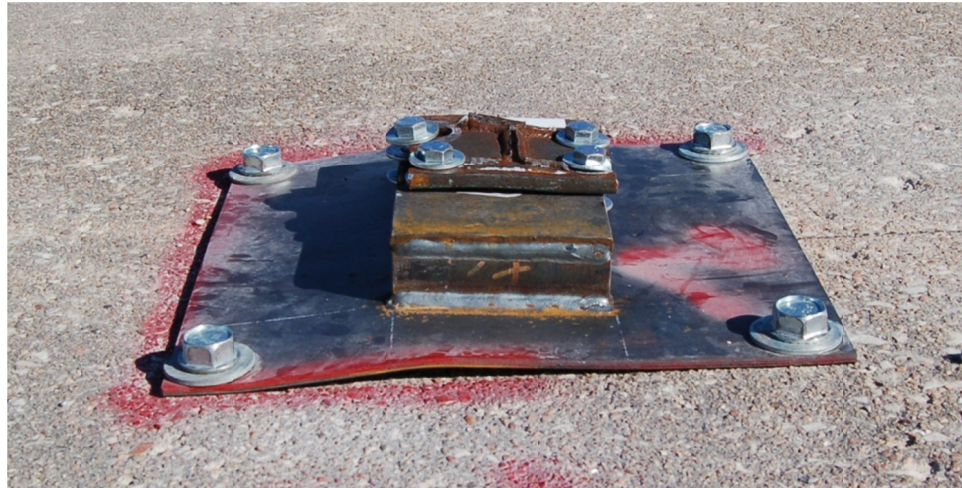
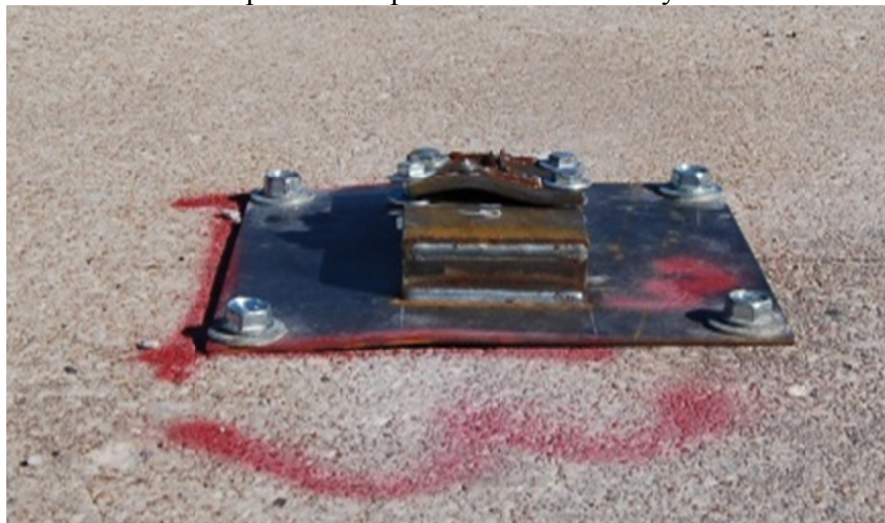
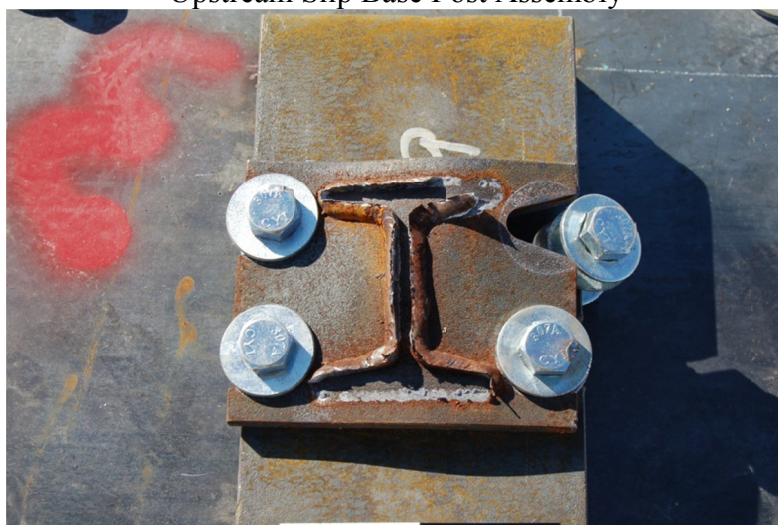
Figure 54. System Damage, Test No. HTCT-1

Upstream Slip Base Post Assembly
