Development and Recommendations for a Non-Proprietary, High-Tension, Cable End Terminal System

DEVELOPMENT AND RECOMMENDATIONS FOR A
NON-PROPRIETARY, HIGH-TENSION, CABLE END
TERMINAL SYSTEM

A THESIS

Presented to the Faculty of
The Graduate College at the University of Nebraska
In Partial Fulfillment of Requirements
For the Degree of Master of Science

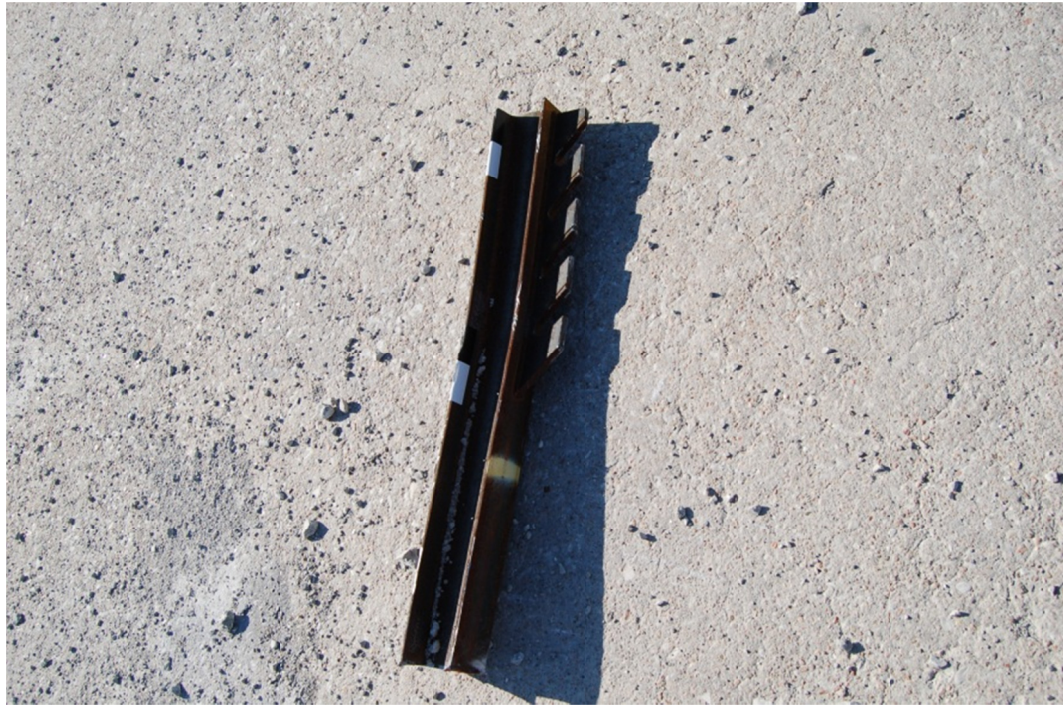
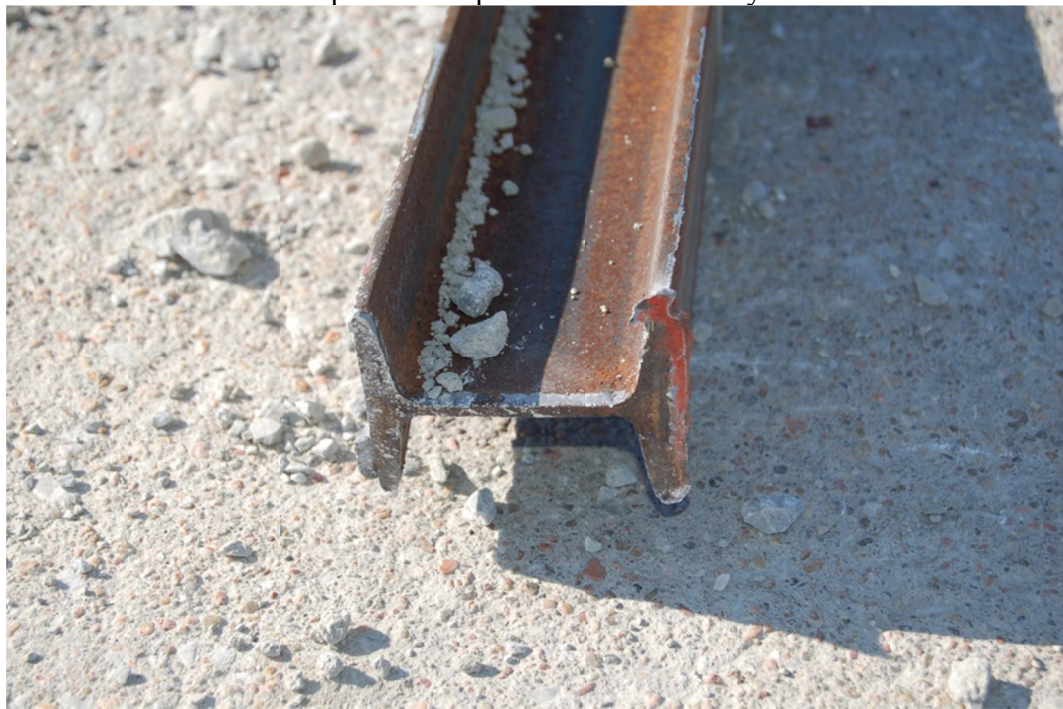
Figure 55. System Damage, Test No. HTCT-1

Upstream Slip Base Post Assembly

components of the cable anchor bracket assembly were undamaged. There was some contact and/or gouging on the base plate of the upstream cable release lever due to highly concentrated contact forces with the cable end fitters. However, there was no plastic bending in the base plate or the vertical impact tubes. Damage photos are shown in Figures 52 through 58.

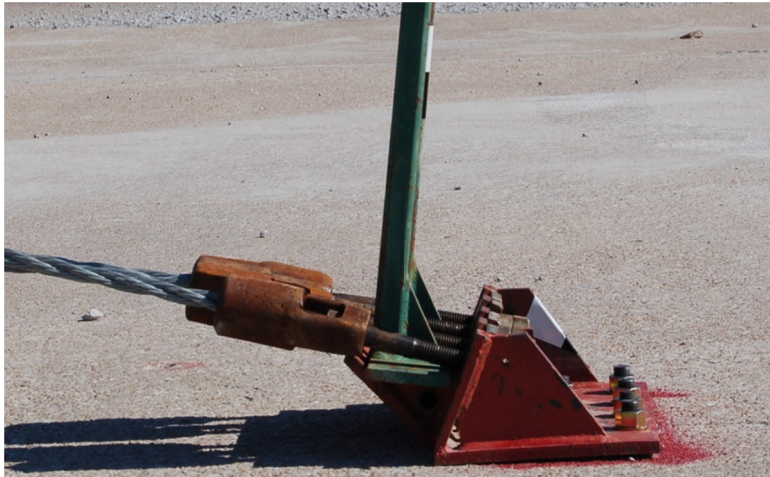
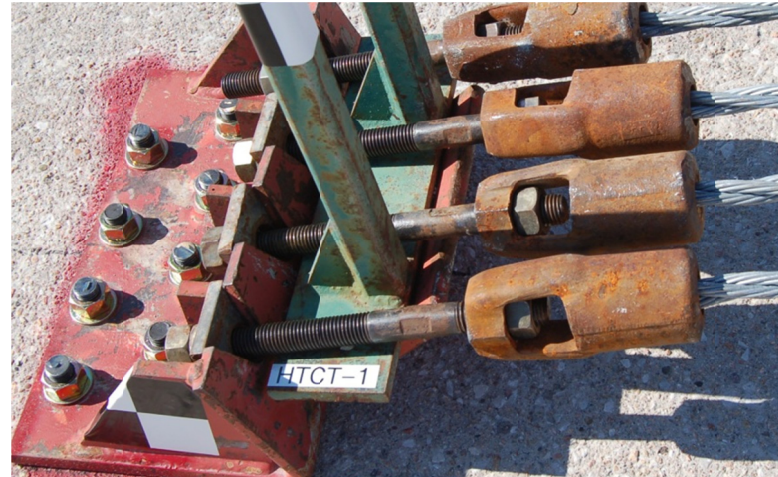
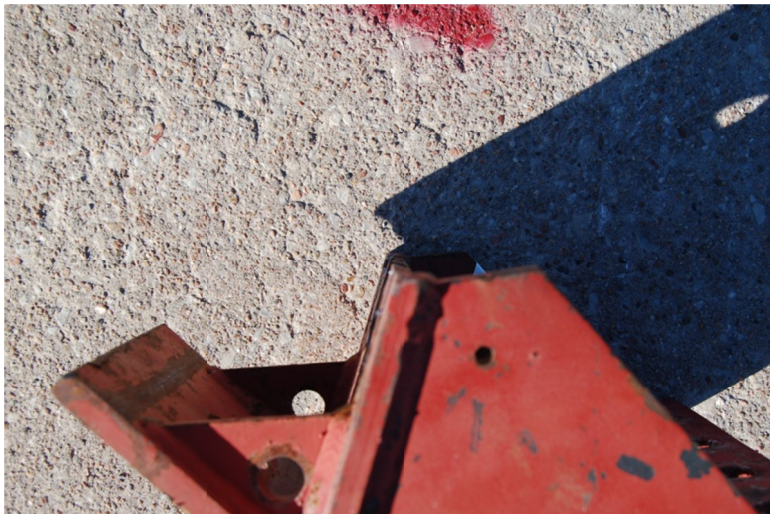
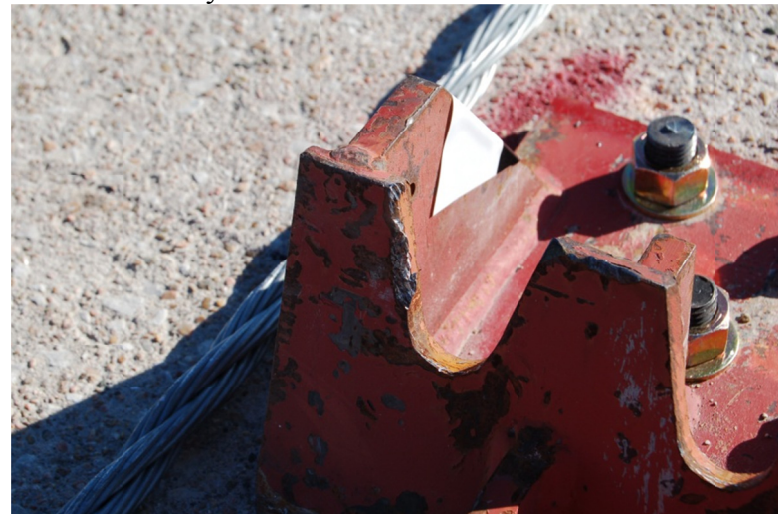
Figure 58. System Damage, Test No. HTCT-1

Downstream Cable Anchor Bracket Assembly – Pre-Test

Downstream Cable Anchor Bracket Assembly – Post-Test

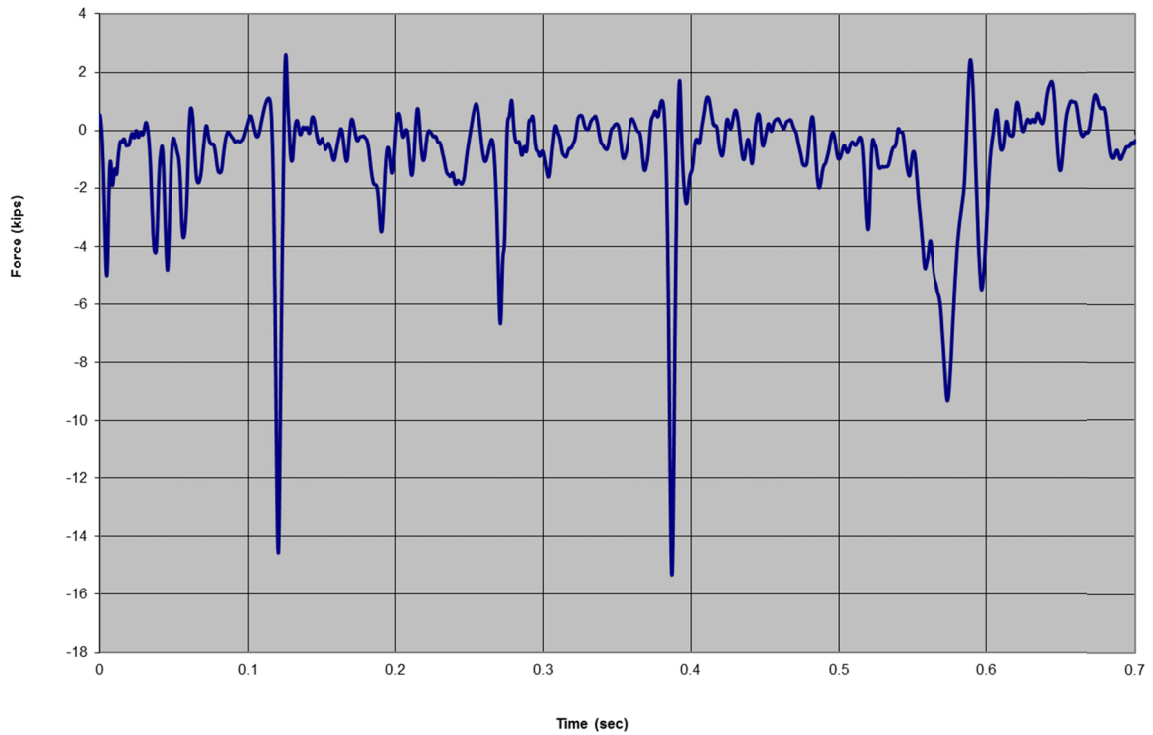
Figure 59. Force vs. Time, Test No. HTCT-1

The bogie's left-front wheel impacted the downstream cable anchor bracket at approximately 573 ms. The impact resulted in a peak force of 9.2 kip. After the bogie impact with the downstream cable anchor bracket, the bogie continued out of the system before coming to a stop downstream of the test setup.

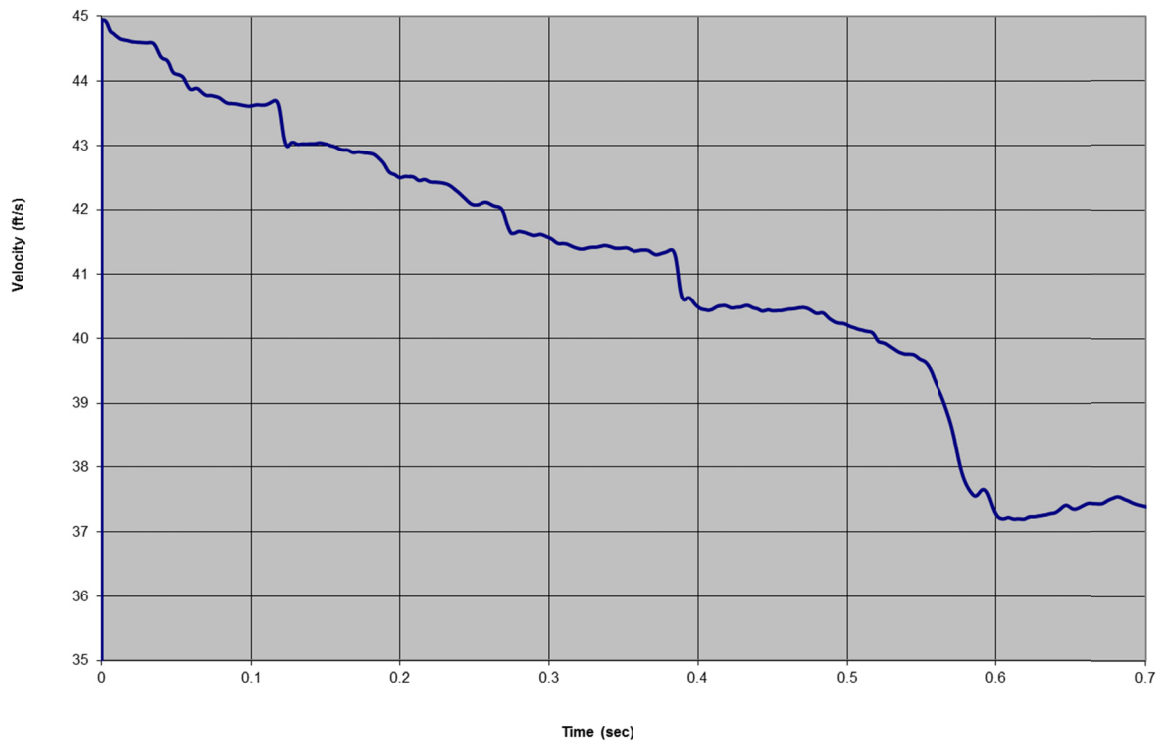
Figure 60. Longitudinal Velocity vs. Time, Test No. HTCT-1

Force, velocity, and energy dissipation curves for the bogie test were created from accelerometer data and are shown Figures 59, 60, and 61, respectively. Also note that standard MwRSF bogie test documentation sheets can be found in Appendix C.

The velocity data agreed well between the physical bogie test and the simulation. The average error in velocity between the physical test and numerical simulation was 0.79 percent. After the anchor bracket impact, the bogie velocity in both the simulation

and physical test stabilized for a short time before small impacts with the system cables and other detached anchor bracket components. These secondary impacts caused small velocity reductions at roughly 35 ms after initial impact. The stabilized velocity in test no. HTCT-1 after impact with the cable anchor bracket was 44.6 mph, compared with 44.3 mph observed in the simulation. The resulting error in the Δv from the impact was 0.7 percent.

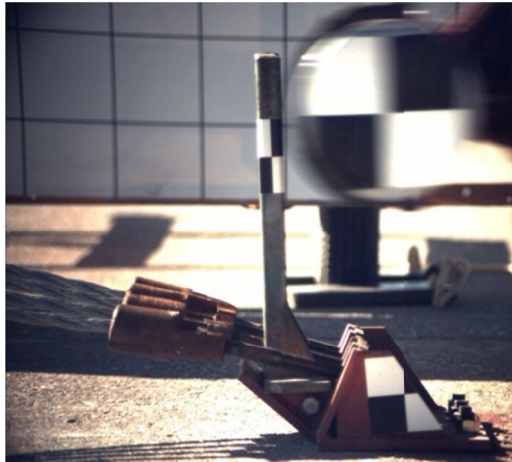
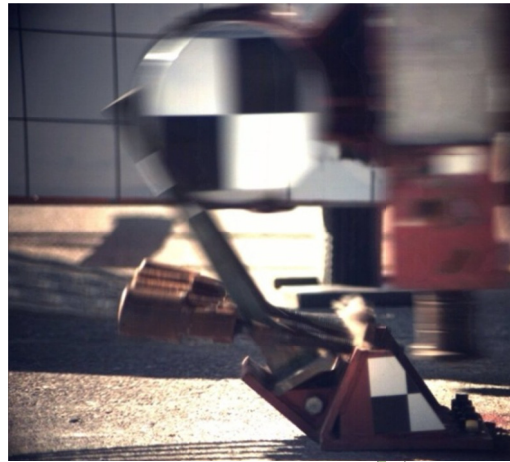
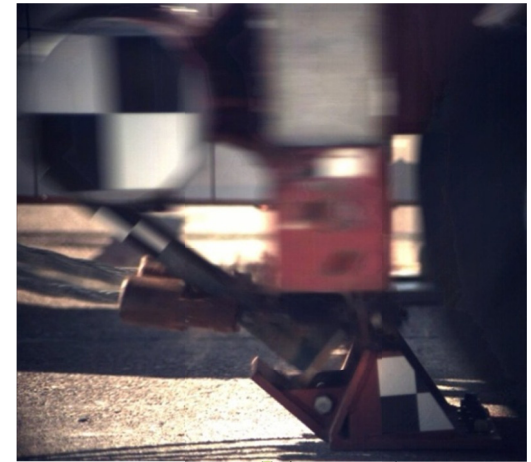
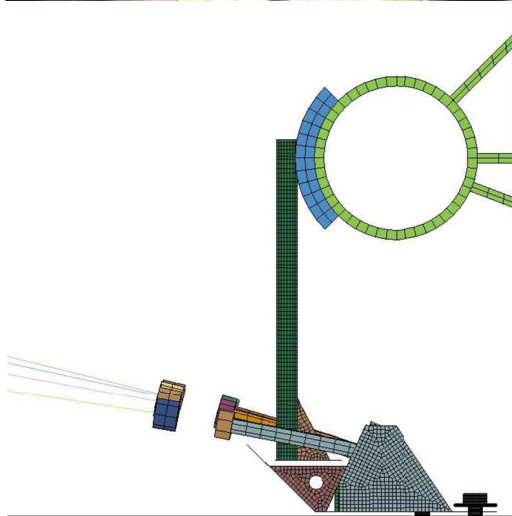
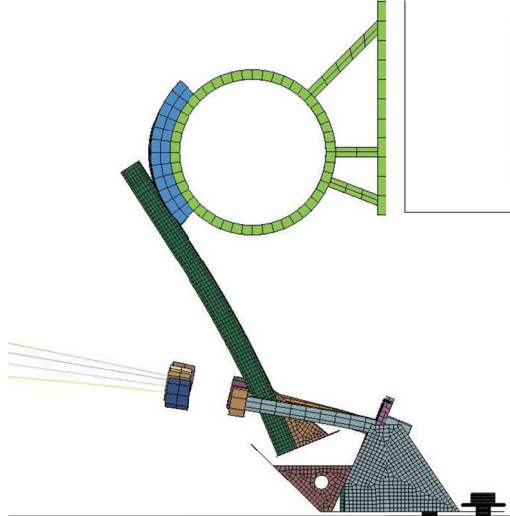
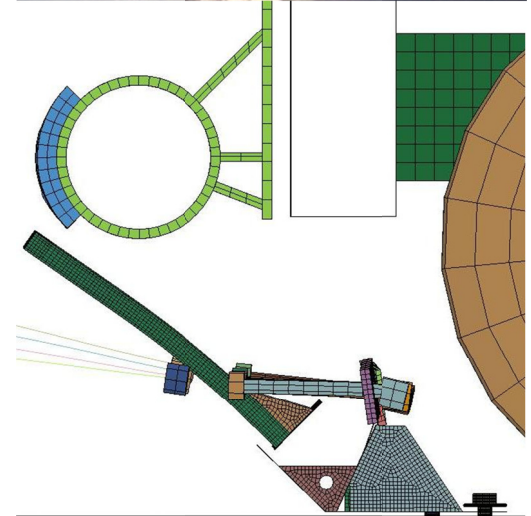
Figure 62. Cable Release Event Comparison, Test No. HTCT-1 vs. Simulation

High-speed video from test no. HTCT-1 was used to incrementally compare the release mechanics of the cables from the cable anchor bracket to the mechanics observed in the simulation model. A sequential comparison of the cable release event is shown in Figure 62. The cables showed smooth release without snag in both the simulation as well as the physical test. The cables fully released from the cable anchor bracket at roughly 18 ms as compared to 20 ms in the physical test. The error in release times could partially be attributed to frame rate limitations in physical testing. The frame rate on the actual high-speed cameras was 500 frames/sec. While this limitation is likely not the sole cause of the error, it could have contributed to the difference in release time.

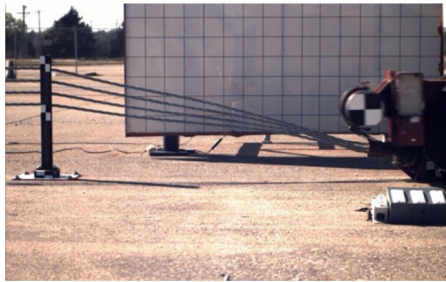
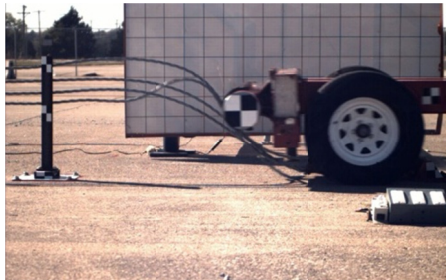
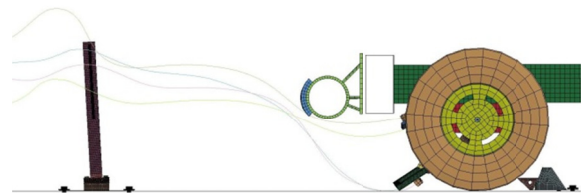
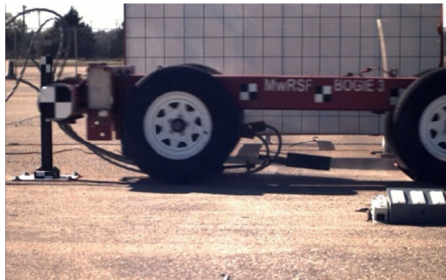
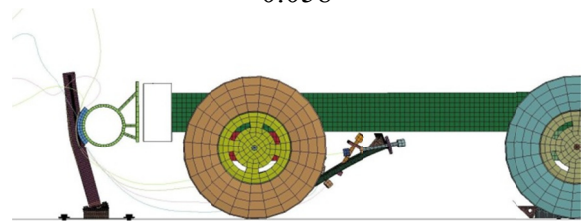
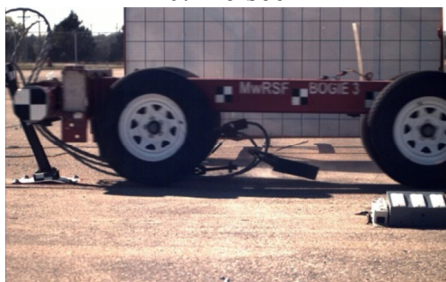
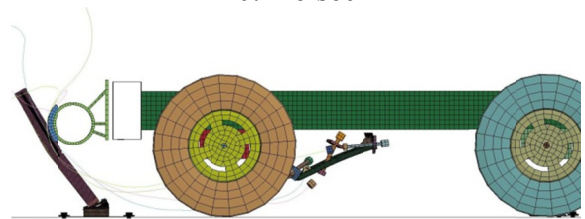
Figure 63. Sequential Comparison, Test No. HTCT-1 vs. Simulation

The timing of the bogie impact with the slip base post correlated well between the simulation and the physical test. The bogie in the simulation impacted the slip base post at 111 ms. The bogie in test no. HTCT-1 impacted the slip base post at 116 ms. The error could again be partially attributed to frame rate limitations with the high-speed cameras or simplifications and assumptions made in the simulation model that led to a divergence from actual component behavior. Differences in cable material properties and interactions with the bogie impact head could have resulted in higher longitudinal changes in bogie velocity (Δv 's) and also contributed to the error. The higher Δv 's would increase the time between the initial impact with the cable lever arm and the impact with the slip base post. A sequential comparison of test no. HTCT-1 and the associated simulation is shown in Figure 63.

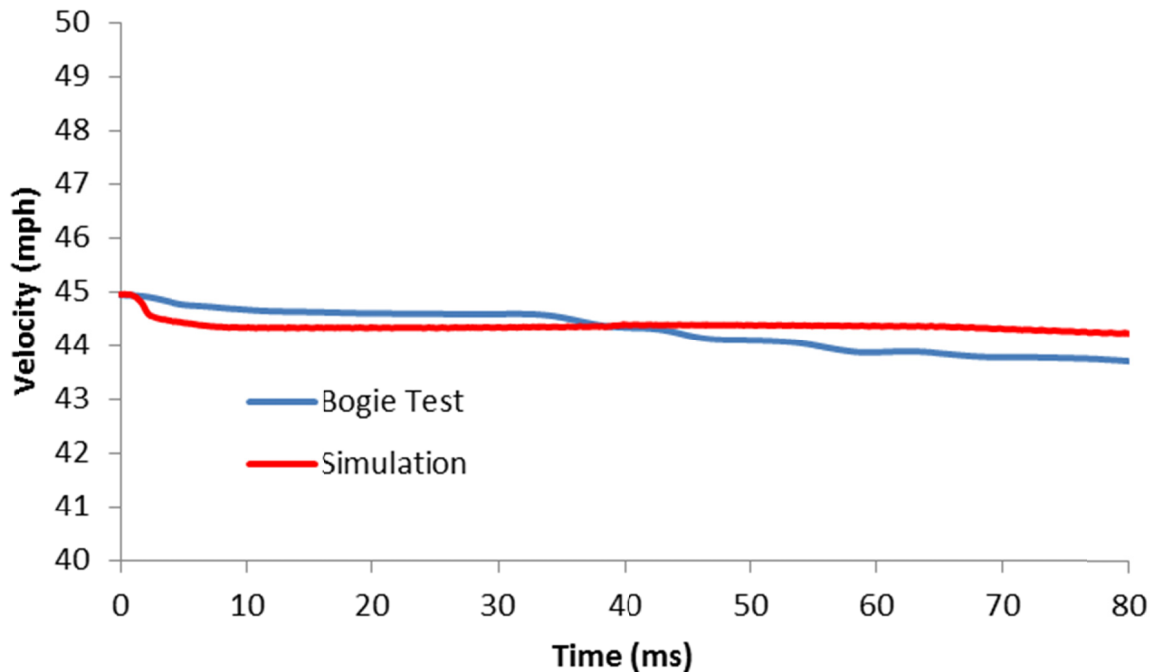
Figure 64. Bogie Velocity Comparison, Test No. HTCT-1 vs. Simulation

Bogie velocity was also used to evaluate the accuracy of the simulation model. Accelerometer data captured during the actual and simulated bogie tests was processed in order to calculate and compare bogie velocities. The bogie velocities for the simulation and physical test are shown in Figure 64. The velocity trace is plotted through the impact with the upstream cable anchor assembly. However, it is cut off prior to the bogie's impact with the slip base post. Although similar failure modes were exhibited in both the simulation and the physical testing, the main focus of the comparison is the modeling of the cable anchor bracket and its release mechanics.

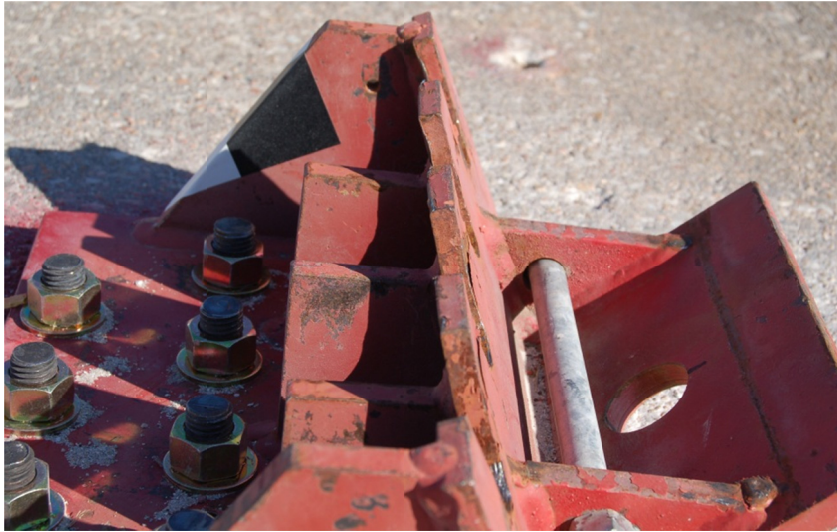
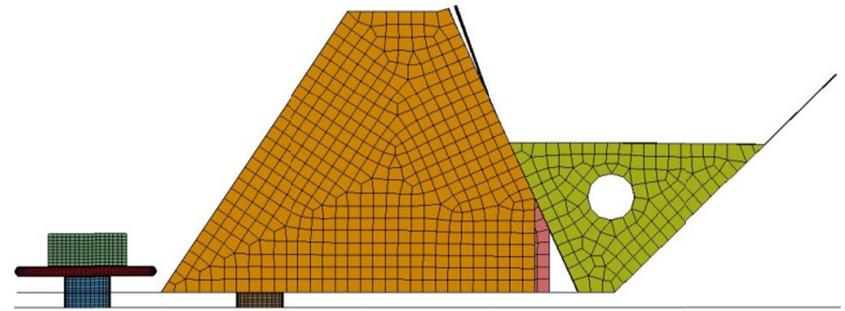
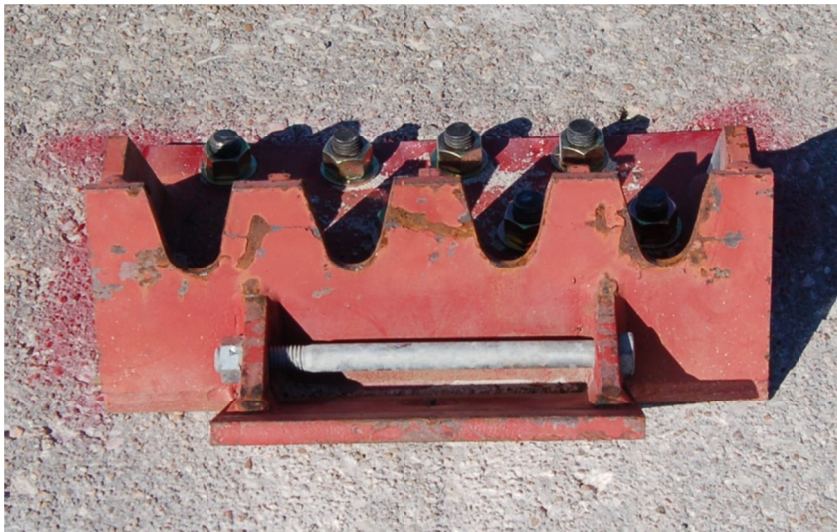
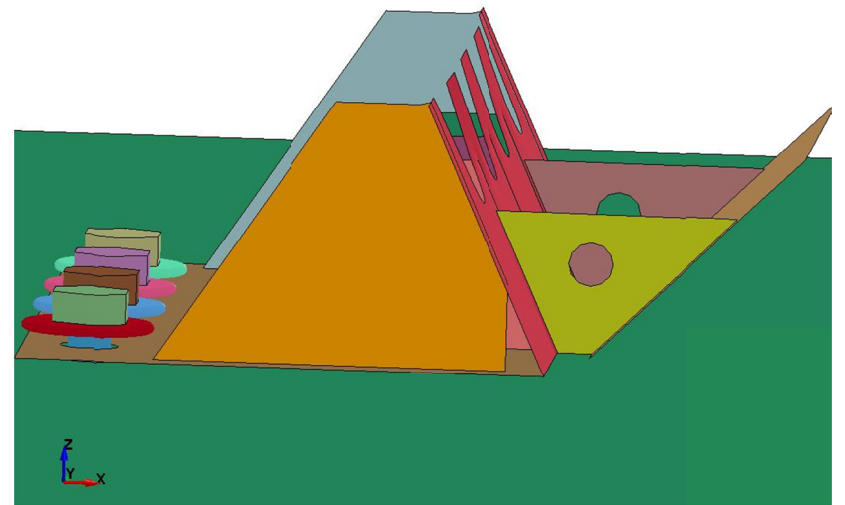
Figure 65. Upstream Cable Anchor Damage Comparison, Test No. HTCT-1 vs. Simulation

There was relatively little component damage to the cable anchor bracket assembly in both the physical testing and the simulation. The only permanent deformation to the assembly was plastic bending in the cable plate. The S3x5.7 post section on the first slip base post assembly sustained some plastic deformation in the impact region during the physical test and the simulation. A comparison of the damage is shown in Figures 65 and 66. Although the cable release lever did not sustain any damage, it was pulled downstream with the bogie after several of the system cables wrapped around the assembly's crossbar. This behavior occurred in both the simulation and the physical test. The cable release lever was pulled downstream in both the physical test and the simulation, as shown in Figure 67. Although the dynamics and trajectory of the lever do not match exactly between the simulation and physical test, the fact that the cables

wrapped around the crossbar in both events further support that the cable release event is being simulated accurately.

There was very little component damage to the cable anchor bracket during test no. HTCT-1. Damage that did occur to the anchor bracket was concentrated in the cable plate. The deformation to the cable plate on the anchor bracket was replicated well during the simulation. No other permanent deformation to the anchor bracket or its components occurred during the bogie test.

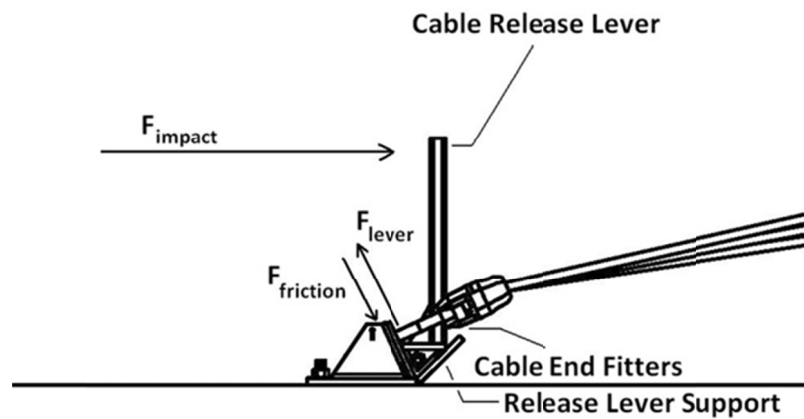
Figure 68. Simplified Free Body Diagram of Cable Release Lever During Cable Release

The increased release time is partially due to a higher friction force that must be overcome during the rotation of the cable release lever assembly. The higher friction force results from the increased cable tension and the additional system cable. A free body diagram of the forces involved in the release of the cables is shown in Figure 68.

In order for the cable release lever to begin to rotate, the lever force, F_{lever} , must be greater than the friction force due to the contact between the plate washers on the cable end fitters and the cable plate. The lever force is generated as a result of a moment force applied by the impacting vehicle, F_{impact} , and the corresponding upward prying action. The friction force between one of the washers and the cable plate can be calculated using equation 1.

The normal force in equation 1 can be approximated as the cable tension. The static/dynamic coefficient will remain constant between the low-tension and high-tension tests. Therefore, the total normal force will increase from 2.7 kips to 16.8 kips with the addition of one cable and an increase in cable tension from roughly 900 lbs/cable to 4,200 lbs/cable.

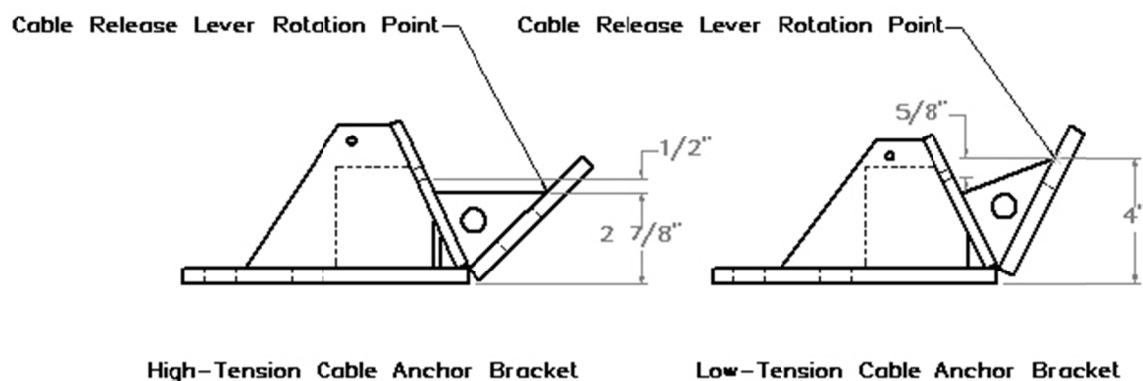
Figure 69. Rotation Point Comparison

Another reason for the increased release time pertains to the geometry of the cable anchor bracket assemblies. The two cable anchor bracket assemblies are shown in Figure 69. The rotation point for the cable release lever on the low-tension, cable anchor bracket assembly was located 5/8-in. above the bottom of the cable slots on the cable plate. The rotation point for the cable release lever on the high-tension cable anchor bracket assembly was located 1/2-in. below the bottom of the cable slots on the cable plate. The low-tension, cable anchor bracket assembly's geometry allowed for more upward movement of the cables with less rotation of the release lever due to the higher rotation point.

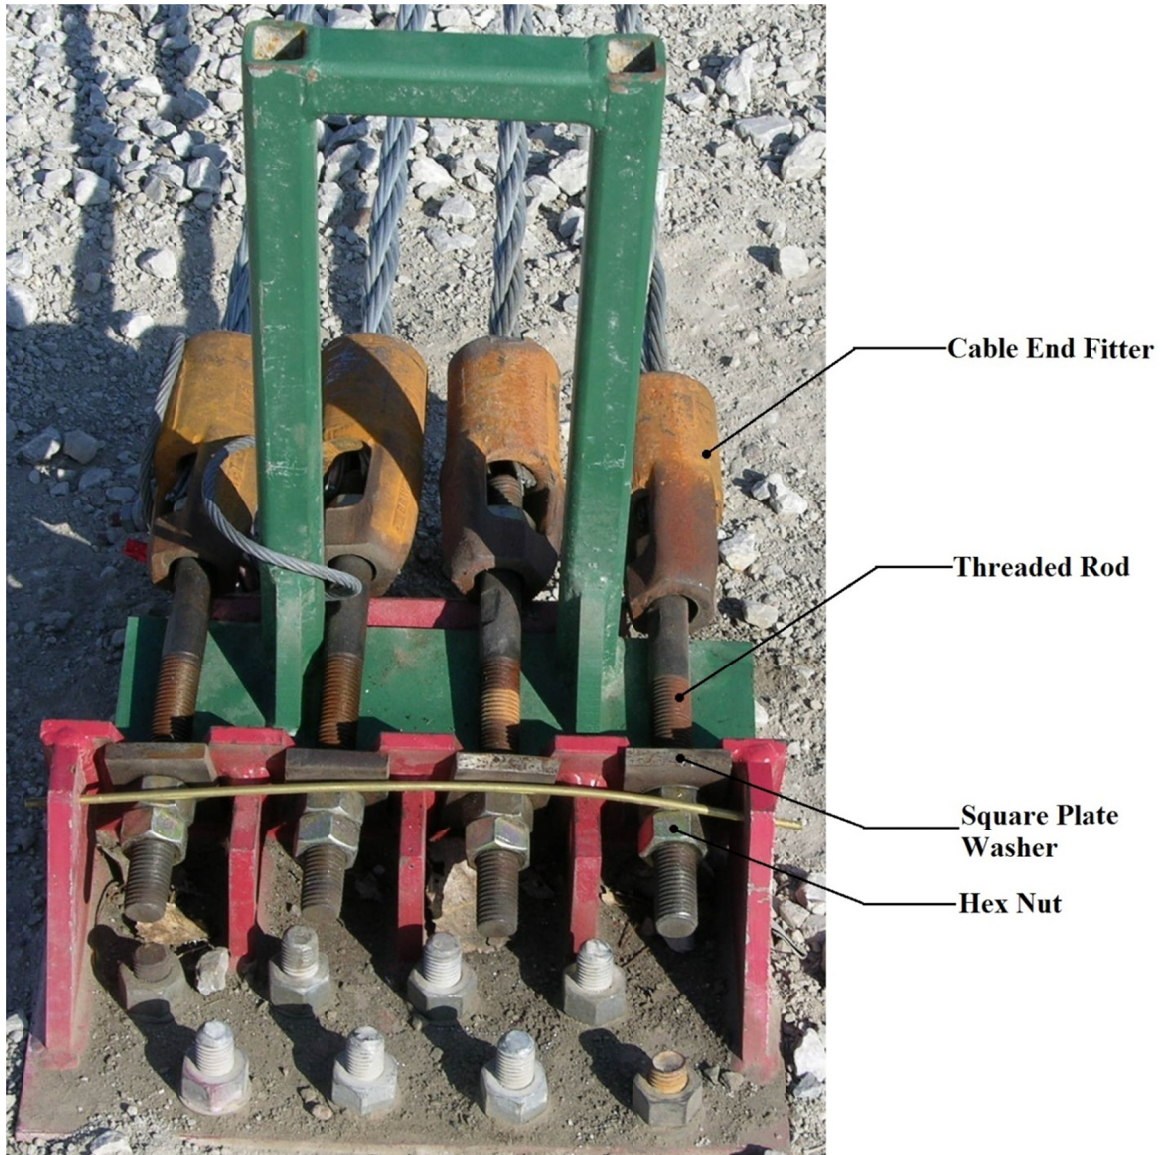
Figure 70. Cable End Fitter Interference

Another concern regarding the geometry of the current high-tension cable anchor bracket assembly pertains to its overall width. The current assembly is shown in Figure 70. During the assembly of the four cables and end fitting hardware and placement into the cable anchor bracket assembly, space may be somewhat limited. This could potentially result in difficult system construction.

In the current design, four cable end fitters are placed side by side in their respective slots, thus leaving very little room for adjustments within the assembly. Cable tension is achieved by tightening the inline cable turnbuckles and cable end fitters. As cable tension is increased, the cable end fitters move closer together horizontally, thus reducing the spacing between them. This movement is exhibited in Figure 71.

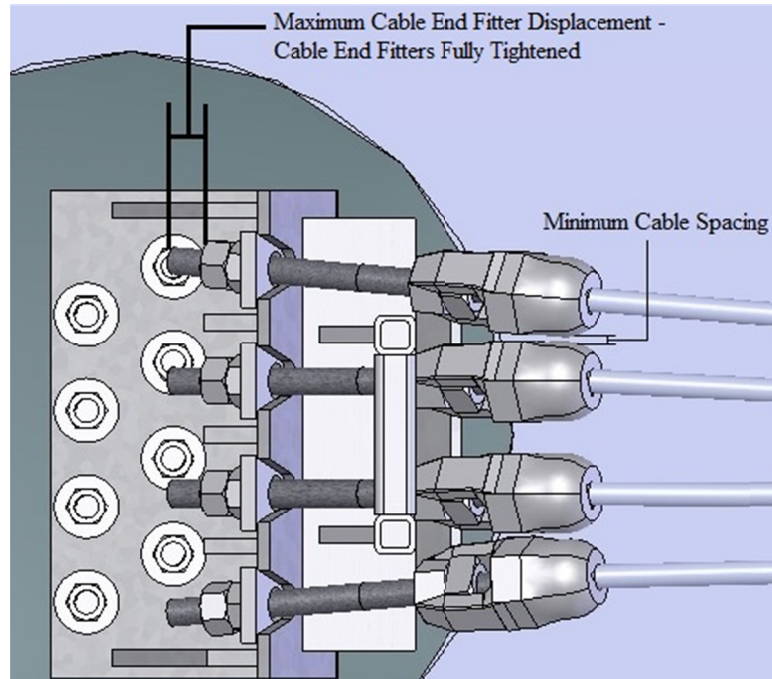
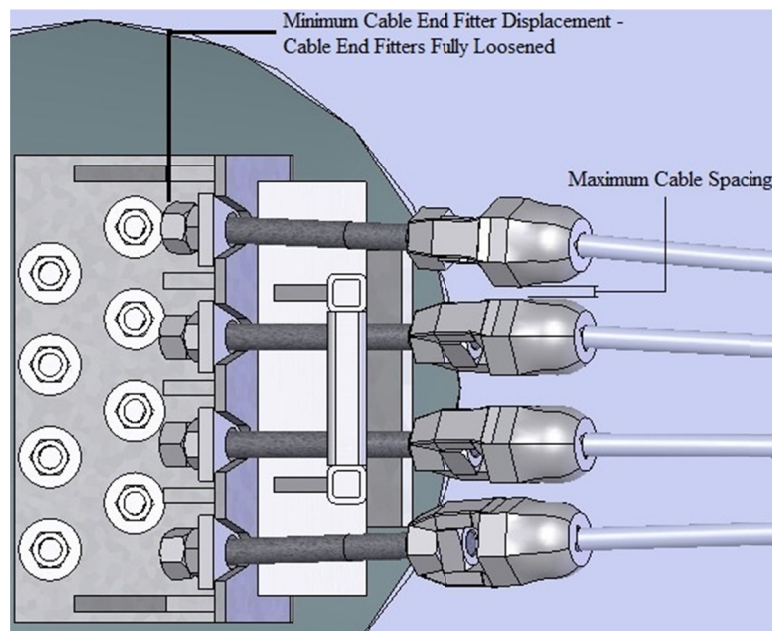
Figure 71. Cable End Fitter Movement

Cable End Fitters at Minimum Cable Spacing

Cable End Fitters at Maximum Spacing

The smaller the spacing between the end fitters, the more difficult it is to assemble the anchor bracket. There is also a limit to how much slack can be taken up in the end fitters since the end fitters will eventually contact each other and cause flexural deformations in the threaded rods.

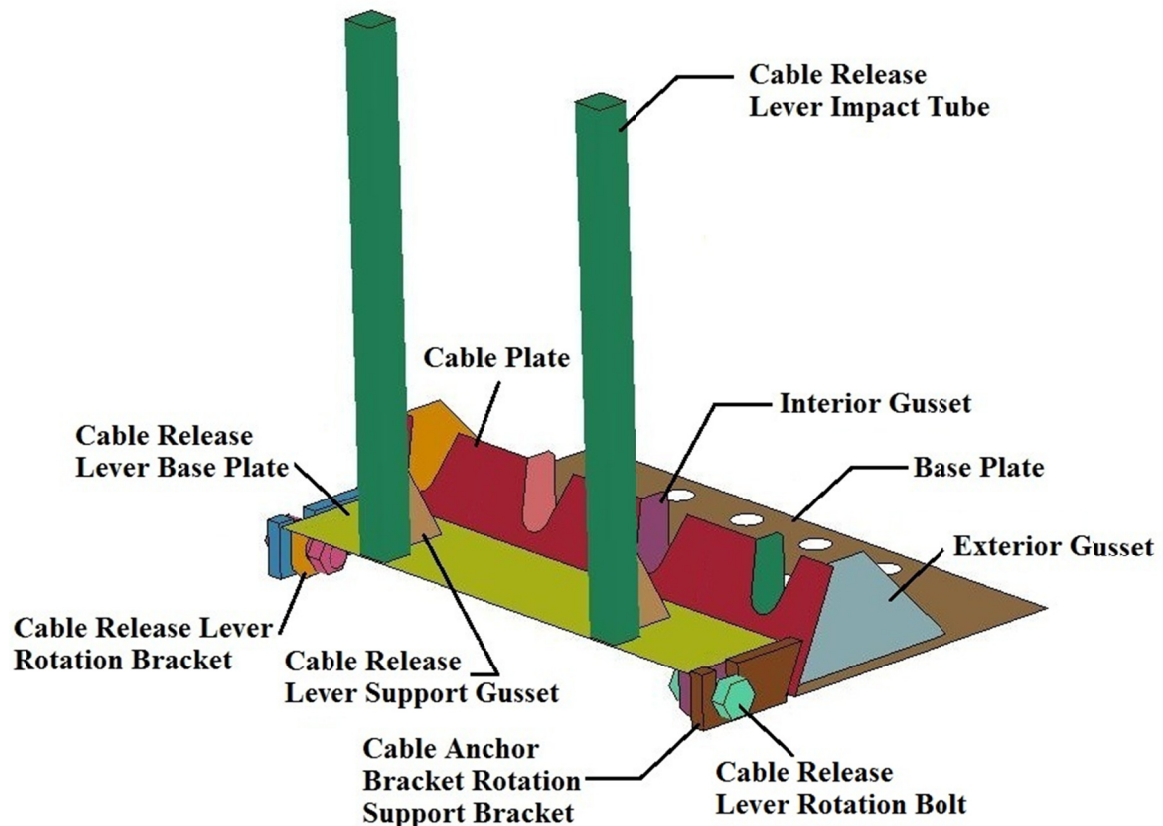
Figure 72. Redesigned Cable Anchor Bracket Assembly Model

In order to evaluate potential designs and modifications, a finite element model was developed for use with the LS-DYNA FE code. An initial, finite element model of the redesigned cable anchor bracket assembly is shown in Figure 72.

The primary purpose of the redesigned, high-tension, cable anchor bracket assembly was to release the system cables when the cable release lever was impacted by a vehicle. Since the mechanics enabling the release of the cables was similar to those in the previous design, many of the element and material formulations were reused.

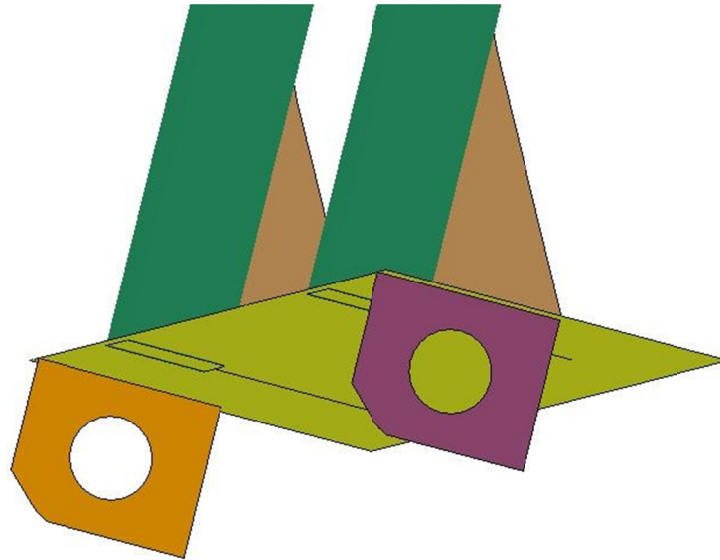
Figure 73. Cable Release Lever Rotation Bracket Model

Brackets needed to be attached to the cable release lever assembly in order to retain the release lever after the release of the cables. To accomplish this, two brackets

were modeled and attached to the underside of the release lever base plate. An initial bracket model was discretized using three-noded and four-noded shell elements. A piecewise-linear, plastic material model with ASTM A36 steel material properties was specified for the bracket. A Belytschko-Leviathan element formulation was specified for the shell elements. The bracket model is shown in Figure 73.

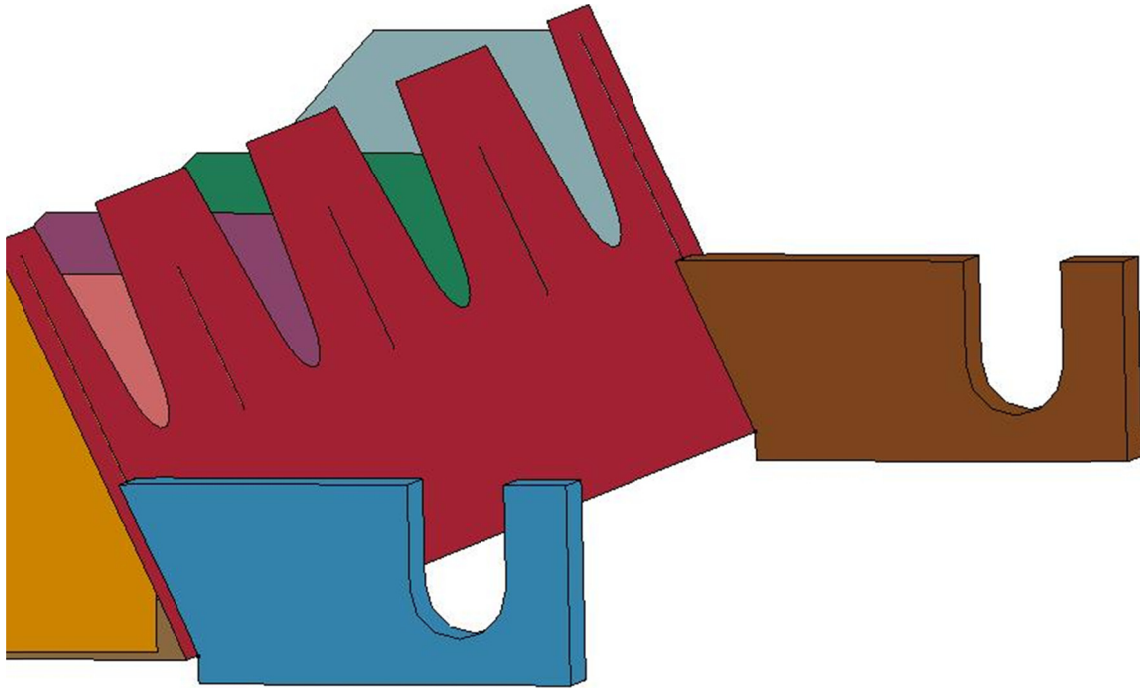
Figure 74. Cable Anchor Bracket Assembly Rotation Support Bracket Model

A new bracket was necessary to support and accommodate the rotation of the cable release lever assembly during the cable release. Two brackets were attached to the front of the cable plate to create a rotational joint on the front of the cable anchor bracket assembly. A preliminary design was modeled using eight-noded hexagonal elements. A piecewise-linear, plastic material model with ASTM A36 steel material properties was specified for the bracket model. A Fully Integrated S/R solid element formulation was used for the solid elements. The bracket model is shown in Figure 74.

It was determined that the cable anchor bracket rotation support bracket's geometry and performance was the primary cause for the cable release lever not being retained. Deformation in the bracket slot as well as the bracket height allowed for the cable release lever rotation bolts to slide upwards out of the slot. It was concluded that

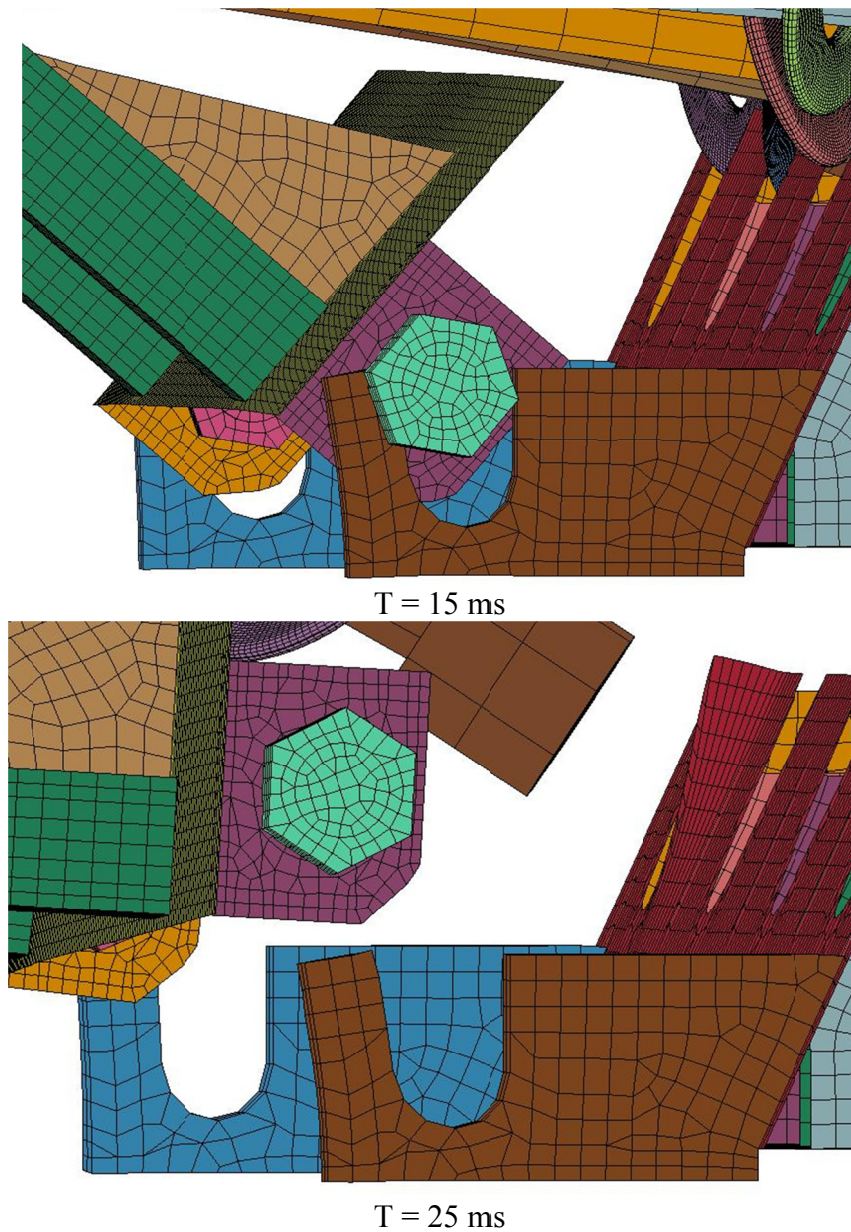
Figure 75. Release Lever Disengaging from Assembly, Simulation No. 1

Initial simulations with the redesigned, cable anchor bracket assembly resulted in questionable performance. Although the assembly did release the cables, the cable release lever was not retained. The retention of the cable release lever was one of the primary goals of the redesign. The cable release lever as it is detaching from the anchor bracket assembly during the simulation is shown in Figure 75.

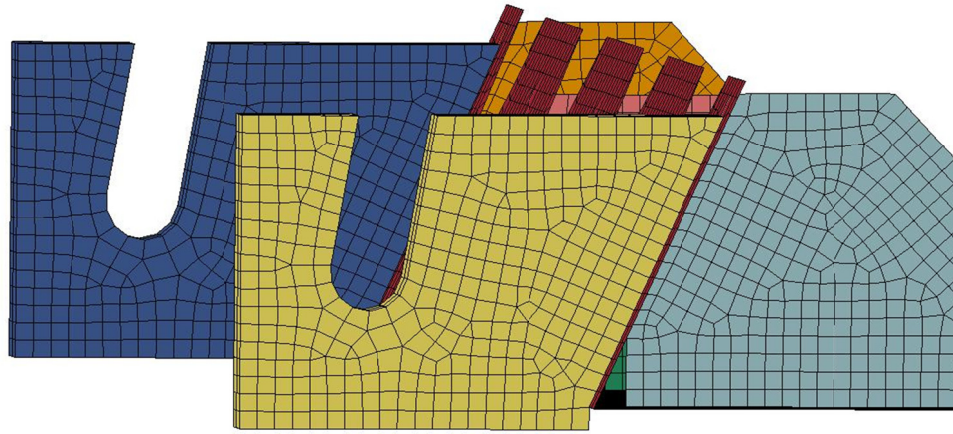
Figure 76. Redesigned Cable Anchor Bracket Support Bracket Geometry

It was determined that a taller support bracket would perform better. The slot in the support bracket was also angled back towards the anchor bracket to inhibit the bolt from riding up in the slot. A cable release lever base plate with a mounting angle of 11.5 degrees was selected to use with the updated model. Initial analysis of the new configuration showed that the angled baseplate would reduce the cable release time and result in better cable release mechanics. The redesigned bracket and cable release lever are shown in Figures 76 and 77, respectively. The new design was then inserted into the bogie model and simulated.

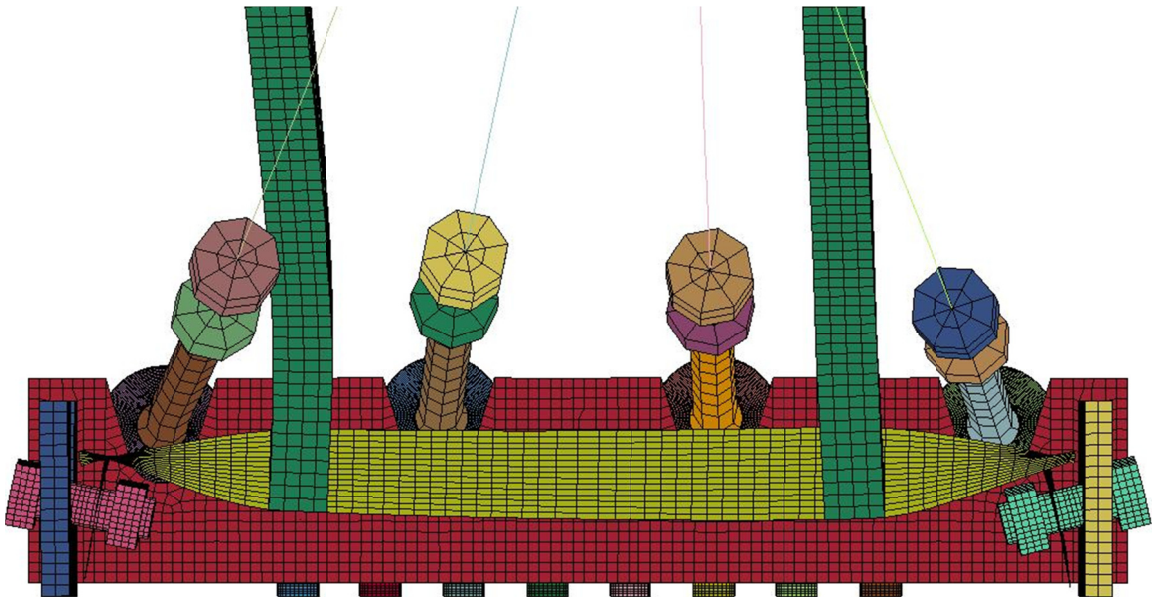
Figure 78. Distorted Joint on Cable Anchor Bracket Assembly, Simulation No. 2

The redesigned cable anchor bracket assembly encountered several issues during the second round of simulation. During simulation no. 2, the cables were released successfully. However, there was severe damage to the anchor bracket assembly. The release of the cables took much longer than in previous simulations as well.

The poor release mechanics were primarily due to the release lever assembly binding up upon impact. The binding was caused when the bolts which connect the release lever rotation brackets to the cable anchor rotation support brackets rotated downwards. This created a distorted rotational joint on the front of the cable anchor bracket. The distorted joint resulted in deformation in the release lever base plate. The base plate deformation delayed the cable release and led to high impact forces being imparted to the rest of the assembly. This behavior resulted in the damage to the cable release lever assembly as well as the support brackets. Hardware damage and rotation behavior are shown in Figures 78 through 80.

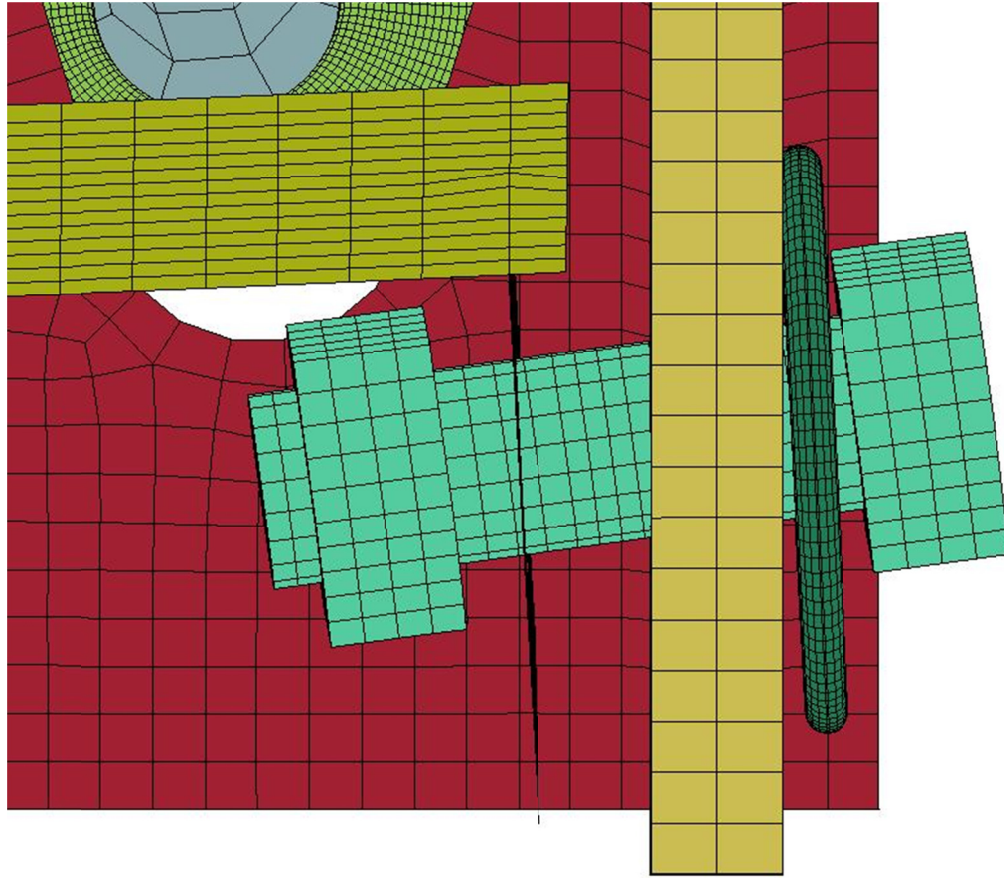
Figure 81. Bolt Rotation with Washer

To address the rotation issues, several possible solutions were investigated. Washers were placed in between the bolt head and the outer face of the support bracket. While this improved the stability of the rotational joint, there was still some bolt rotation. This led to similar damage to the anchor bracket and release lever assembly, although not to the same extent as seen in simulation no. 2. The bolt rotation with inserted washers is shown in Figure 81.

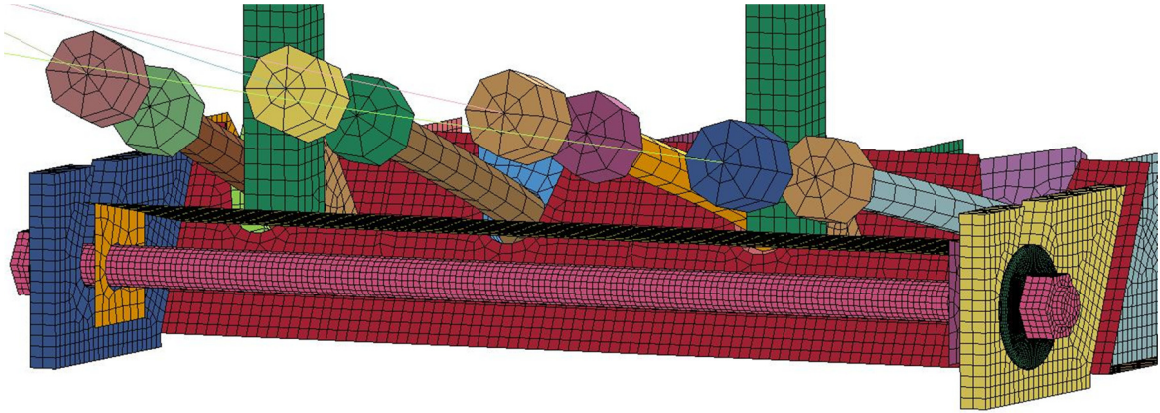
Figure 82. Anchor Bracket Assembly with Rod

After the washers did not correct the issue, the two bolts were exchanged for one long, steel rod with threaded ends. As long as the rod does not fail, the rotational joint should remain intact. The washers were used again between the nuts at each end of the rod and the outer surface of the support brackets. The washers were reused to ensure that there was no pullout of the rod in the support bracket slots. The anchor bracket assembly with the rod and washers is shown in Figure 82.
