Development and Recommendations for a Non-Proprietary, High-Tension, Cable End Terminal System

DEVELOPMENT AND RECOMMENDATIONS FOR A
NON-PROPRIETARY, HIGH-TENSION, CABLE END
TERMINAL SYSTEM

A THESIS

Presented to the Faculty of
The Graduate College at the University of Nebraska
In Partial Fulfillment of Requirements
For the Degree of Master of Science

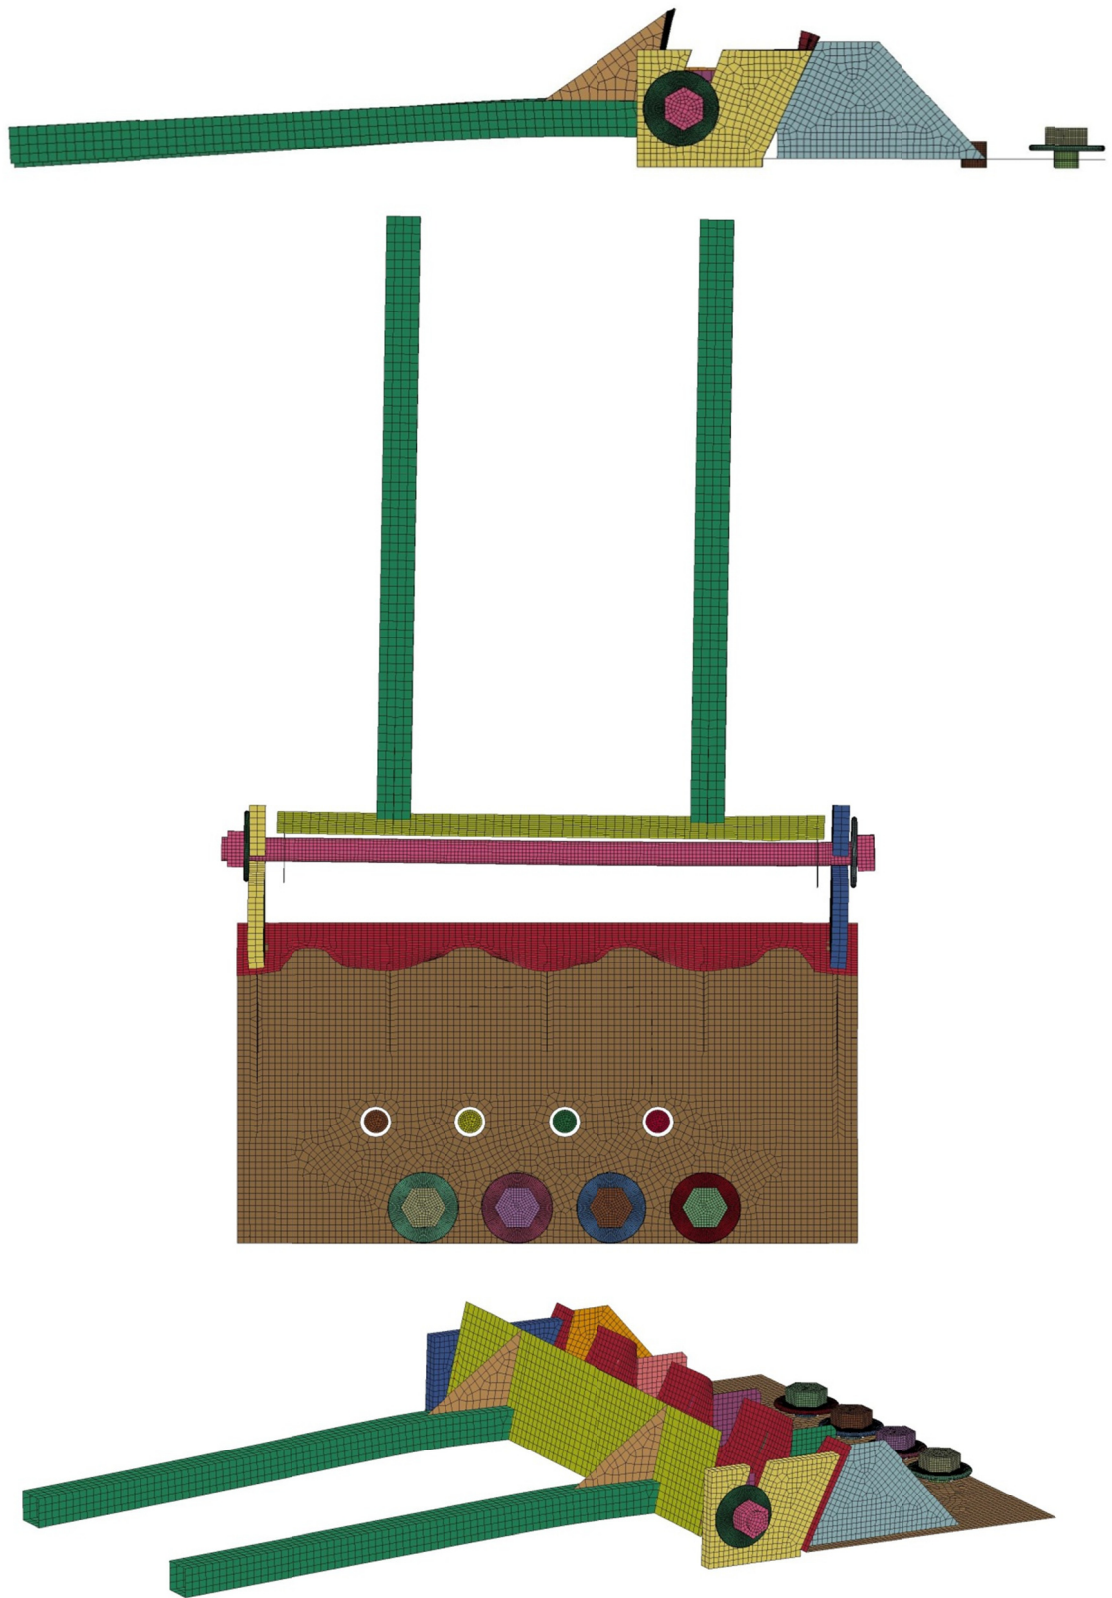
Figure 83. Cable Anchor Bracket Assembly Deformation, Simulation No. 3

During simulation no. 3, the cable release lever rotated smoothly during impact. The cables were released evenly and without incident. At the conclusion of the simulation, the cable release lever was successfully retained. There was some slight deformation to the vertical release lever tubes, and extensive deformation to the angled cable plate. The support brackets and remainder of the anchor bracket assembly were undamaged during the simulation. The cable anchor bracket assembly at the conclusion of simulation no. 3 is shown in Figure 83.

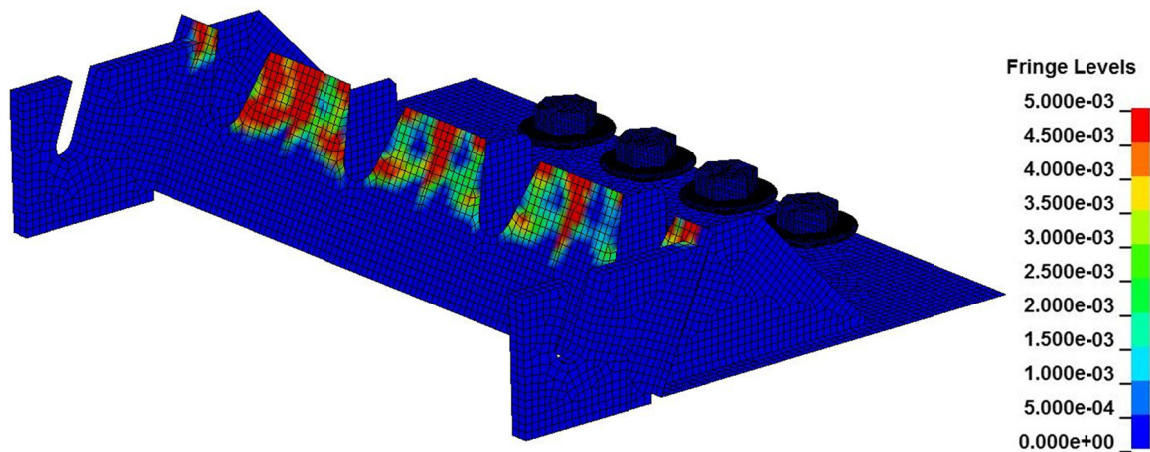
Figure 84. Anchor Bracket Assembly Plastic Strain, Simulation No. 3

The cable plate sustained severe plastic deformation in such a manner that the entire anchor bracket assembly would require replacement before the terminal could safely function. The robustness of the high-tension, cable end terminal design as a whole would be greatly aided by an anchor that was reusable or required minimal repair following an impact event. The plastic strain distribution in the anchor assembly after the release of the cables is shown in Figure 84.

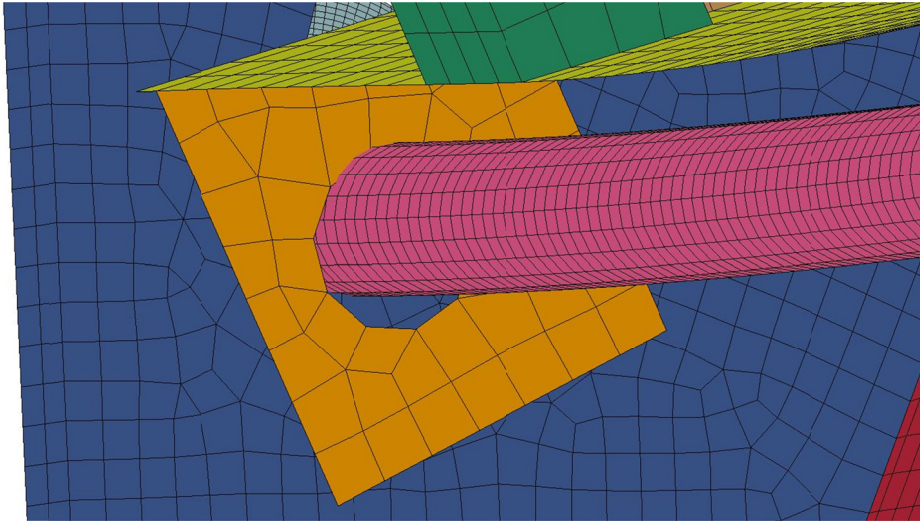
Figure 85. Nodal Penetration in Rotation Bracket Contact

Initial simulations with the updated anchor bracket assembly model revealed several problems with the design and the modeling techniques. Significant nodal penetrations were evident in the contact between the cable release lever rotation brackets and the steel rod. The node penetrations resulted in non-physical deflection of the cable release lever, poor rotation mechanics, and ultimately the cables were not released during the simulated interaction between the cable anchor bracket assembly and the bogie. The node penetration between one of the rotation brackets and the steel rod is shown in Figure 85.

To correct the contact issue, the rotation brackets were remodeled using solid elements. While shell elements are more computationally efficient and easy to use, solid element contact is much more robust and omnidirectional.

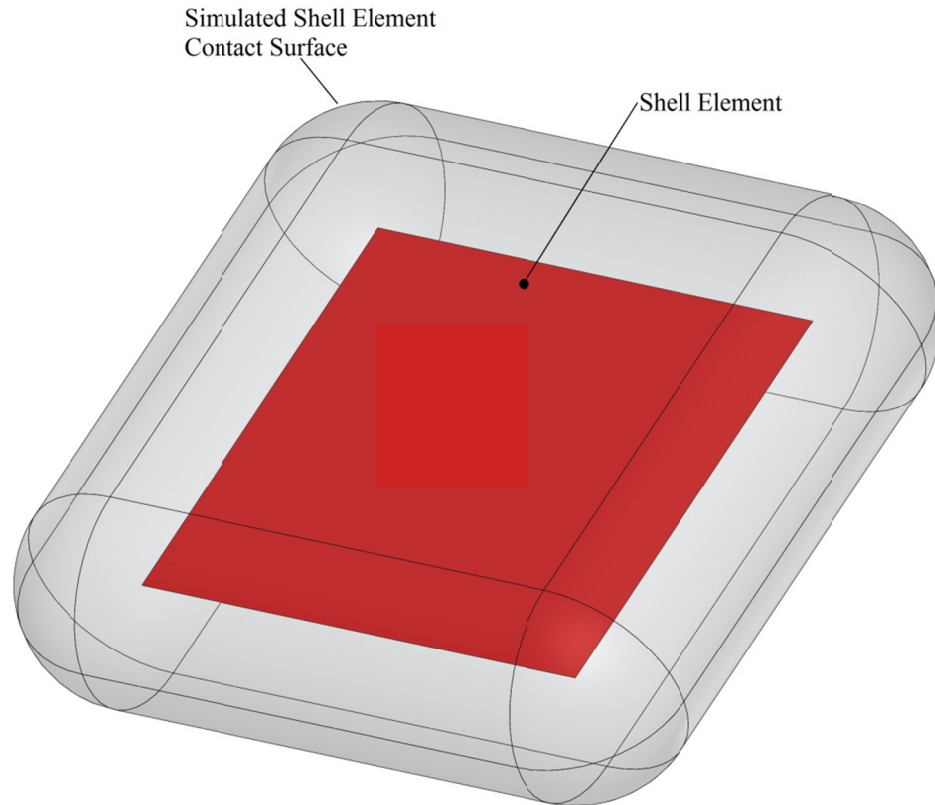
Figure 86. Typical Shell Element and Simulated Contact Surface

The primary issue with shell contacts arises in the instance when a shell edge contacts another element of any type. While solid elements have well defined surfaces for contacts, shell elements utilize artificially created “thicknesses” as contact surfaces on edges. In order to simulate a smooth contact surface, the contact thickness is radially projected around the edge of a shell element boundary. These artificial surfaces can create edge and node penetration issues, which in some cases can yield unrealistic contact behavior and misleading simulation results. For this reason, solid elements are the more reliable option, although more computationally expensive. An example of a typical shell element and its simulated element thickness is shown in Figure 86.

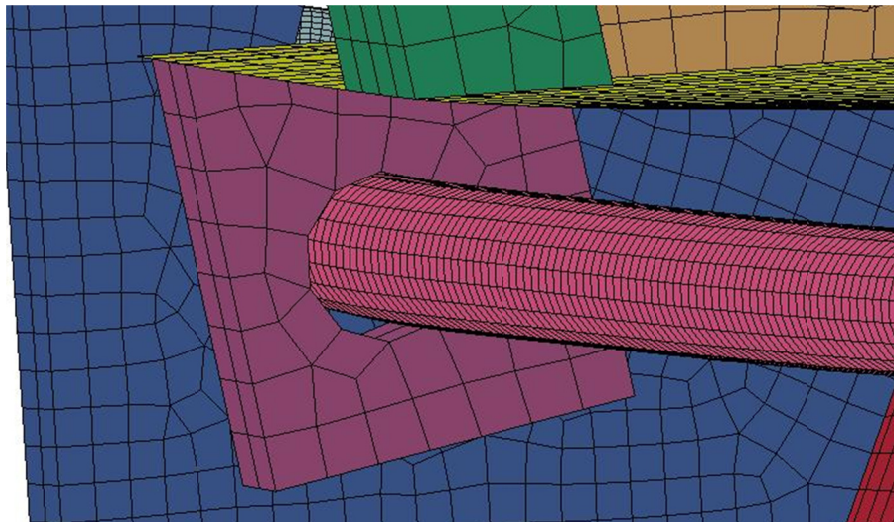
Figure 87. Rotation Bracket Contact Using Solid Elements

Another simulation was conducted with the updated cable anchor bracket assembly model. The solid element rotation brackets improved the contact between the brackets and the steel rod. The updated contact is shown in Figure 87.

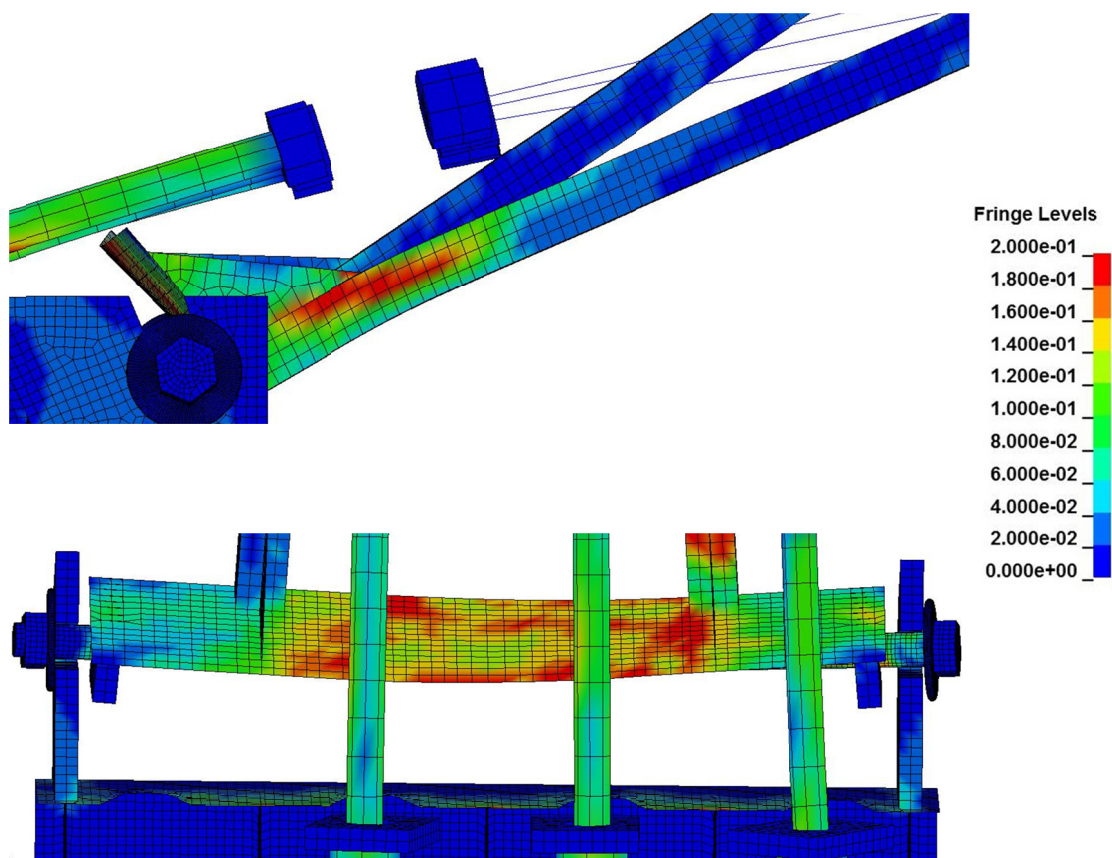
Figure 88. Deformation of Release Lever Assembly Components, von Mises' Stress

The anchor bracket assembly again failed to release the cables. However, deformation to the vertical tube as well as torsion in the release lever assembly base plate prevented the cables from releasing during the bogie impact. The tube bending prevented the release lever from fully rotating and the torsion in the base plate caused one side of the plate to deflect downward. The deflection in turn prevented the cable end fitters from fully translating up and out of their respective slots on the cable plate. Fringe plots of the damaged components are shown in Figure 88.

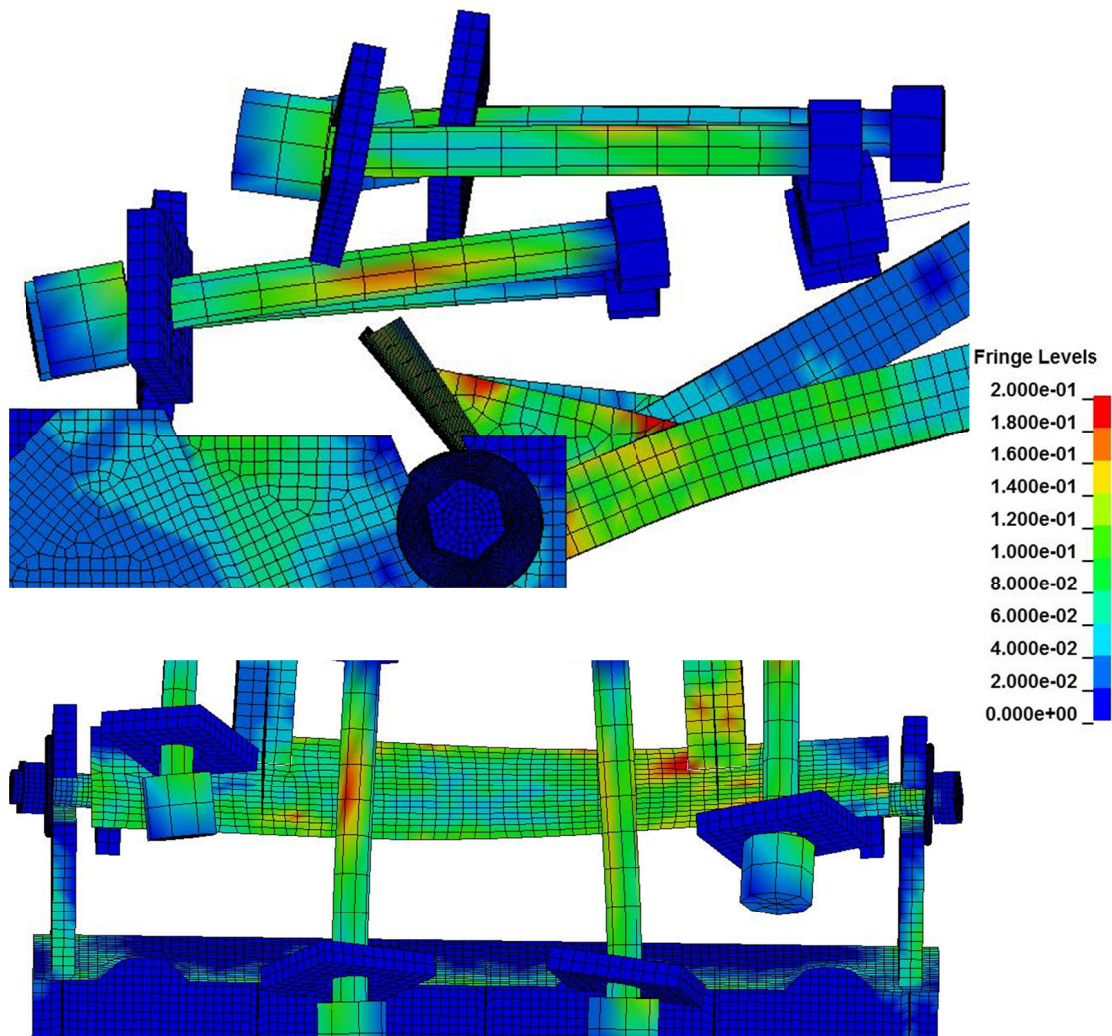
Figure 89. Cable Anchor Bracket Assembly von Mises' Stress, Simulation No. 4

There was still some bending in the vertical tube as well as torsion in the base plate of the cable release lever assembly. The deformation, however, was mitigated by the strengthened components. The deformed components did not exhibit any potential to effect the release mechanics of the redesigned, cable anchor bracket assembly. Therefore, this deformation is considered acceptable. Note also that the cable release lever assembly was the only component of the anchor bracket that would require replacement post impact. The damage in the cable anchor bracket assembly at the instant the cables fully released is shown in Figure 89.

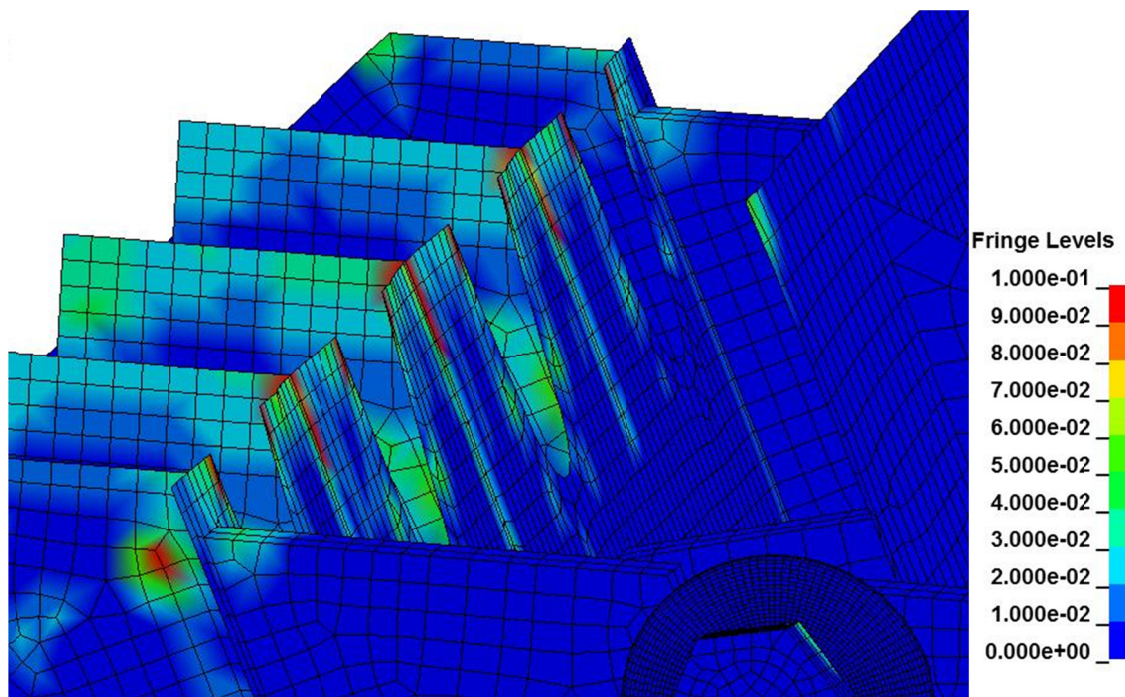
Figure 90. Cable Plate Plastic Strain, Simulation No. 5

Although the design tension for the system cables is 4,200 lbs, temperature fluctuations could result in increased cable tension. A simulation was conducted in which the cable tension was doubled to 8,400 lbs/cable. The goal of the simulation was to analyze the effects that increased cable tension would have on the cable release mechanics. The bogie head was centered on the cable anchor and an impact speed of 45.0 mph was used in the simulation.

The bogie head impacted the cable release lever and rotated the cables out of their respective slots on the cable plate. The duration of the cable release process was roughly 6 ms longer as compared to simulation no. 3. Significant plastic deformation in the cable plate flanges occurred due to the prying action of the cables during impact. The maximum plastic strain in the cable plate was 0.65. Since the simulation represents a worst case scenario, however, this deformation was deemed acceptable. The plastic strain in the cable plate at the conclusion of the simulation is shown in Figure 90.

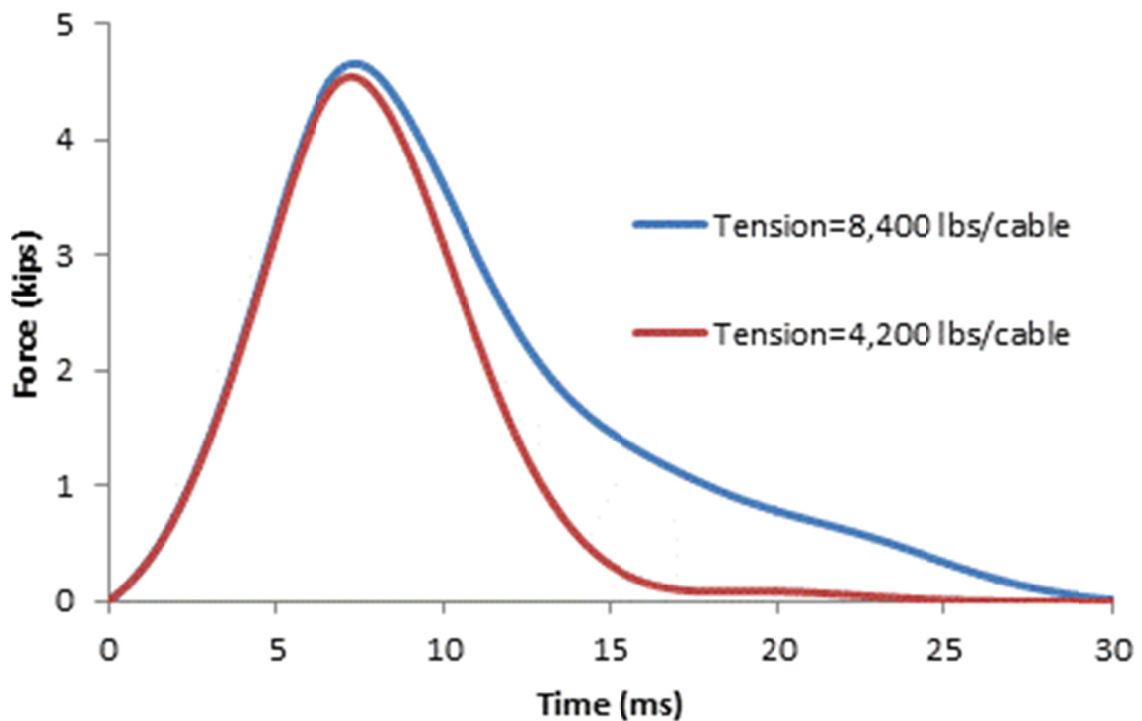
Figure 91. Impact Force Comparison, Increased Cable Tension vs. Design Tension

The impact forces experienced by the bogie were examined to quantify how increased tension might effect the trajectory of an impacting vehicle. A similar simulation was conducted with the specified design tension in order to compare the two scenarios.

Although the cable tension was doubled, the maximum impact force imparted to the bogie was only 1 percent higher as compared with the simulation with the design

tension. This is in part due to anchor component deformation that occurred in the simulation with increased cable tension. Although the normal force was increased significantly, plastic deformation in the cable release lever and cable plate absorbed energy reducing the peak impact forces. No plastic deformation to the cable anchor bracket assembly was seen in the simulation with the design tension. The average force after the maximum in the simulation with double tension was 1.5 kips as compared to 1.2 kips in the simulation with design tension. The increased average force and elongated cable release time also resulted in more energy dissipation by the bogie due to the larger sliding friction force. The simulation resultant forces on the bogie head from initial impact are shown in Figure 91.

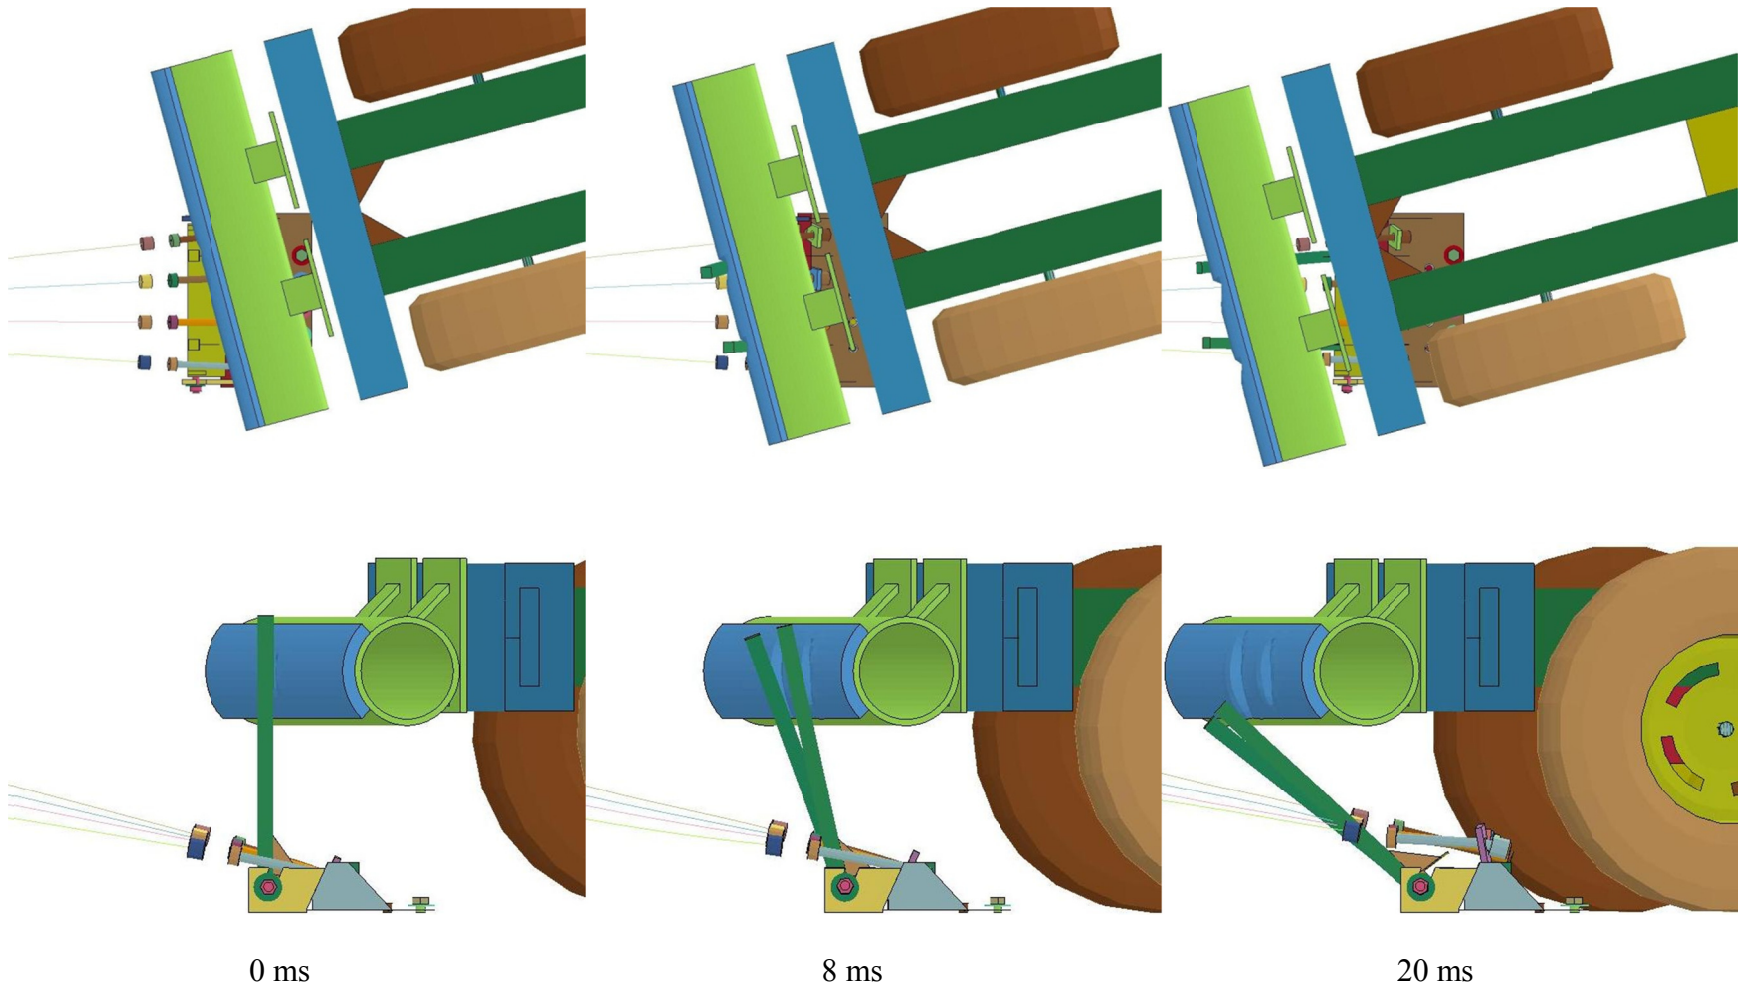
Figure 92. 15 Degree Impact Scenario Sequentials, Simulation No. 6

To evaluate the robustness of the redesigned cable anchor bracket assembly's cable release mechanics, a simulation was conducted with the bogie impacting the anchor assembly at an angle of 15 degrees. The bogie head was aligned with the center of the redesigned anchor assembly. The impact angle was selected to reflect impact orientation requirements for MASH Test No. 3-33. An impact speed of 45.0 mph was used.

The bogie impacted one of the vertical release lever tubes and smoothly rotated the cables out of their respective slots on the cable plate. The cable release lever base plate exhibited noticeable bending during the cable release process, primarily due to the forces exerted on the impact tubes out of plane with the rotational joint. There was some permanent deformation in the vertical impact tubes at the conclusion of the simulation, however since the cables were released smoothly and the oblique impact scenario is a worst case scenario, the deformation was deemed acceptable. Sequential images of the oblique impact simulation are shown in Figure 92. The plastic deformation in the cable release lever assembly is shown in Figure 93.

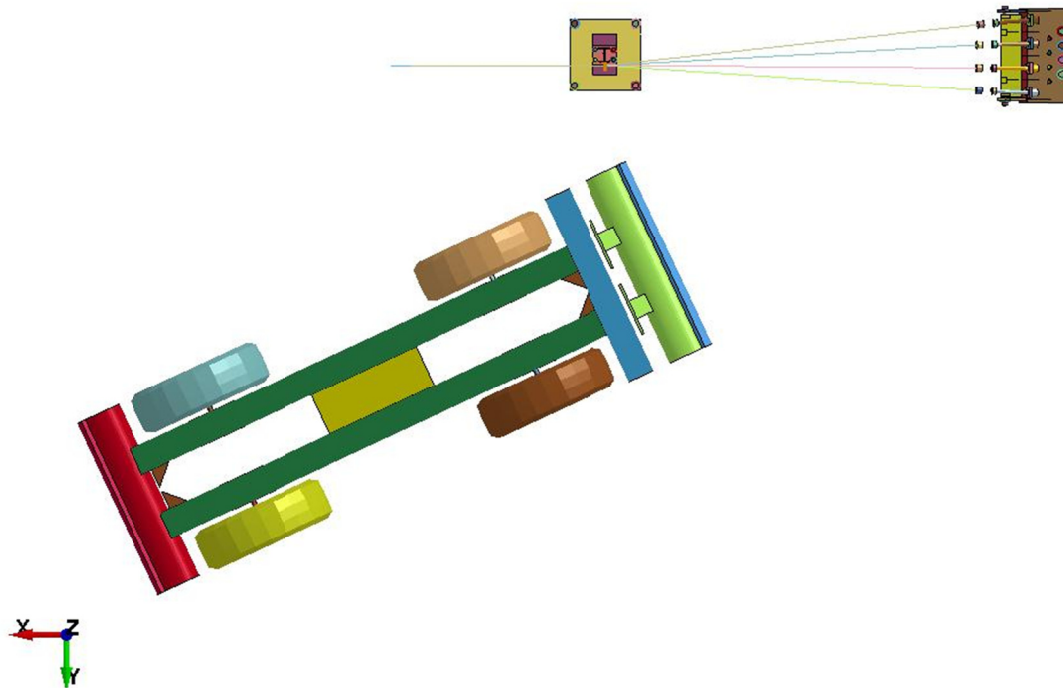
Figure 94. Bogie Impact Orientation, Simulation No. 7

Since the redesigned cable anchor bracket assembly is intended to be used in median applications, the possibility exists that the anchor will be subjected to a reverse direction impact. To analyze this scenario, the bogie model was oriented behind the cable

anchor bracket assembly at an angle of 25 degrees. The bogie head was aligned with the center of the redesigned anchor bracket assembly. The 25 degree impact angle was selected to reflect impact orientation requirements for MASH Test No. 3-37. The initial model setup is shown in Figure 94.

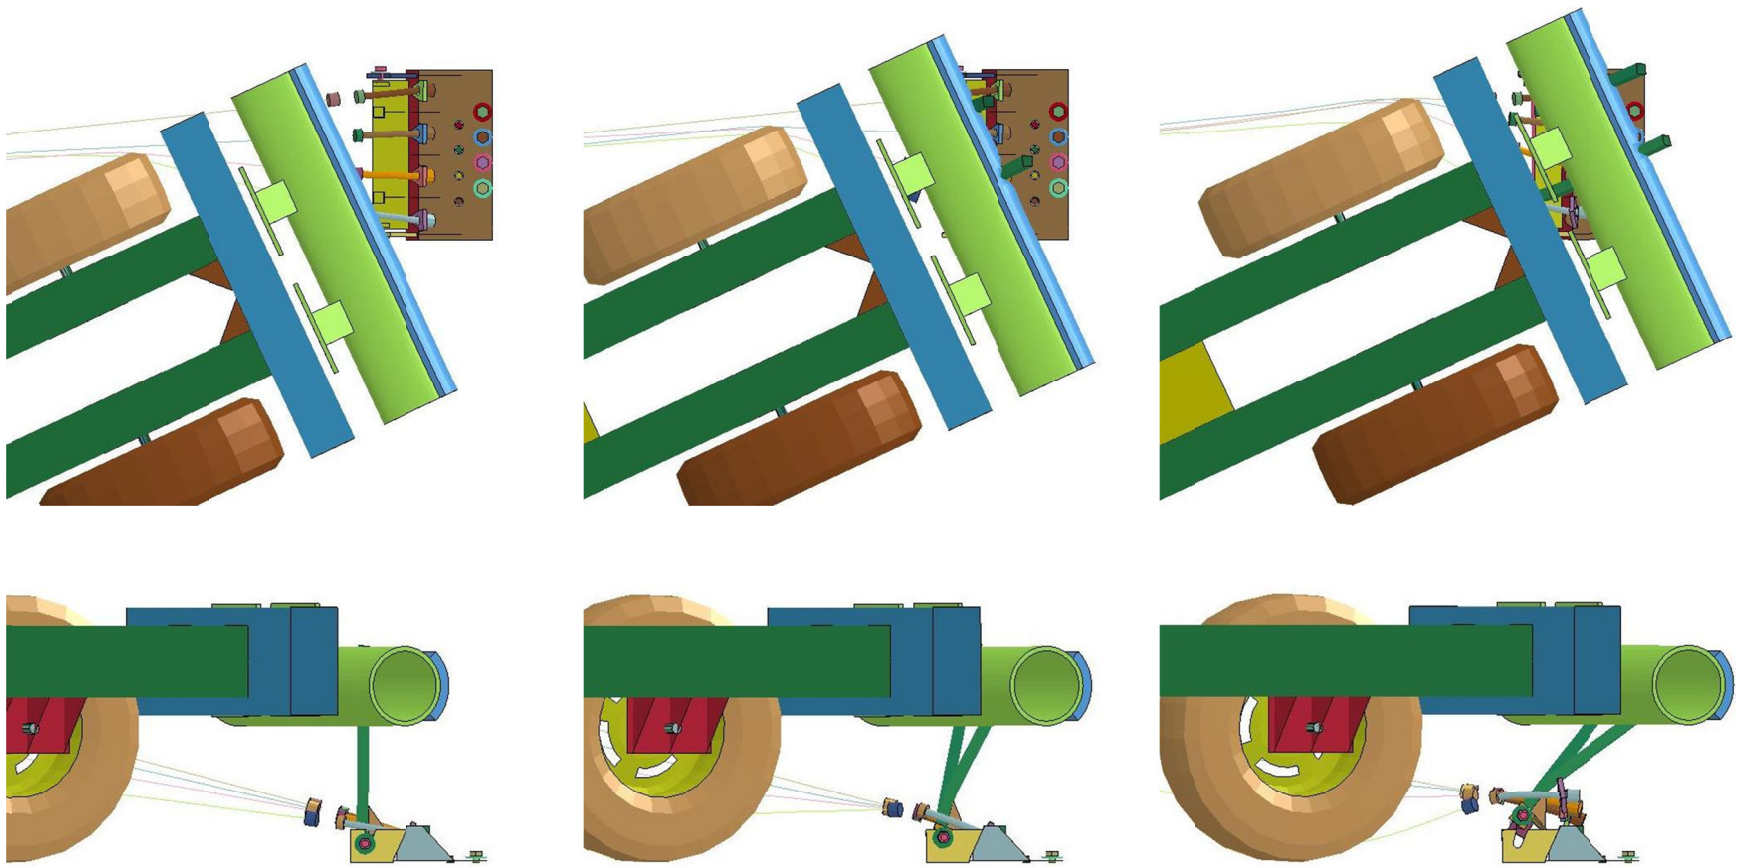
There was significant plastic bending in the vertical impact tube that was initially impacted as well as the cable release lever cable plate. Both support brackets and the rotation bolt also sustained significant plastic deformation. The permanent damage to the cable release lever assembly, support brackets and rotation bolt is shown in Figure 96.

Although the anchor bracket assembly would require significant repair after impact, the release lever was allowed to disengage from the anchor bracket assembly during the reverse direction impact. This ability greatly reduces any concerns that a vehicle will snag on the cables or impact lever in a reverse direction impact. Although the redesigned anchor bracket assembly model exhibited potential in the reverse direction impact simulation, physical testing is still necessary to definitively evaluate the reverse direction release mechanics.

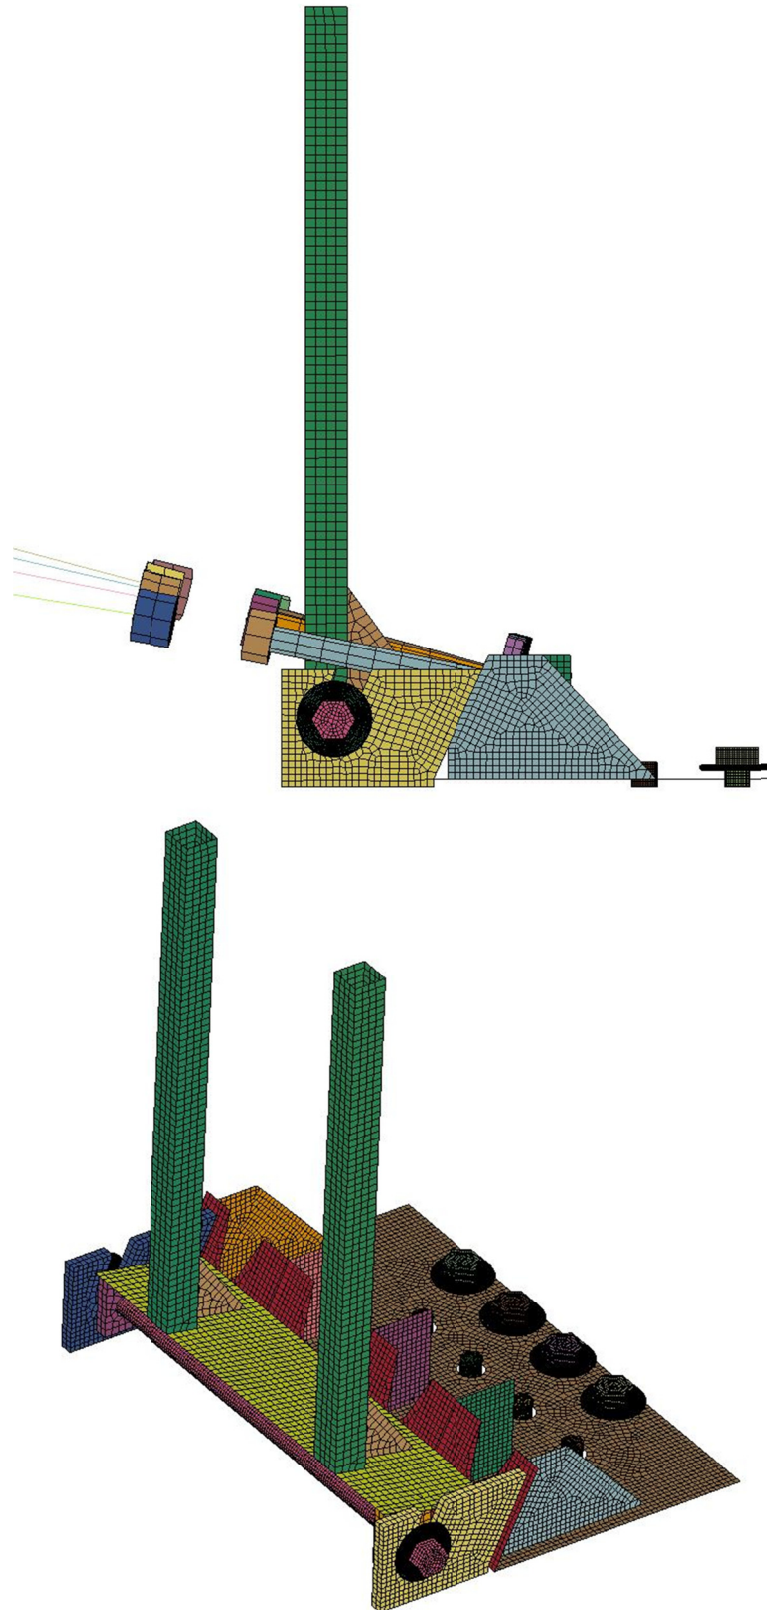
Figure 97. Redesigned, High-Tension, Cable Anchor Bracket Assembly Model

The simulation of the redesigned cable anchor bracket assembly exhibited good mechanics and behavior in simulation nos. 4, 5, 6, and 7. To fully evaluate the final design, the scenario when both vertical tubes were impacted was simulated. Results from the final simulation could also be used to compare the final design to initial concepts as well as the current high-tension cable anchor bracket assembly. The final finite element model of the cable anchor bracket assembly is shown in Figure 97. Technical drawings of the cable anchor bracket assembly are shown in Figures 98 through 102.

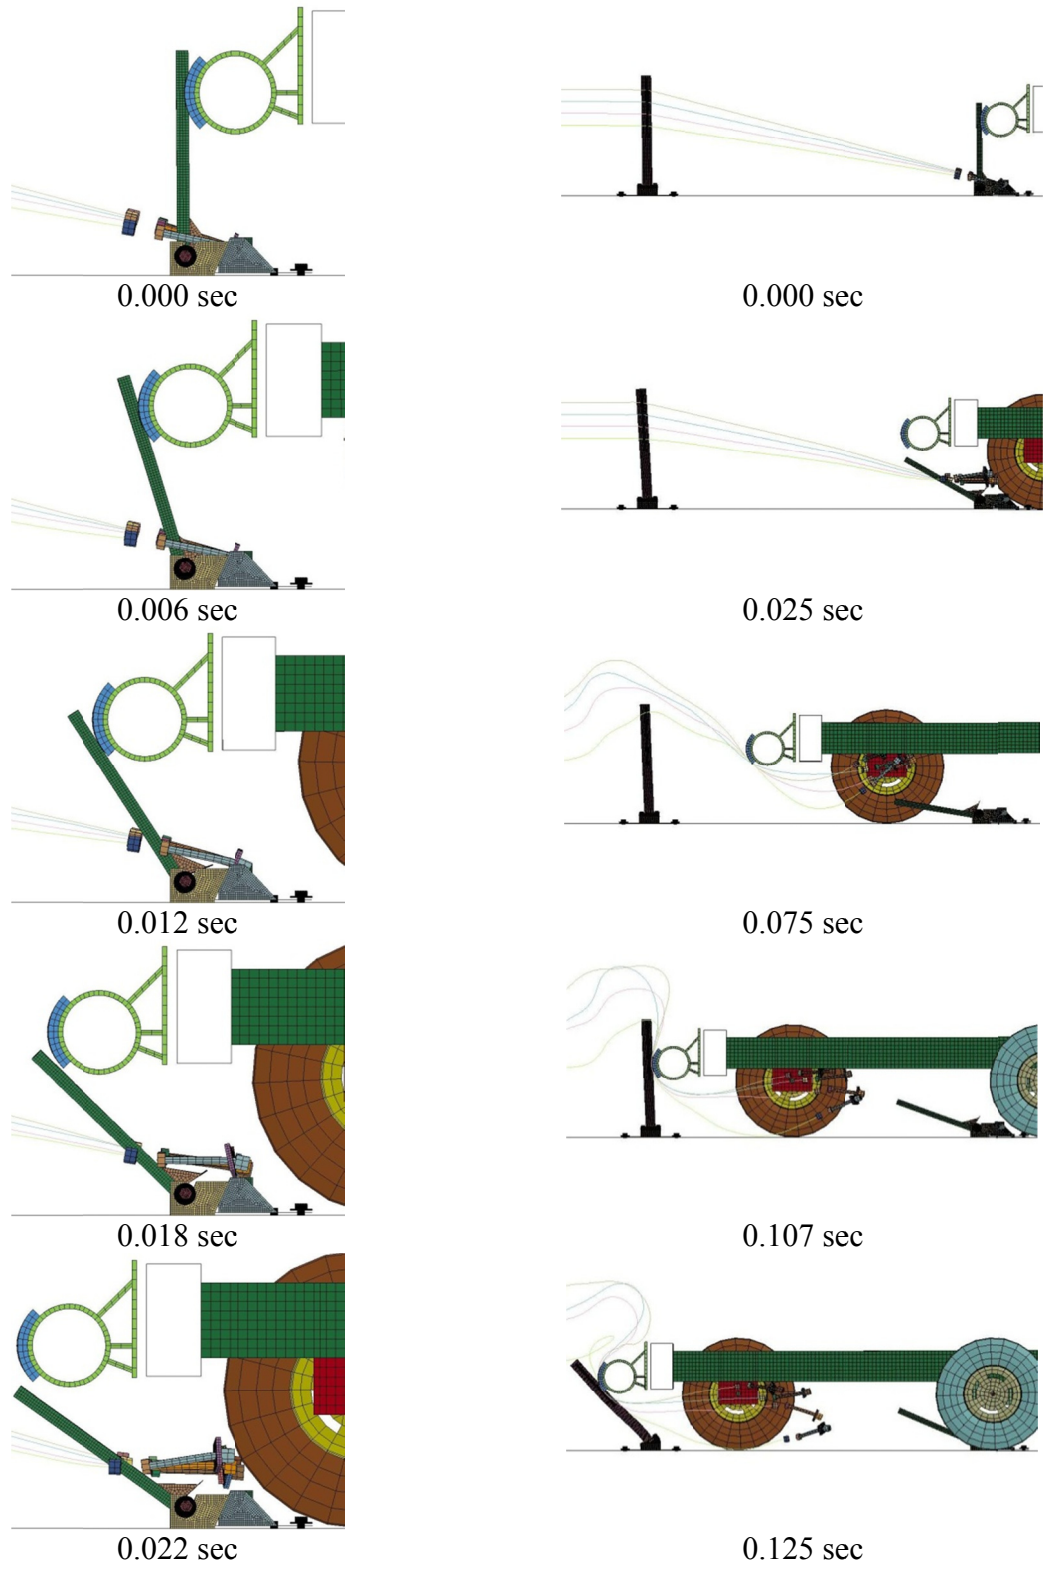
Figure 103. Sequential Photographs, Final Redesign

Initial impact was between the center of the bogie head and the center of the cable release lever. A sequential description of the impact events is contained in Table 11. Sequential images of the simulation are shown in Figure 103. Note that the outer wheel of the bogie is not shown to clarify the release mechanics of the anchor assembly.

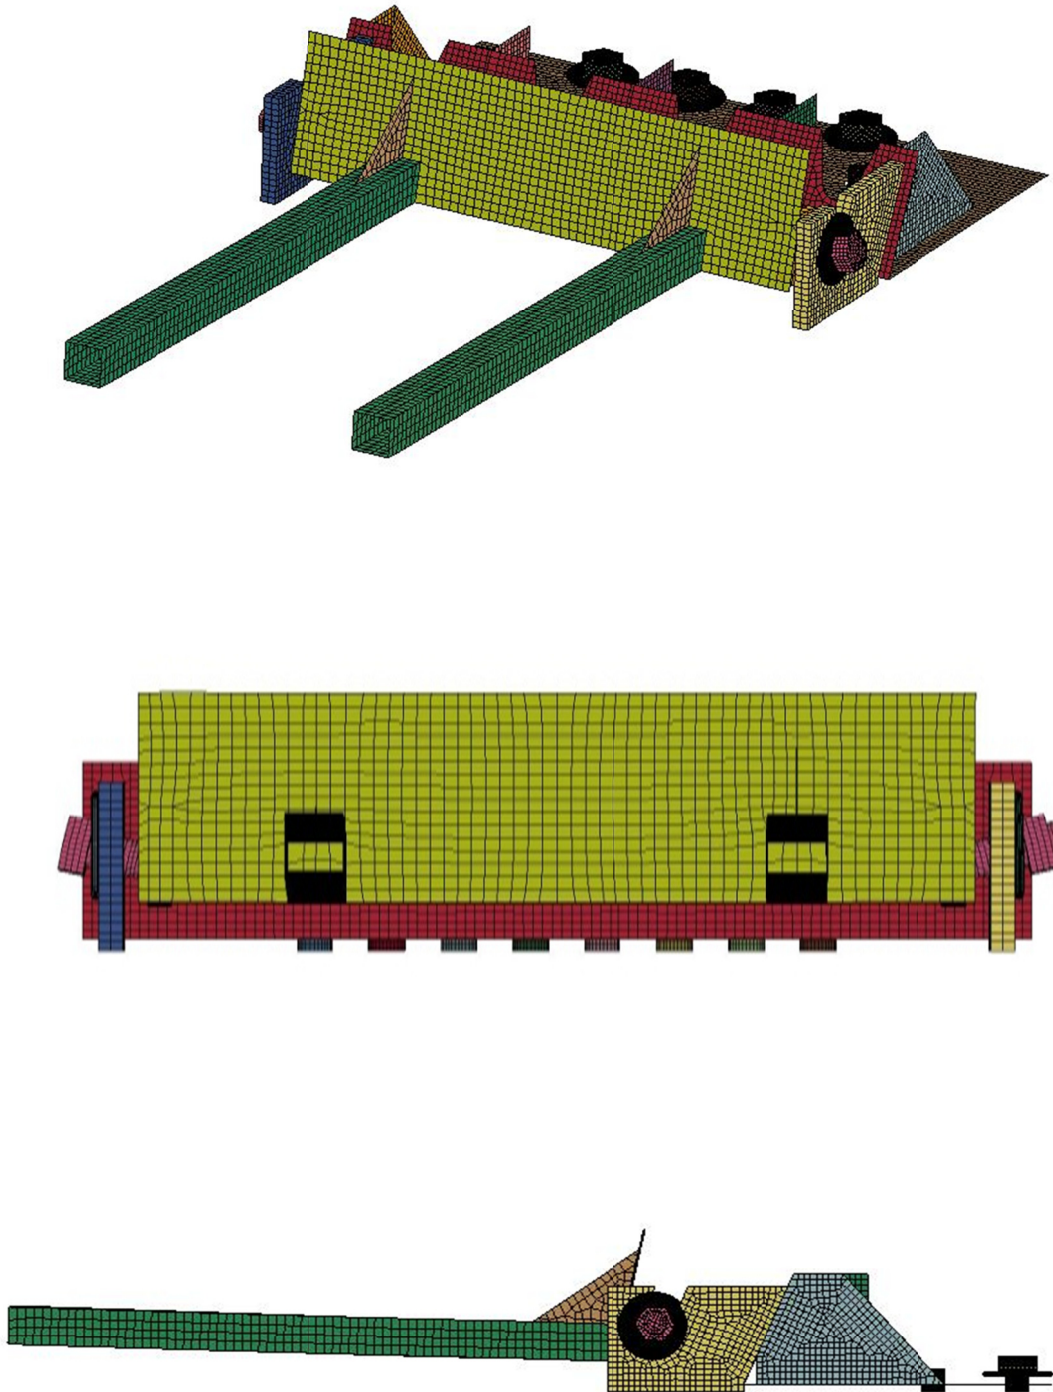
Figure 104. Cable Anchor Bracket Assembly Damage, Final Redesign

Damage to the cable anchor assembly was minimal. The cable plate sustained no plastic deformation. The rotational joint for the cable release lever remained intact throughout the impact event. The only component of the rotational joint that sustained permanent damage was the rotational bolt. Other structural components of the anchor assembly had no deformation. Post-test images of the anchor bracket assembly at the conclusion of simulation are shown in Figures 104 through 106.

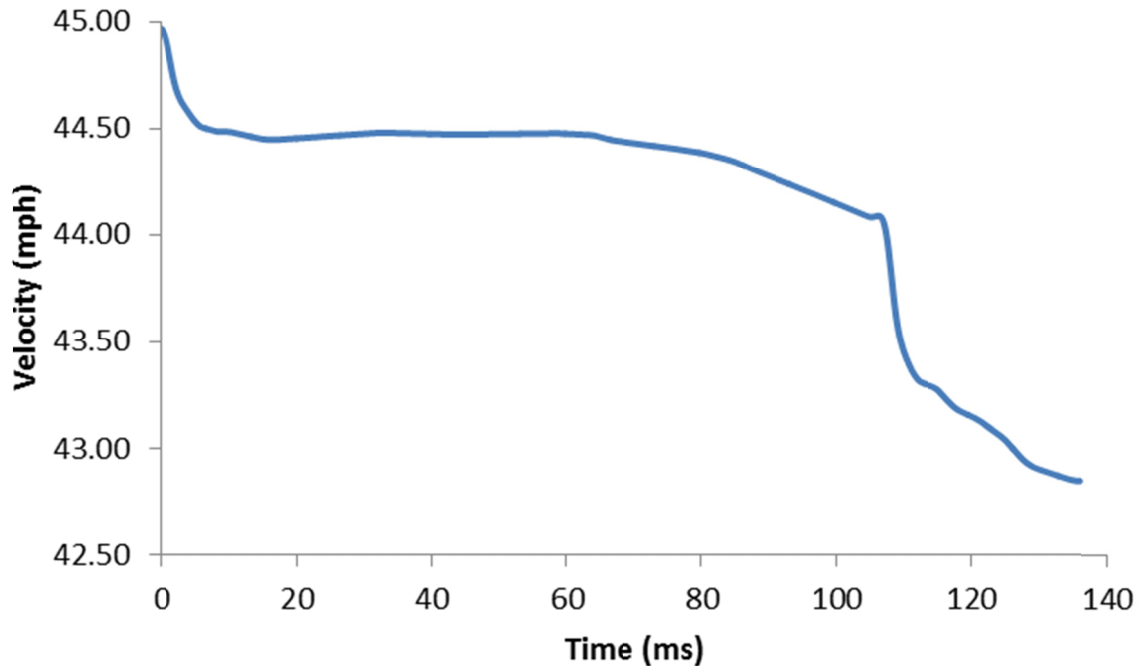
Figure 107. Bogie Velocity, Final Redesign

After impact, the change in velocity due to impact with the anchor bracket assembly and the release of the cables was 0.48 mph. After the release of the cables, the

bogie maintained a velocity of roughly 44.5 mph. The bogie experienced a linear decrease in velocity due to the cables coiling against the impact head beginning at roughly 63 ms. The cable interaction resulted in a total Δv of 0.38 mph. The bogie then impacted the slip base post which resulted in a Δv of 1.25 mph. The bogie's velocity during the simulation is shown in Figure 107.

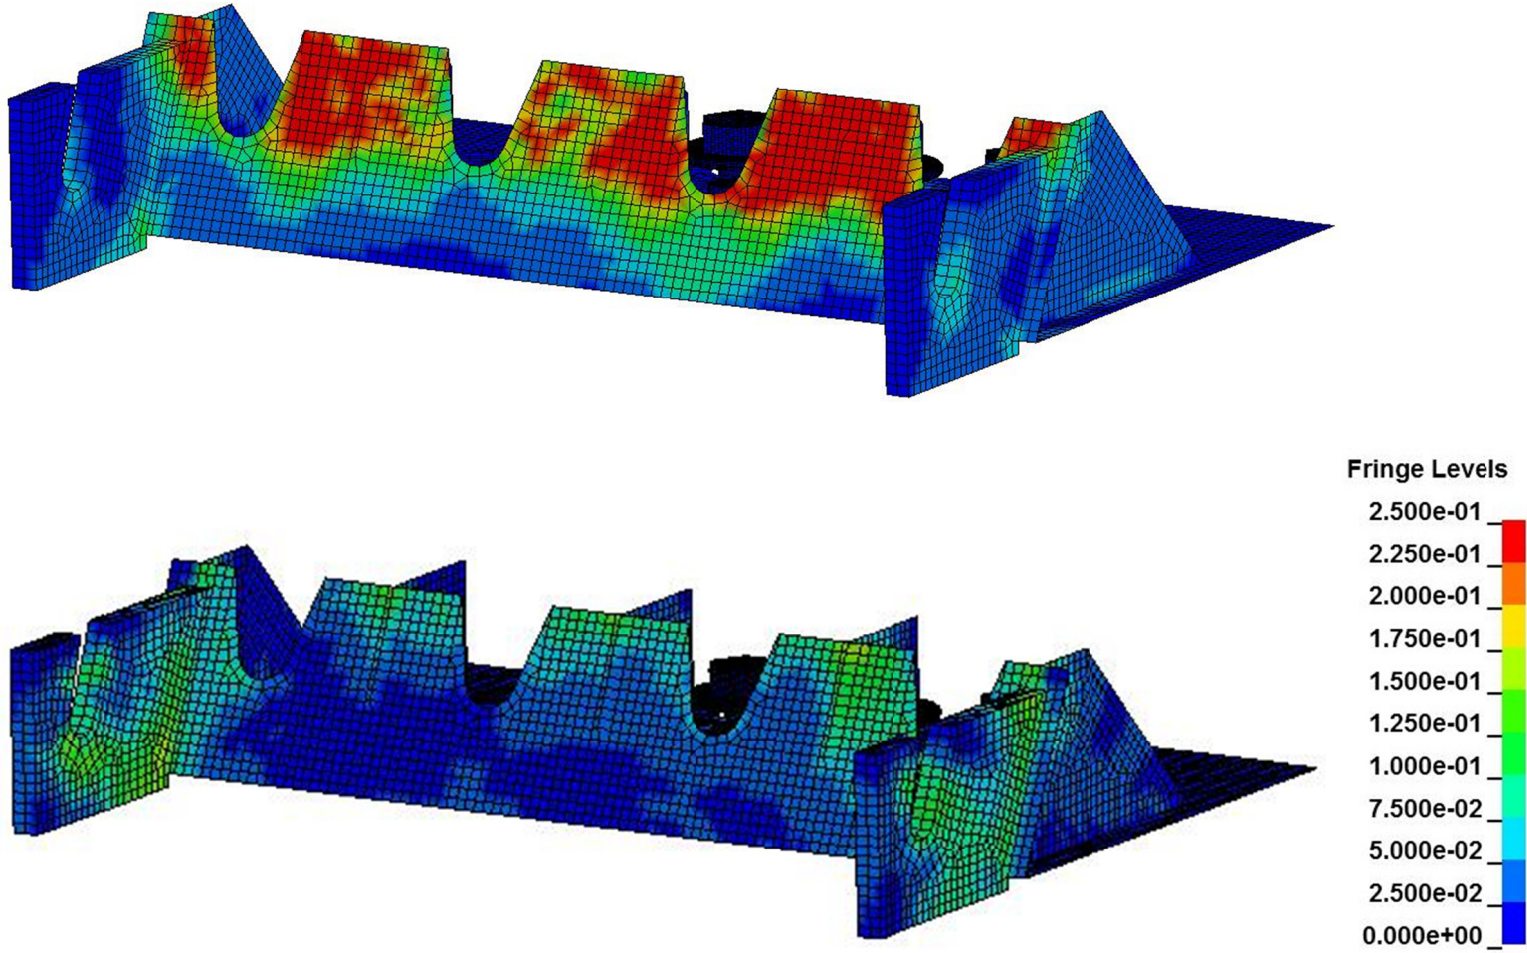
Figure 108. Comparison of Anchor Assembly von Mises' Stress Distribution

These modifications eliminated much of the plastic deformation to the assembly, and in many impact scenarios would ultimately allow the assembly to be reused through multiple impacts. The maximum von Mises' stress in the cable plate was reduced from 58.5 ksi to 48.4 ksi. The final simulation showed no permanent deformation to the cable anchor bracket assembly. Based on analysis of the simulation results and engineering judgment, a replacement of the rotational bolt would allow the assembly to be reused without concern for structural adequacy or unintended release mechanics upon impact. Substituting the currently specified bolt in the assembly with one fabricated from a higher grade steel could potentially eliminate the deformation entirely, and is also an option. The maximum stress in the anchor bracket components are shown in Figure 108.
